Reference: Burlington Memorial Auditorium; Masonry Wall Deterioration

The following is a summary of my observations and opinions regarding the deterioration of the exterior masonry walls at the Burlington Memorial Auditorium. This summary is intended to supplement a more comprehensive Facilities Assessment Report on the Auditorium that was prepared by Stantec in April 2009 (see Attachment 2).

**FACILITIES ASSESSMENT
REPORT
For
Burlington Memorial Auditorium
Burlington, Vermont**

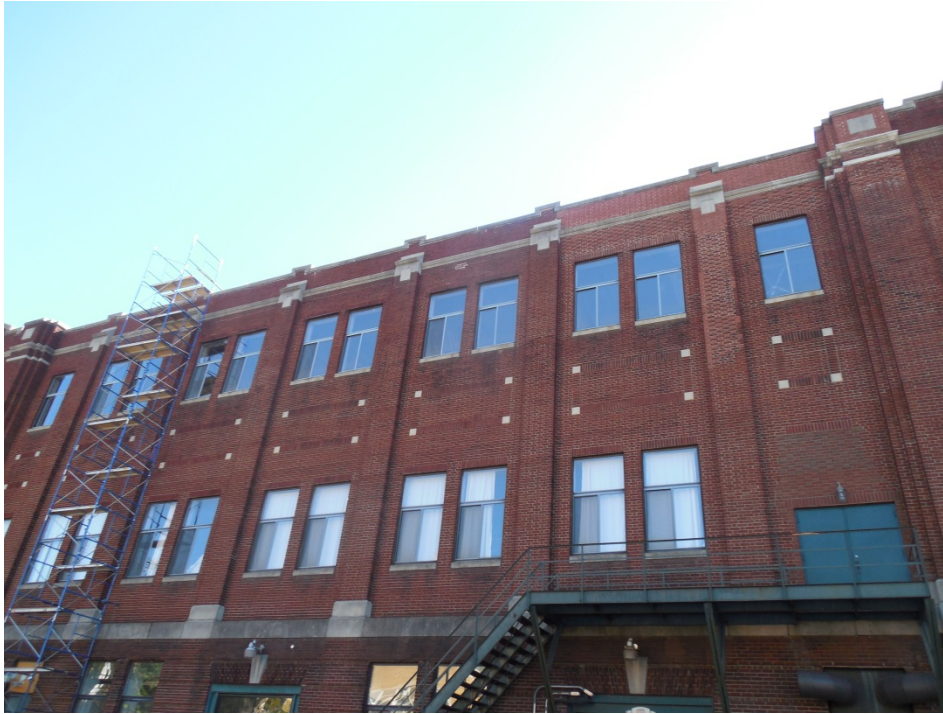
Photo 1: North Wall

The exterior walls of the building are multi wythe brick masonry, with ornate cast stone (concrete) belt and cap courses, sills and trim (see Photo 1). A 12" wide brick parapet wall extends above the roof level. There are 6 brick pilasters in the north and south walls of the building. 12" deep steel columns are embedded in these pilasters to support the steel roof trusses. There are also 6" deep horizontal steel beams embedded in the brick walls, just above the upper window level. The steel members that are embedded in the wall are corroding in some areas, due to moisture in the wall. Since there is no insulation or air barrier in the wall, moisture migration is likely occurring from the interior and exterior depending on seasonal and diurnal temperature and humidity differentials. In areas of the wall where the masonry is in tight contact with the steel, the steel corrosion is exerting pressure on the masonry, resulting in cracks in the brick walls (see Photos 2, 3 & 4). The worst locations are the upper portions of the pilasters and the area of the horizontal steel beams that are located above the upper windows. The steel lintels for the upper windows are also corroding badly and exerting pressure on the window units (see Photo 5). Additionally, the cast stone elements have deteriorated significantly in some locations (see Photo 6). These problems mainly exist in the north and south walls of the building. The north wall is in worse condition than the south wall, likely due to warming and drying effect of the sun on the south side. The corrosion of the vertical steel columns is also worse on the outside flange of the columns, probably due to the generally colder temperatures on the outside face. The east and west ends of the building do not have embedded steel members in the wall, so they do not exhibit similar problems.

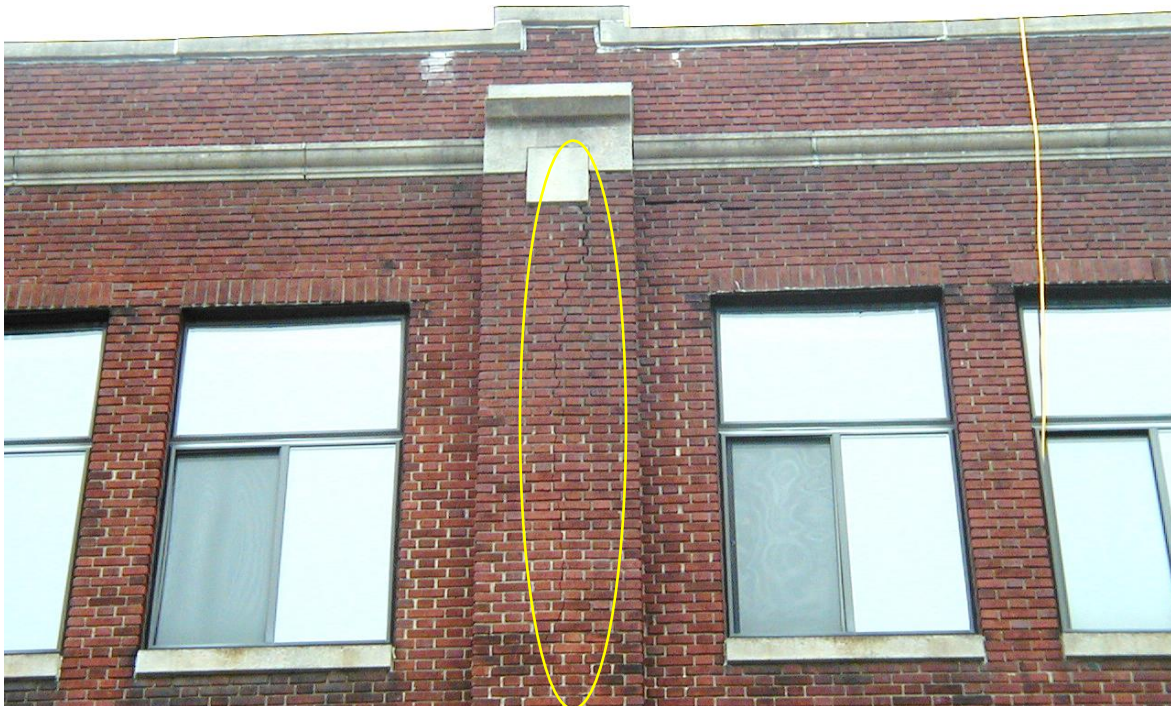
Photo 2: Pilaster Vertical Crack

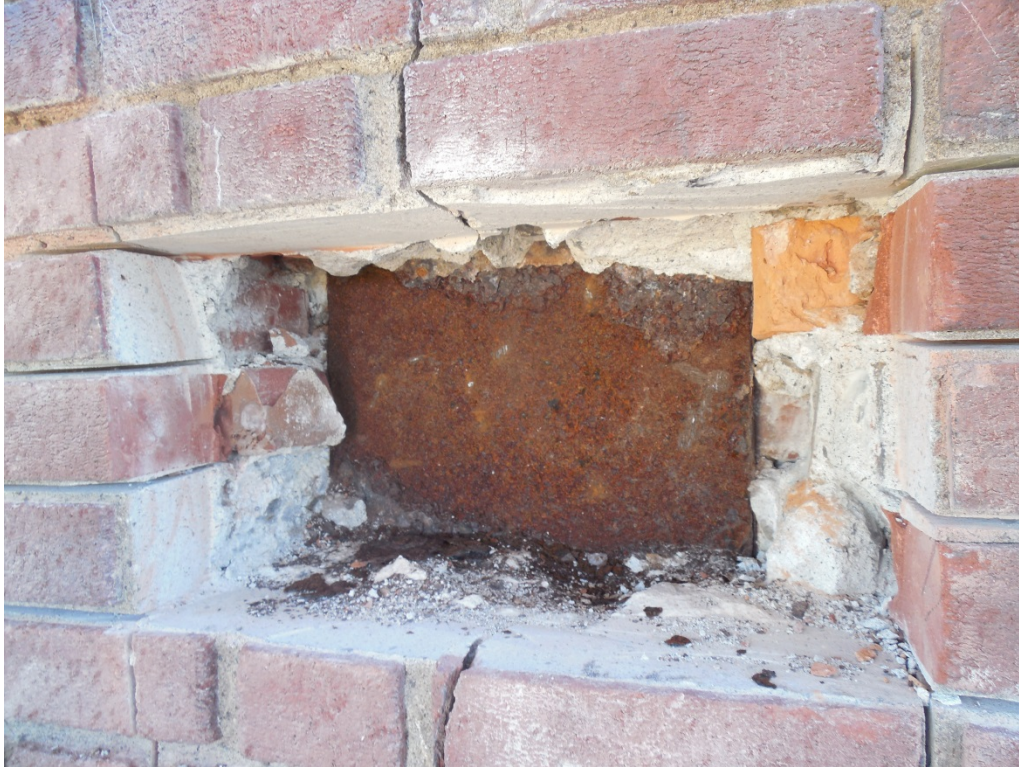
Photo 3: Steel Column Corrosion

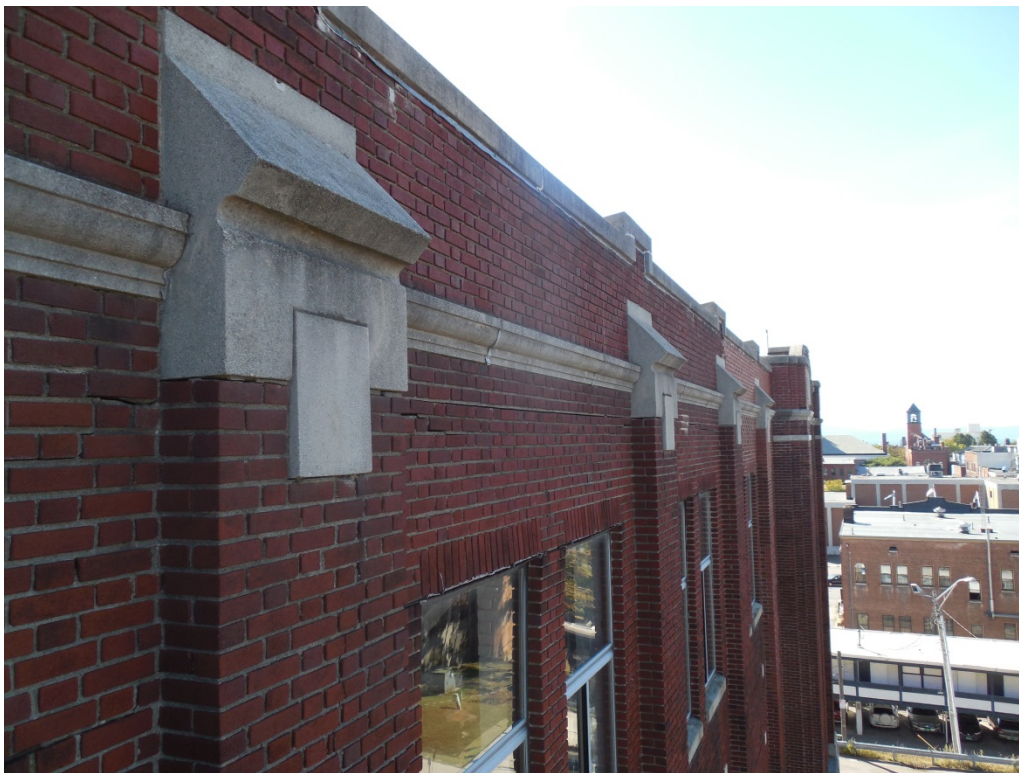
Photo 4: Horizontal Masonry Crack

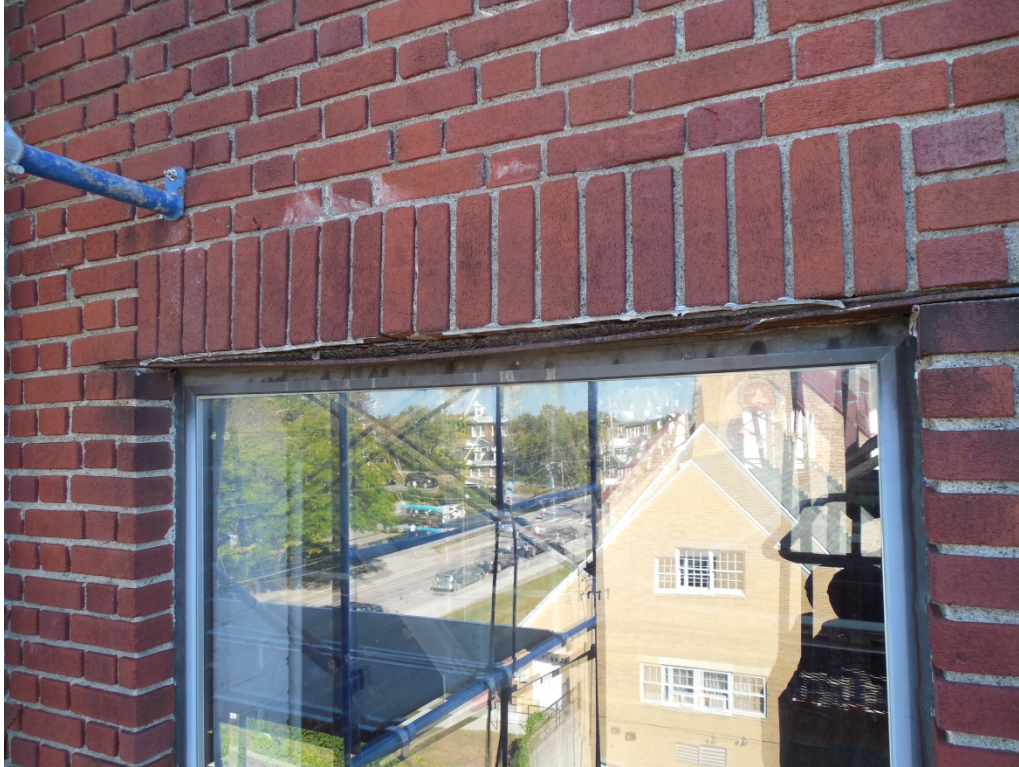
Photo 5: Steel Lintel Corrosion

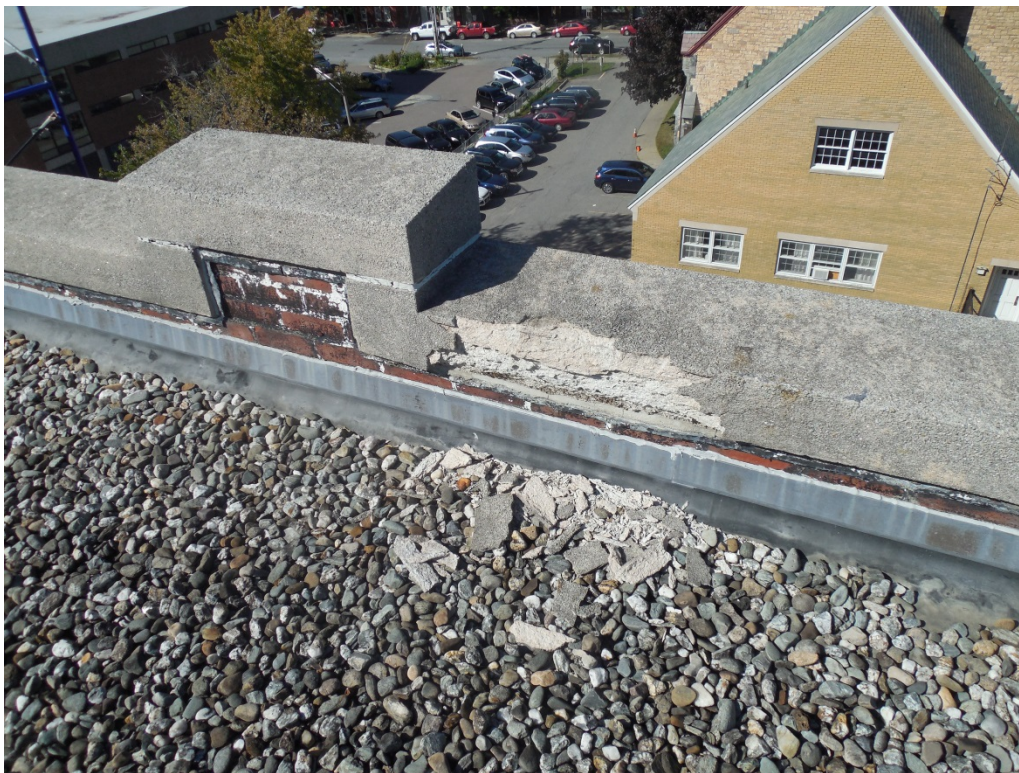
Photo 6: Concrete Cap Deterioration

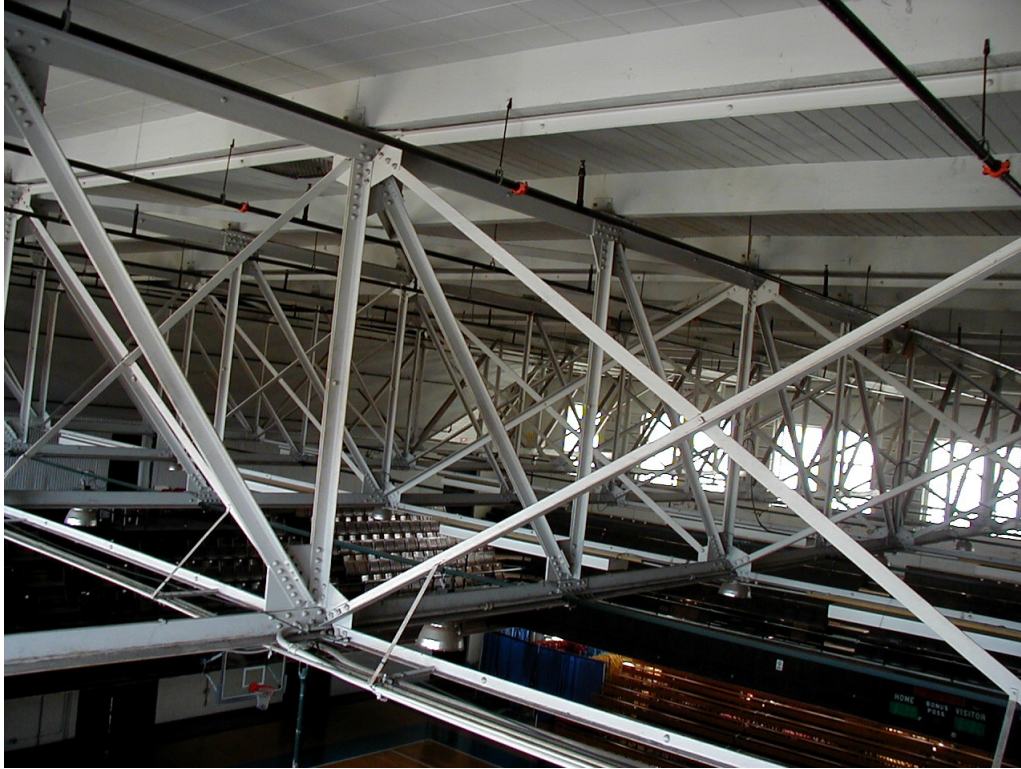
Photo 7: Steel Roof Trusses

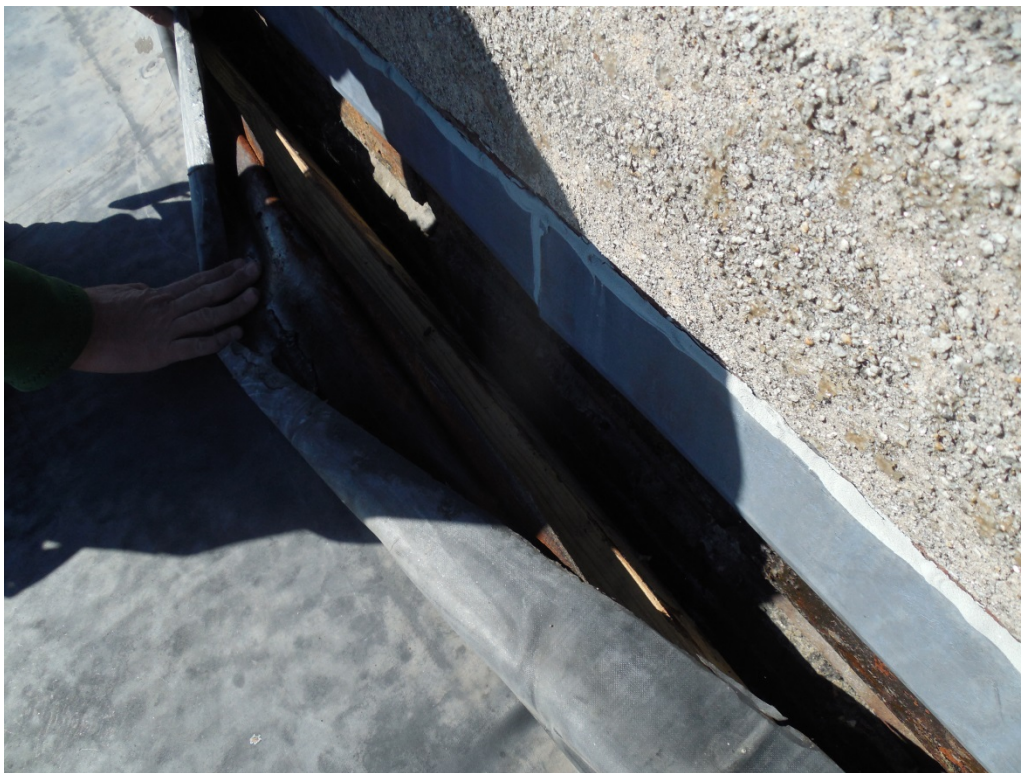
Photo 8: Roof Membrane

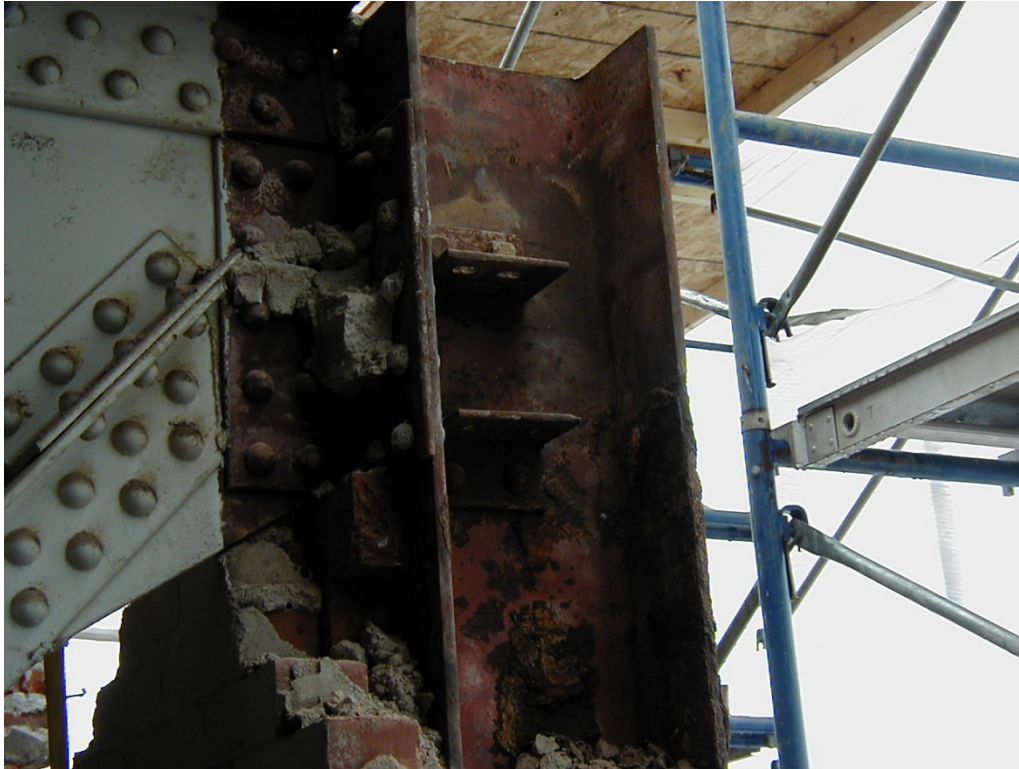
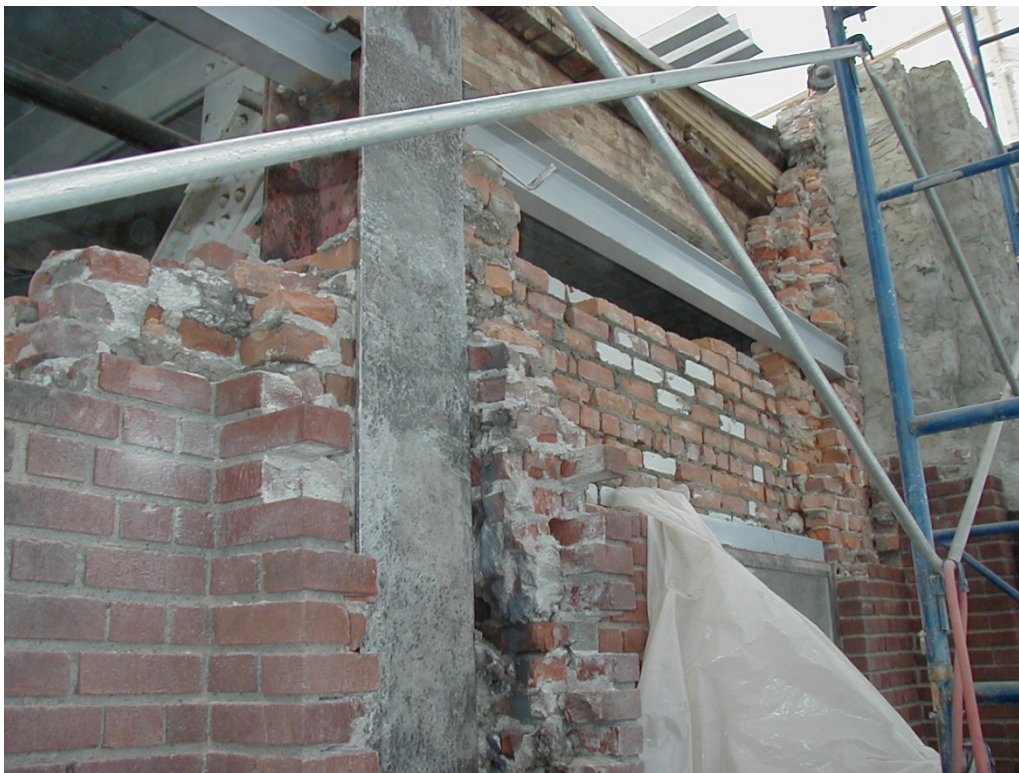
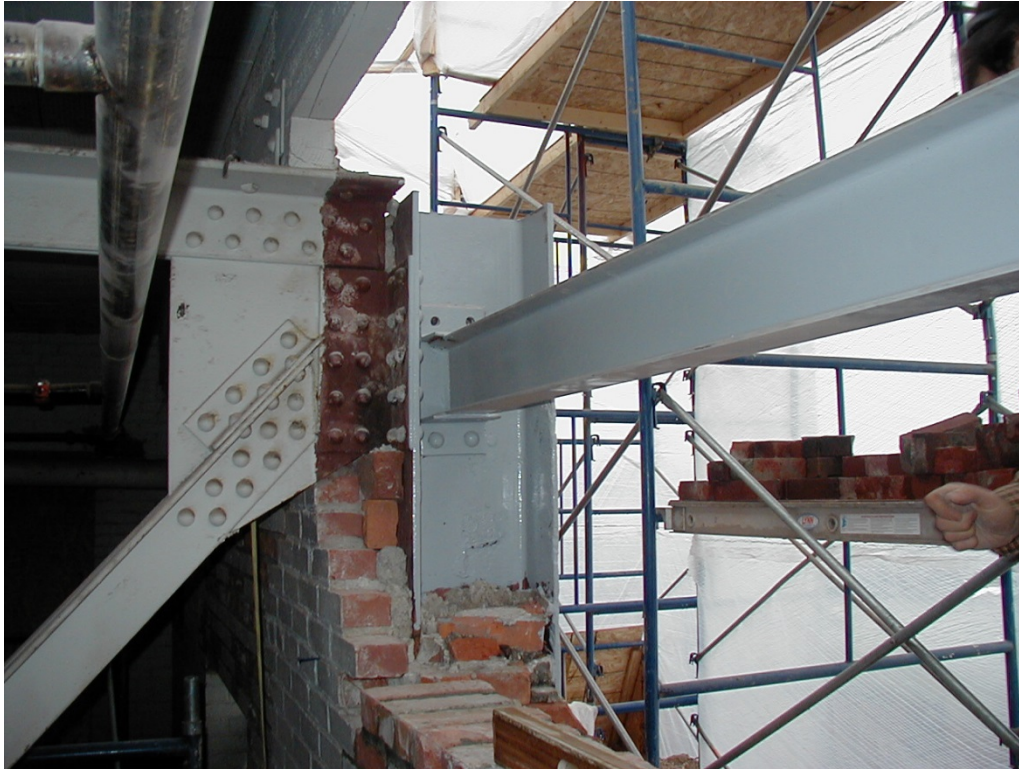
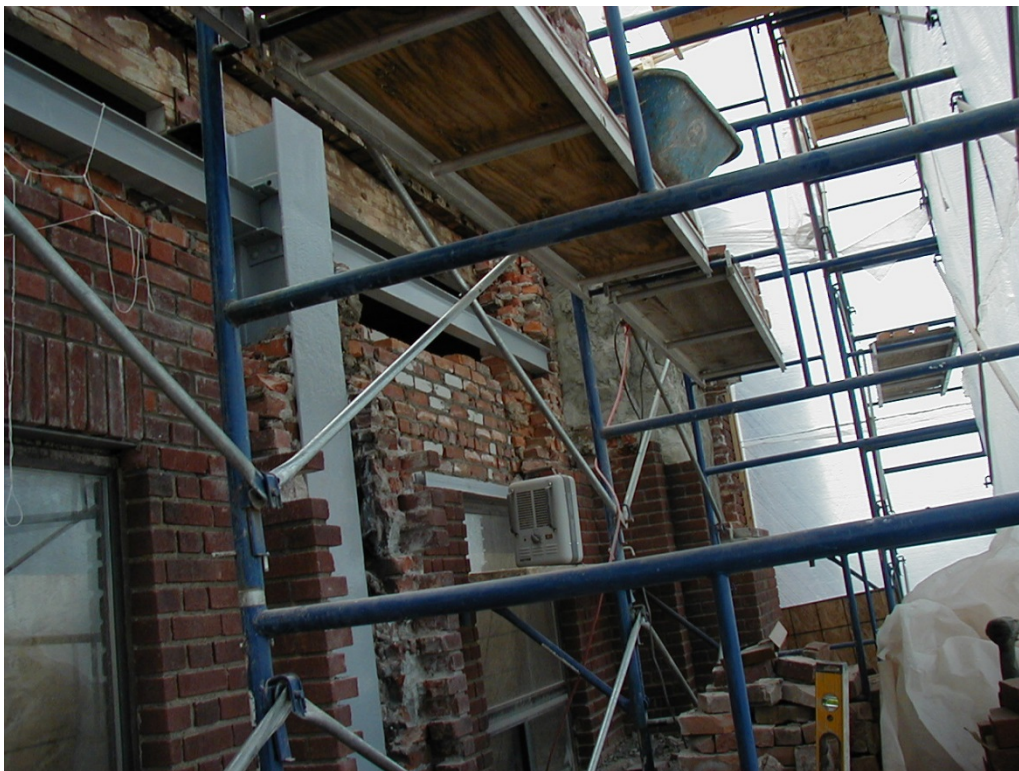
In April of 2008, repairs to the west end of the north wall were made to correct the problems noted above (see Photos 9-12). This work included removal of the brick around the top portion of the

steel columns, removal of the brick on the outside face of the steel column down to about 20' from the top of the column, and removal of the brick wall above the top of the upper windows. The 6" deep horizontal steel beams between the tops of the columns were in very poor condition and were replaced with new steel beams. The outside flanges of the columns were cleaned and painted with a protective coating and new steel lintels were installed over the windows. Pre-cast stone elements were also replaced, as needed.

Photo 9: 2008 Repairs
