# Arms Grant Property Trail System

## Trail Maintenance Management Plan and Inventory

**Prepared by Sinuosity, LLC**

**For the City of Burlington Department of Parks & Recreation**

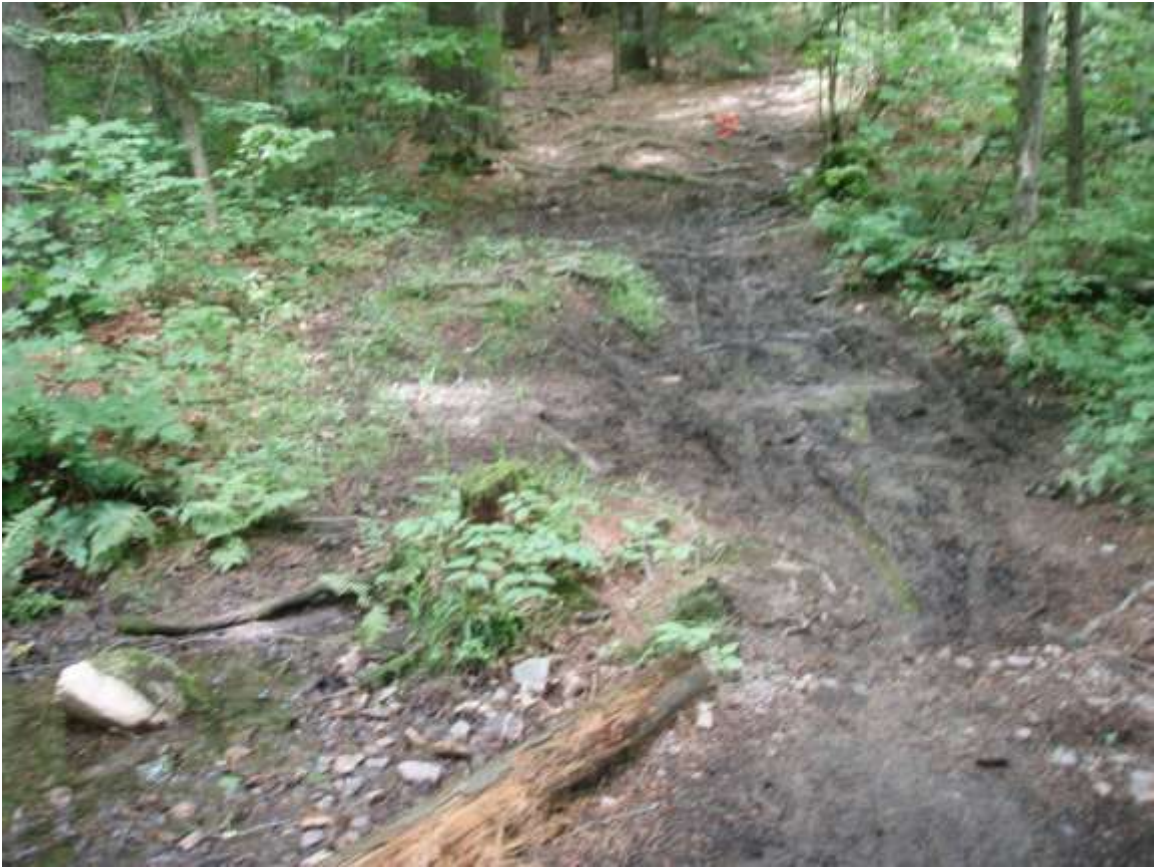
X-C Course: Steep muddy area, boardwalk and re-route proposed

Summary of Recommended Improvements: Boardwalks and importing tread material to raise the tread will mitigate the current trail widening in wet and muddy areas along with two short reroutes to more sustainable terrain and the instillation of drainage, where possible. Sections of exposed bedrock with occasional protruding rock and roots can be graded with fill to even out the tread way and bring the trail to a continual Class 3 status. To reduce the erosion to the upper BHS parking lot entrances to this trail, drainage features can be installed and paired with closing the more southerly entrance to concentrate use on the more stable route.

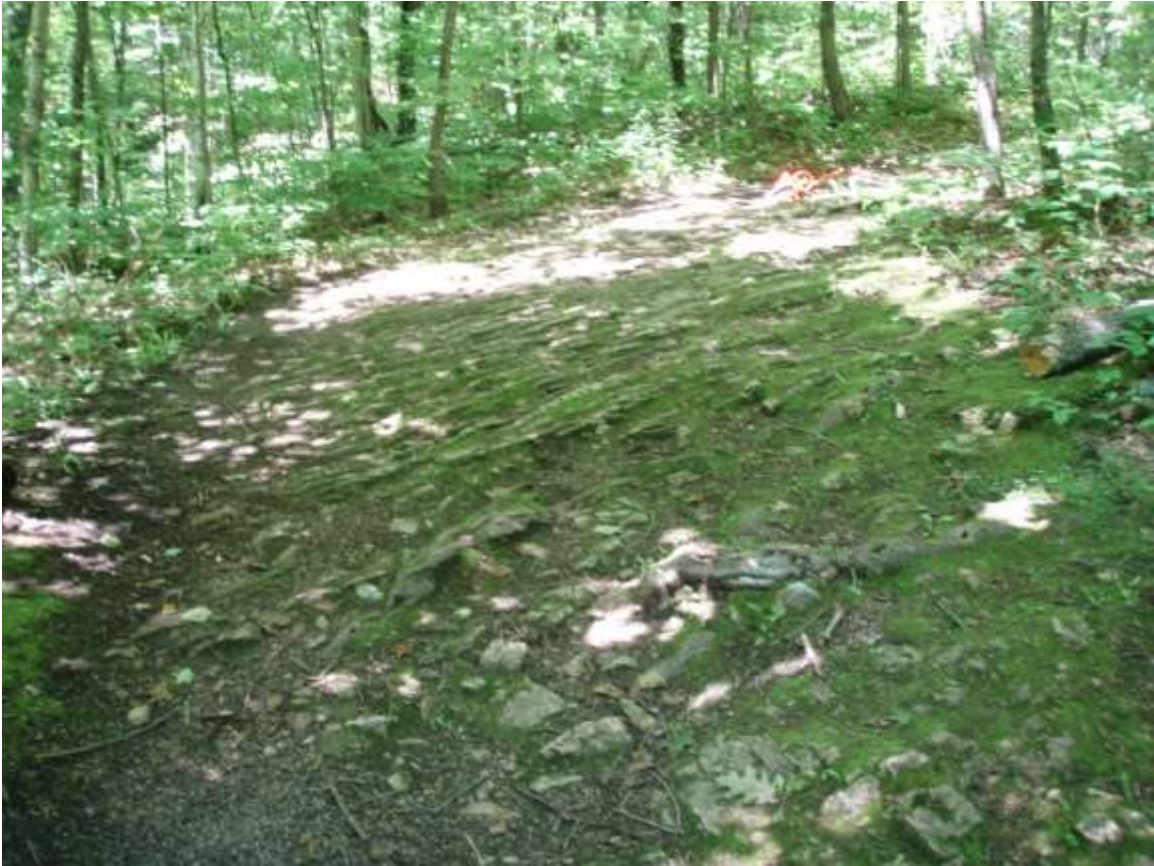
X-Country Course: Tread creep on a wide section of exposed ledge, crushed stone surfacing with retaining rock cribbing are proposed

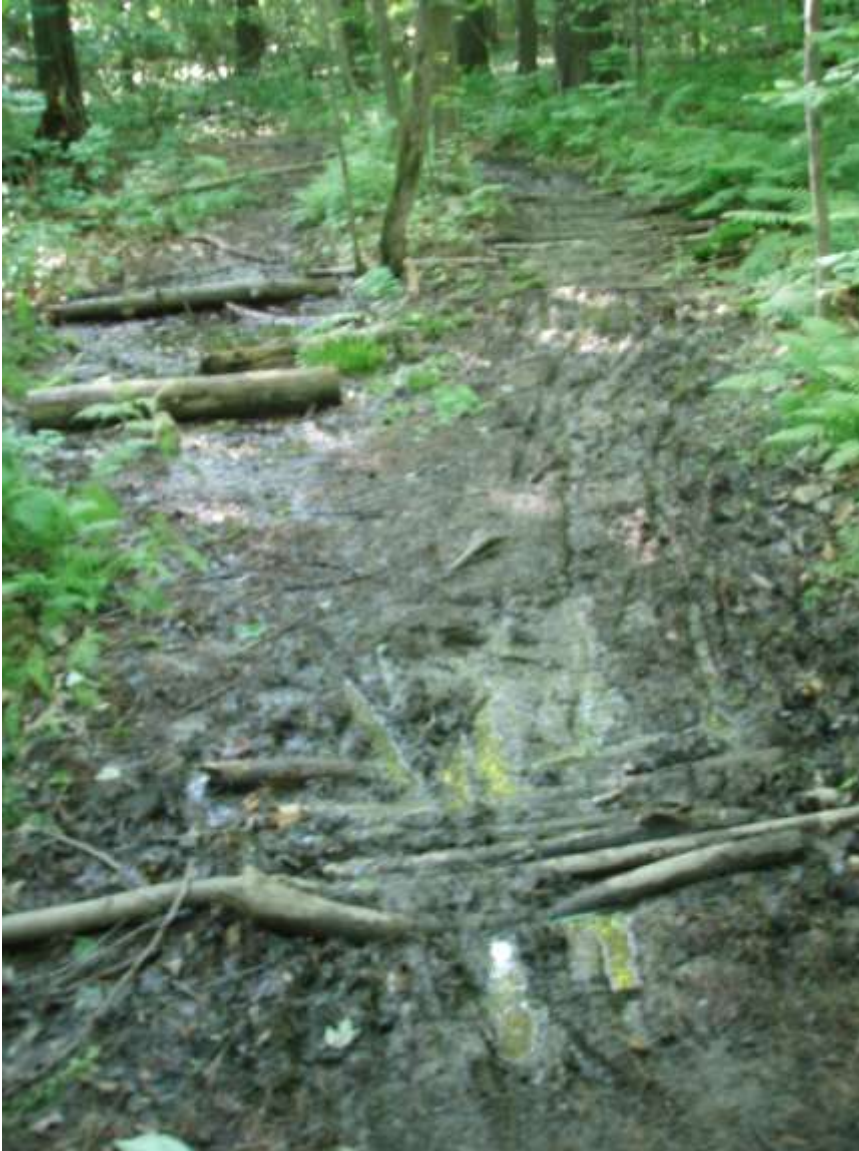
Boardwalk Trail: Low lying muddy section, boardwalk proposed

Summary of recommended improvements: 208 feet of boardwalk would bring this trail up to standard and mitigate current trail widening. It is recommended that constructed boardwalk is in keeping with an Intermediate (Class 2) trail experience.

Priority: Trail improvements on this trail are considered of moderate priority (year 2 of the maintenance and improvement plan) since the trail is quickly widening due to the wet and muddy trail conditions. These improvements will bring the entire trail to a Class 2 standard.
