CHURCH STREET MARKETPLACE PEDESTRIAN & STREETScape ASSESSMENT

*Final Report
June 2, 2017*

CHURCH STREET
MARKETPLACE

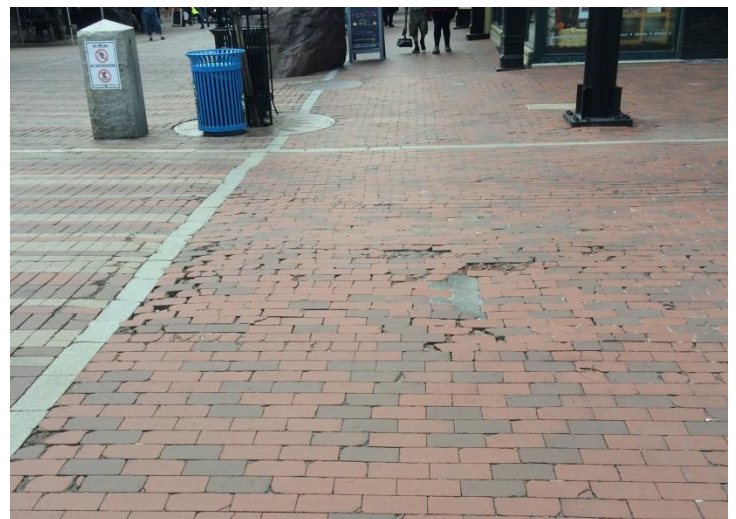
Figure 2: Paver Damage at Bank & Church Streets

As depicted on Sheet 1 of Appendix C, this intersection features granite curb bump-outs, a roughly 80-foot wide brick-paved pedestrian corridor, and Bank Street catch basins east of Church Street. The existing paver pattern here is a tri-tone, repeating linear pattern that matches the bricks paving the center of Church Street. The brick pavers at this intersection are currently severely damaged as depicted in Figure 2. Additionally, there is a slight heave spot around a utility manhole at the northwest corner of the intersection. This corridor also lacks ADA tactile warning surface pavers. Sheet C-2B of Appendix D illustrates Dubois & King's proposed improvements to this high-priority location, which are listed below. **(Budgetary estimate for this intersection upgrade is \$220,000)**

- Full width granite detectable warning strips similar to those at Church and Cherry Streets intersection. Details found in Appendix E.
- Granite bordered crosswalks at each vehicular approach
- Extension of granite meridian line through intersection
- General alternating paver pattern similar to alternatives

Existing Bank Street granite speed rumble control strips on both Bank Street vehicular approaches are also to be removed and paved over. It was noted during project meetings that these fall outside of the Marketplace's domain.

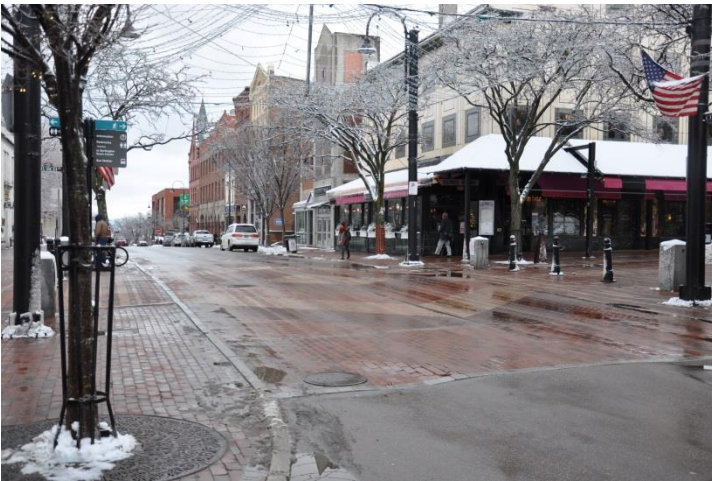
Figure 3: Paver Damage at College & Church Streets

An existing conditions plan for the Church and College streets intersection can be found on Sheet 2 of Appendix C. This intersection is similar to Church and Bank Streets; featuring the same granite curb bump-outs as well as a roughly 65-foot wide brick-paved pedestrian corridor. The current paver pattern here is a tri-tone, diamond-shaped pattern matching that of the Church and Cherry Streets intersection. There are existing catch basins on College Street just east of the intersection. Crosswalk paver damage here is moderate but there are accompanying drainage problem spots, as Figure 3 shows. There is also a low spot on the northern edge of College Street east of the intersection. Sheet C-2A of Appendix D shows the proposed improvements to the Church and College streets

intersection, which incorporates the same elements as Church Street and Bank Street. **(Budgetary estimate for this intersection upgrade is \$195,000)**

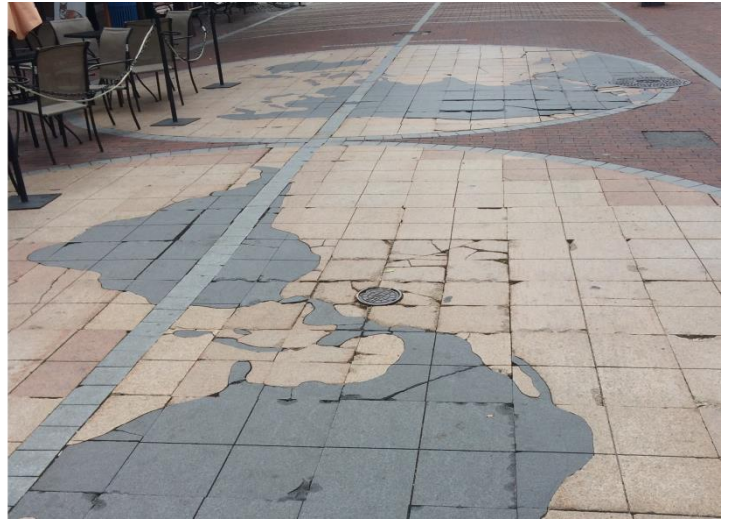
Figure 4: Stone Globe Paver Damage

Many of the stone globe pavers in front of Burlington City Hall are loose and fragmented as Figure 4 illustrates, tarnishing the Marketplace aesthetics that attract visitors from around the world. This is likely due to improper installation and compaction especially for some utility maintenance work, reducing the lifespan of this feature. The Globe Stone Paver Detail on Sheet C-3 of Appendix D outlines the correct installation procedure for these pavers. Maintenance for this area will require careful review of paver type and layout to be provided by contractor. This typical detailing for paver installation should be a requirement for tenants and for utilities performing work within Church Street. Management of this may require the use of approved vendors. **(Budgetary estimate for repair of this area is \$65,000)**

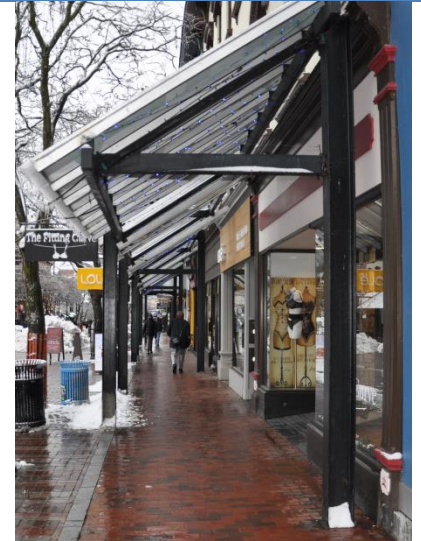
Storefront canopies like the one pictured in Figure 5 are a prevalent feature of the shops at Church Street Marketplace. Originally designed to be easily modified into second story walkways, that vision was never realized. Now many members of the Marketplace are interested in their removal. Some previously removed canopies and associated foundations were not properly removed, leaving frost /hard spot humps in the replaced pavers. Dubois & King has provided a Typical Canopy Post Removal Detail on Sheet C-3 of Appendix D that outlines the proper method for canopy post removal.

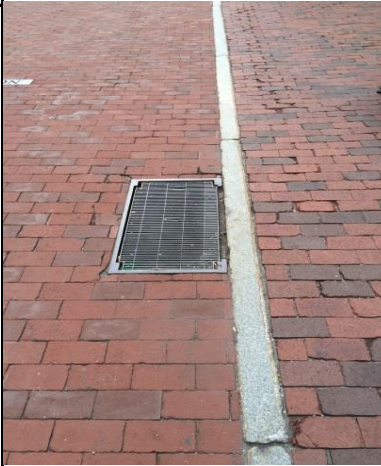
CHURCH STREET MARKETPLACE	Visual Site Evaluation
			Updated Date: 1/30/2017
REQUIRED MAINTENANCE			
Item #	Category	Description	Image
1	Grading	Puddle	
2	Utilities	GV low	
3	Vaults	Stormwater leaking into vault (office space)	
4	Utilities	Catch basin lip low (looks typ for this model CB)

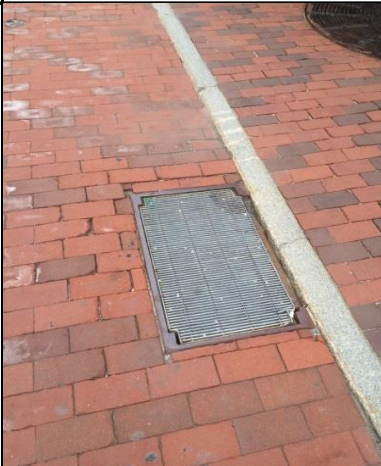
5	Utilities	Catch basin lip low (looks typ for this model CB)

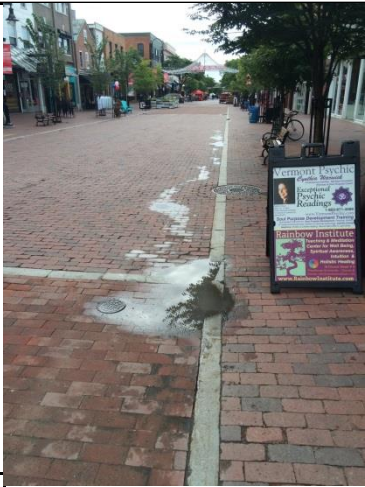
8	Grading	Puddle

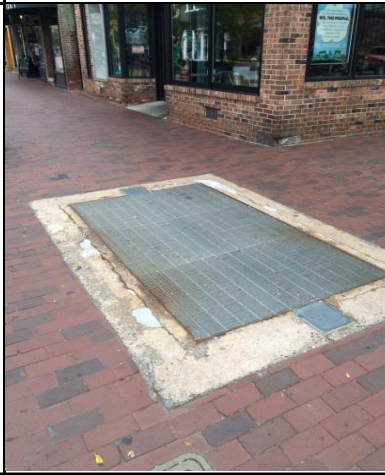
9	Grading	Puddle	
10	Grading	Puddle	
11	Vaults	Concrete edge of vault severely cracked

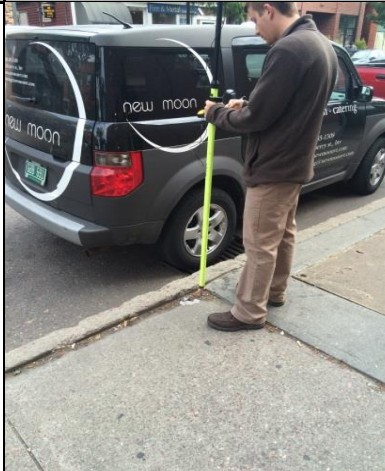
12	Grading	Puddle	
13	Damaged Pavers	Curb lip dips

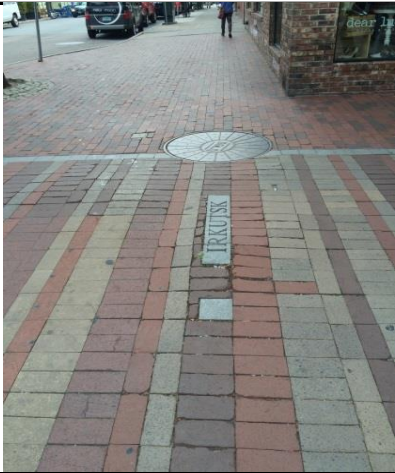
14	Damaged Pavers	bump in brick pavers at international city 'Irkutsk' granite paver

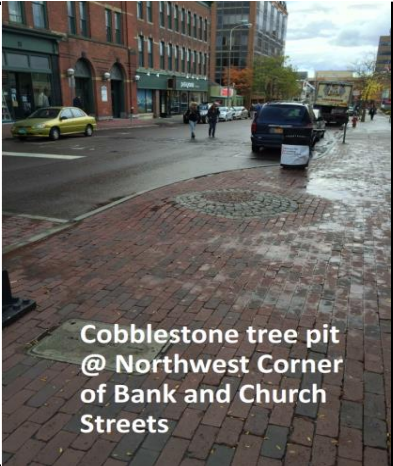
19	Tree Pit Removal	Cobblestone tree pit at northwest corner of Bank & Church Streets to be removed and paved over

The two dying trees called out on Sheets C-1 and C-2 of Appendix A are to be removed. There are also three tree pits to be removed and bricked over per the Typical Brick Paver Detail on Sheet C-3 of Appendix D. They are located at the northwest and southeast corners of the Bank and Church streets intersection (maintenance items #19 and #21 respectively) as well as in front of 107 Church Street (currently the Optical Center, maintenance item #28), shown on Sheets C-2 and C-3 of Appendix A. These tree pits are no longer in use; their trees have been previously removed and stumps cut down flush with grade.

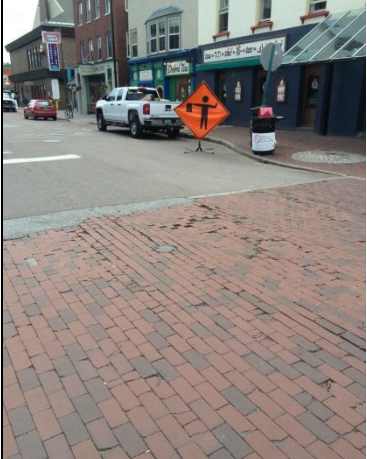
A photograph showing a cobblestone tree pit at the northwest corner of Bank and Church Streets. The pit is a circular area of cobblestones in the middle of a brick-paved sidewalk. In the background, there are brick buildings, a yellow car, and a dark car on the street.
20	Damaged Pavers	Bank Street intersection crosswalk bricks damaged

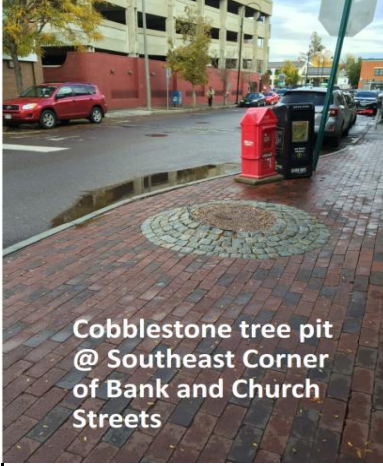
A photograph showing the intersection of Bank Street and Church Street. The crosswalk area is paved with red bricks, some of which appear damaged or missing. A white pickup truck is parked on the street, and a yellow diamond-shaped construction sign is visible.
21	Tree Pit Removal	Cobblestone tree pit at southeast corner of Bank & Church Streets to be removed and paved over

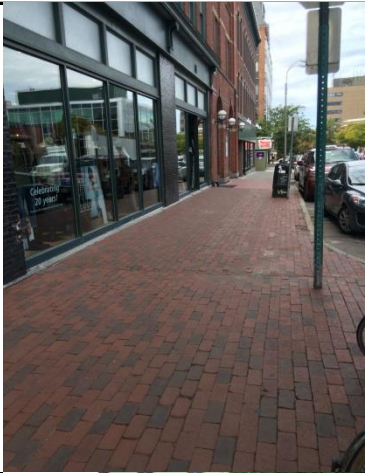
24	Vaults	Potential vault

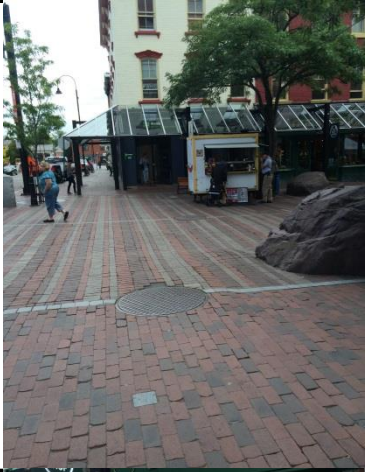
25	Utilities	Manhole heave

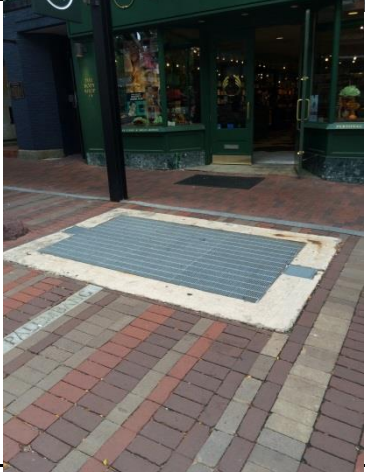
26	Vaults	Concrete edge of vault high - trip hazard

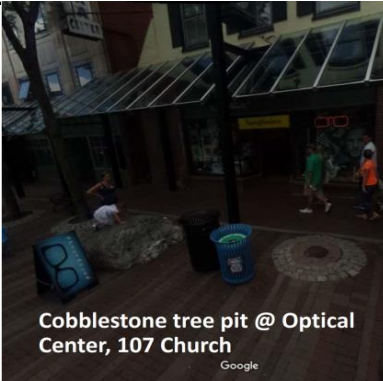
28	Tree Pit Removal	Cobblestone tree pit at 107 Church St (Optical Center) to be removed and paved over

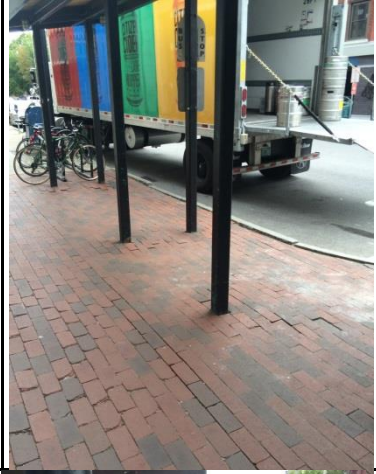
<p>Cobblestone tree pit @ Optical Center, 107 Church</p> <p>Google</p>
29	Damaged Pavers	Brick settle under bus stop roof

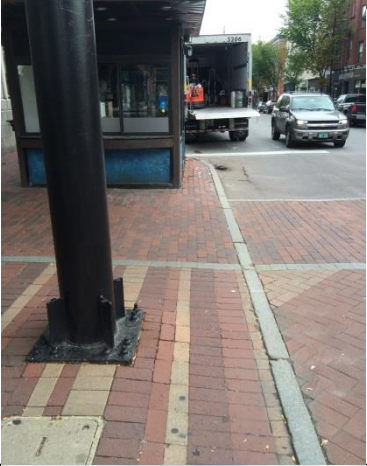
30	Grading	Low spot in road

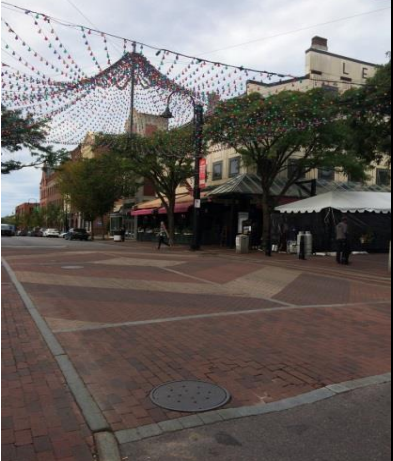
31	Damaged Pavers	College Street intersection crosswalk bricks damaged

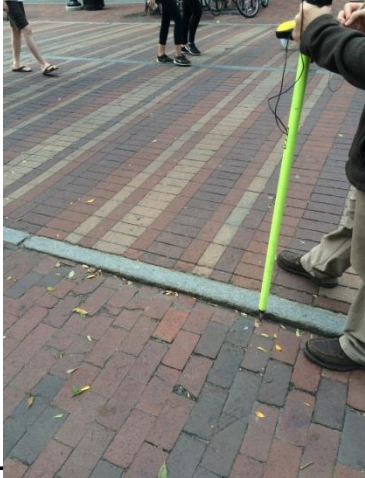
32	Utilities	Manhole low	
33	Damaged Pavers	Granite paver divider high - trip hazard

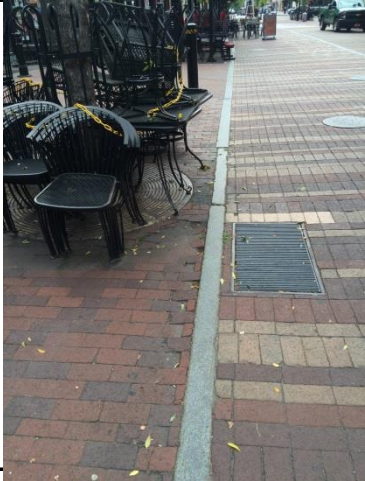
34	Utilities	Electric Manhole rim high - trip hazard	
35	Vaults	Vault & concrete edge in rough shape	
36	Utilities	GV low	
37	Damaged Pavers	Trip hazard

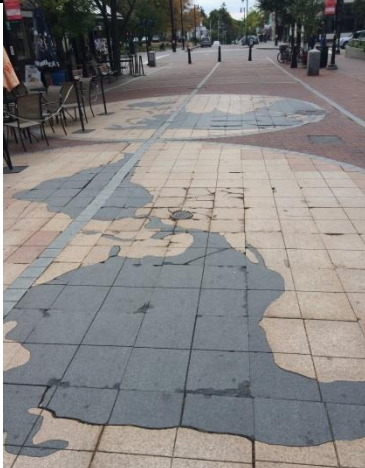
38	Damaged Pavers	Concrete pad high - trip hazard	
39	Damaged Pavers	Tree paver low	
40	Damaged Pavers	Globe paver broken

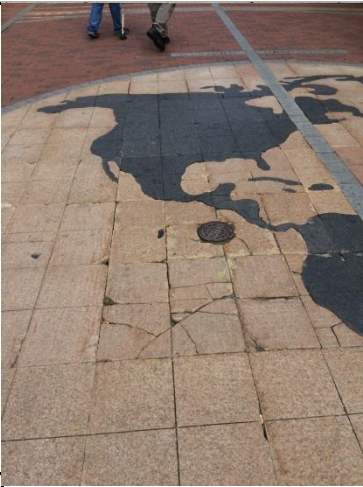
41	Utilities	WV in globe pavers

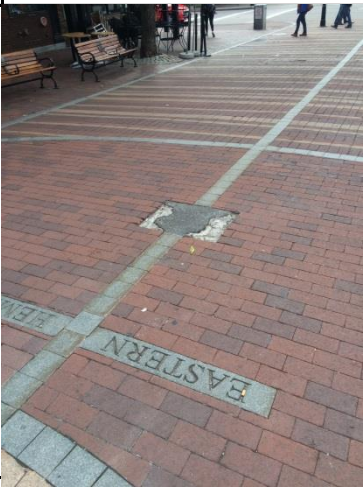
42	Vaults	Vault	
43	Damaged Pavers	Paver missing
