# FACILITY CONDITION ASSESSMENT AND LEVEL I ENERGY AUDIT

## FACILITY CONDITION ASSESSMENT AND LEVEL I ENERGY AUDIT of MEMORIAL AUDITORIUM 250 Main Street Burlington, Vermont 05401

**EMG Project #:** 110266.14R-009.294  
**Date of Report:** October 28, 2014  
**On site Date:** August 28 and 29, 2014

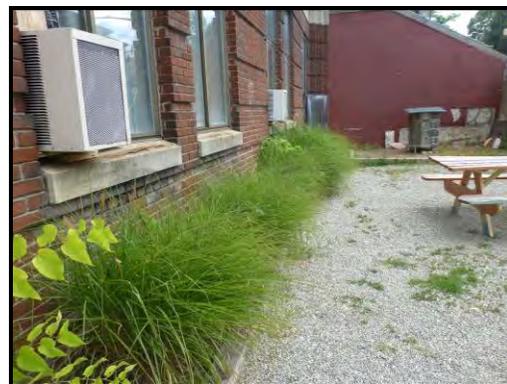
- It was reported by the tenants that during storms the south side of the building backs up with municipal drainage water. The topography and adjacent properties present conditions detrimental to the property. An engineering drainage study is required to determine the cause and possible solutions. The cost of this work is included in the Replacement Reserves Report.
- The landscape materials are in good condition and will require routine maintenance during the assessment period.
- The retaining wall on the south side of the property and the retaining wall on the north side driveway ramp are in fair condition. The walls have minor signs of cracking and spalling. To maintain the overall integrity of the wall the faults will require repair during the assessment period. The cost to study this work is included in the Replacement Reserves Report.

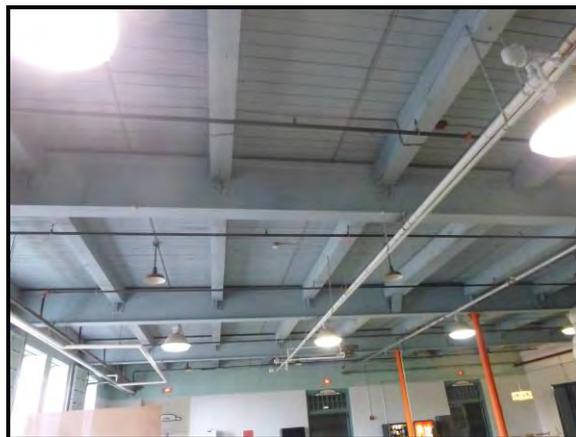
- The superstructure is exposed in some locations, which allows for limited observation. It was reported by the maintenance personnel that the building's exterior walls are pulling away from each other. Through a limited on site investigation the walls and floors do not appear to be plumb, level, and stable. There are some signs of deflection and movement, mainly localized on the southern wall. The building is located on a site adjacent to the Fletcher Free Library, which saw similar reported issues. The building had to take measures by adding increased structural elements to stabilize the building movement. The cause of the library's movement was due to the ground conditions. The auditorium is located in the vicinity of the library and may be suffering from similar issues. An engineering study will be required to assess the issues and possible solutions. The study will be included with the one mentioned in section 6.1.

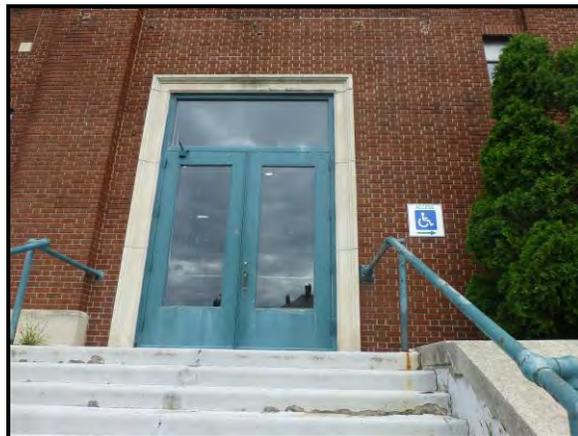
- The main entrance doors are in poor condition. The bottom portions of the doors have rusted and a pen can be pressed through the door panel. The doors weather stripping has failed and the doors no longer sit within their frames flush thus offering an inadequate seal. The frames that the doors rest in are rusted as well. Due to the age and current condition of the doors they will require replacement during the assessment period. The cost of this work is included in the Replacement Reserves Report.

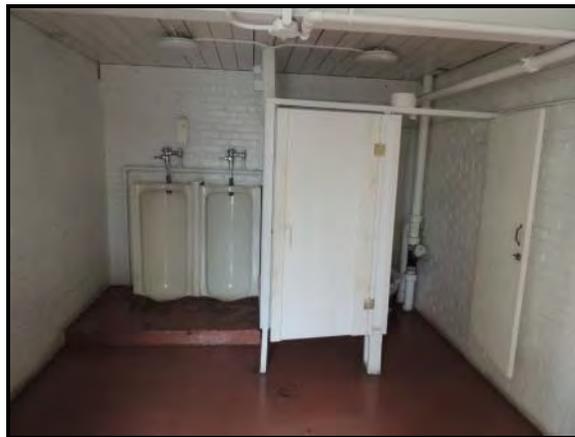
- The plumbing systems appear to be original to the building and in poor condition. The water pressure appears to be adequate. The plumbing systems will require routine maintenance during the assessment period.
- There is no evidence that the property uses polybutylene piping for the domestic water distribution system.
- The pressure and quantity of hot water appear to be adequate.
- The water heaters appear to be in fair condition. Based on their estimated Remaining Useful Life (RUL), the water heaters will require replacement during the assessment period. The cost of this work is included in the Replacement Reserves Report.
- The accessories and fixtures in the restrooms are in poor condition and will require routine maintenance during the assessment period.

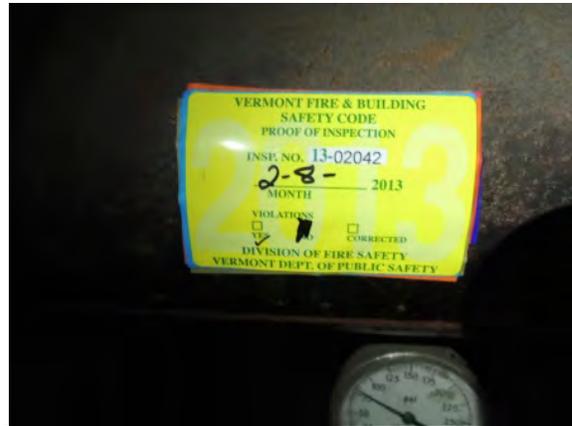
Photo #34: Most recent vermont fire and building safety inspection tag #13-02042 dated february 8, 2013 stating violations exist

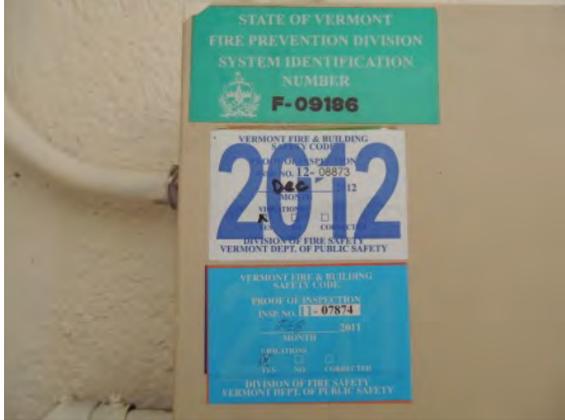
Photo #37: Most recent vermont fire and building safety inspection tag #1208873 dated december 2012 stating violations exist

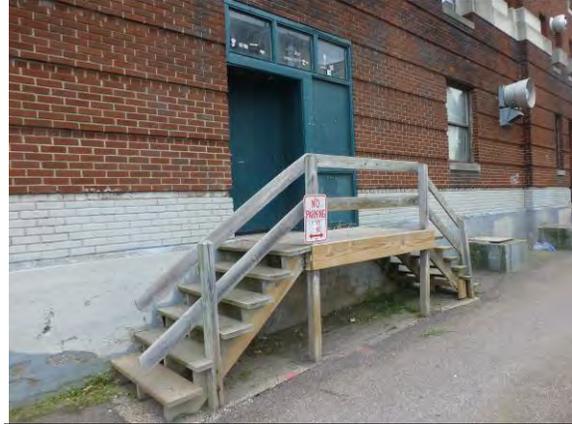
Photo #8: Exterior stairs

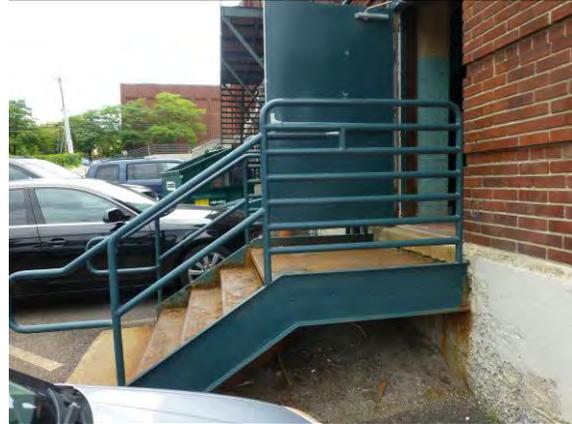
Photo #10: Exterior stairs

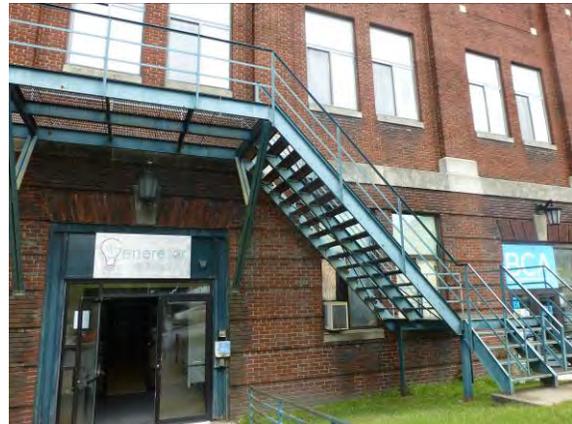
Photo #12: Exterior stairs

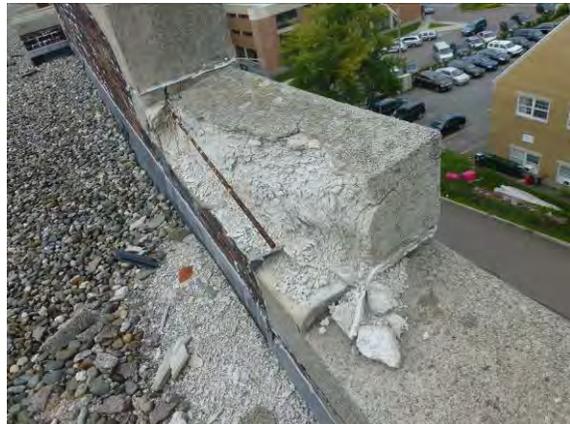
Photo #24: Damaged parapet wall
