Code Enforcement DPW appeal

66-68 South Union Street

Code Enforcement Timeline of inspections at this property

Code Enforcement DPW appeal hearing

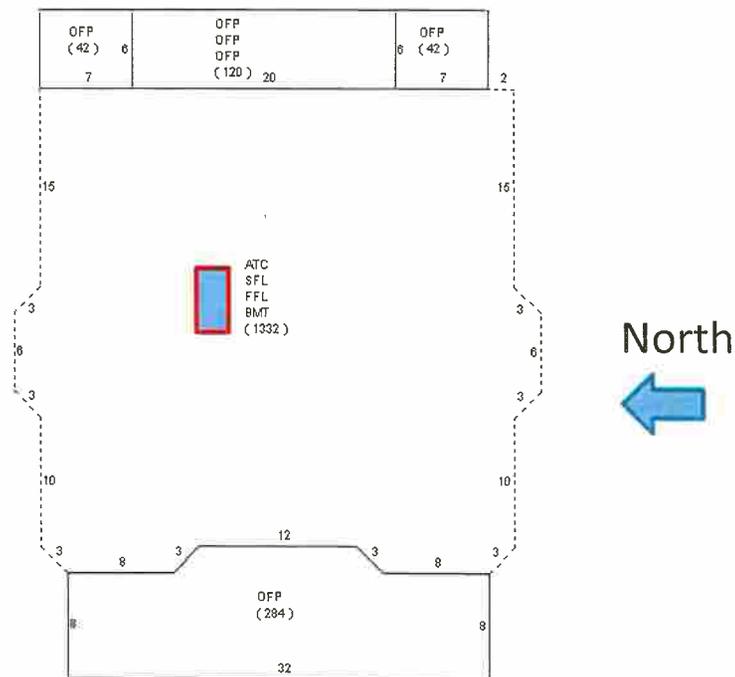
Unit/Area Basement steps (Item 7 of 18)

Finding: Path of egress is obstructed or otherwise unsafe. debris at top of stairs to basement not allowing door to open fully as per fire marshal inspection on 11/20/2015

Basement door indicated by red rectangle. Door leads from ground floor into the basement
This door would not open fully. It was partially blocked by stored debris.

Remedy: Remove obstructions behind door to basement and maintain safe path of egress at all times

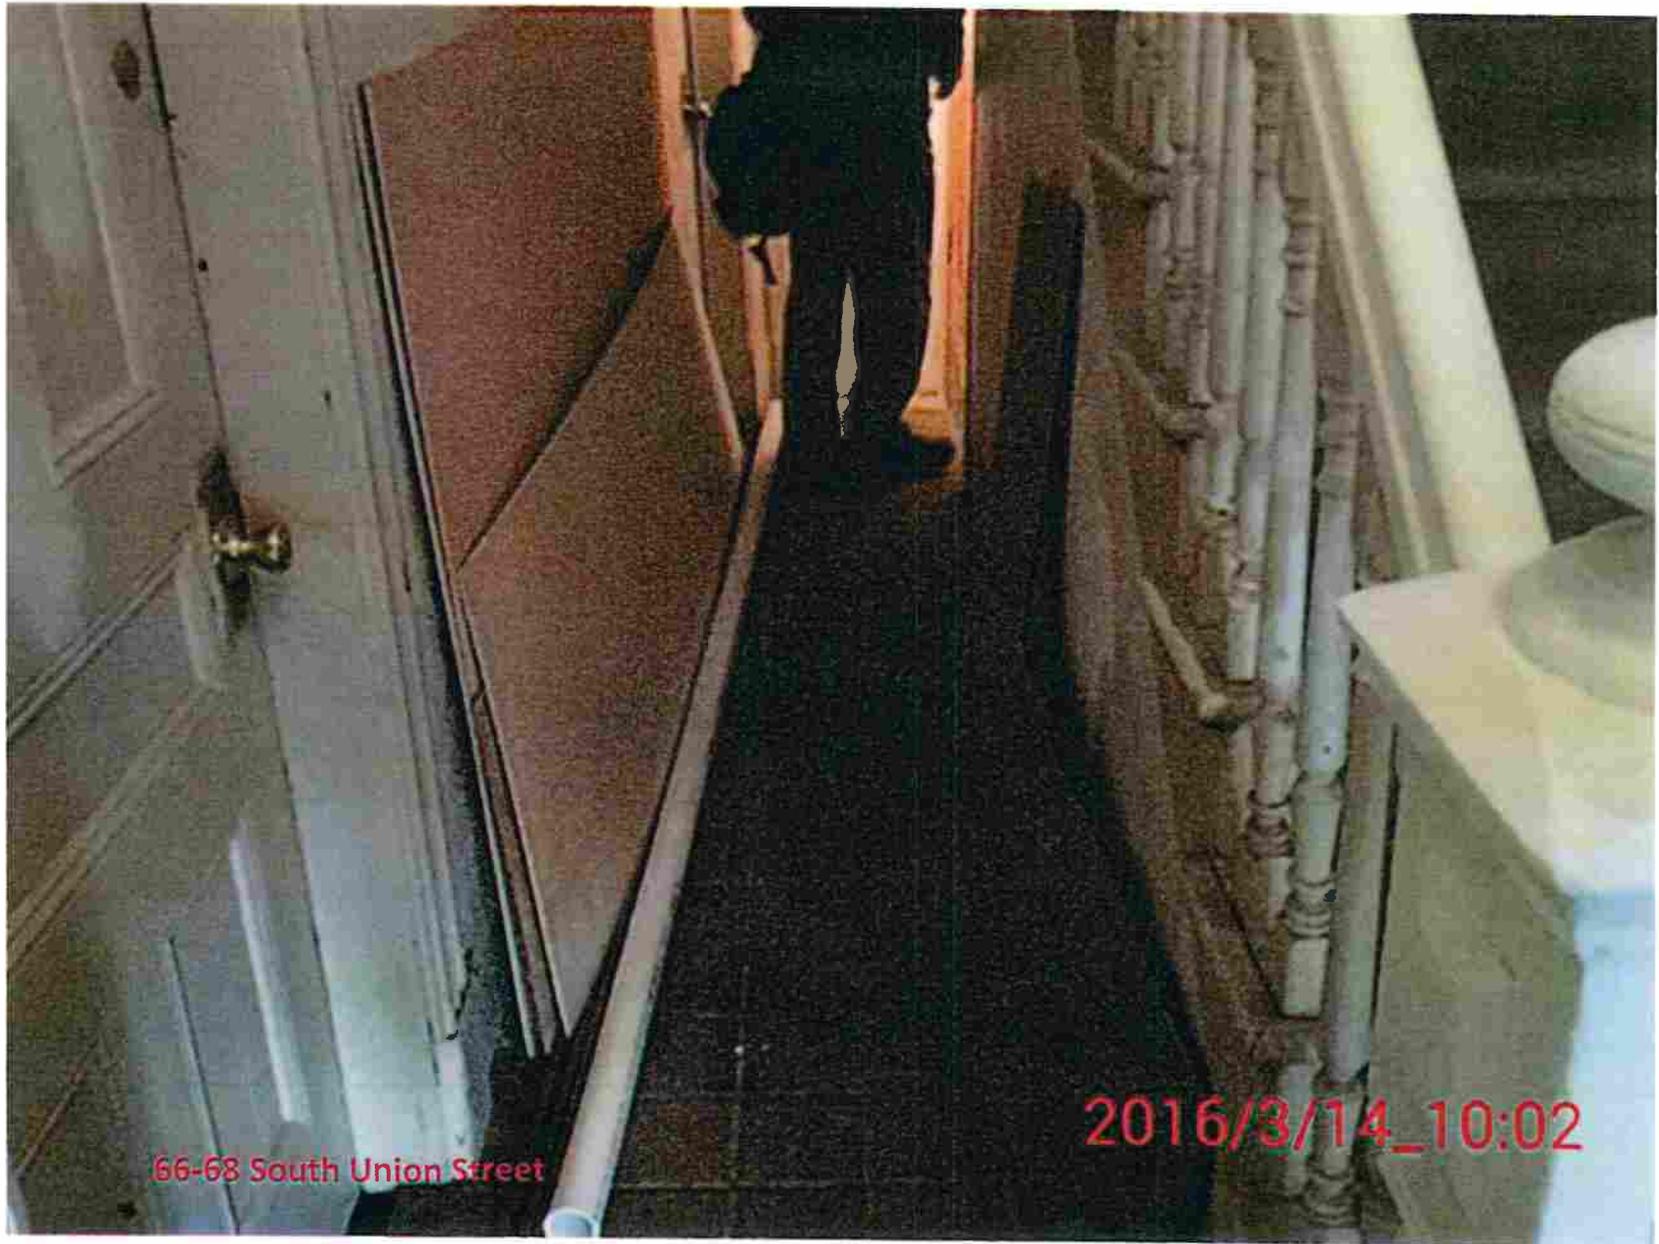
Conditions observed on March 14, 2016 – Photograph taken by William Ward

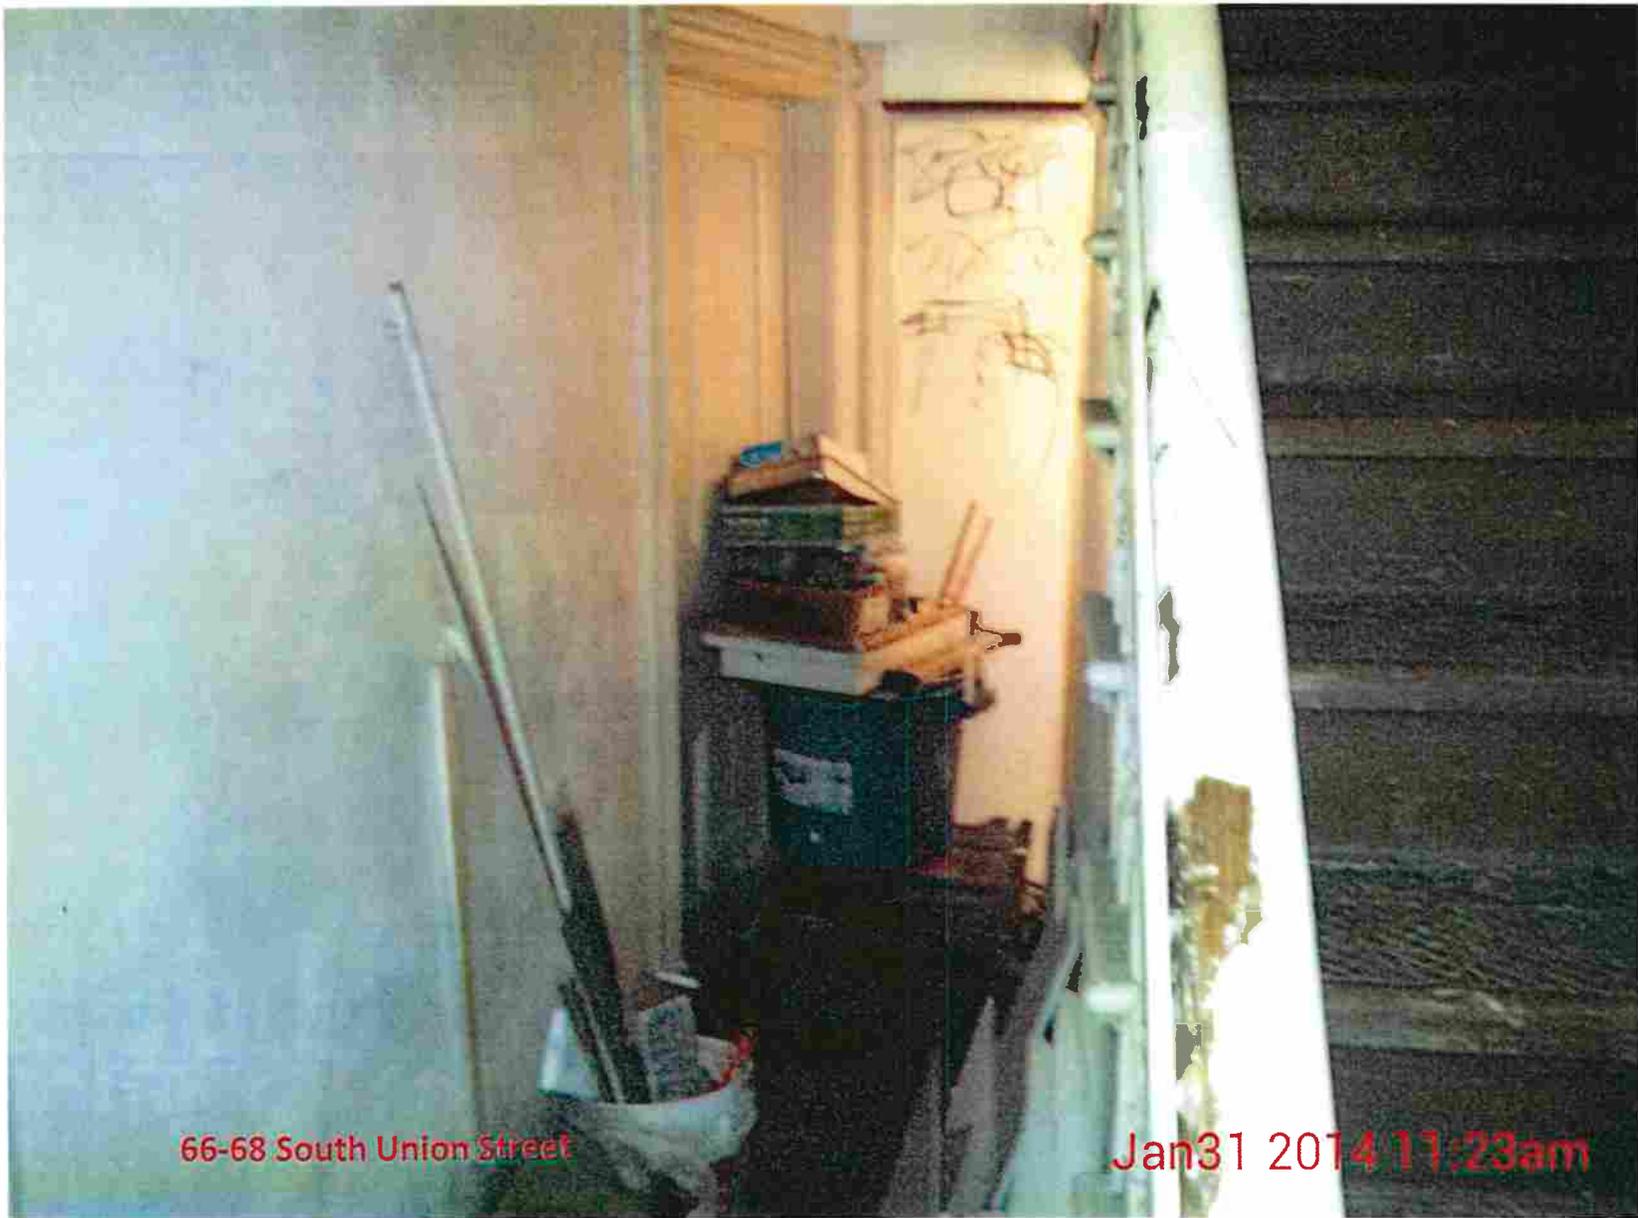
Conditions observed on January 31, 2014 – Photograph taken by William Ward

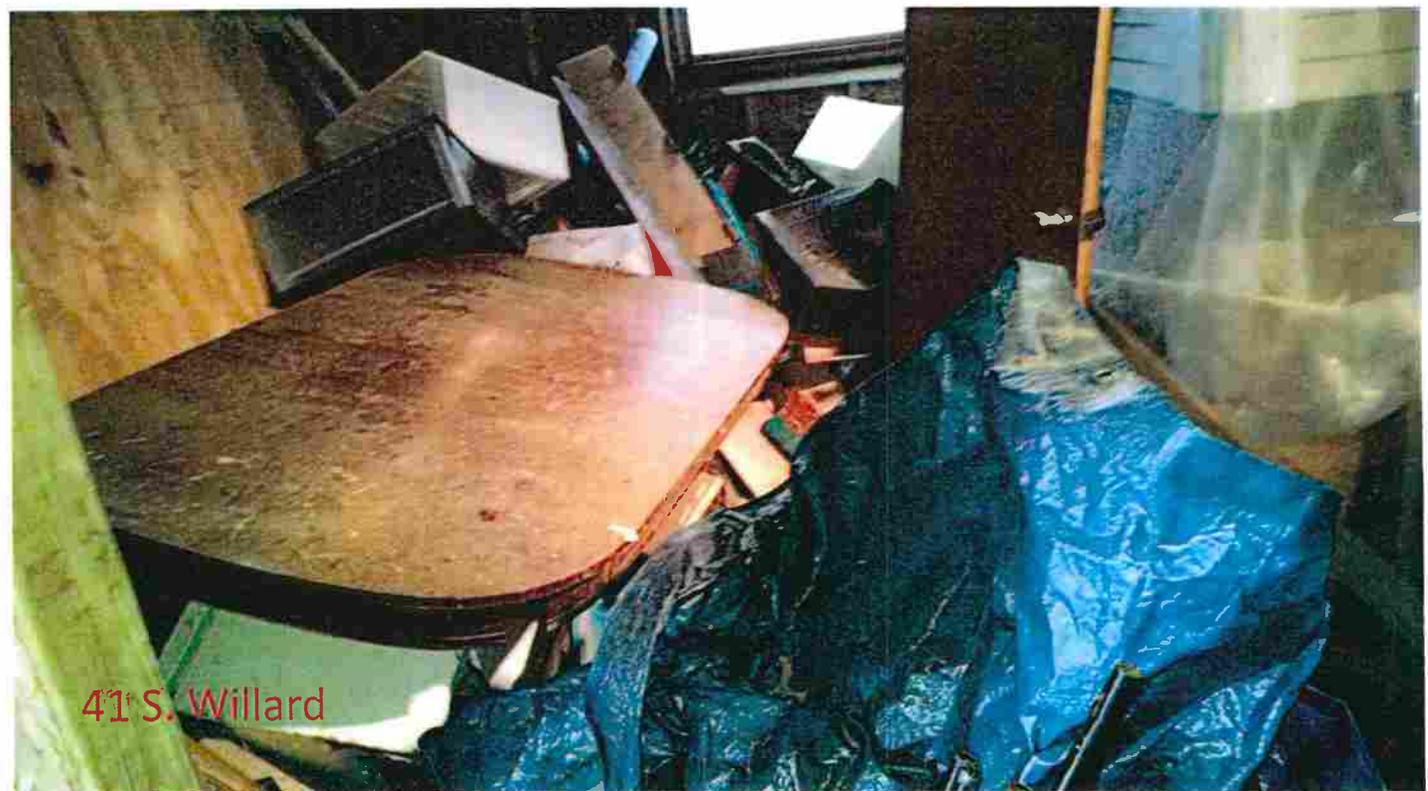
Unit/Area
cellar (Item 10 of 32)

Finding: Unreasonable quantities of accumulated and stored materials on premises. Cellar packed with disordered heaps of hoarded goods.

Conditions observed
on 11-12-15–
Photo taken by
William Ward

Remedy: Reduce accumulations of stored materials. Maintain premises free of excessive accumulations.
