Code Enforcement DPW appeal

66-68 South Union Street

Code Enforcement Timeline of inspections at this property

Code Enforcement DPW appeal hearing

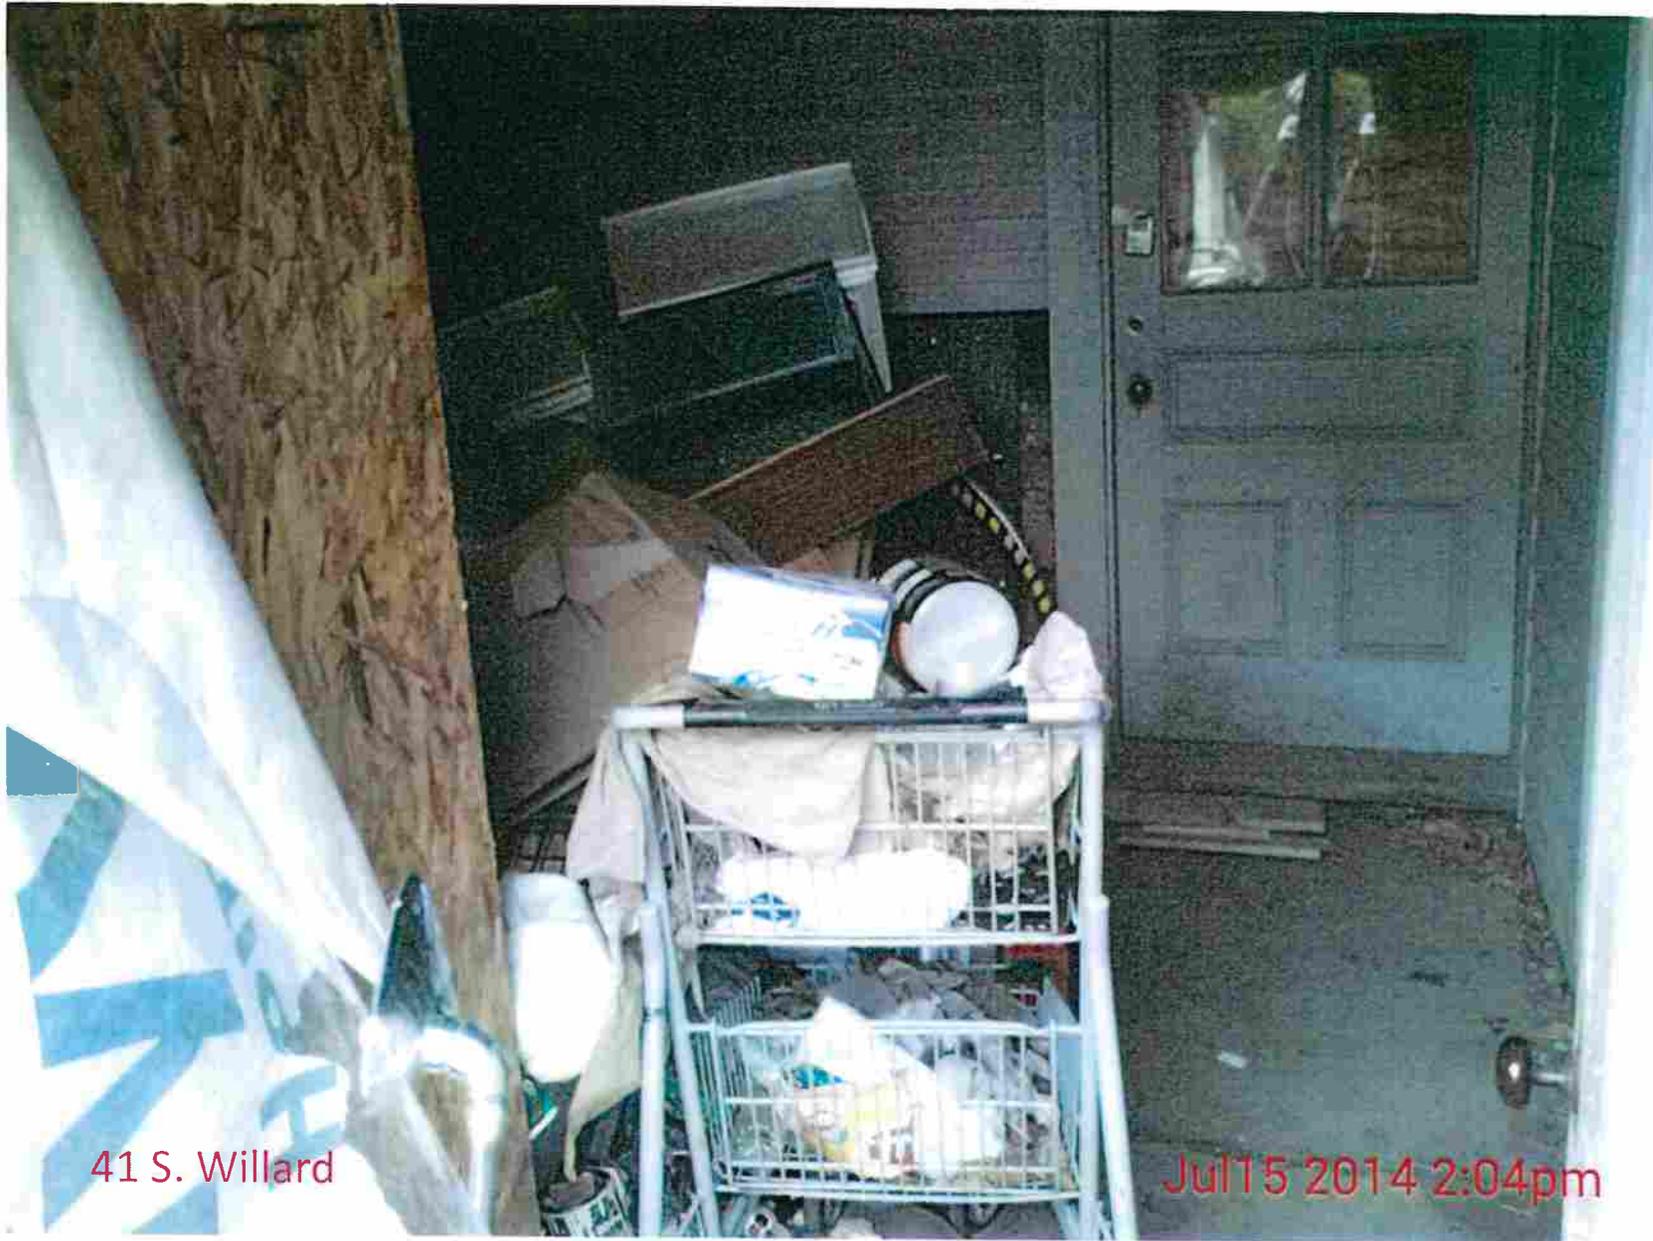
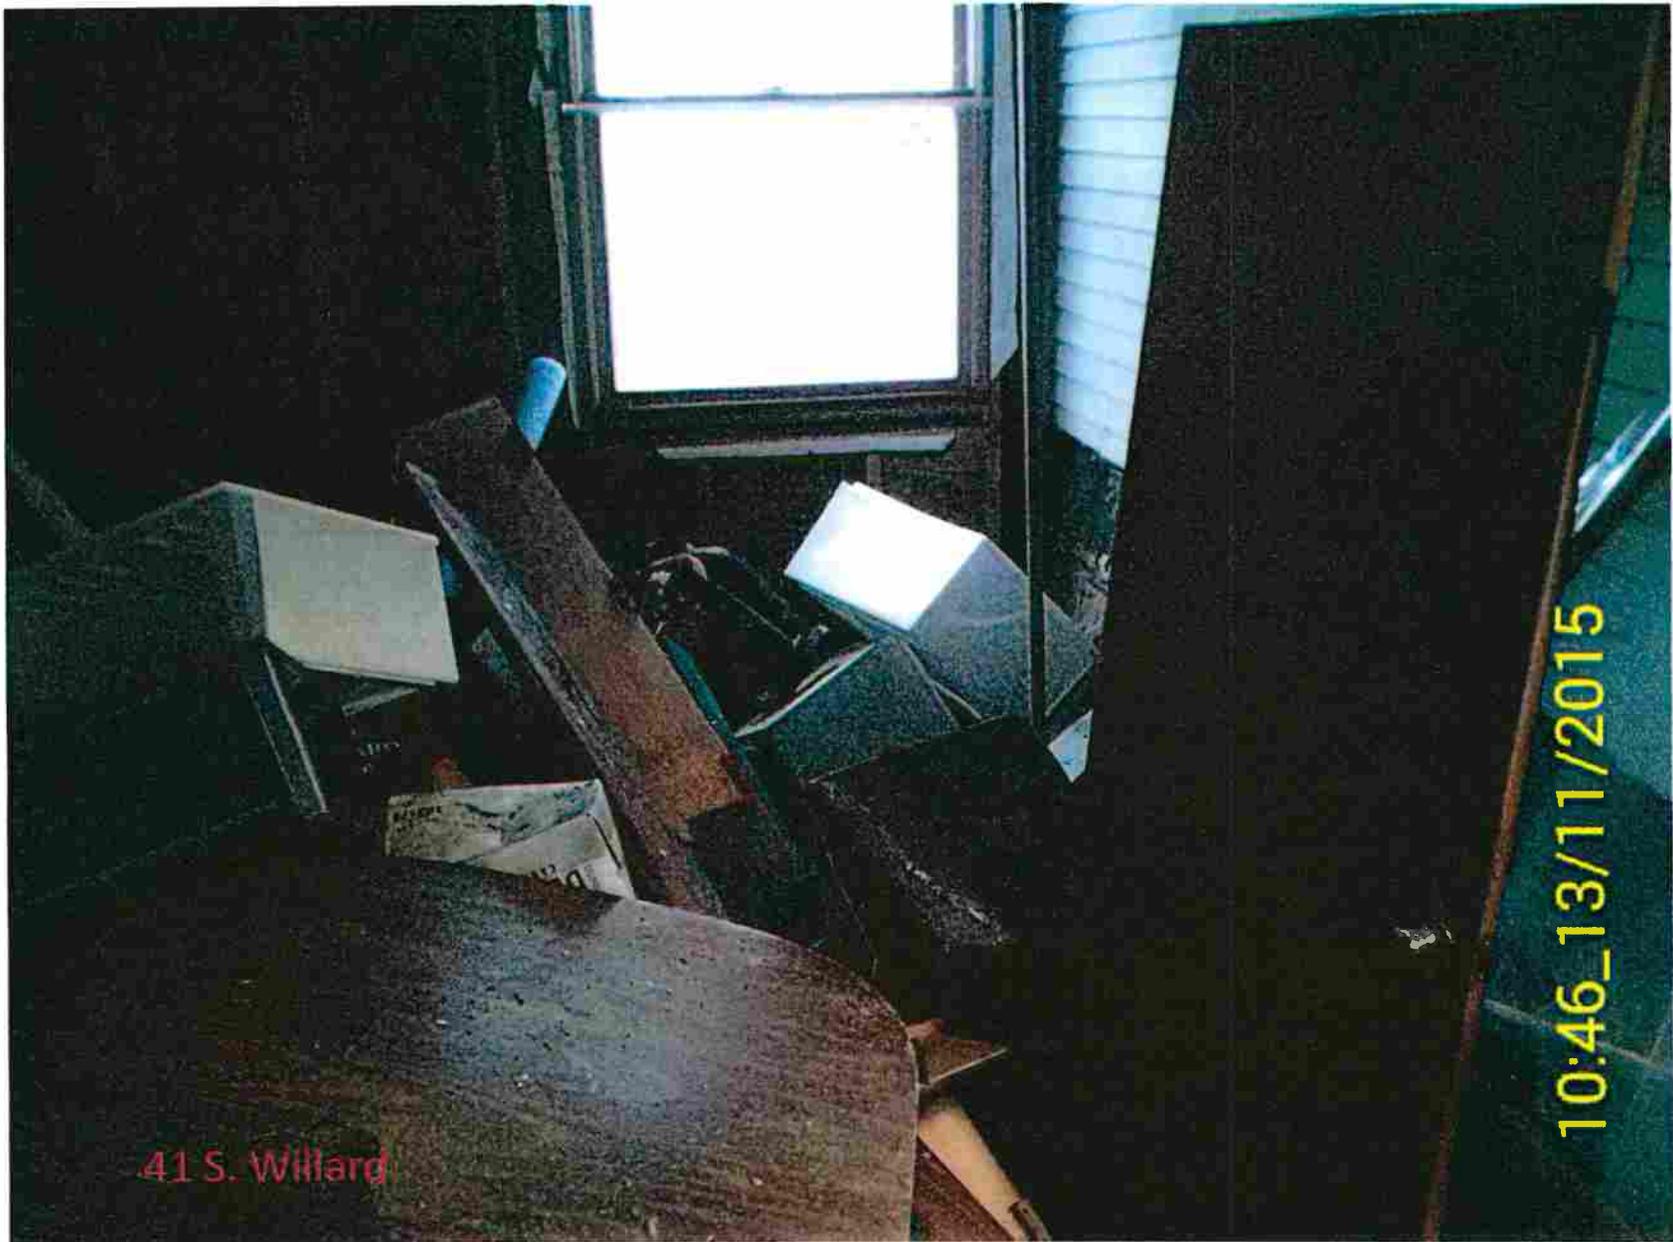
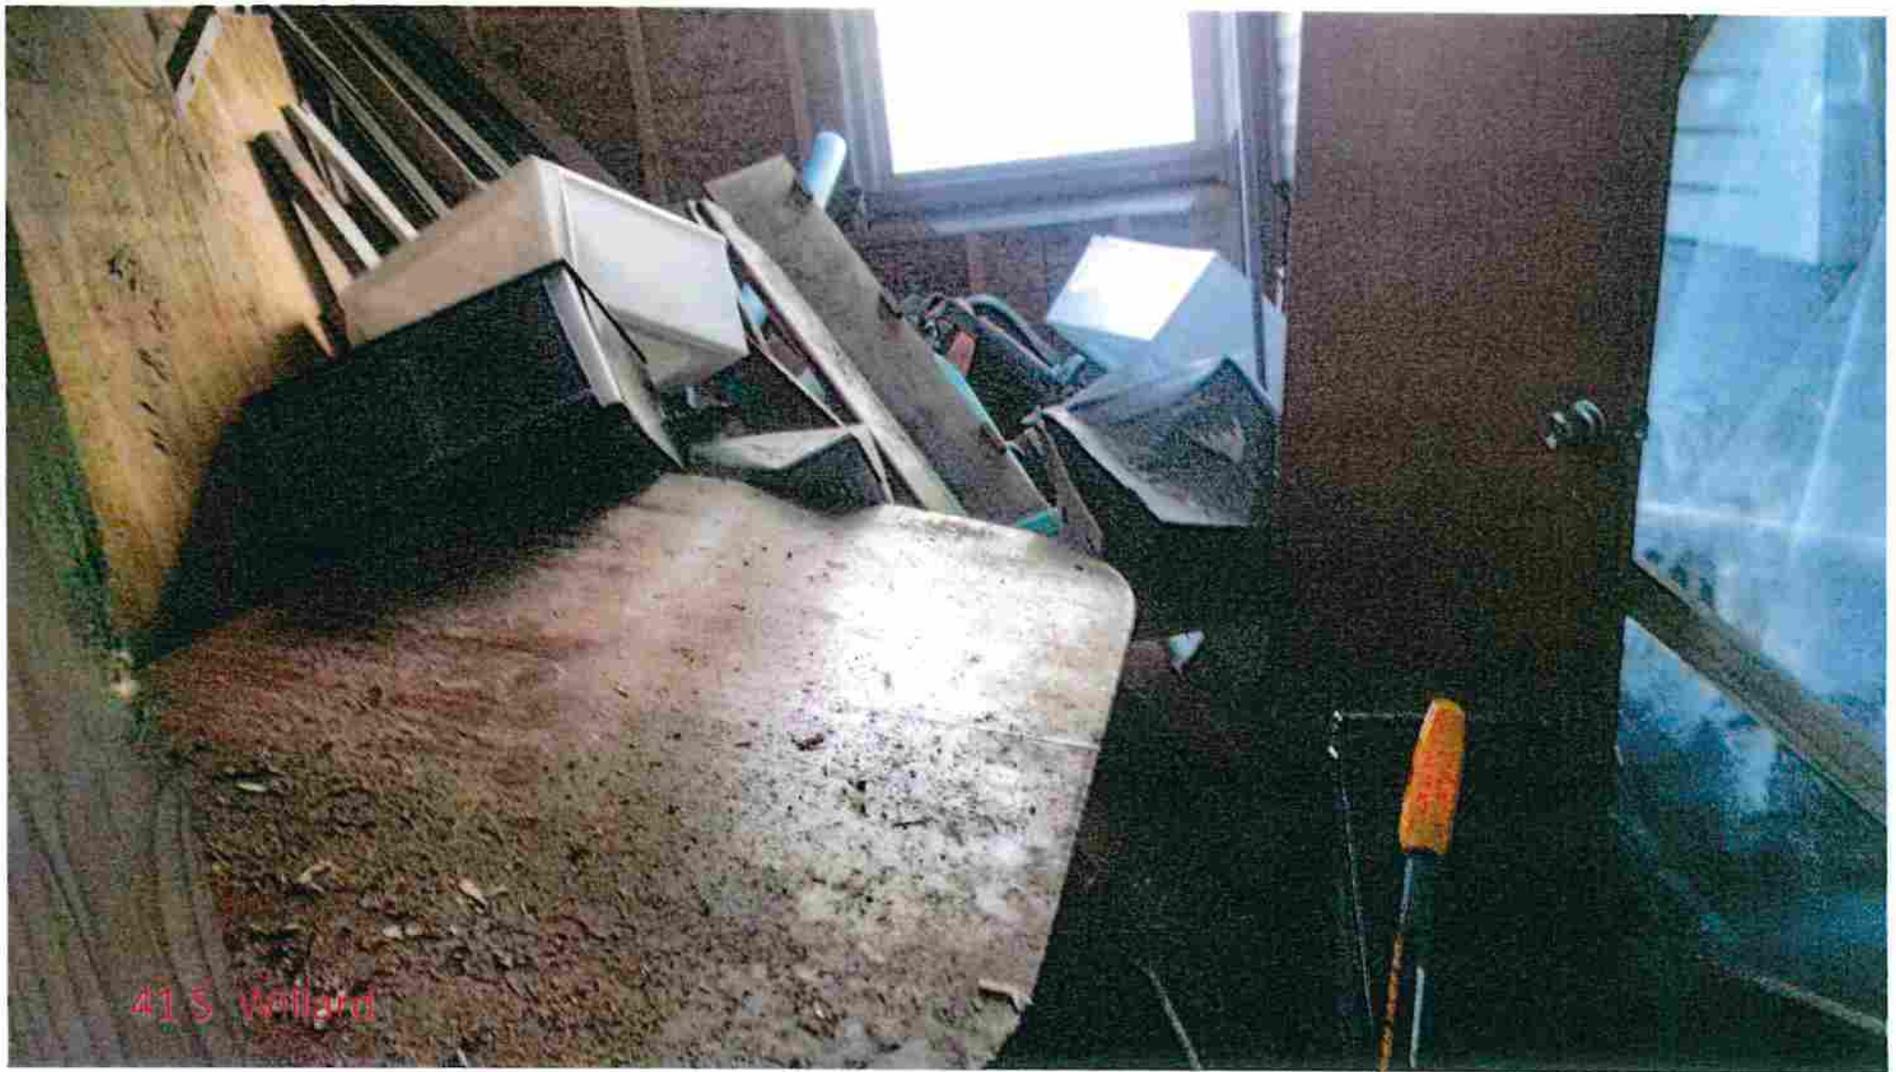
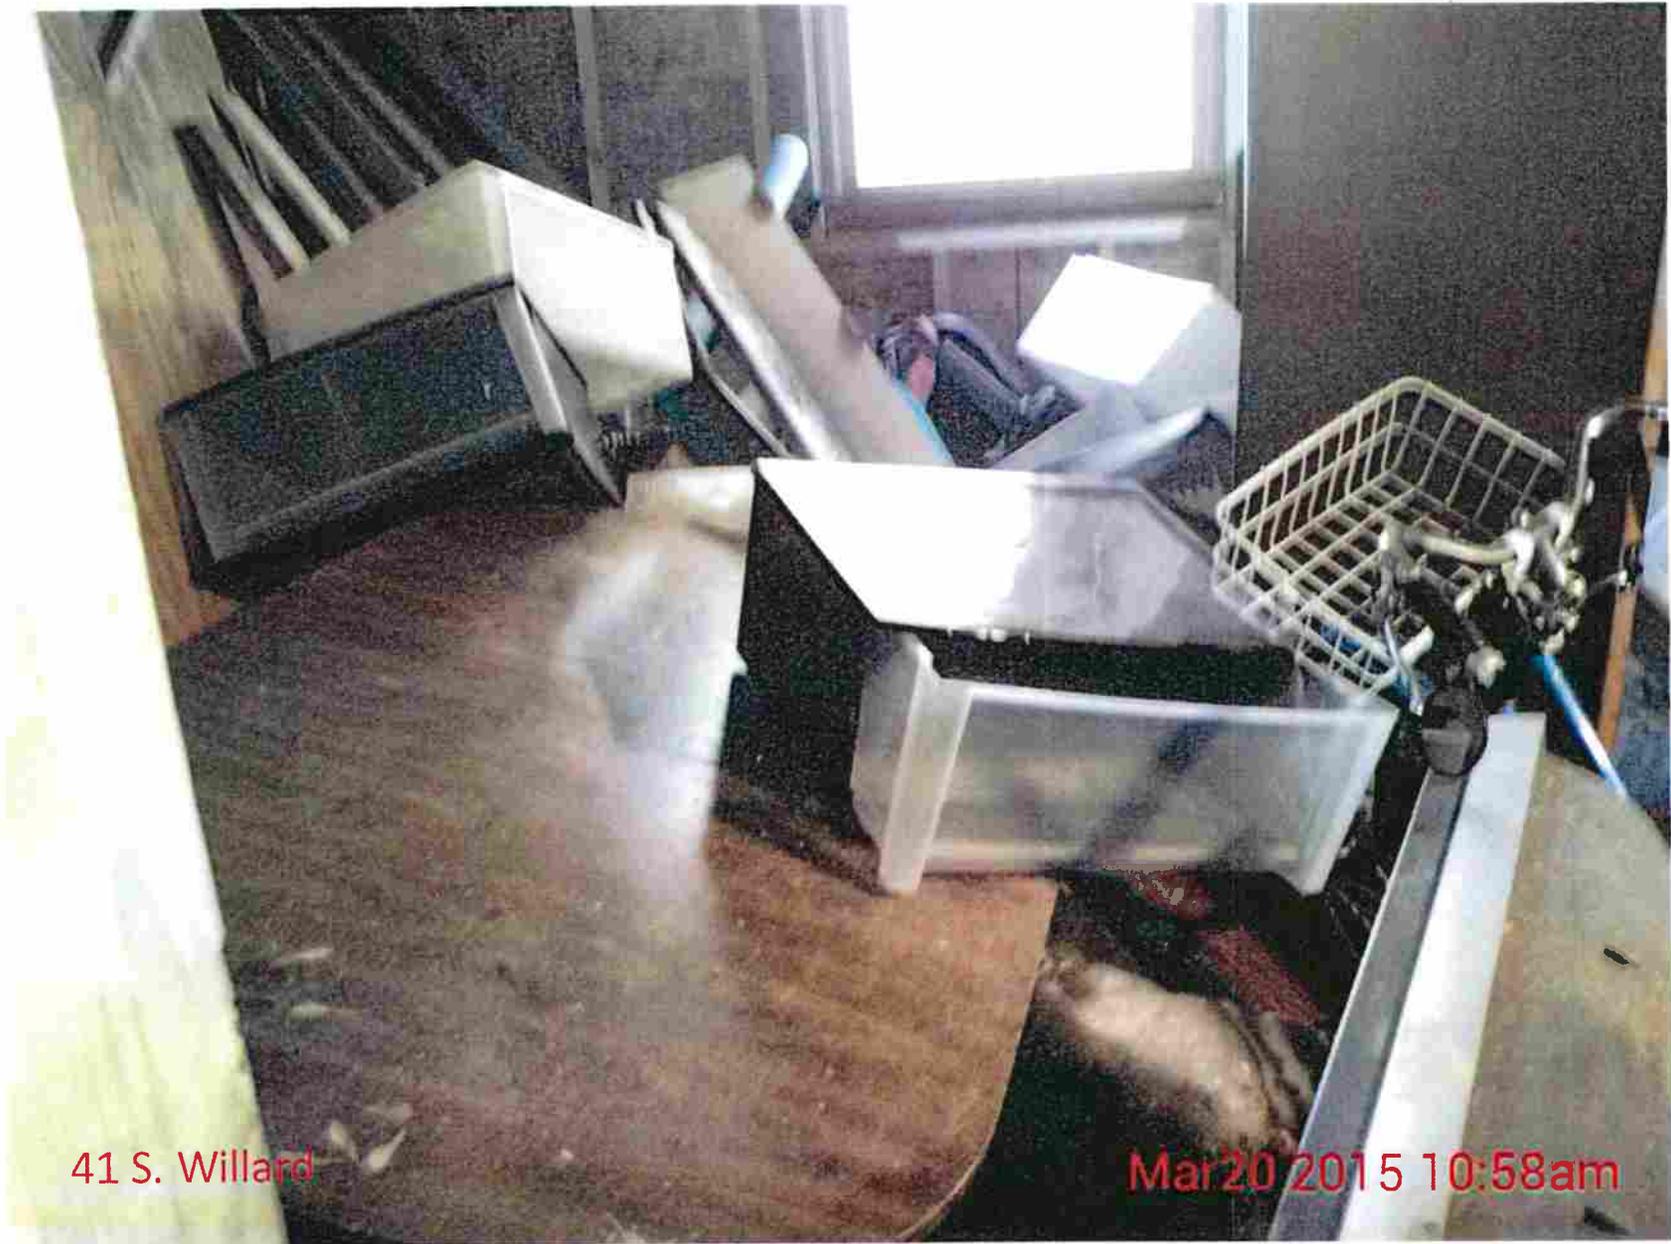
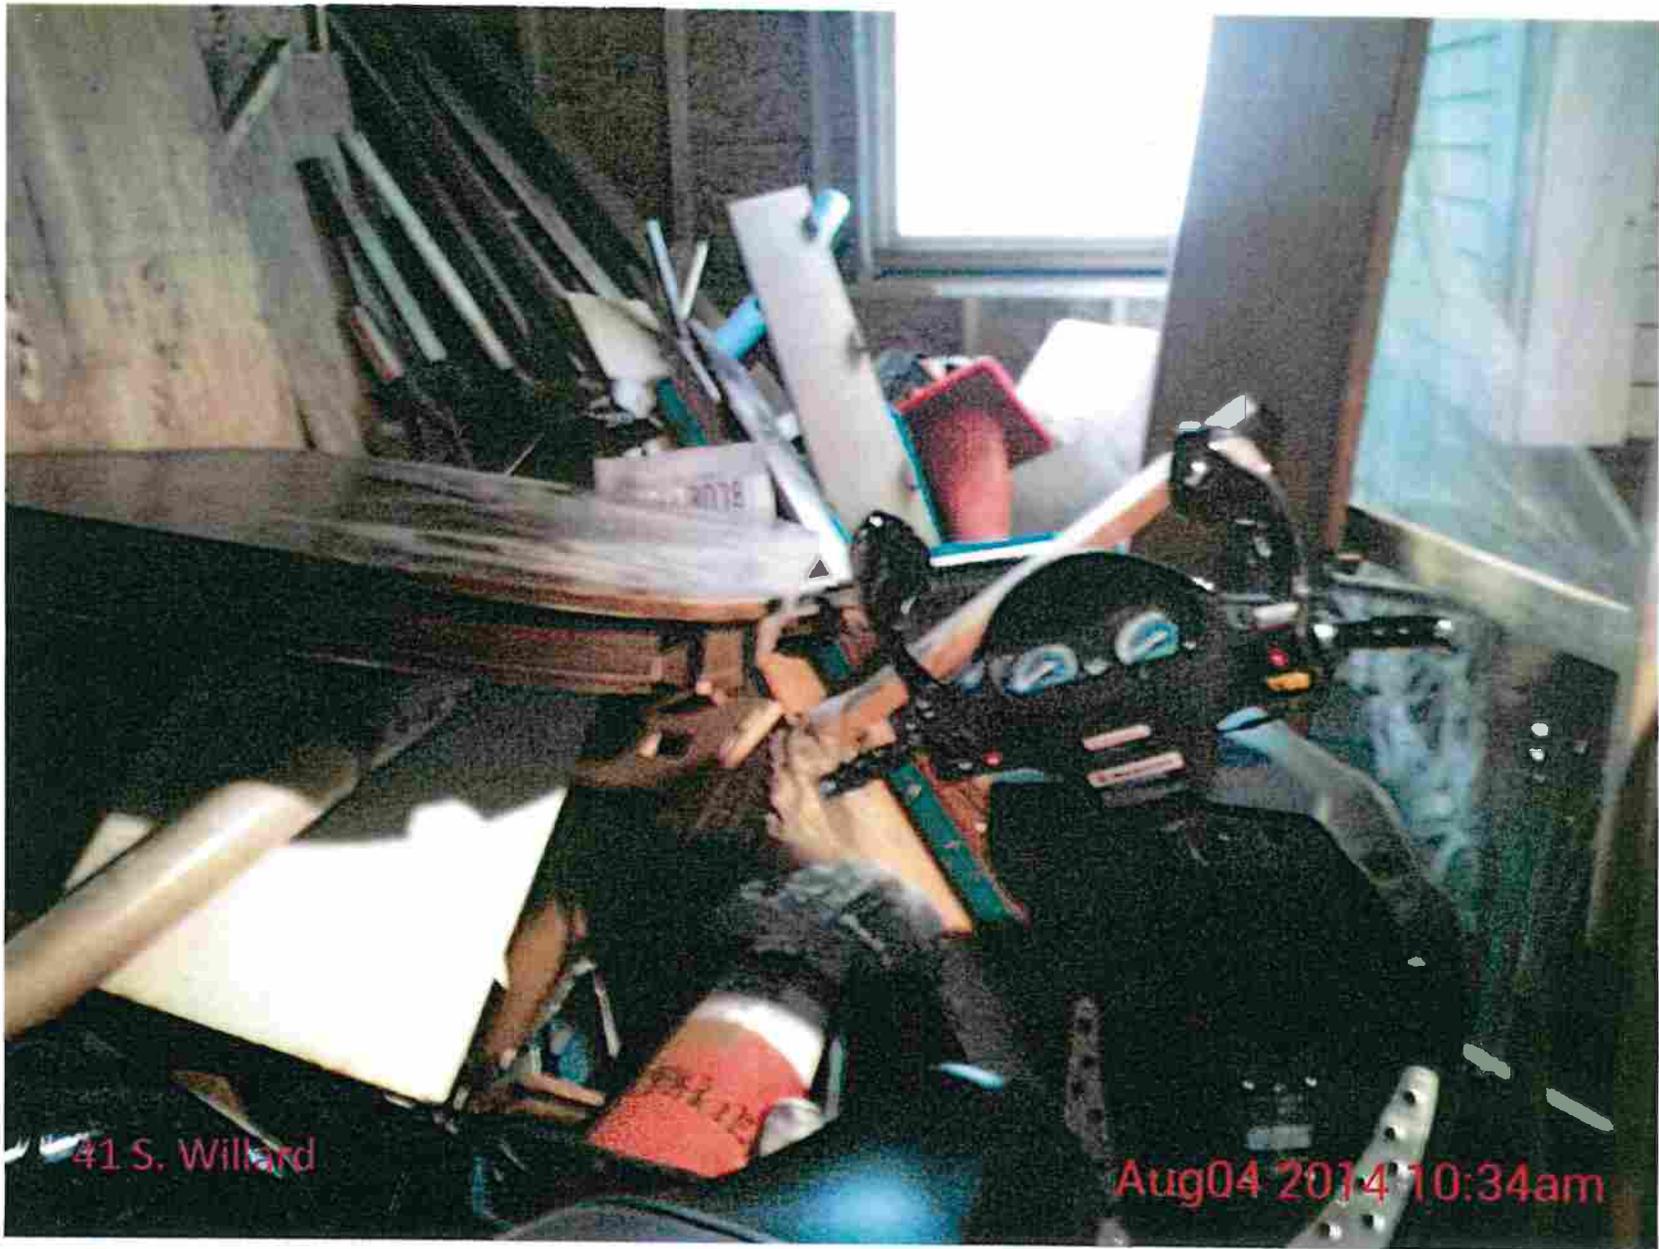
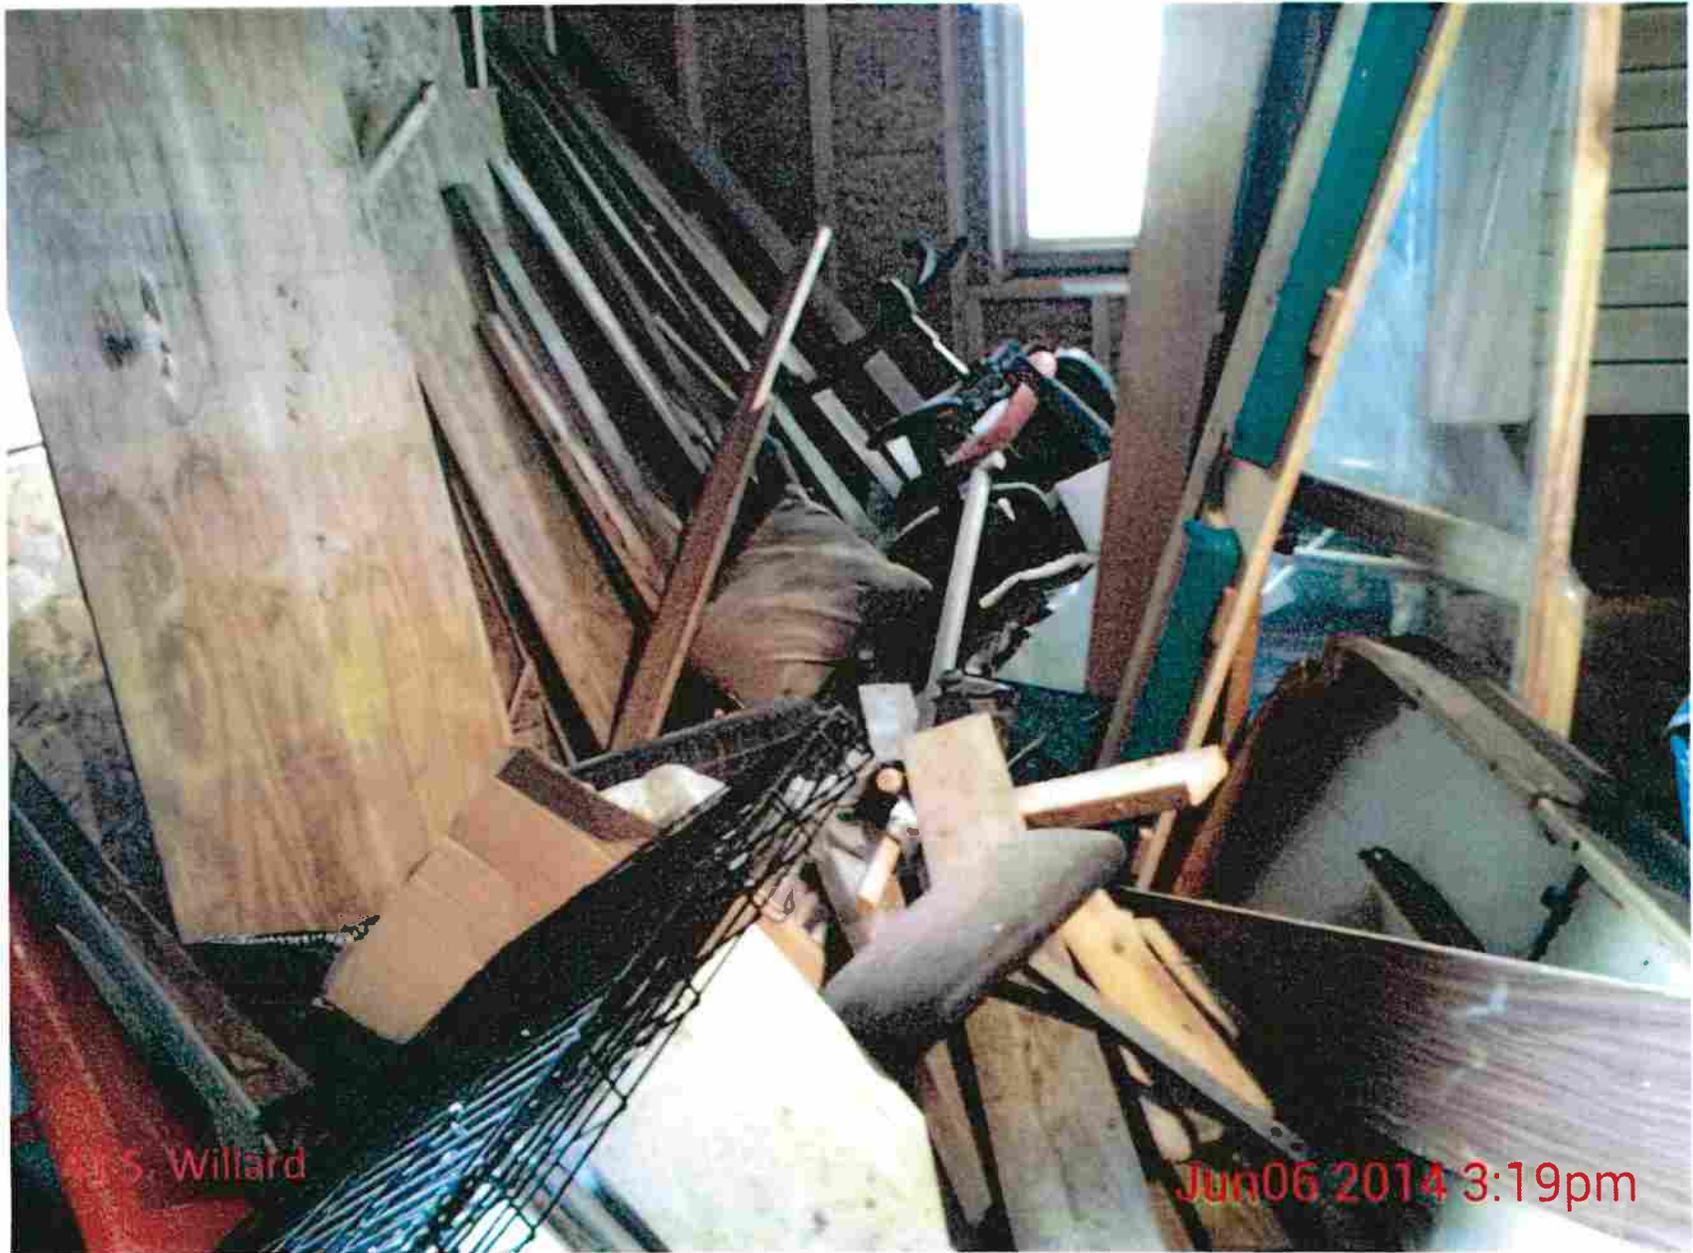
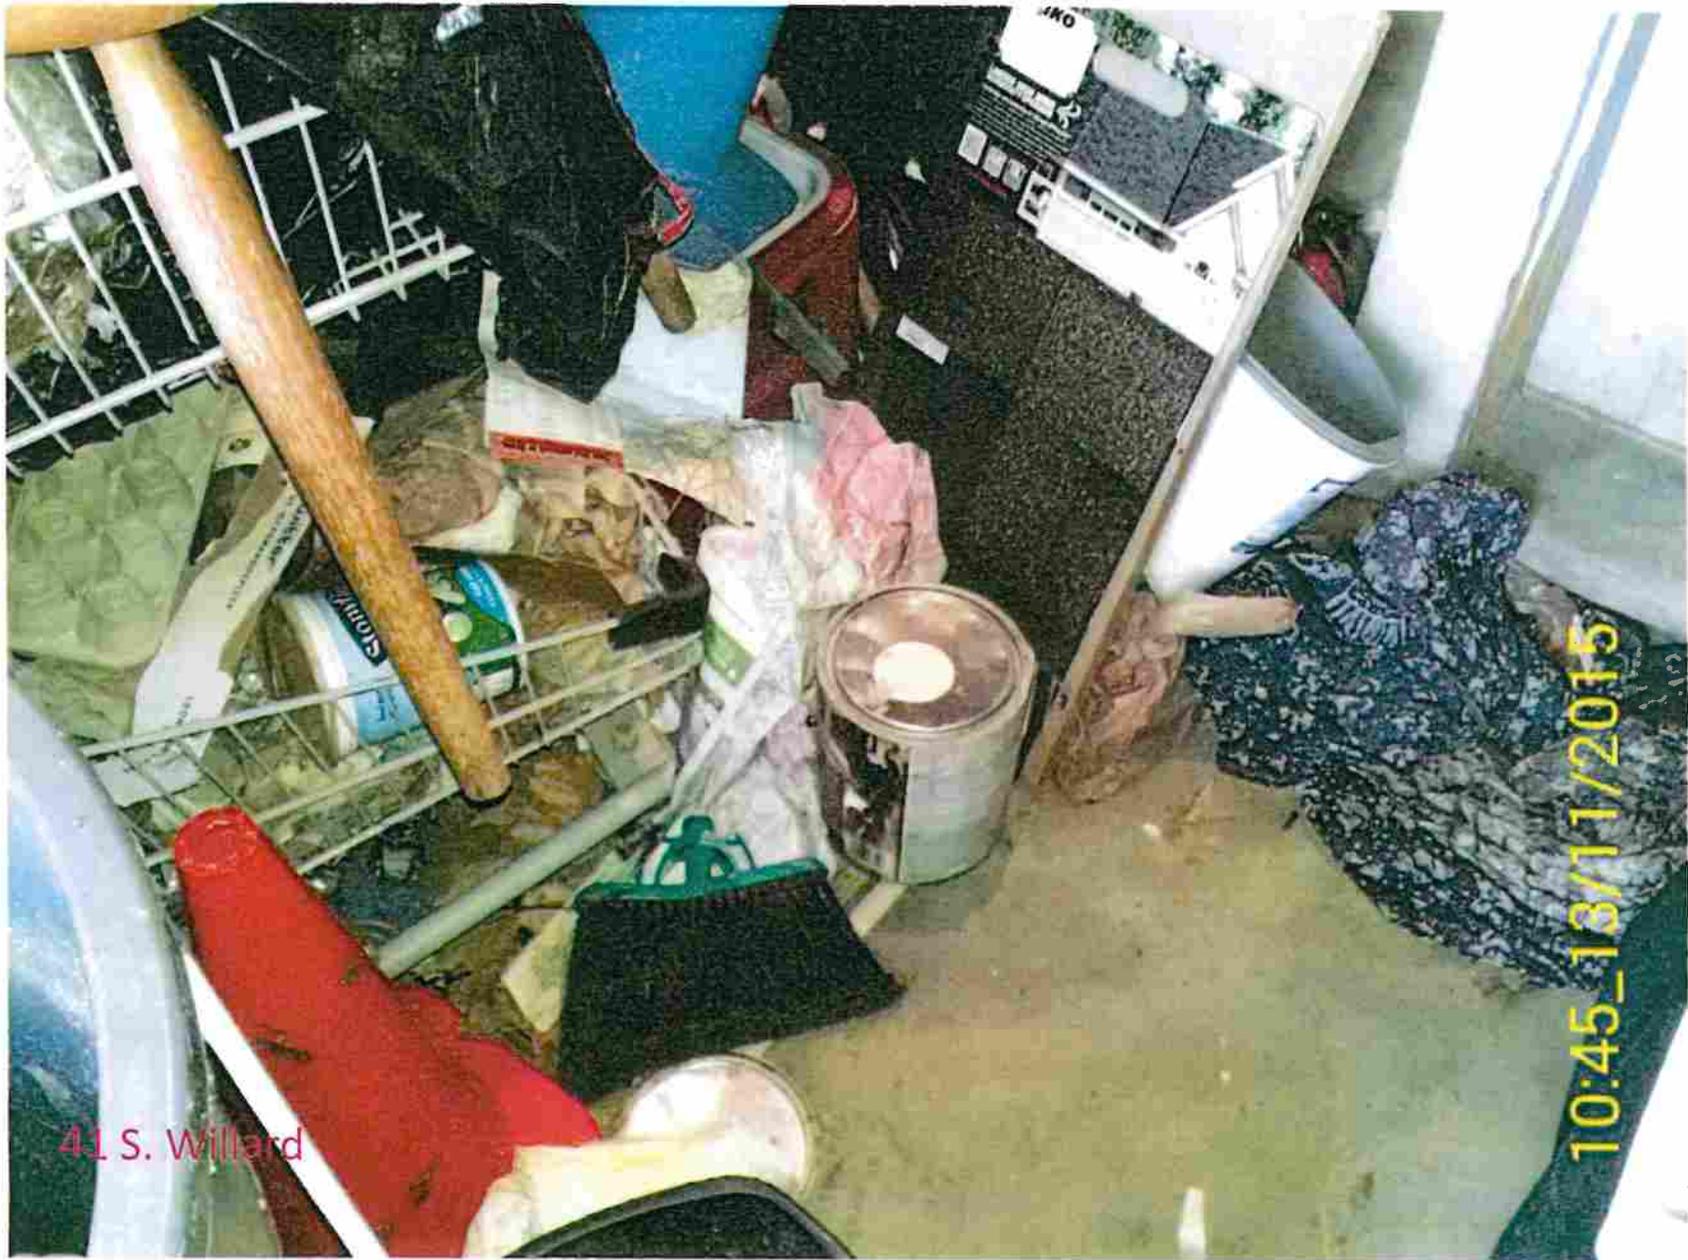
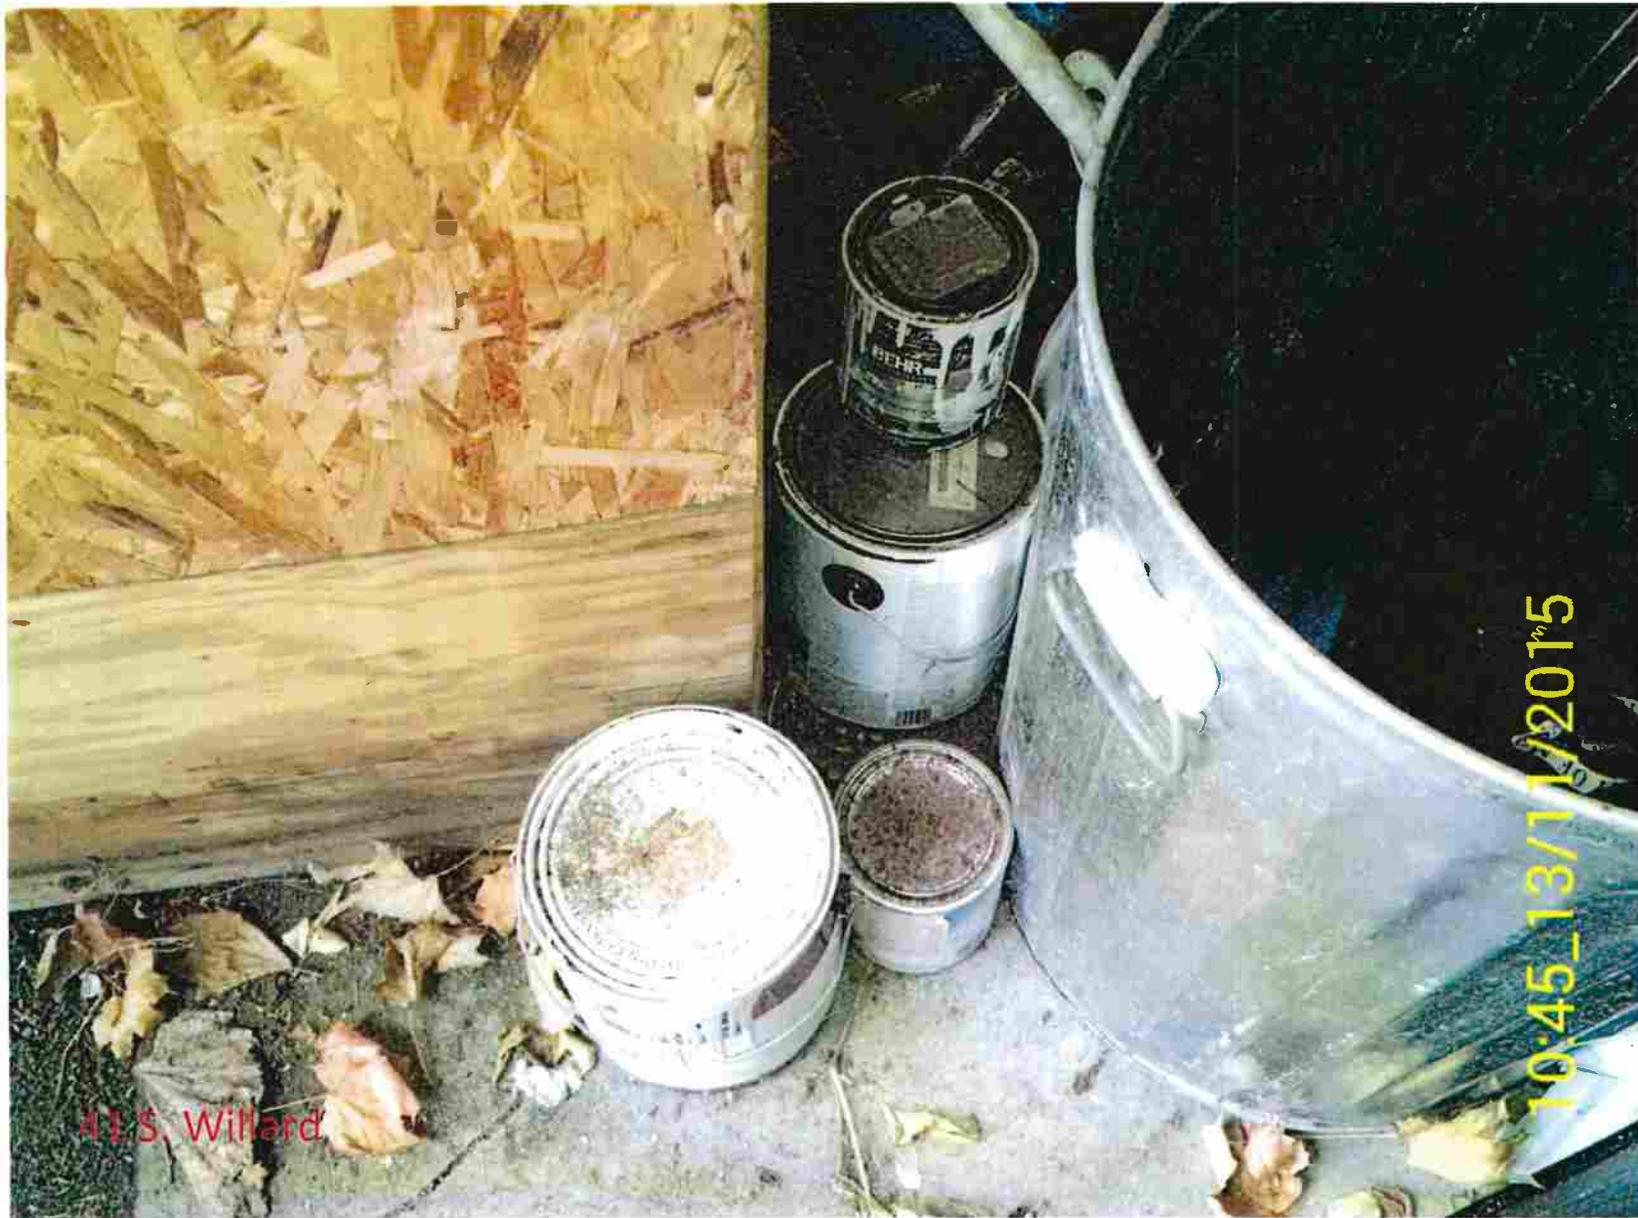
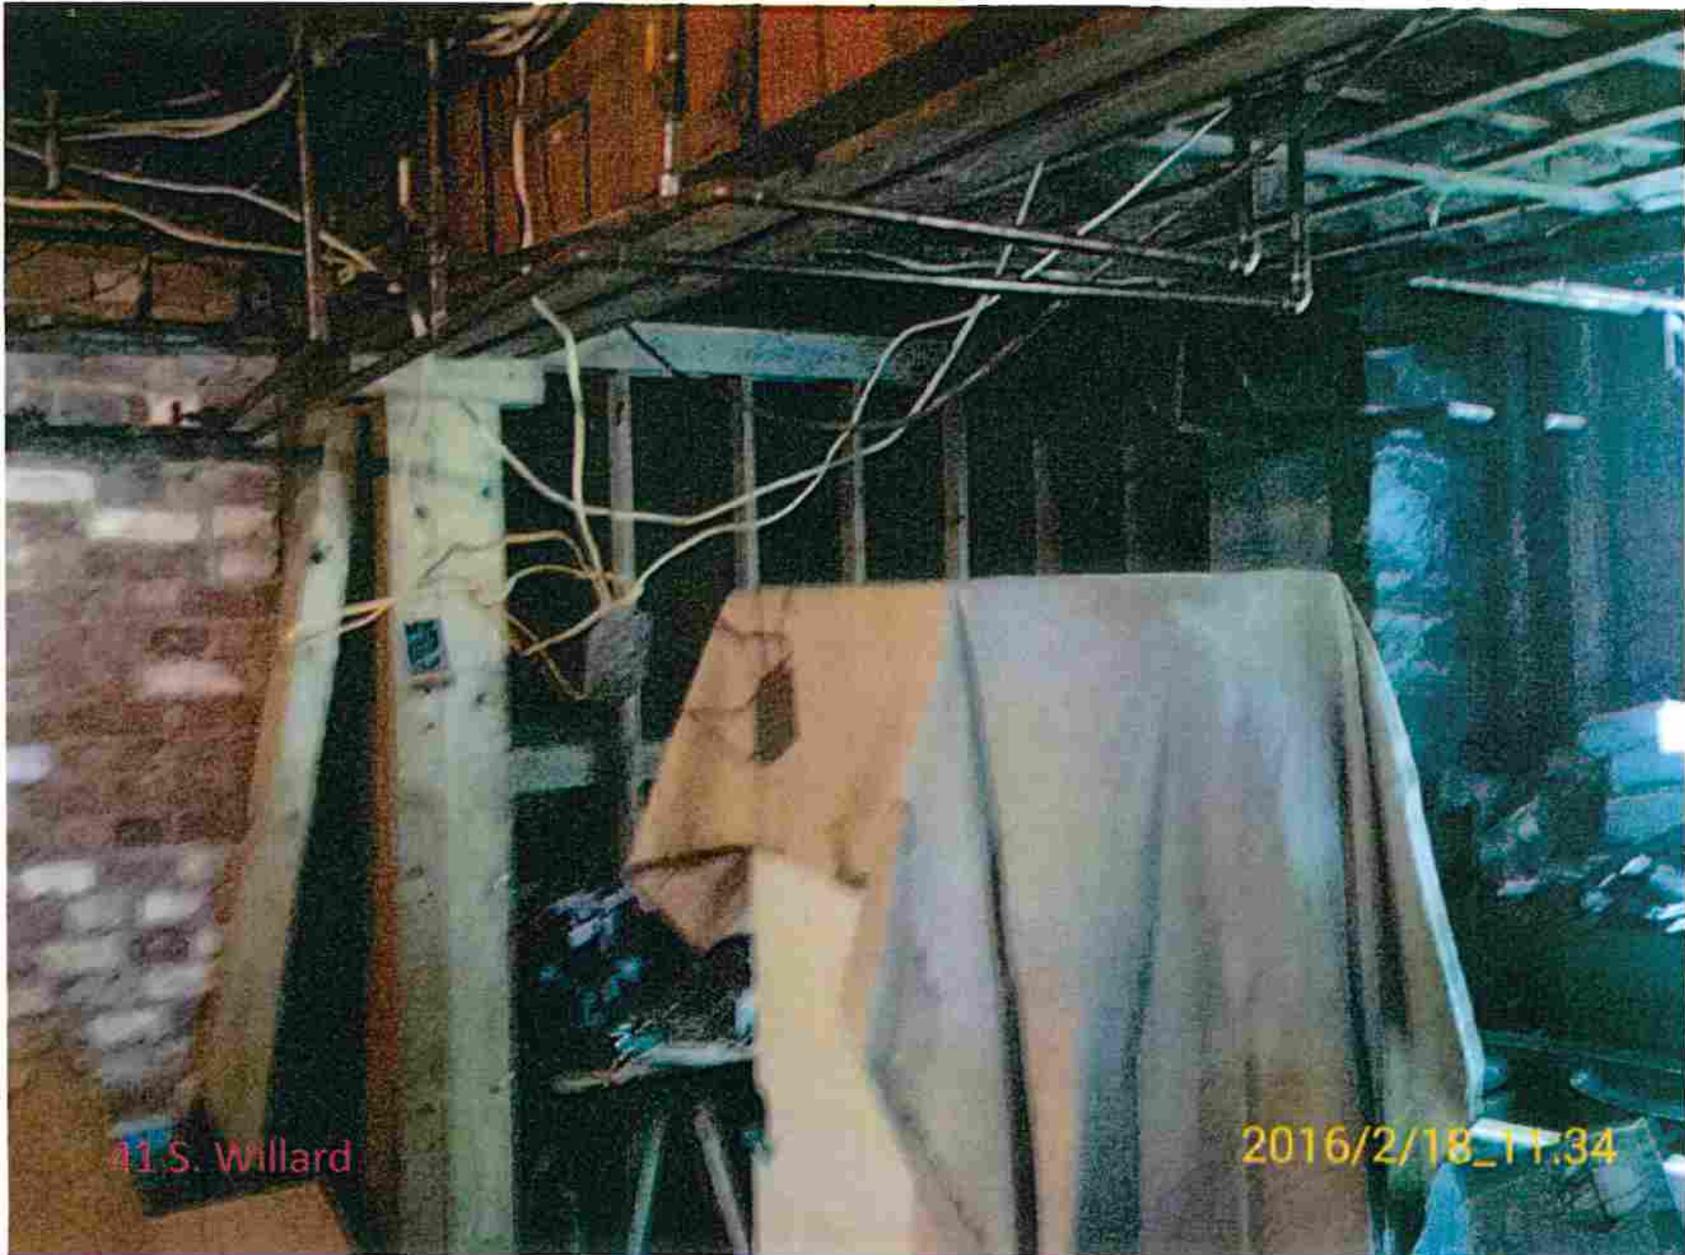
Finding: Unreasonable quantities of accumulated and stored materials on premises. Cellar packed with disordered heaps of hoarded goods.

Remedy: Reduce accumulations of stored materials. Maintain premises free of excessive accumulations.

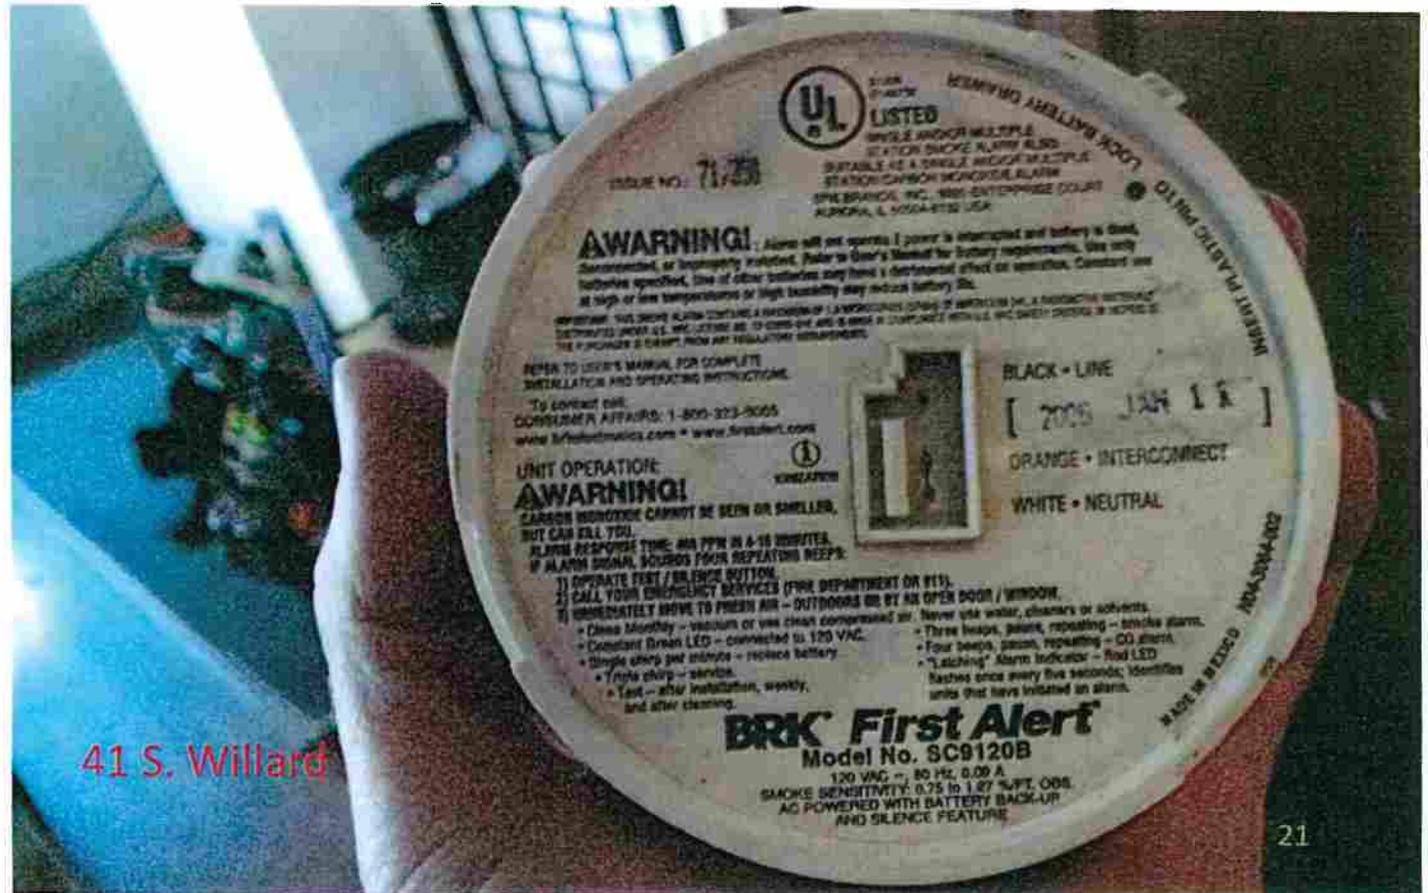
Smoke alarms (Item 31 of 32)

Finding: Smoke/CO detector does not meet required standards: all units seen were too old and should be replaced. Units older than 5 years should be replaced.

Conditions observed
on 11-12-15 –
Photo taken by
William Ward

Remedy: Replace smoke/CO detector to code. Carbon monoxide detectors must be UL 2034 listed or approved by a nationally recognized independent testing laboratory. Installation must be in the vicinity of sleeping areas and on every floor of the dwelling, in accordance with the manufacturer's instructions and State law. City of Burlington electrical permit required for electrical work.

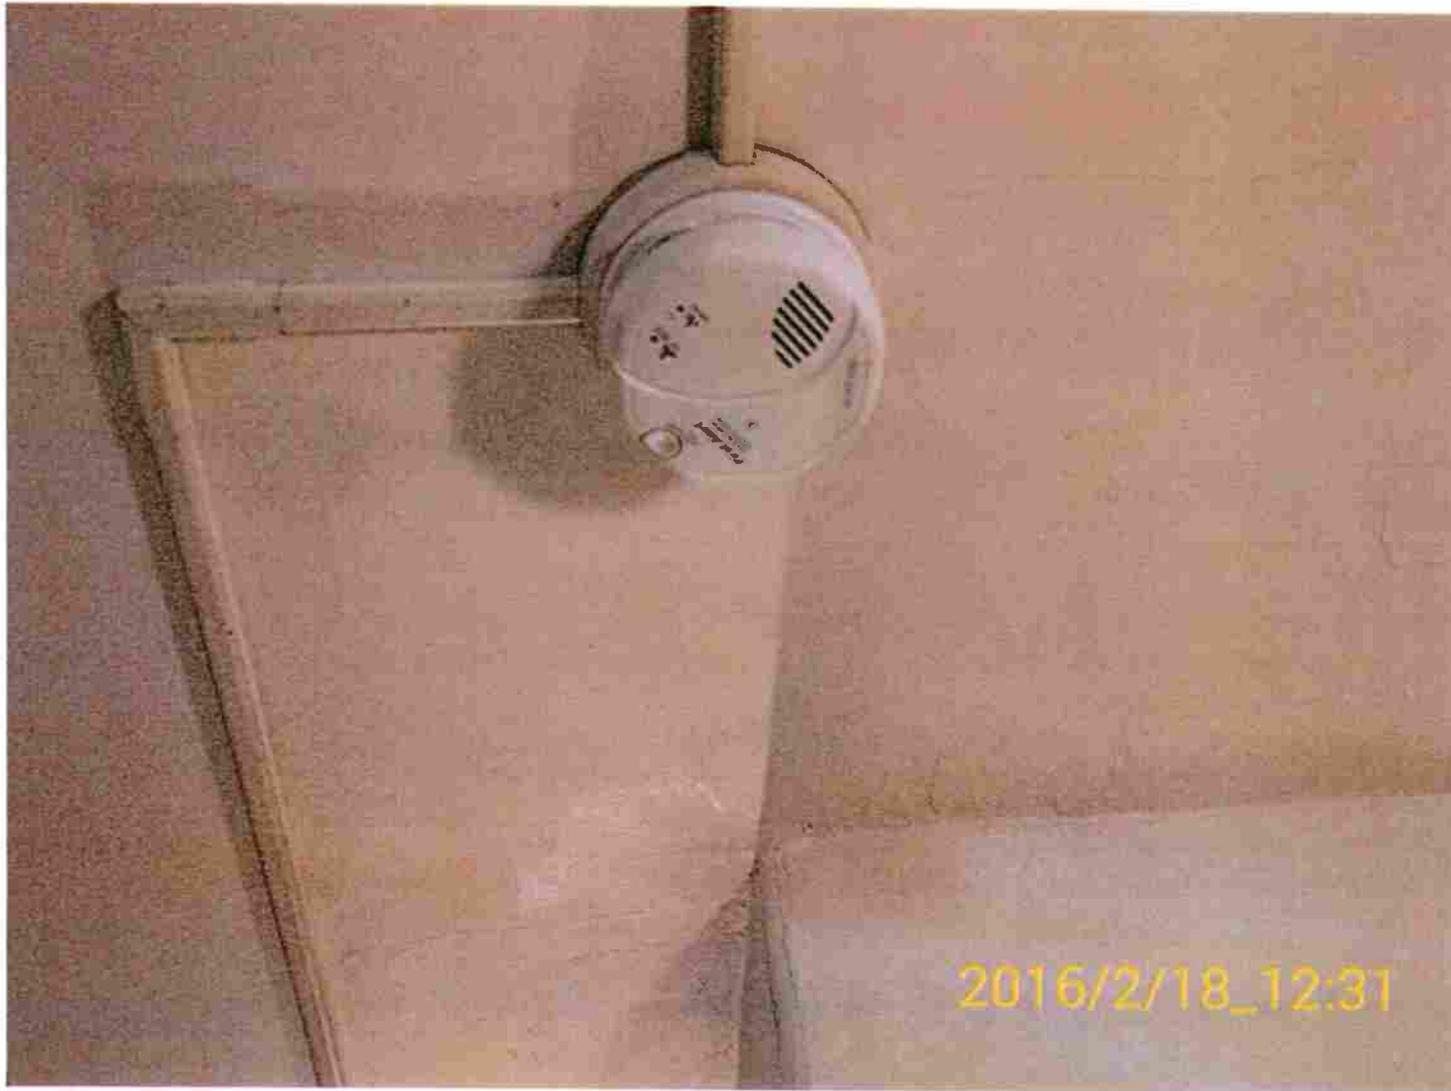
Conditions observed
on 2-18-16 –
Photo taken by William Ward

This item was determined to be in compliance on 2-18-16
