Code Enforcement DPW appeal

66-68 South Union Street

Code Enforcement Timeline of inspections at this property

Code Enforcement DPW appeal hearing

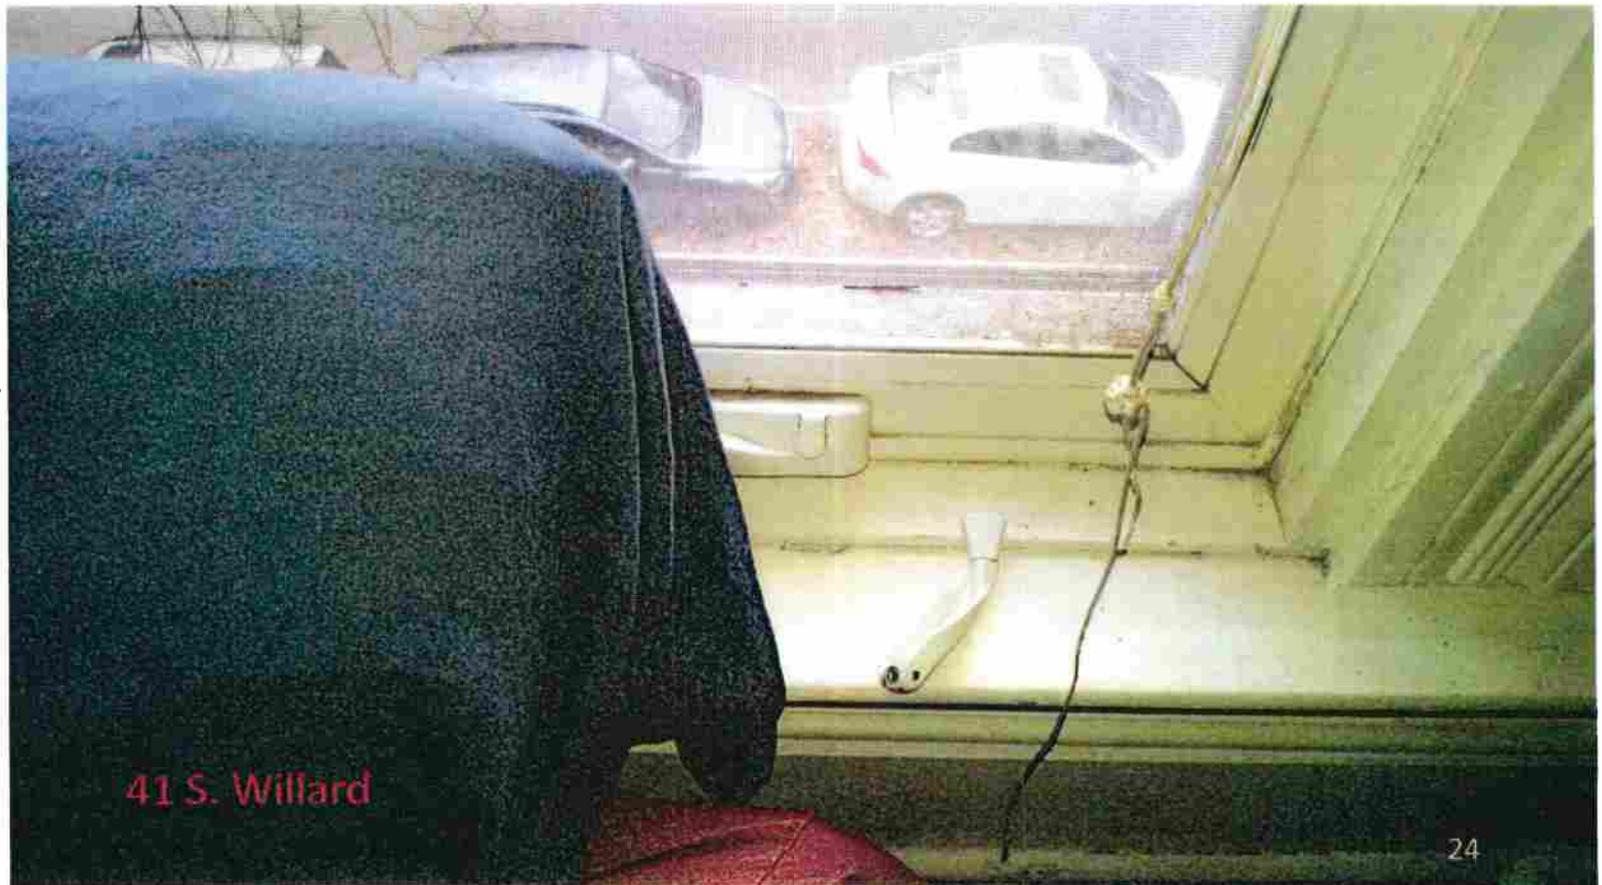
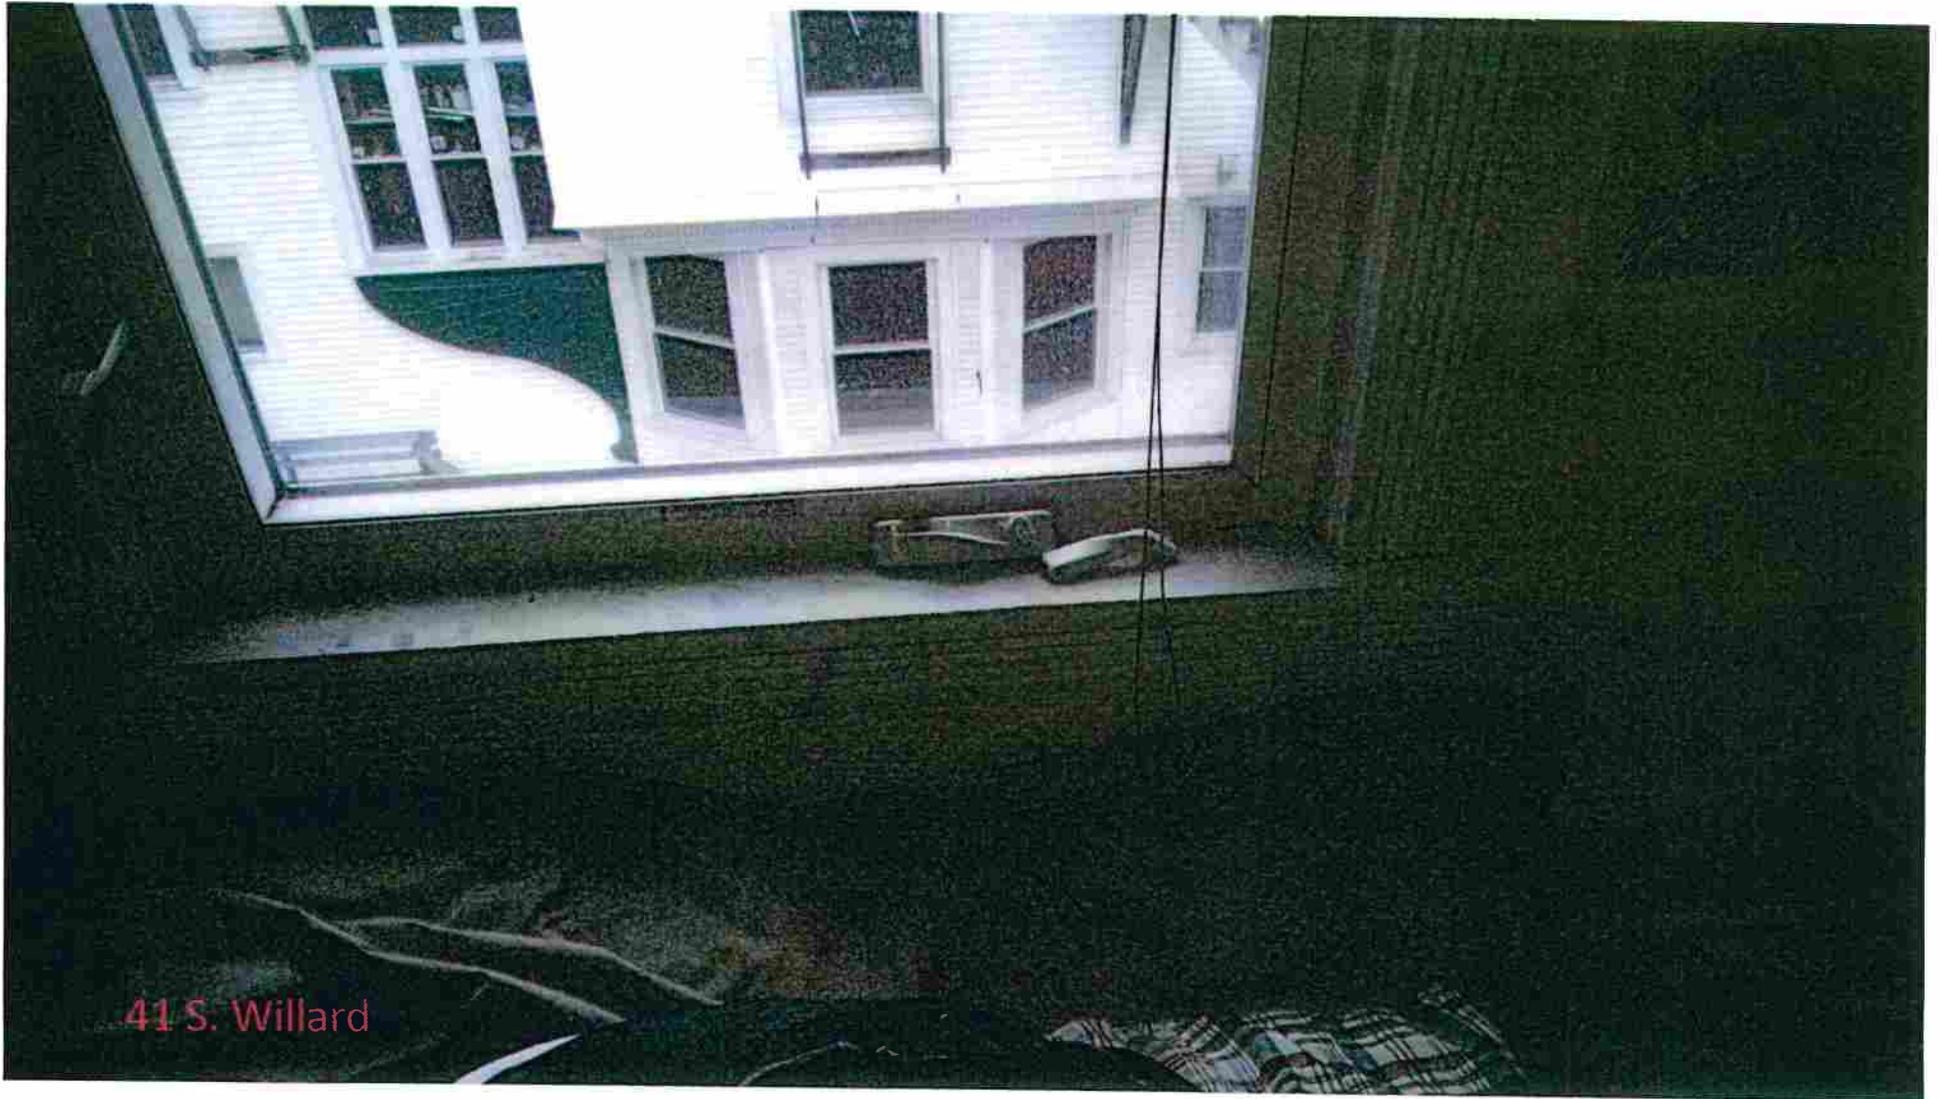
third floor (Item 32 of 32)
east bedroom

Finding: Path of egress is obstructed or otherwise unsafe; third floor east side bedroom egress window has broken off crank. can't be opened.

Conditions
observed on
11-12-15–
Photo taken by
William Ward

Remedy: Repair window

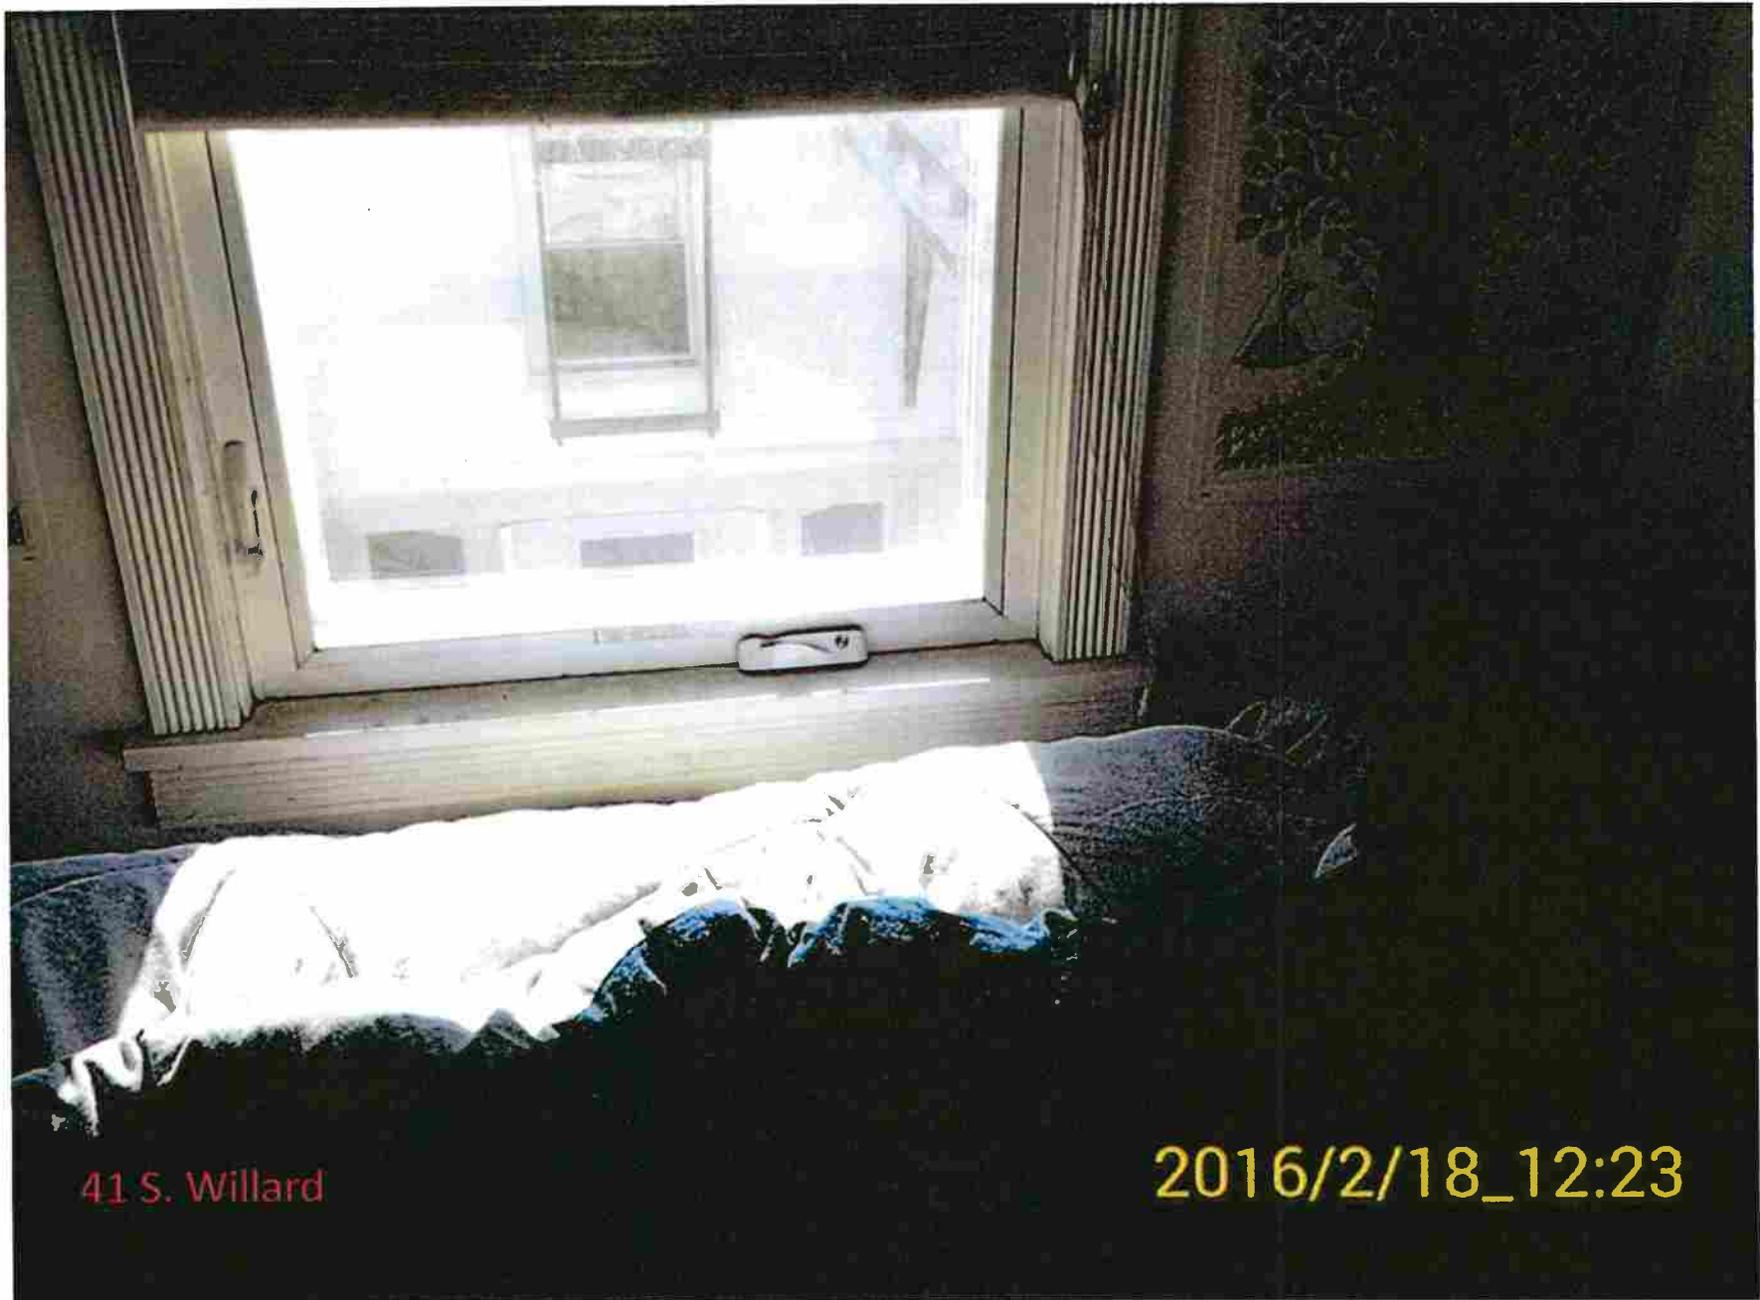
Conditions observed on
11-12-15--
Photo taken by William Ward

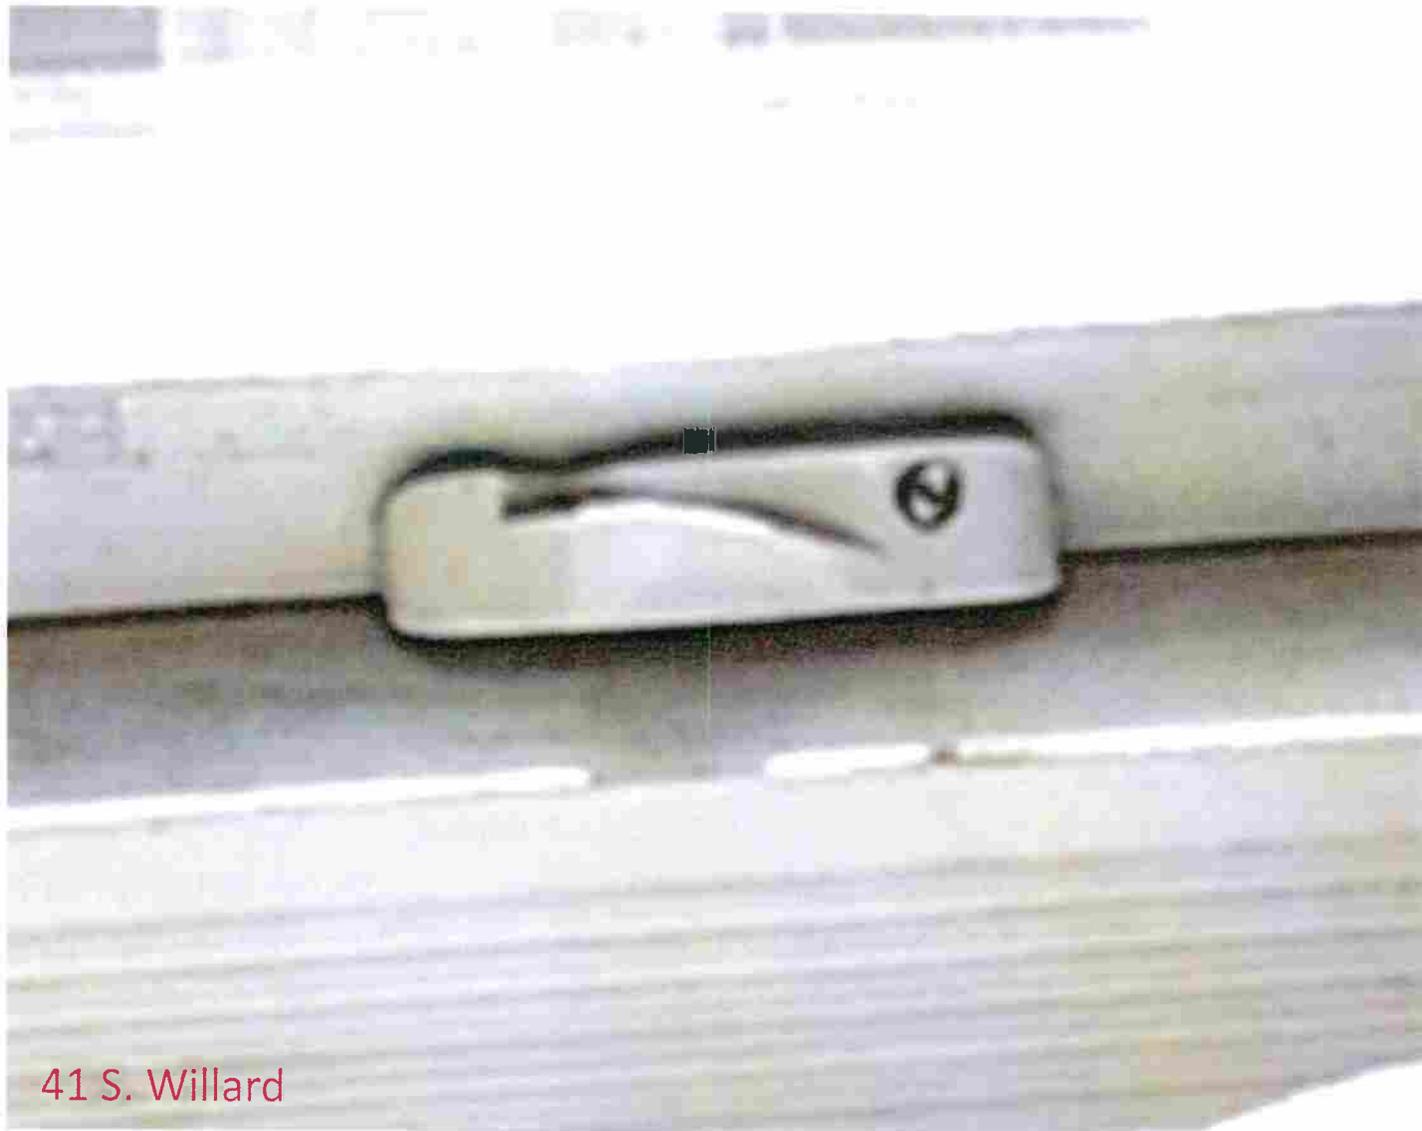
Conditions observed on 2-18-16
Photo taken by William Ward
