162 North Champlain Street

H&D Contractors

Aug. 11, 2018

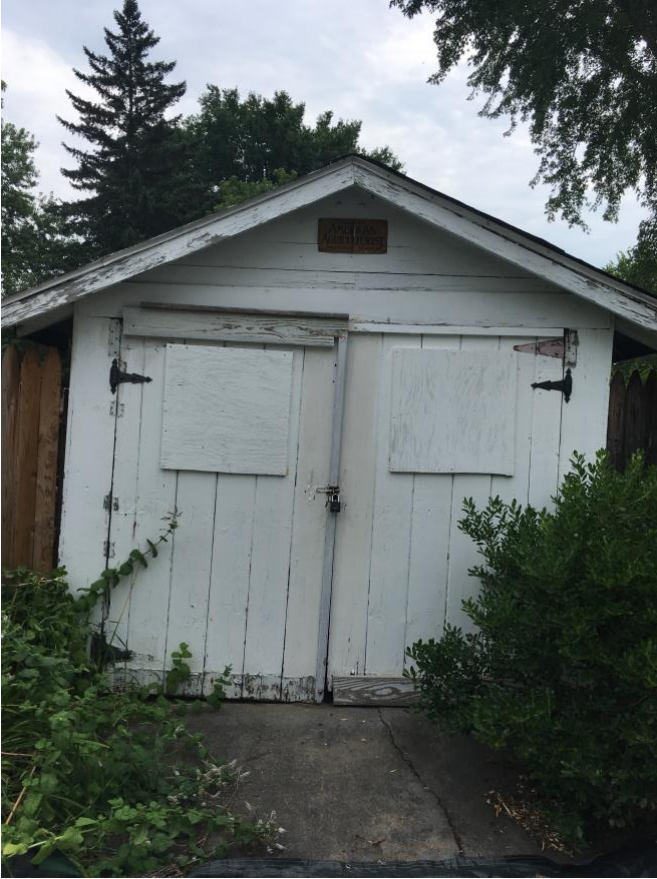
Shed from front (attempted to straighten in fall 2017, but was only able to mildly correct tilt)

After assessing the current condition of your shed and attempting to correct the extreme listing by releasing the collar ties and bottle jacking the structure to no avail I would recommend a complete tear down and rebuild.

If we had a solid platform such as a sidewalk or neighboring structure to sufficiently brace to we might be able to correct the sheds lean. However, due to the inability to sufficiently brace the structure and correct the tilt it is my opinion it would be cheaper and faster to remove the structure and build a new shed from scratch on the existing footprint.

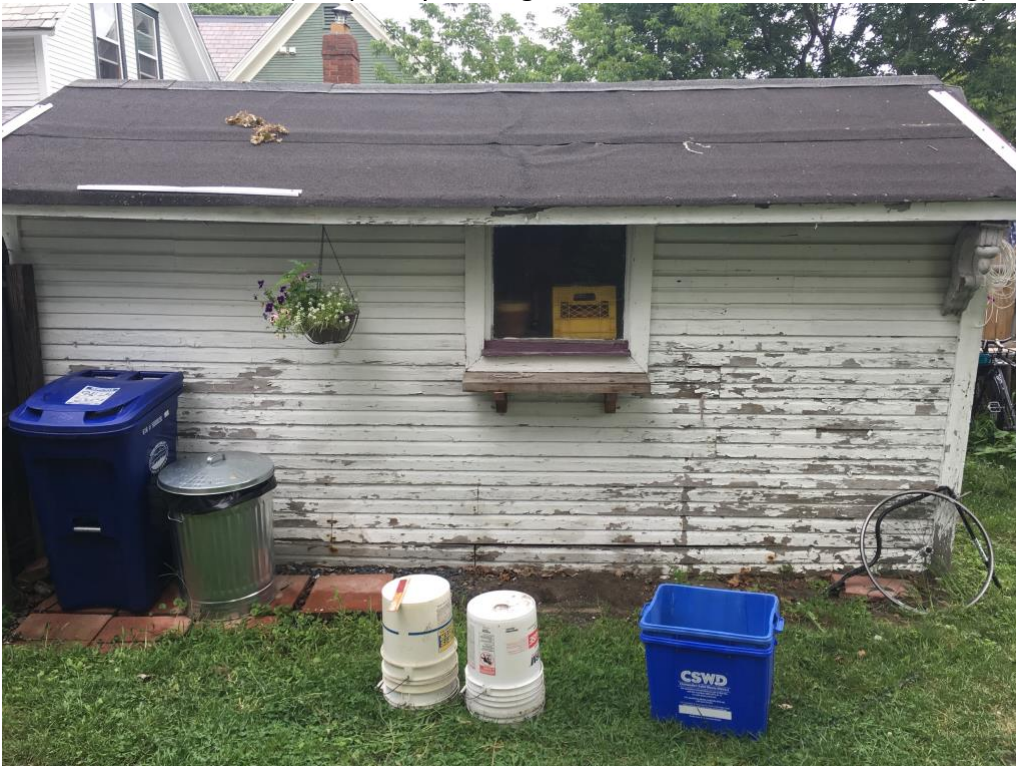
Shed from South side (temporary roofing added summer 2017 after leaking)

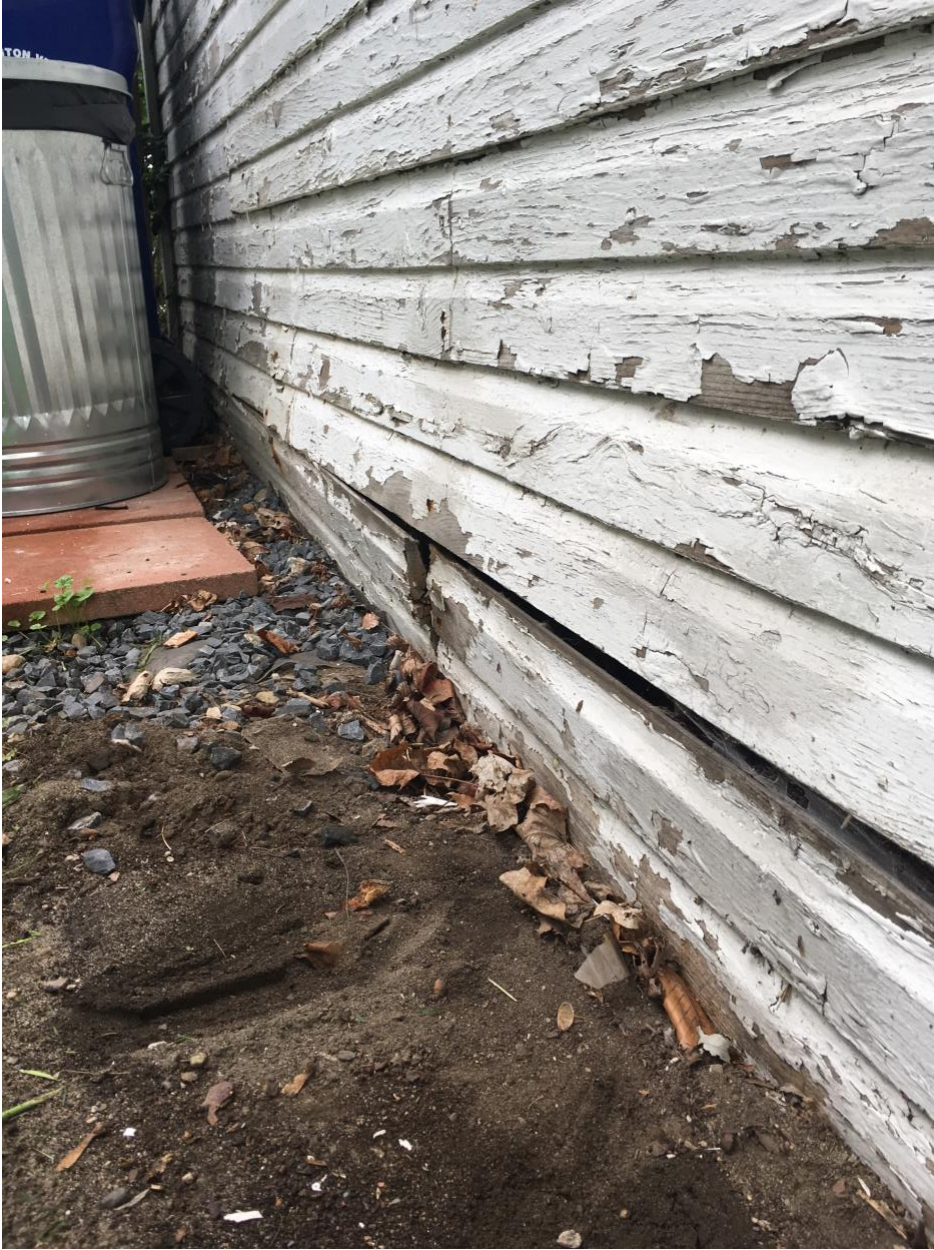
South side detail (deteriorating siding shifted during attempt to straighten structure)

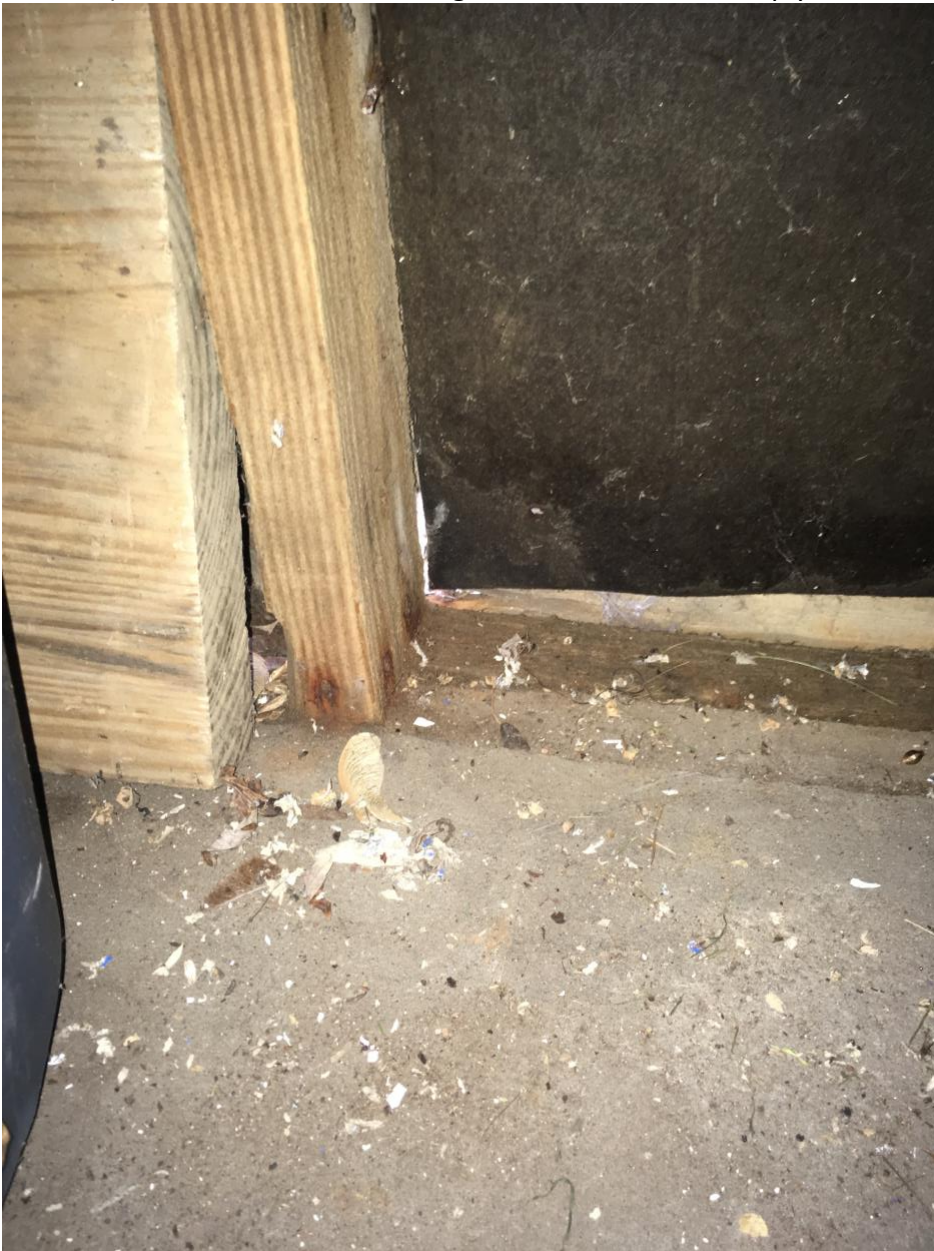
Interior (2x4 studs are deteriorating on the bottom and simply attached to sandwiched 2x4s)

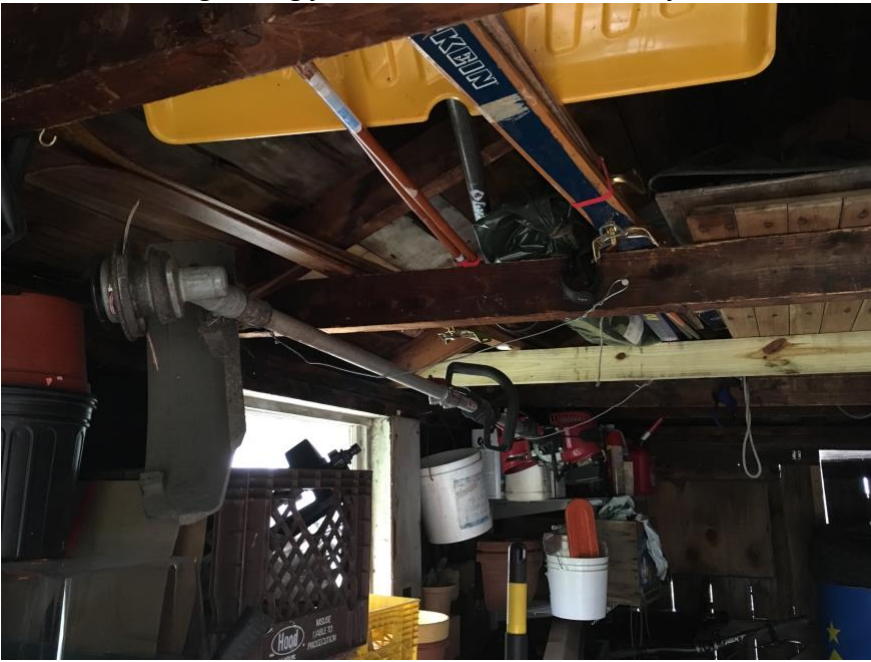
Secured existing ceiling joists and added additional joists in fall 2017

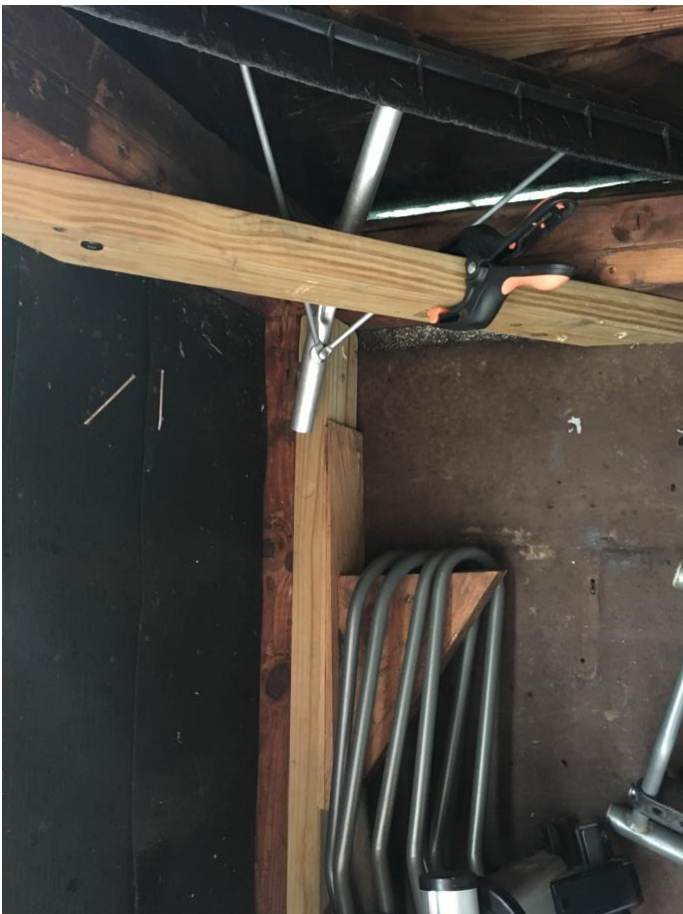
Reinforced corners in fall 2017
