May 6, 2019

Re: 8 Browns Court- Structural Review r1

EV# 19208

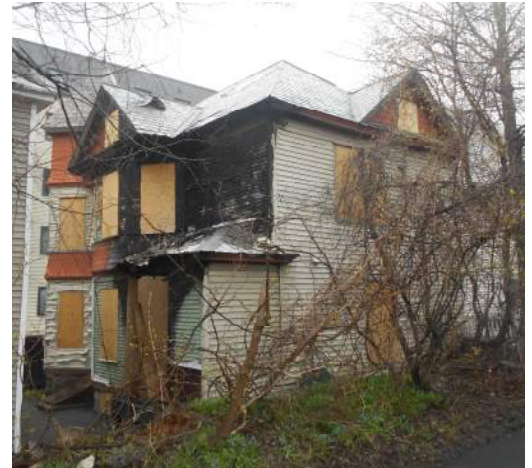
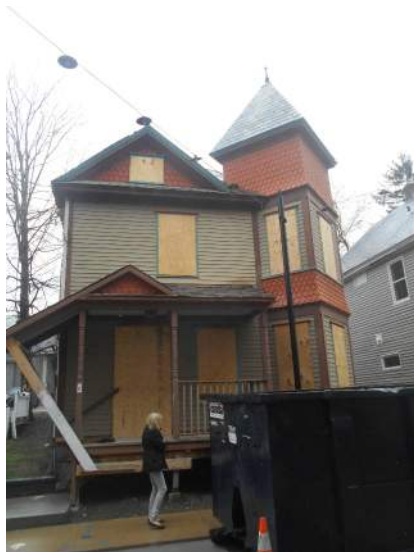
The building was damaged by fire last fall and has been boarded up and left vacant since then. The fire started in the south-east corner and damaged the exterior and about 1/3 of the roof. The main floor and second floor were not damaged directly by the fire, but were heavily smoke damaged with some water damage.

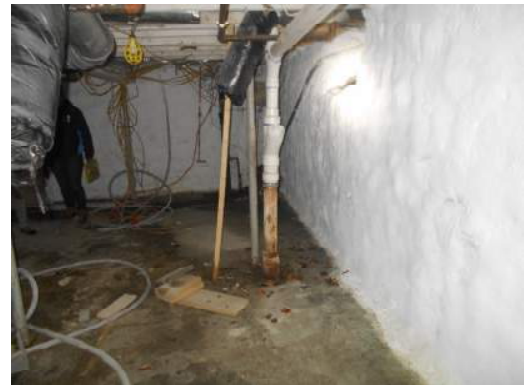
The foundation is mortared stone about 18" thick. The basement floor is concrete. The exterior foundation has been covered with spray-on

insulation making interior observations of the stone impossible without removal of the insulation.

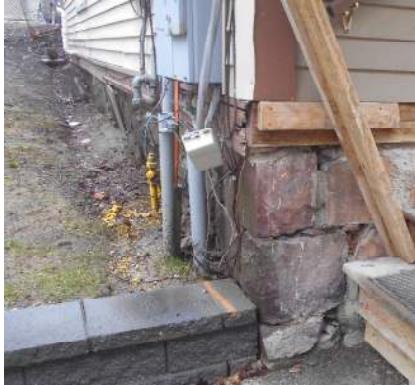
The north wall has pushed in several inches and does not appear stable. There are deteriorated mortar joints and drainage slopes back towards the building.

- The foundations should be either replaced or reinforced/repared or a combination of the two. The north and east walls should be considered for replacement. The west and south walls could be repointed and repaired but a full replacement may be more economical in the long term. Walls that are repaired should be reviewed on a regular basis (every 5-10 years) and repaired as needed.
- Drainage at the north side should be addressed to keep water from flowing toward the building.
- A more detailed review of the roof framing should be conducted. Replacement of the damaged framing is needed and reinforcing of several elements is also warranted since a significant portion of the roof has been damaged.
- Interior finishes should be evaluated for smoke and water damage and will likely need to be 100% replaced.

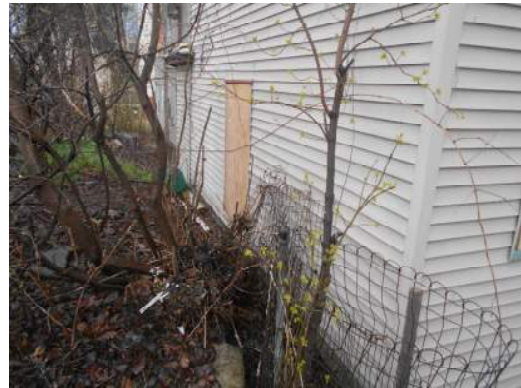
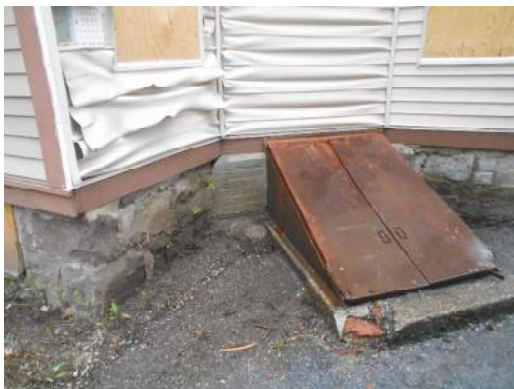
The east wall has soil that has been placed above the main floor as the grade is several feet higher in this location. The foundation itself could not be observed. It appears there were some concrete reinforcing sections added at some point. This area is likely subject to rotted sills and excessive soil pressure.

The south wall has several jogs that help stabilize the wall and therefore it does not appear to be leaning inward. The mortar joints are in poor condition with loose stones and missing mortar.

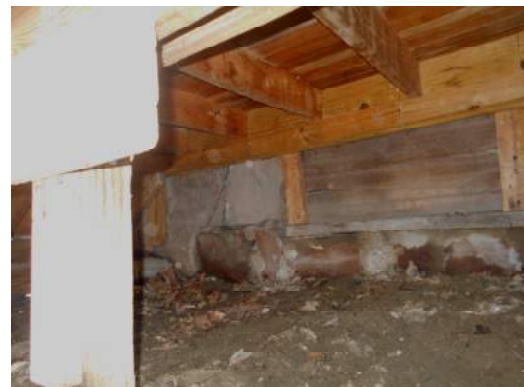
The first and second floor framing were noted to be in good condition without direct fire damage. The finishes will likely need to be replaced due to smoke and water damage.

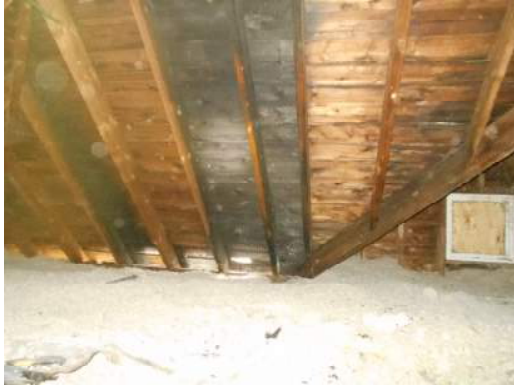
The roof framing was about 1/3 damaged by the fire. The damaged sections will need to be replaced. Additionally, the valley beams that form the dormers of the roof should be further evaluated and likely reinforced.
