## Alfred Larson House, Garage 1920

Location: 87 Hungerford Terrace, Burlington, Vermont 05401

### Demolition of Historic Building

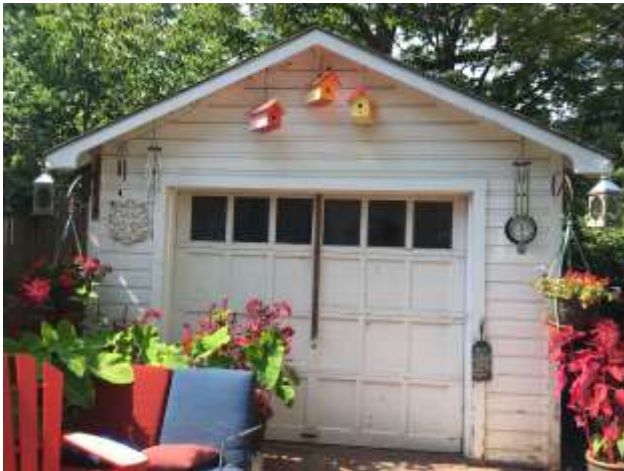
Garage door with wooden rod to keep closed.

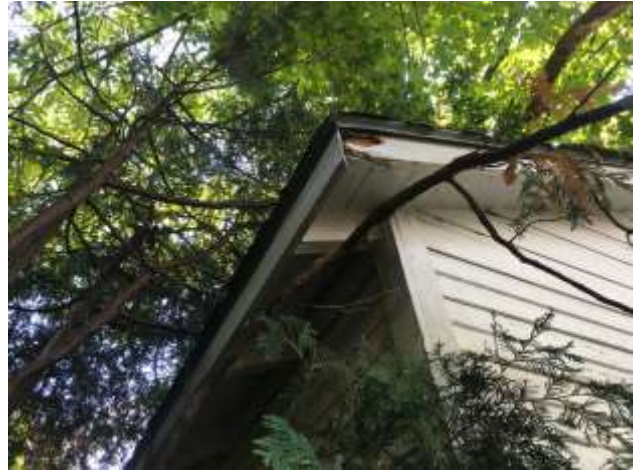
Deteriorated trim at roof eaves.

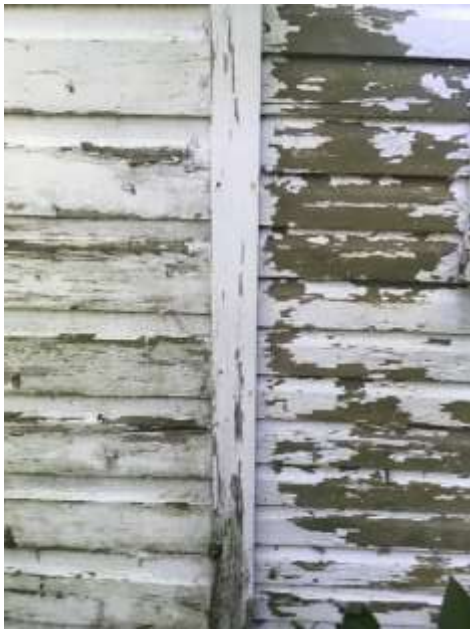
Deteriorating seam that separates the historic structure and the later addition.

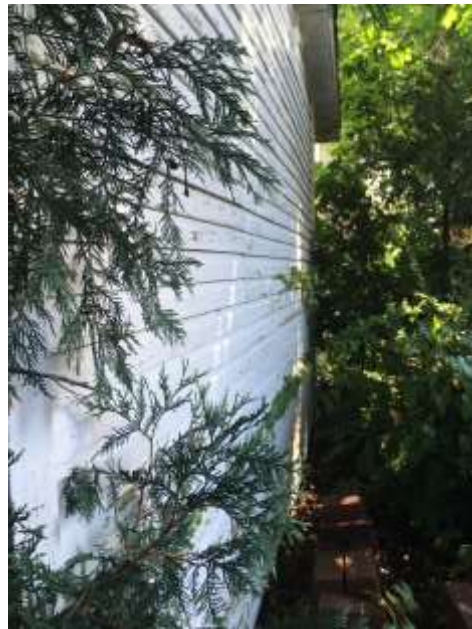
Back side of the siding bows outward.

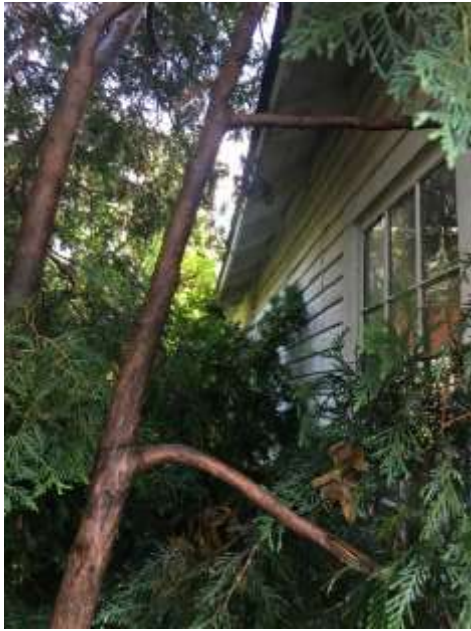
Two windows at rear (historic) section of structure & seam connecting historic to later addition.

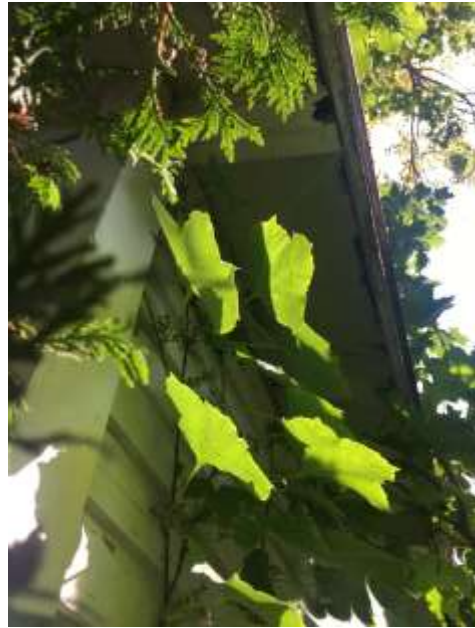
Deteriorating rafters & roof sheathing at South eaves.

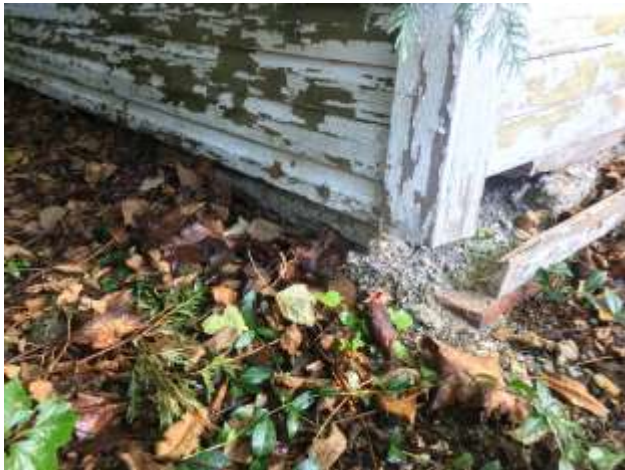
Northwest corner of structure floats above grade.

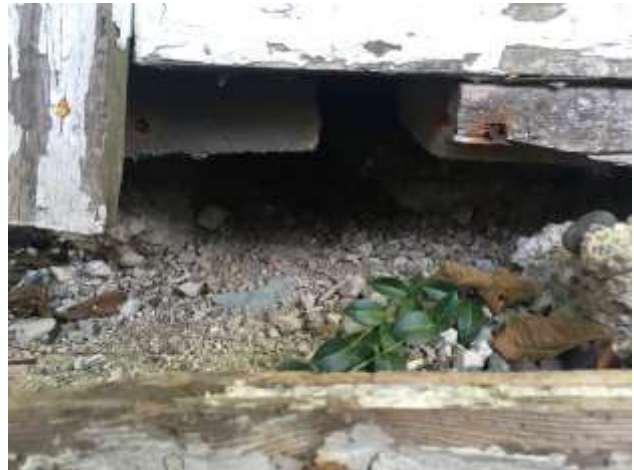
Northwest corner not setting on structural foundation. Gravel has washed out.

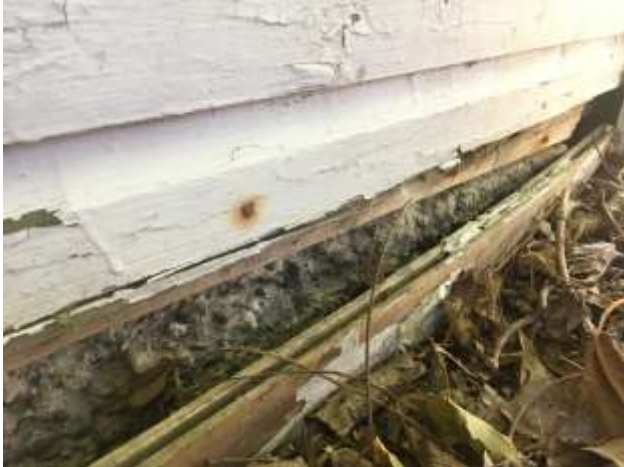
Southwest wall – previous concrete pour has pushed out the siding board at grade.

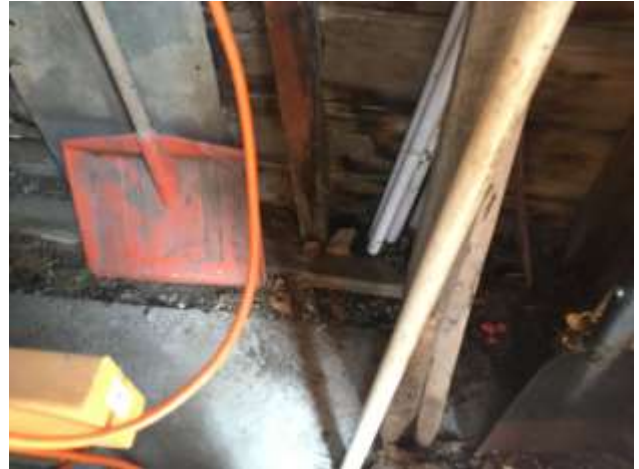
Gap between concrete slab and structure = structure sitting on grade with no structural support. Water damage at siding and framing.

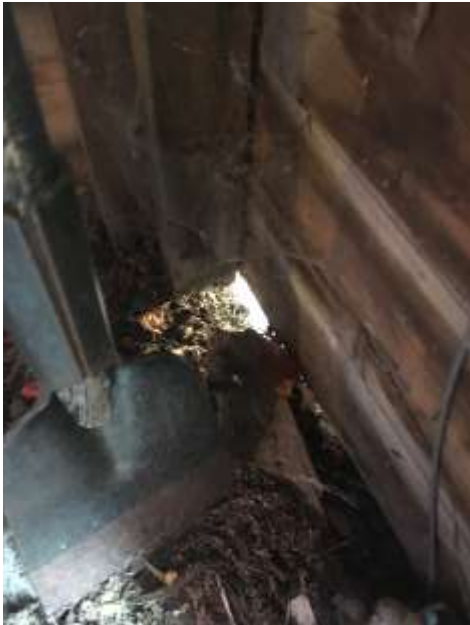
Northeast corner of structure sits above grade = no structural support.

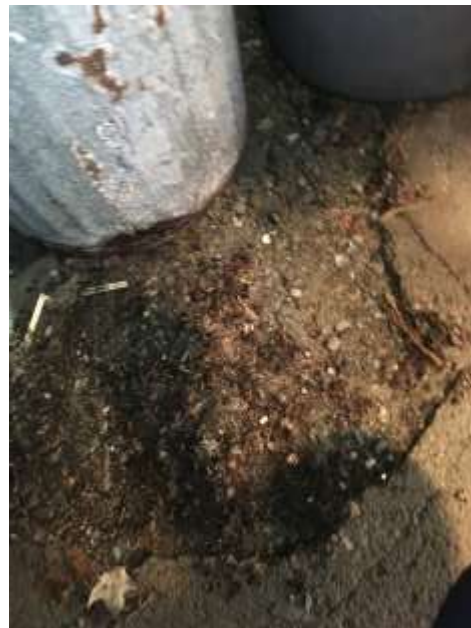
Deteriorated interior slab. Concrete appears to be a topping slab on gravel with no structural slab.

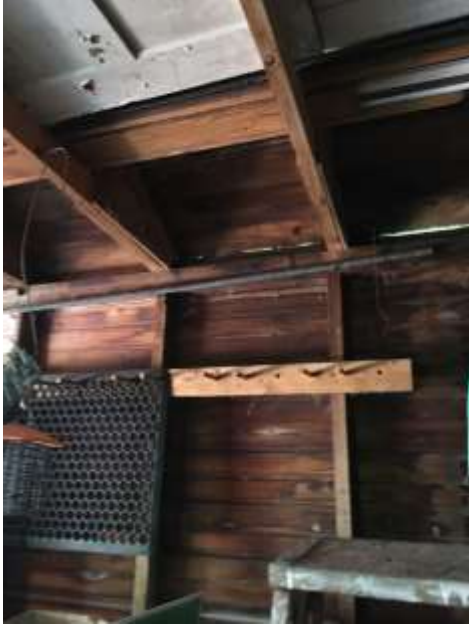
Moisture damage at siding- South wall.

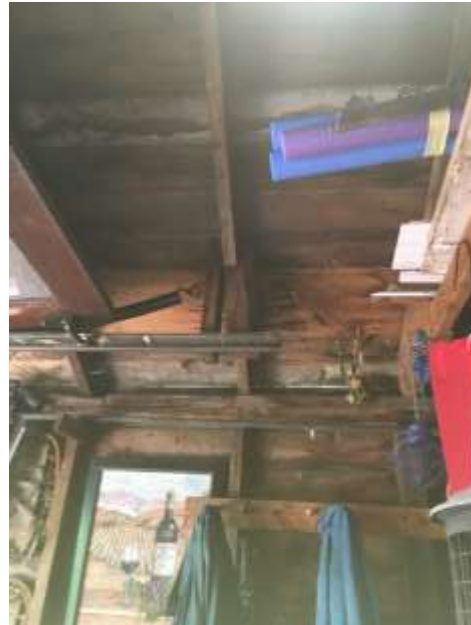
Moisture damage at roof and siding. Broken OHD track.

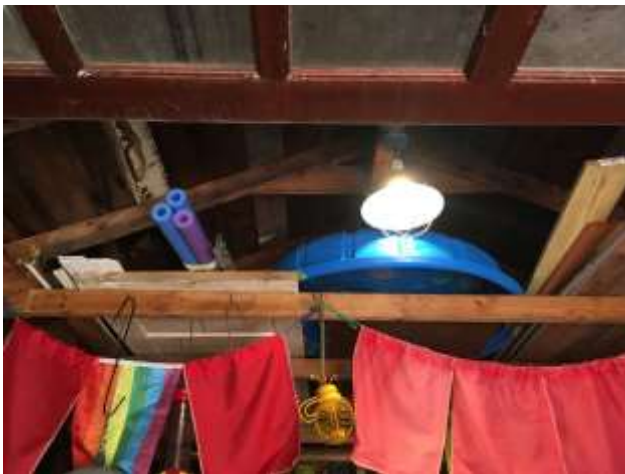
Moisture damage at roof and framing.

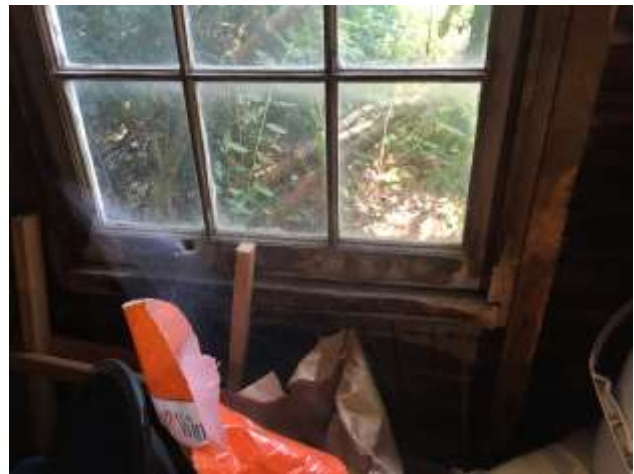
Moisture damage at window.
