495 COLCHESTER AVE. PHOTO TAKEN NOVEMBER, 1927 AFTER THE FLOOD THAT REMOVED THE BRIDGE TO WINOOSKI.

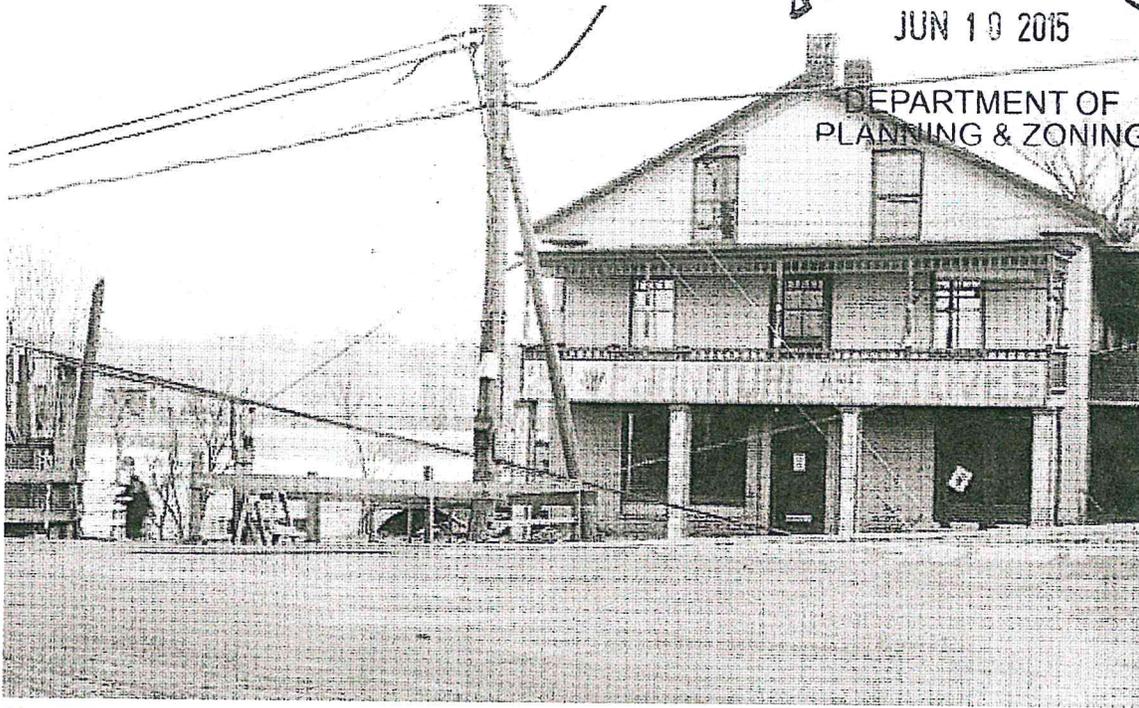
Photo 1. West elevation photo taken 1927, after the flood, but before bridge was rebuilt 9 feet higher.

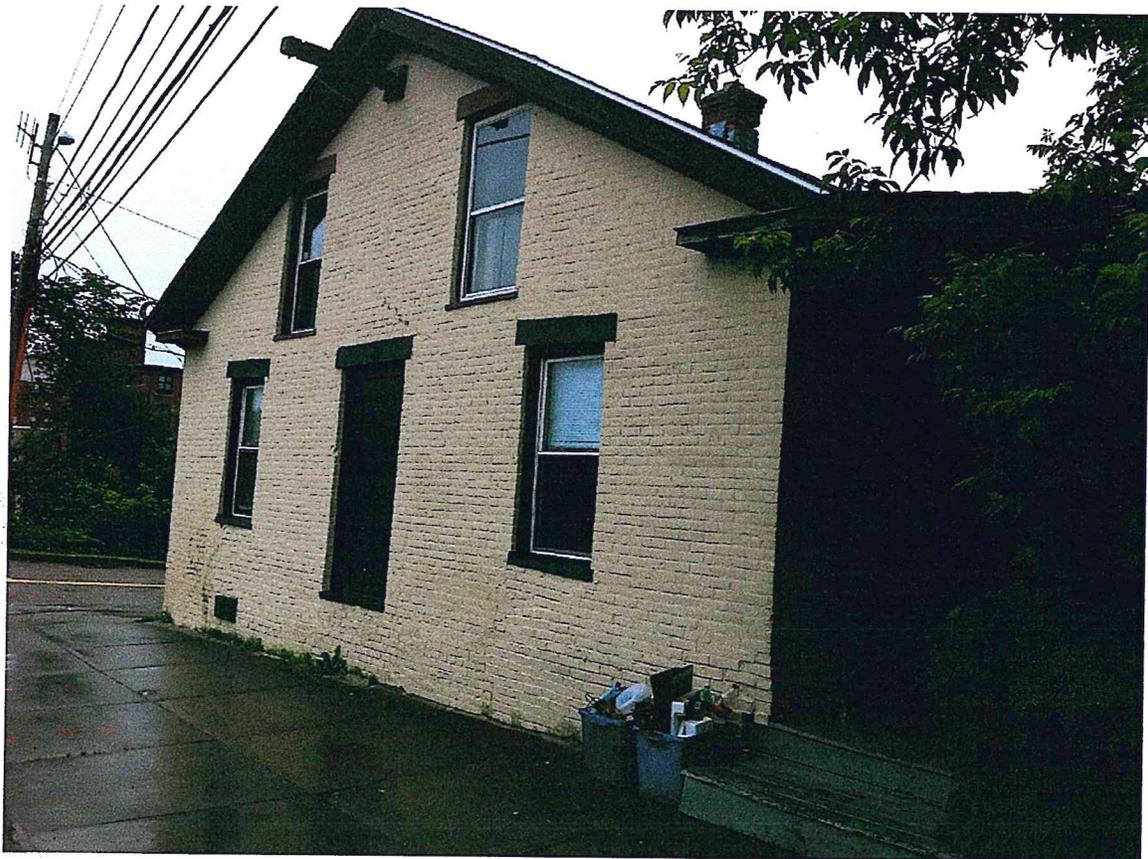
Photo 2. West elevation taken 2014. What is now a blocked in doorway just above the sidewalk used to be a door to the second floor porch seen in Photo 1. The porch was removed when the building was buried. Windows have been replaced with 1-over-1 windows, instead of the original 2-over-2 windows seen in the historic photograph.

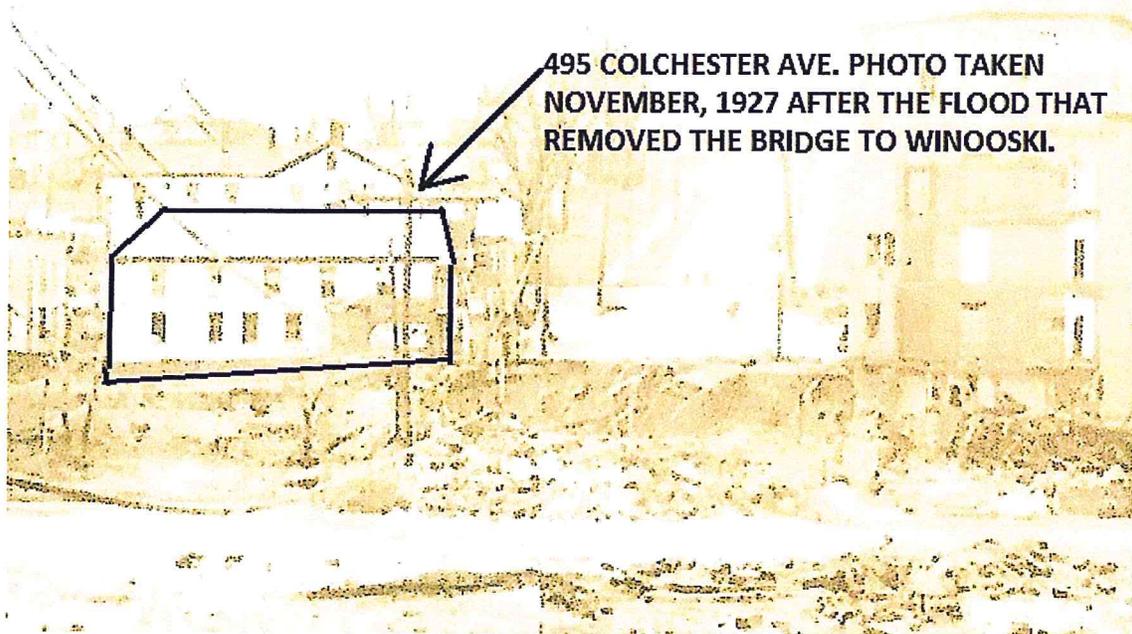
Photo 3. North elevation photo taken 1927, after the flood, but before bridge was rebuilt 9 feet higher. Dark outline is the building of this application. Note the stone foundation wall and windows visible at the Cellar level, and four windows to the left side of the loading doors.

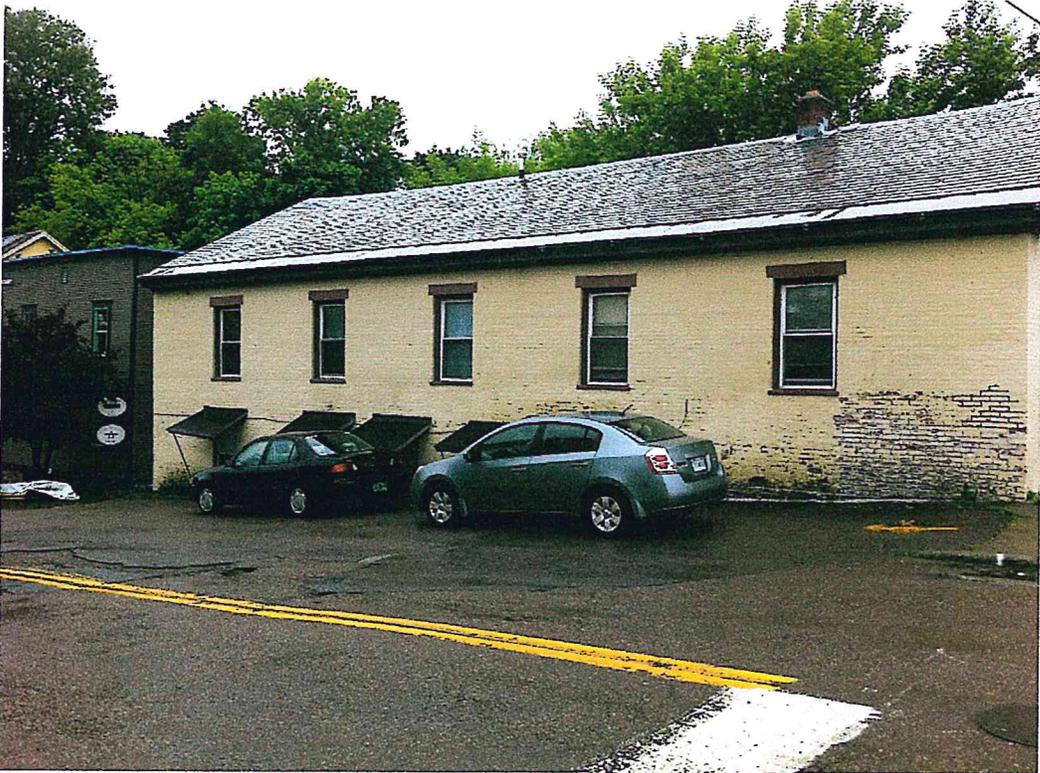
Photo 4. North elevation photo taken 2014.

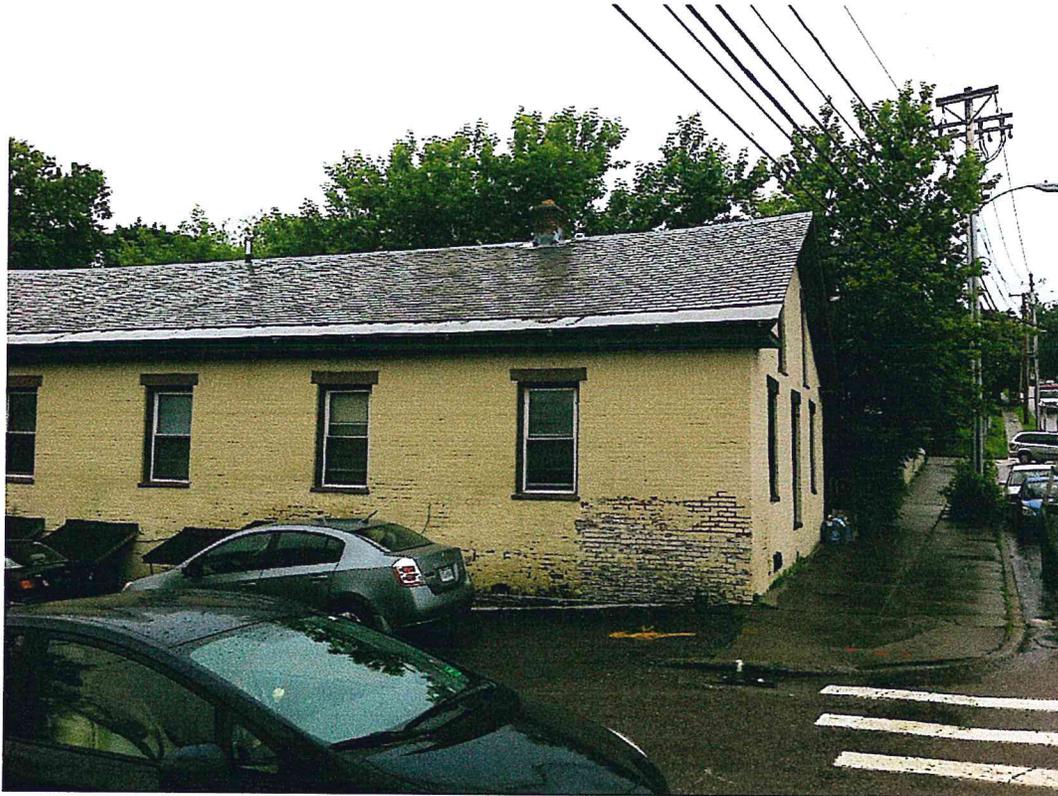
Photo 5. North elevation photo taken 2014. Note evidence of rising damp on the bricks at the west end of the north elevation, caused by the building being buried.

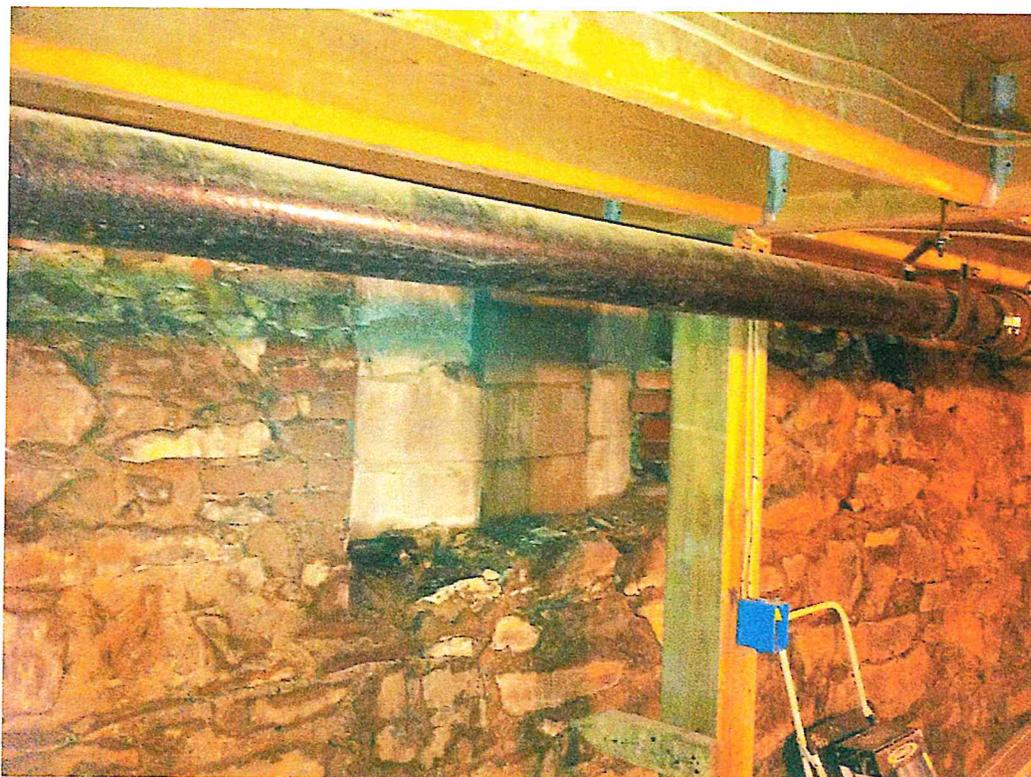
Photo 6. Interior of north wall of cellar showing original stone foundation. Former above ground windows have been filled in. The floor structure supporting the first floor is not original and will be replaced with mill construction techniques matching extant framing of the floors above. Stone walls will remain exposed in the adaptation of this level into a Café.

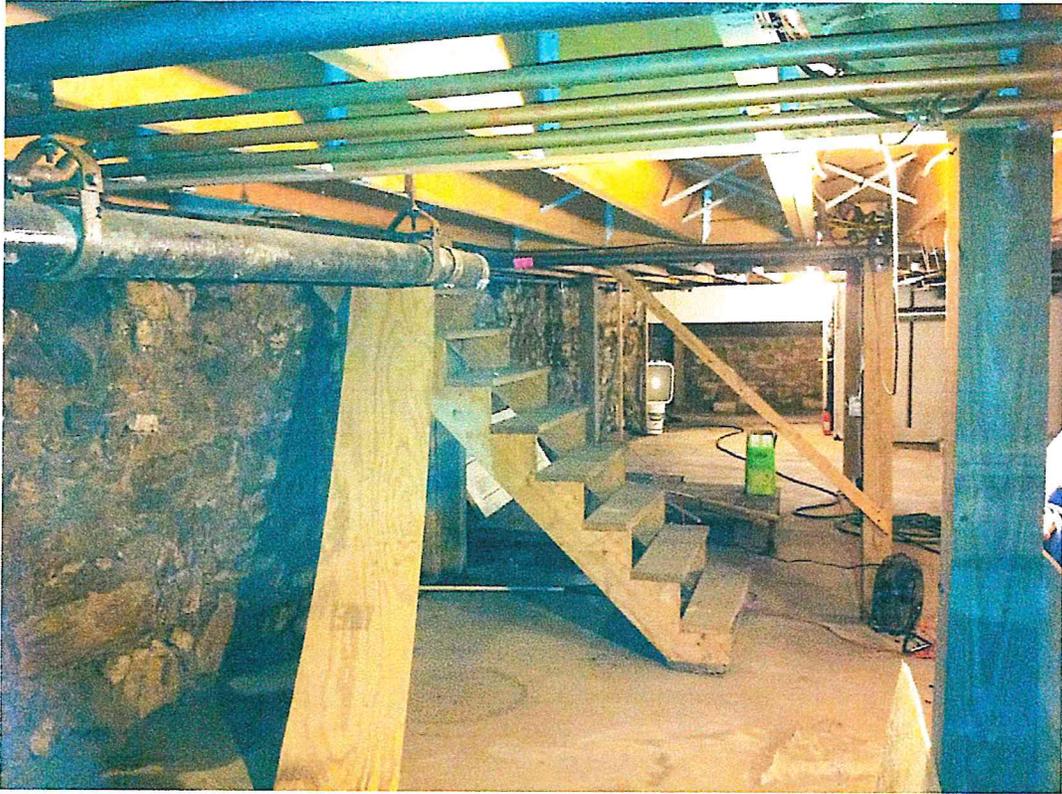
Photo 7. Existing south wall of cellar. Structure of First Floor above is modern, made of 2x10 joists and 6x6 posts spaced 12' apart.

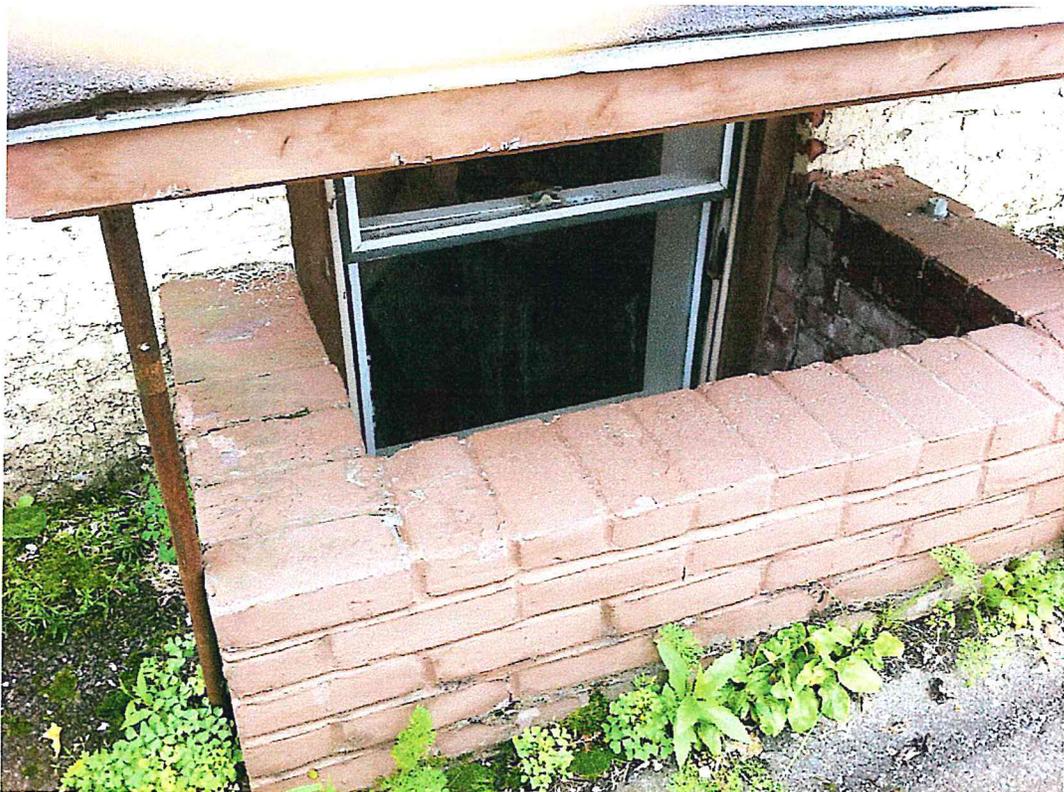
Photo 8. The first floor windows are now mostly buried. The north windows have these little window wells put in to offer some protection from snow and rain. Rooms inside are dark and gloomy. The Cellar is a full floor below the floor these windows are on.

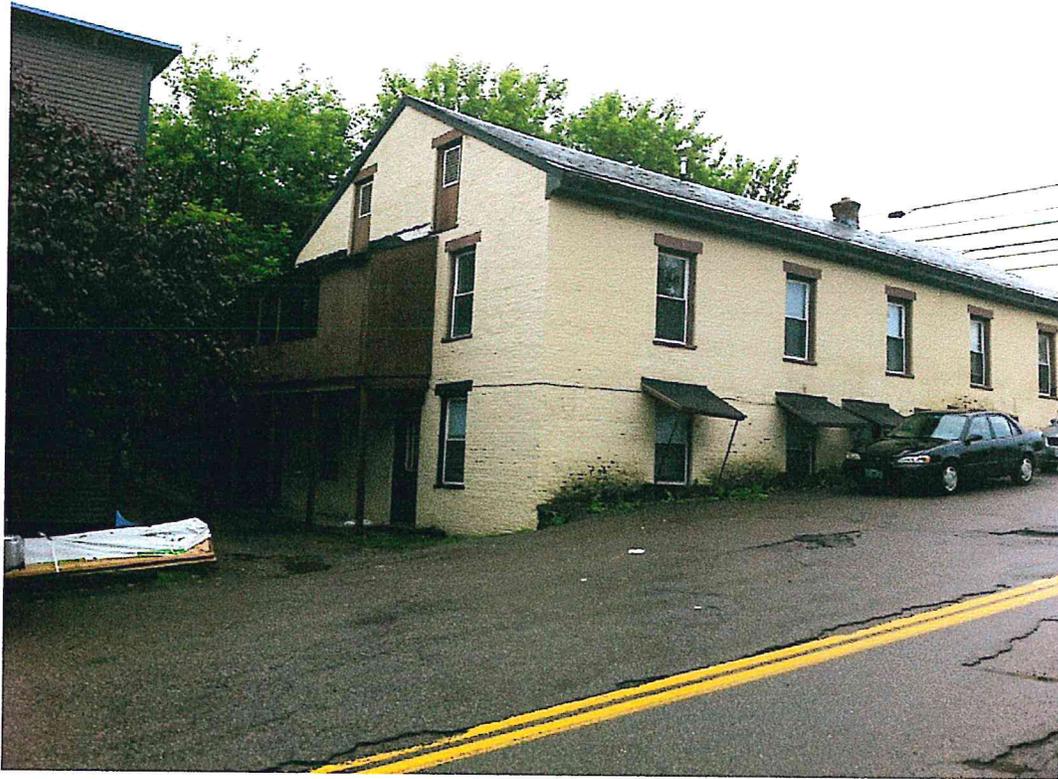
Photo 9. The first floor apartments are currently at grade level on the east end of the building shown here. The apartment door is not original and was cut into the brick façade. Originally this floor was about 9 feet above grade with the cellar having an on-grade access at this end of the building.

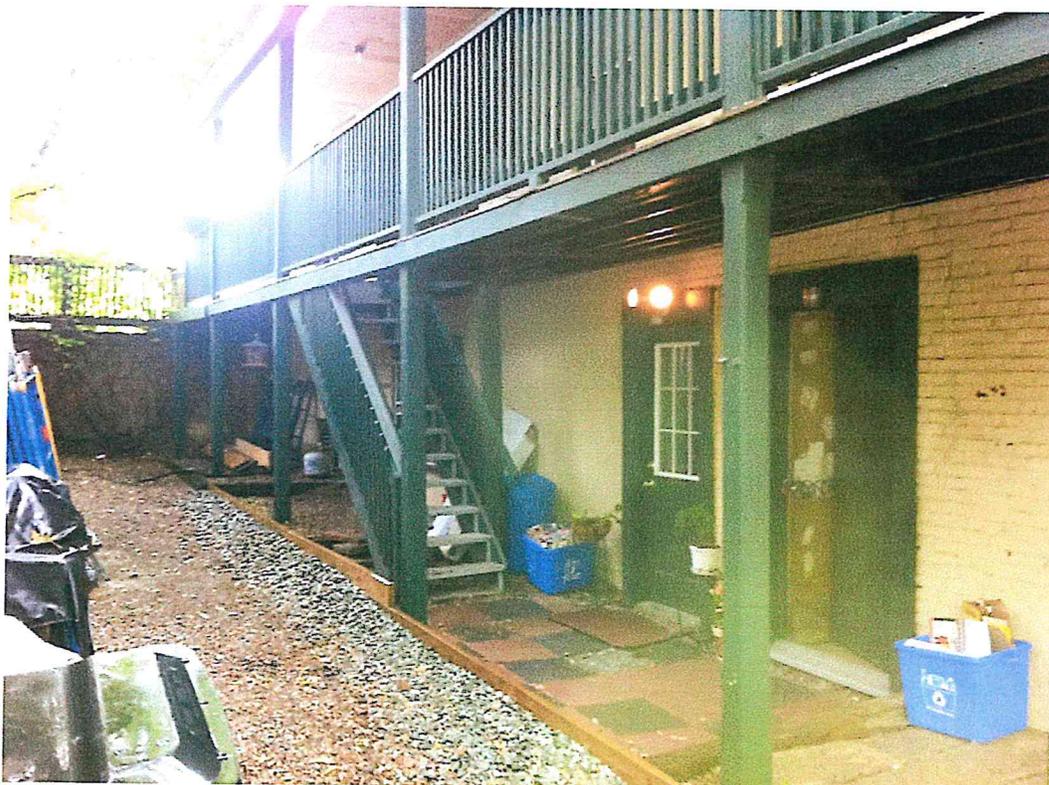
Photo 10. On the south side, a courtyard was cut in to allow access to the first floor apartments. The door on the left leads to one of the apartments. The door on the right leads to the cellar. The side porch was not part of the building prior to the flood.

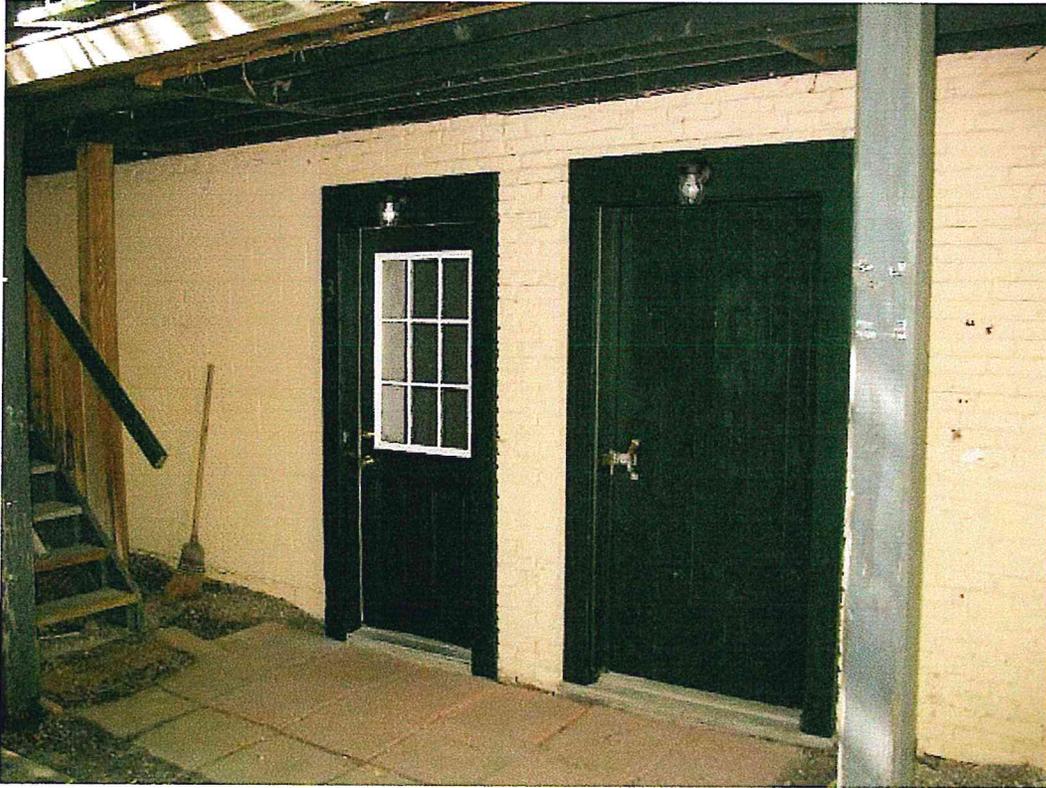
Photo 11. On the south side, the wall east of the first floor apartment past the door with the light in it, was rebuilt in concrete block. We assume that the brick veneer failed at some point and was replaced with concrete block. The renovations will replace this concrete block with brick veneer to match the original brick veneer conditions.

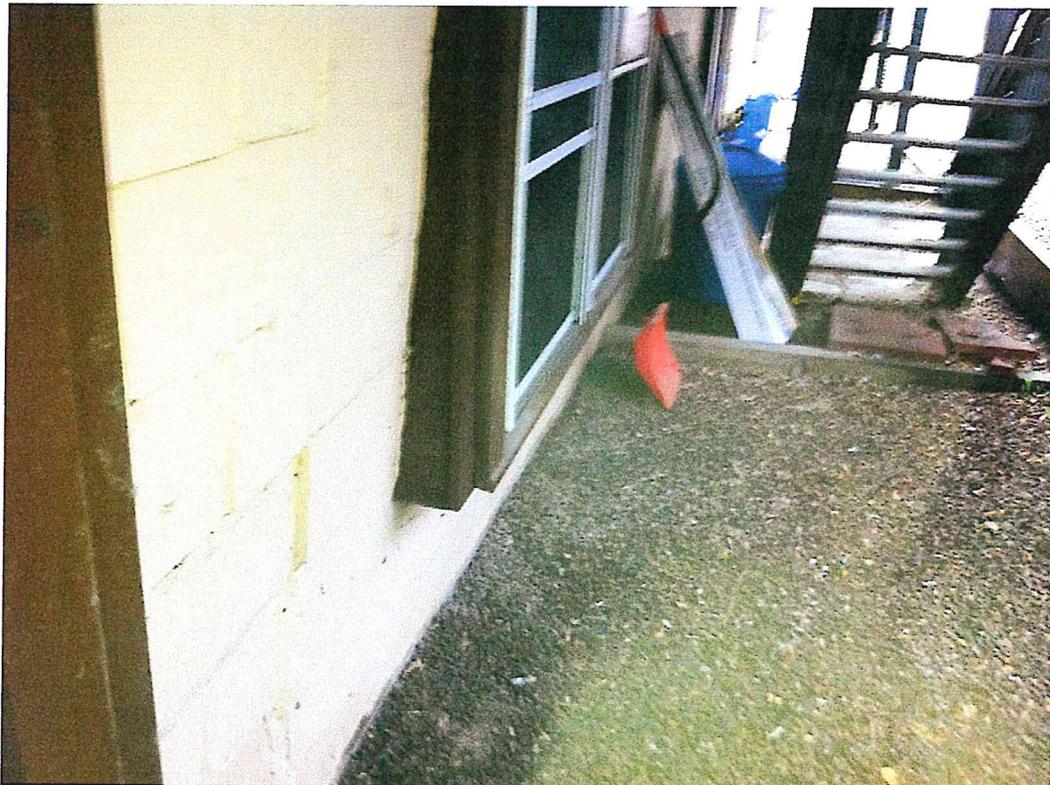
Photo 12. Part of the original south wall was replaced with concrete block. The wall has begun to lean out at the top; the boxed out windows are vertical.

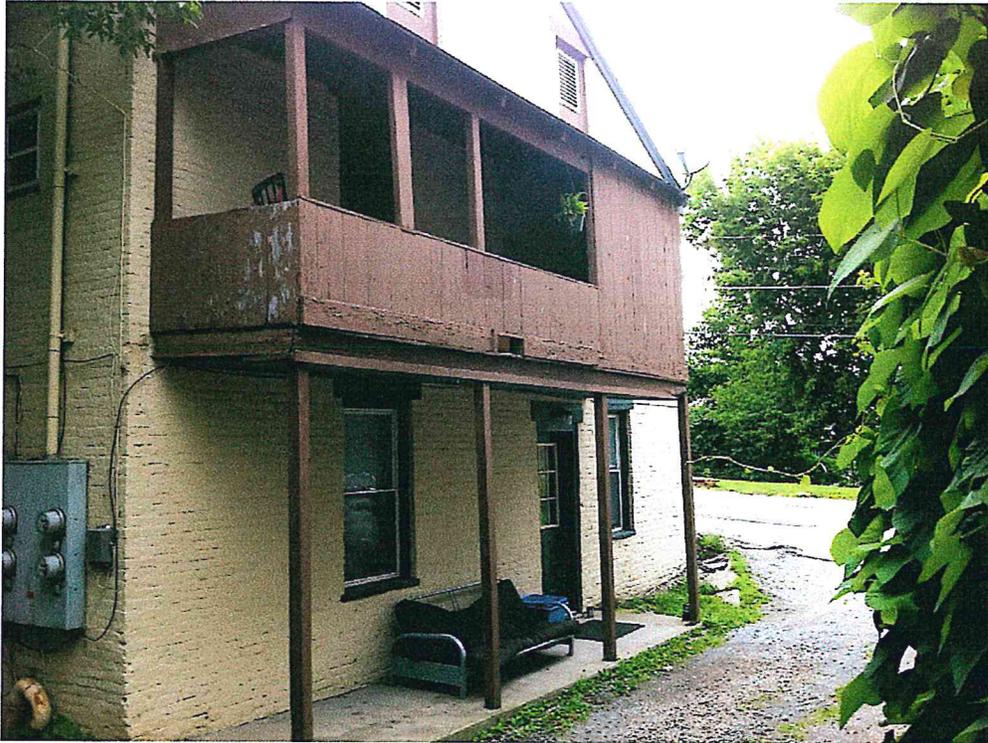
Photo 13. Exterior porch, east side was first built in 1916 and remodeled later to its present condition shown here. The door at the upper level replaced a former window from the 1820 design. The lower door was put in after 1929, as the first floor was well above the ground floor on the east side.

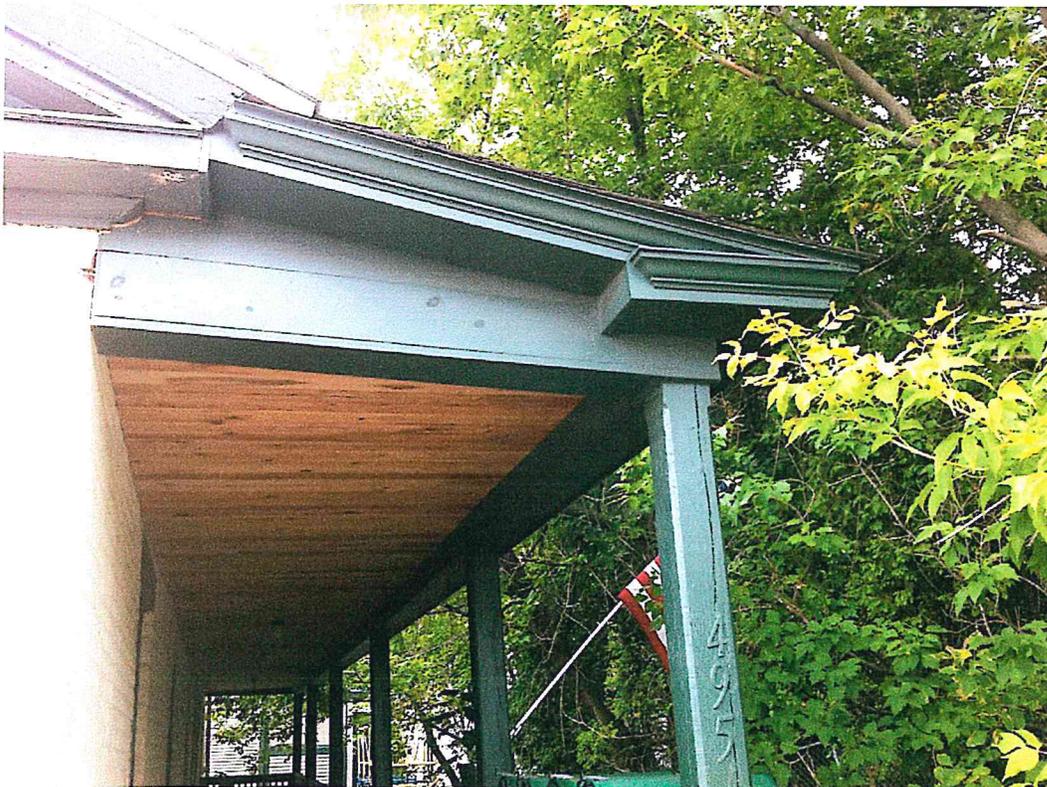
Photo 14. Replaced south side porch. Original south side porch seen in PHOTO 1, does not come all the way to the west façade as this one does. The ceiling of the porch seen here is fairly new.

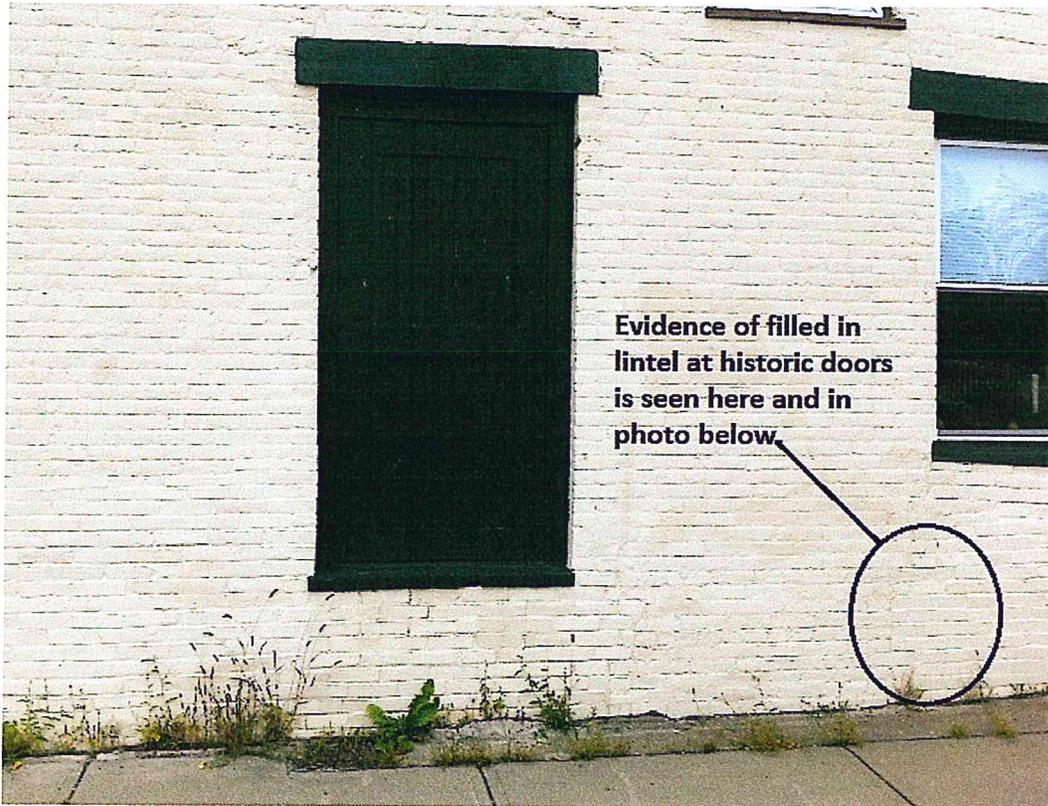
Photo 15. Evidence of where shop doors were filled in with brick. This is the lintel location.

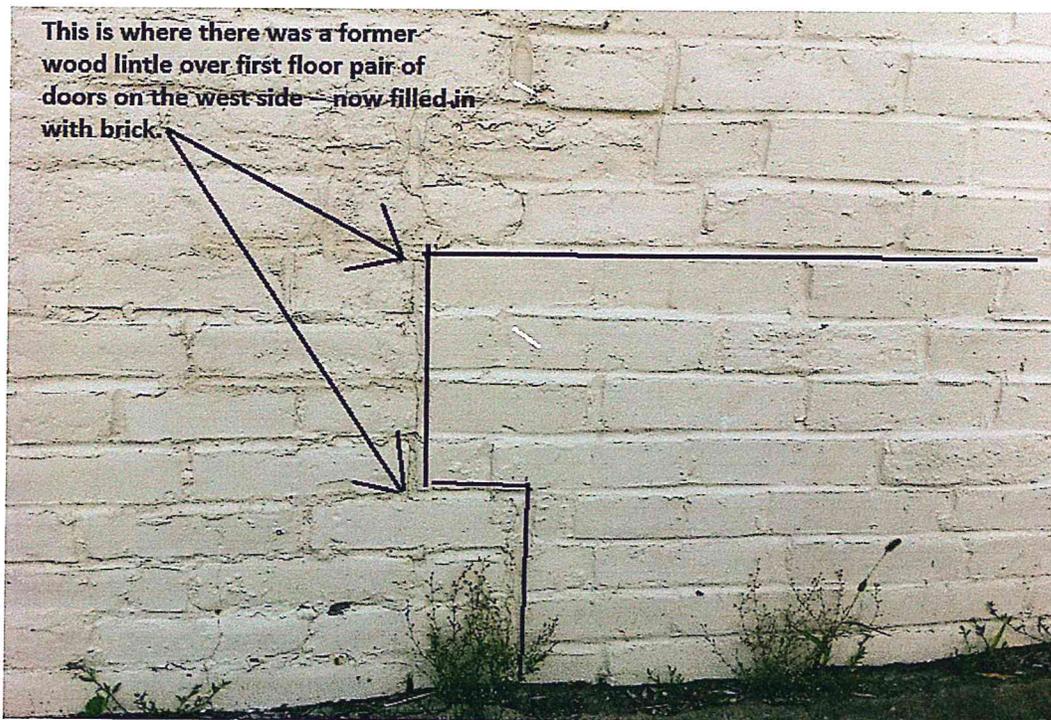
Photo 16. Evidence of where shop doors were filled in with brick. This is the lintel location. Note the difference in joint detail and brick face texture.

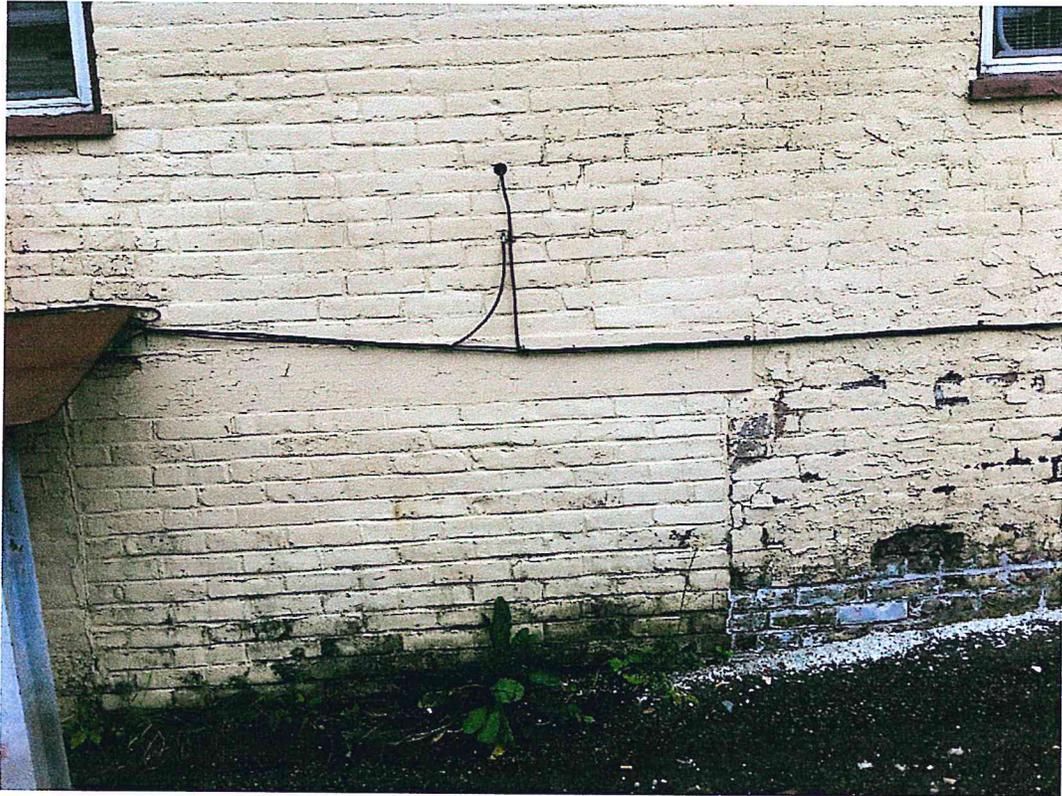
Photo 17. Evidence of where loading dock doors were filled in with brick on the north elevation. The painted wood lintel remains. Note damage from rising damp to the right of the blocked opening. The black lines are cable TV cables.

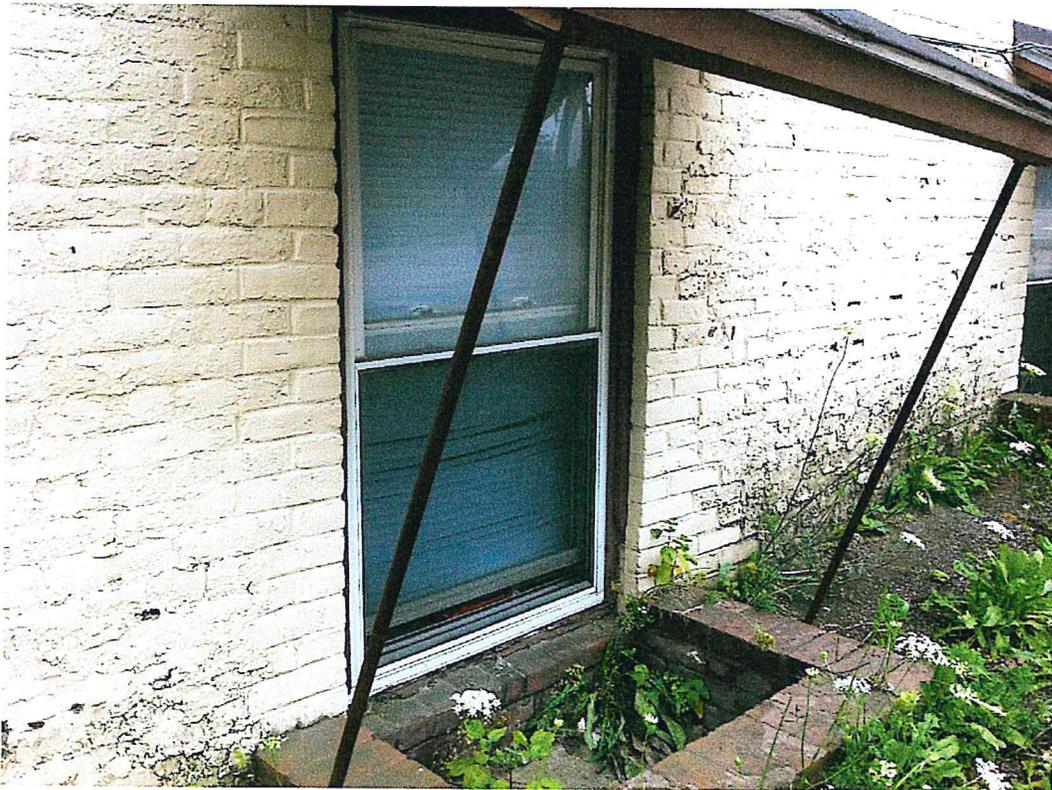
Photo 18. North side windows are buried to various depths. They have more exposure the closer they are to the east side of the building. None of the windows are the original 2-over-2 pattern seen in historic PHOTO 3.

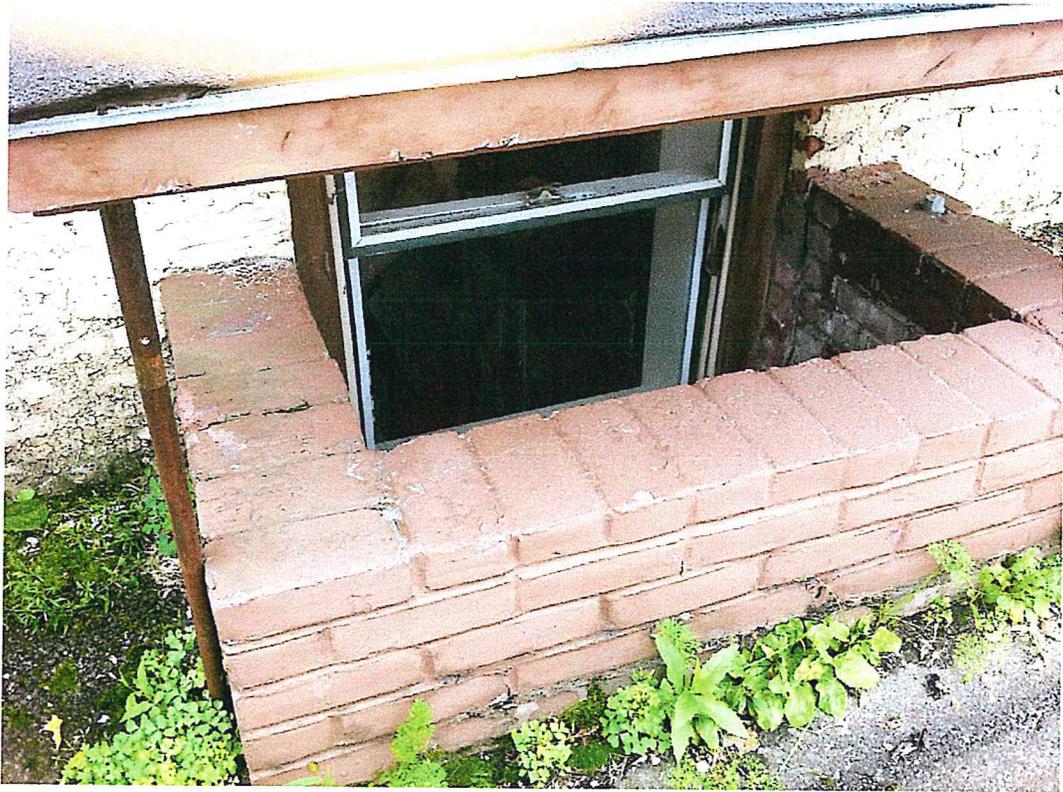
Photo 19. North side first floor windows on the west are buried more than those toward the east due to the slope of the street in front of the windows. The brick window wells were built when the building was buried in 1928.

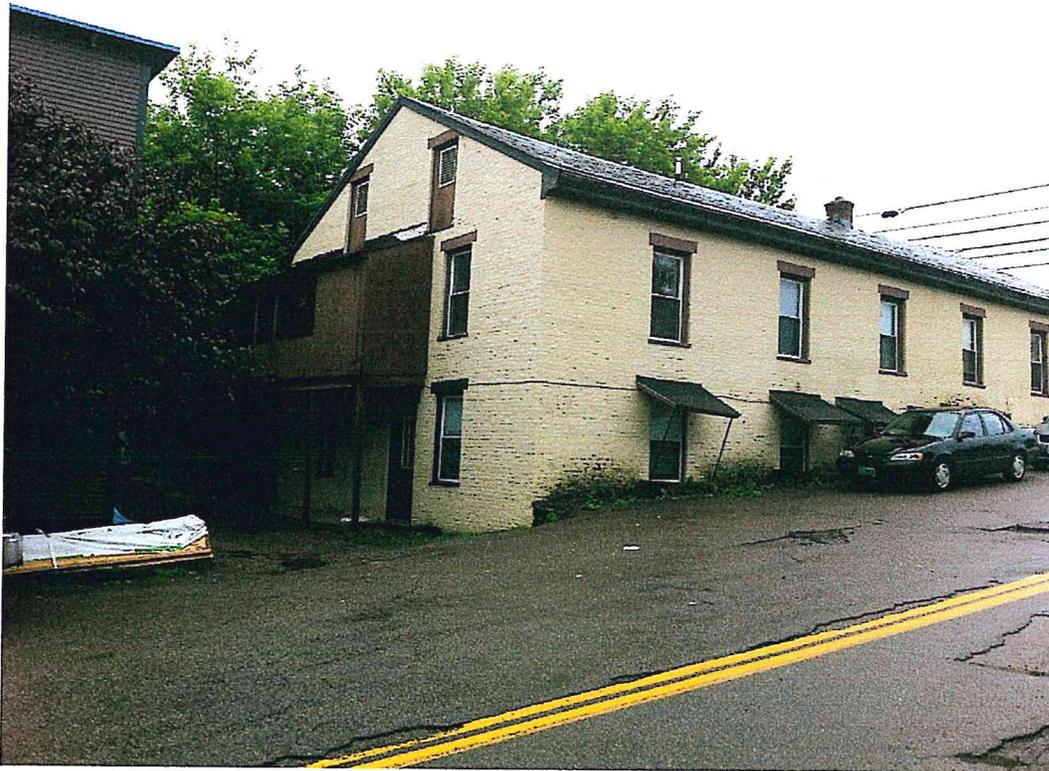
Photo 20. East and North elevation showing location of first and second floor doors and windows. The door just to the left of the window on the east elevation is not original and was cut in to access the apartment at the east end of the first floor in 1928.

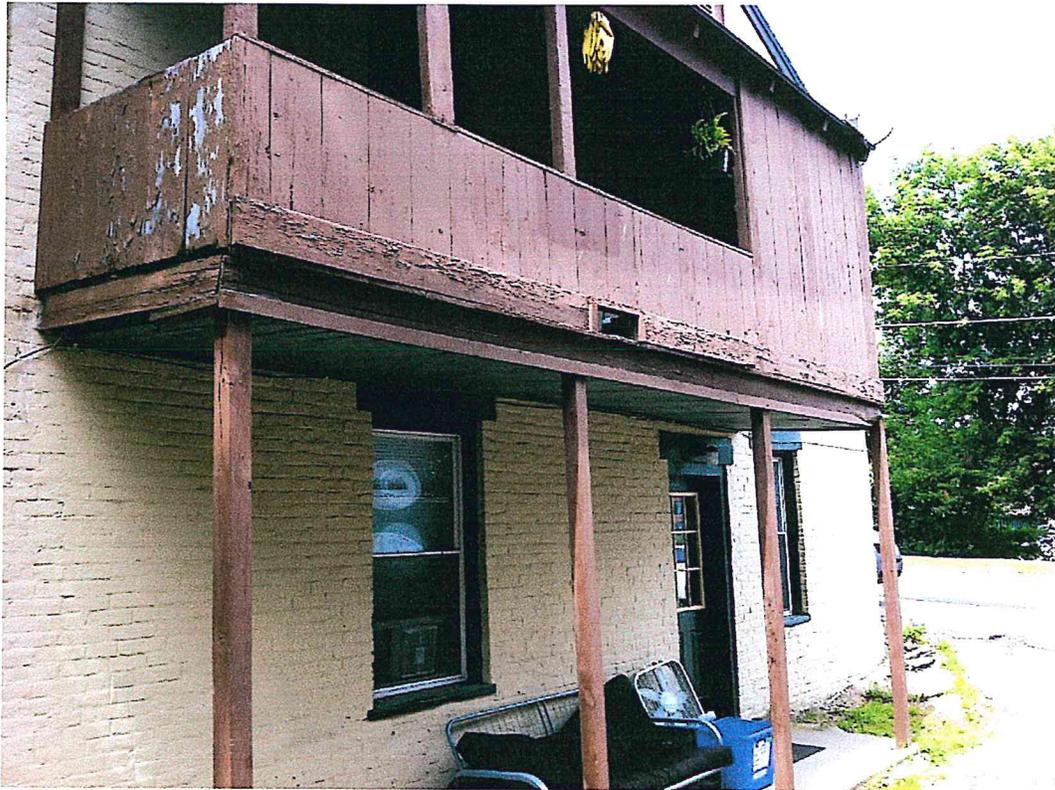
Photo 21. East side showing added porch and door cut in to access the apartment at the east end of the first floor in 1928. The porch was built after 1928.

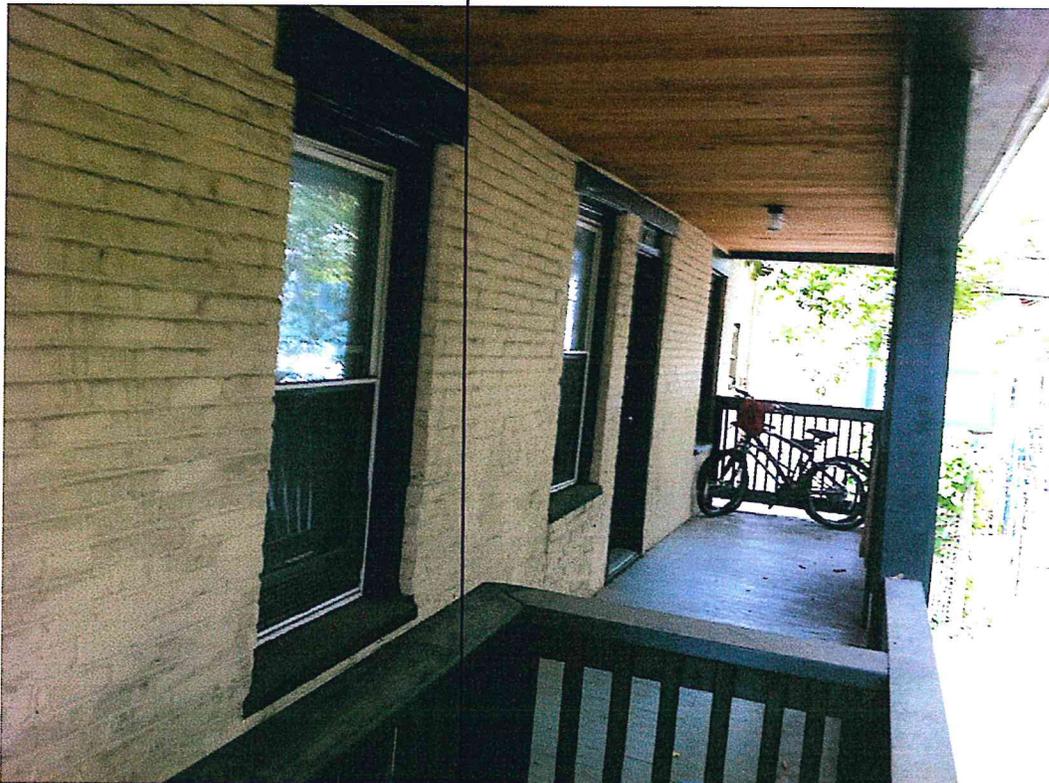
Photo 22. South side at Second Floor of south porch. Windows and doors are at original location with original solid wood headers and sills. Sash and doors are not original.

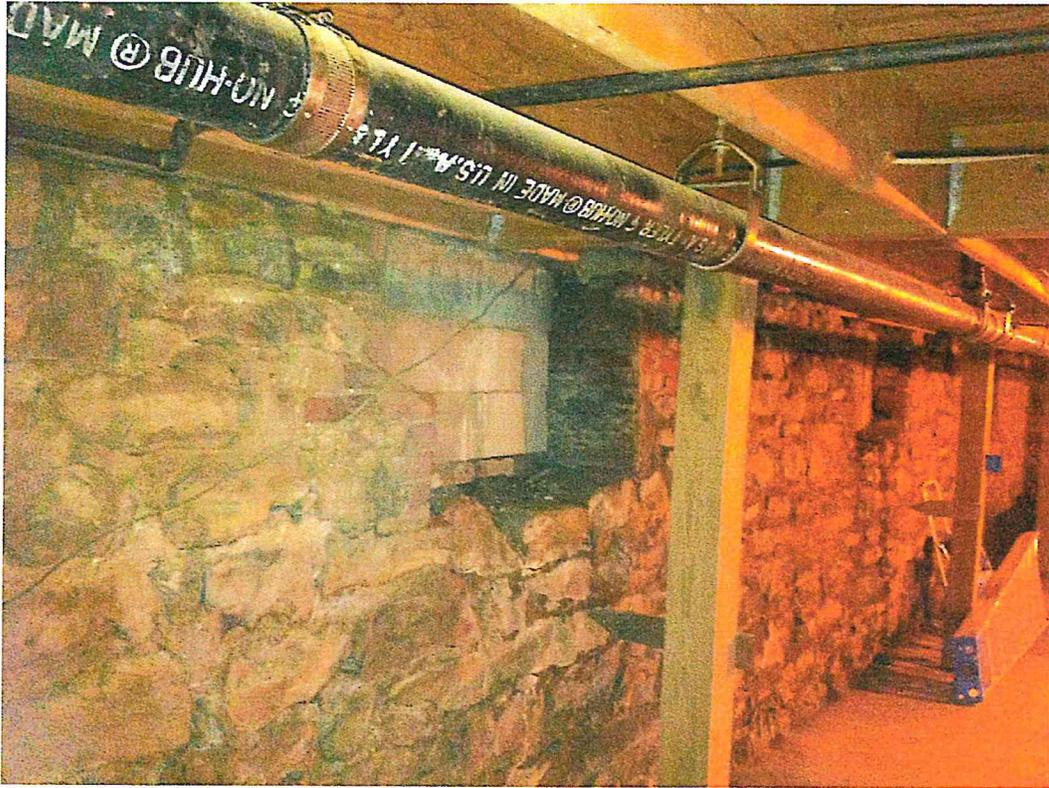
Photo 23. North wall of cellar, showing infill of windows buried in 1928. Locations of these windows will be duplicated in the new Ground Floor walls that will be inserted between these existing walls that will remain and the raised walls of the first and second floors.

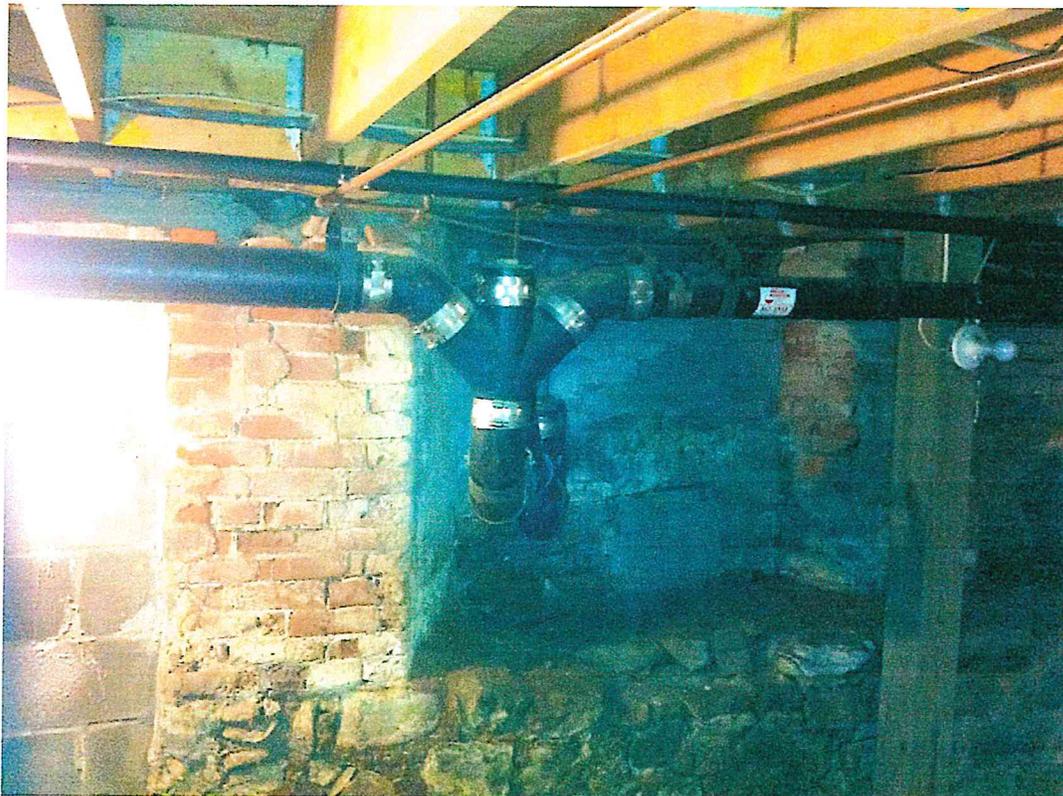
Photo 24. East wall of cellar, showing original on-grade entrance on the left, now blocked with concrete blocks. The pair of windows on the right, provided natural light and display features from the east end, which was fully above grade at this level before 1928. Now sewer lines from the apartments above gather and exit here.

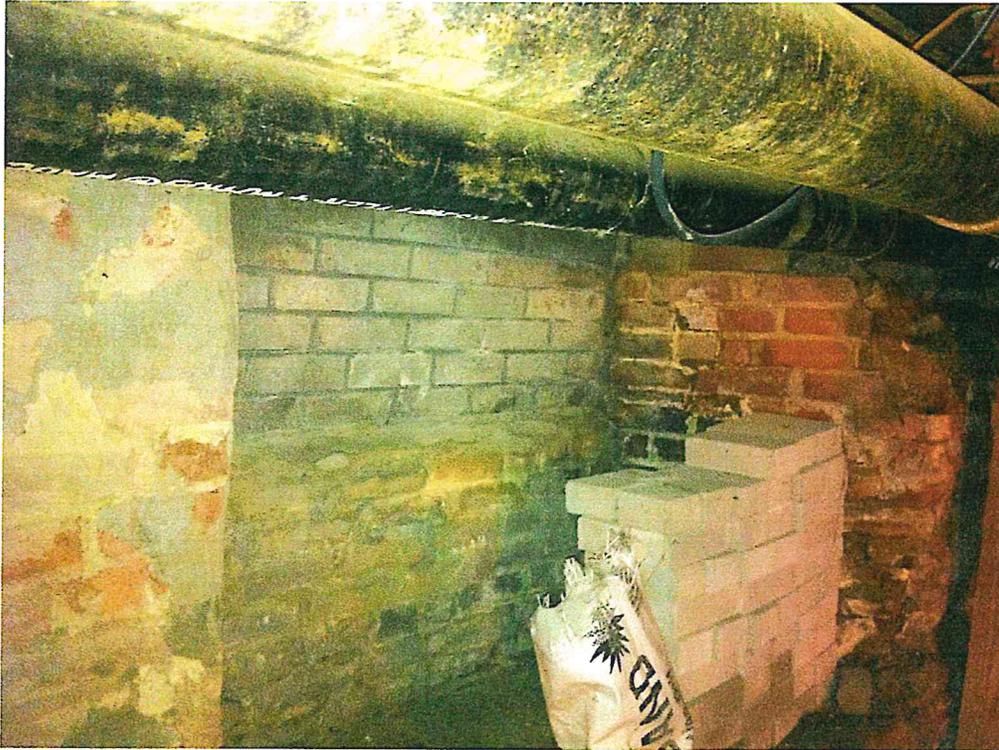
Photo 25. Eastern-most window at the north wall in the Cellar. Original sill was at the top of the remaining stone, which is recessed toward the exterior of the foundation wall. Sewer lines above will be relocated in the renovation to not be parallel to the exterior walls, so as not to block the tops of these windows. Concrete blocks will be plastered over.

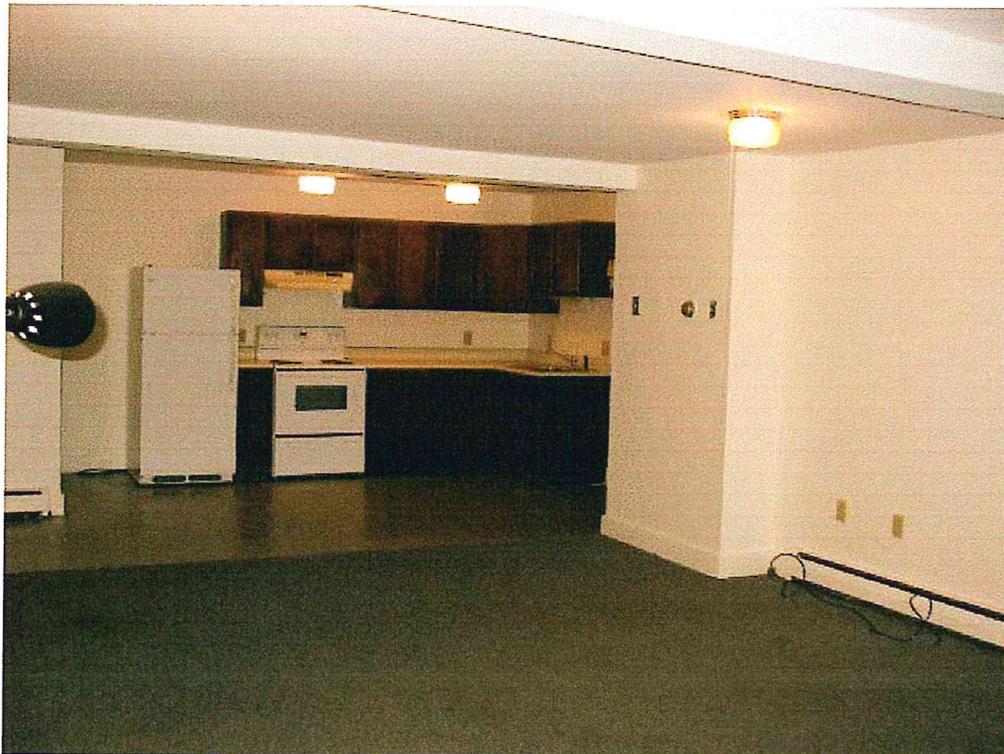
Photo 26. First Floor, west end apartment (#3). The rooms in this mostly buried apartment get almost no natural light. The original beams supporting the second floor are 8x8 wood beams that have been covered in sheetrock. No historic fabric remains at the interior of this level, except for the heavy timber frame made of 8x8 beams that support the second floor and attic floor.
