495 COLCHESTER AVE. PHOTO TAKEN NOVEMBER, 1927 AFTER THE FLOOD THAT REMOVED THE BRIDGE TO WINOOSKI.

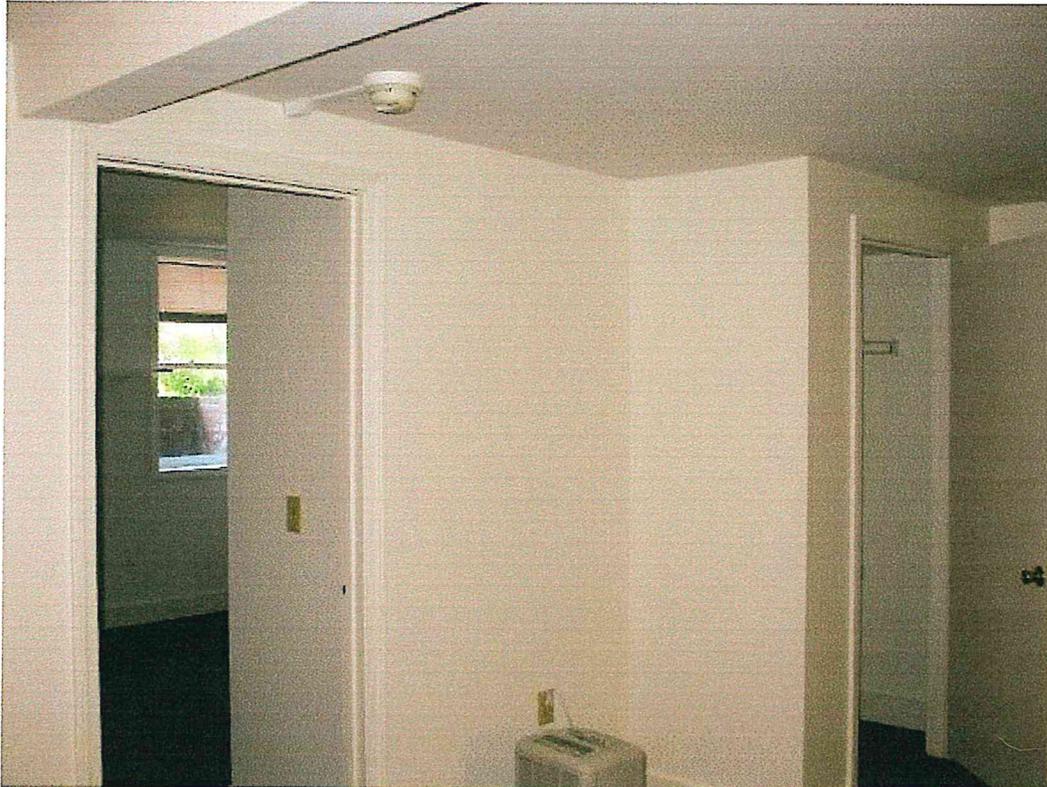
Photo 27. First Floor, west end apartment (#3). Note the mostly buried window visible through one of the two bedrooms in the apartment. One of the historic 8x8 beams (now covered in Sheetrock) is visible in the upper right hand corner.

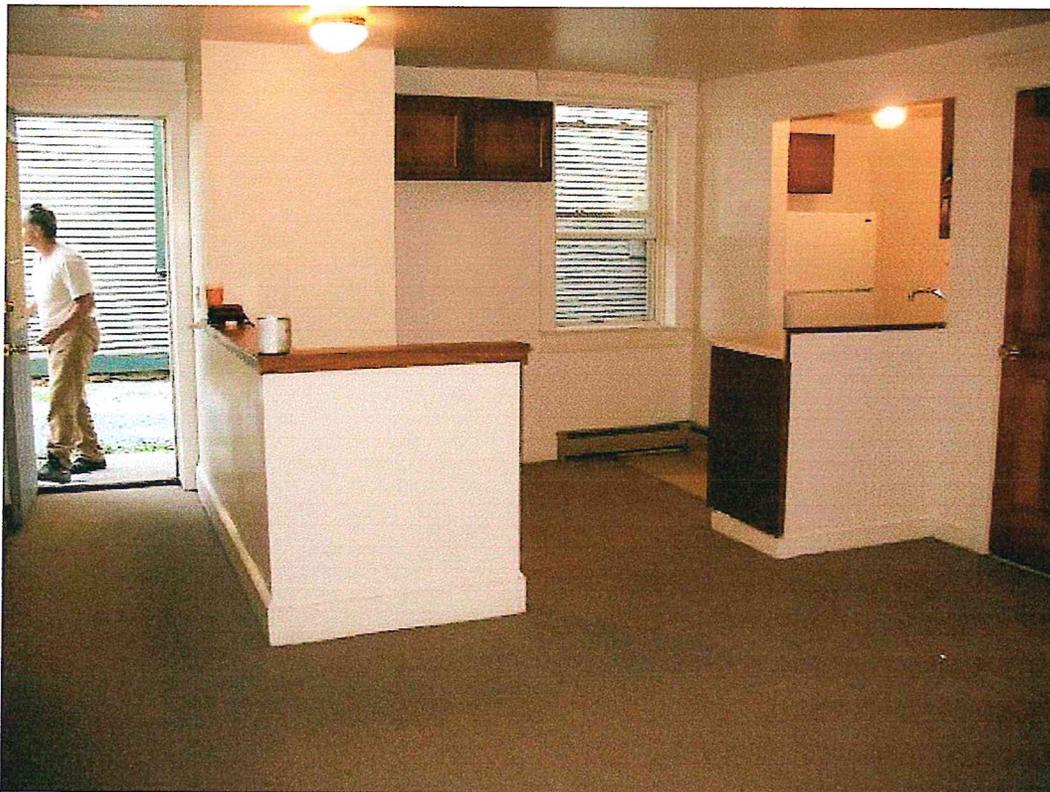
Photo 28. First Floor, east end apartment (#4). This is the brightest part of the apartment.

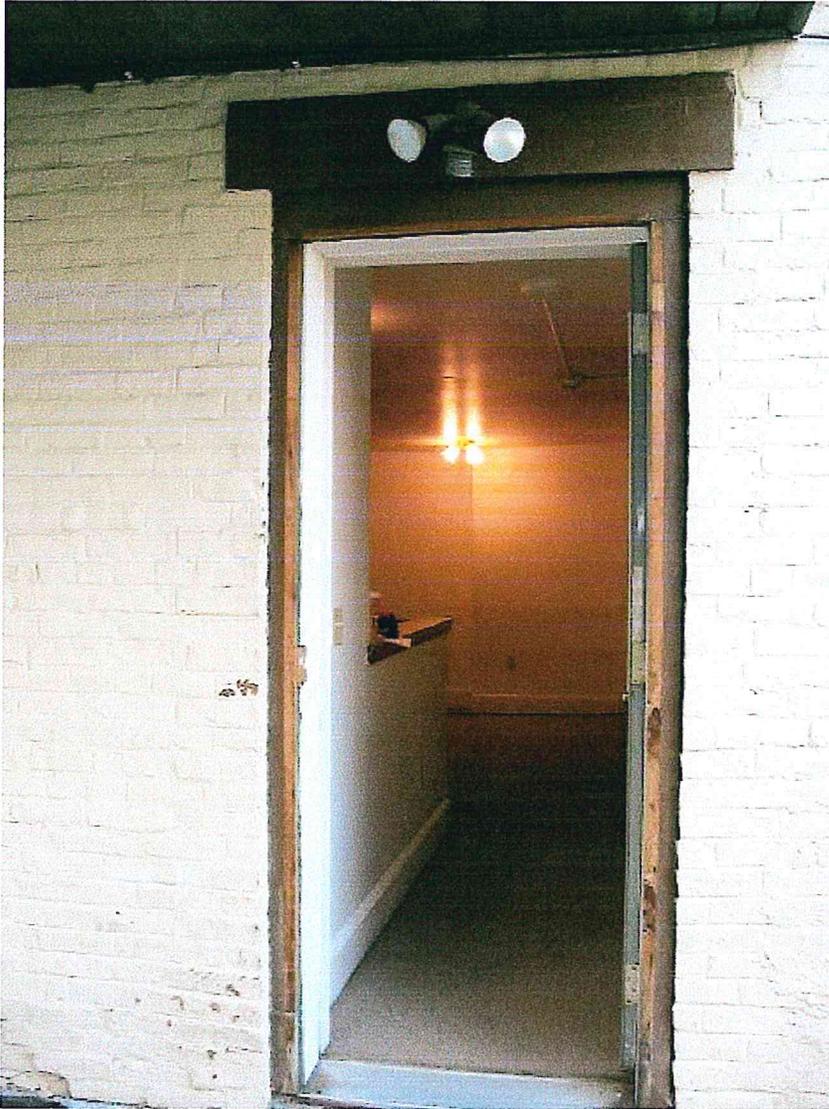
Photo 29. Door to apartment (#4) on east end of first floor. Door frame is modern and bricks have been cut to create this opening.

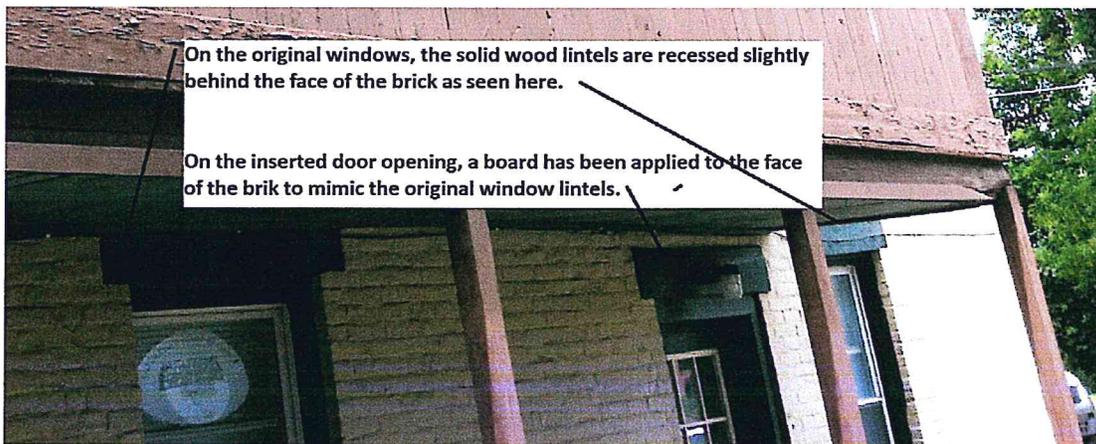
Photo 30. Note that on the historic windows, the solid wood lintels are recessed just behind the face of the brick. Where the door has been inserted under the porch, the historic lintels are mimicked with a faux lintel that is really just a board applied over the brick cut opening with the door frame acting as support for the brick veneer wall surface.

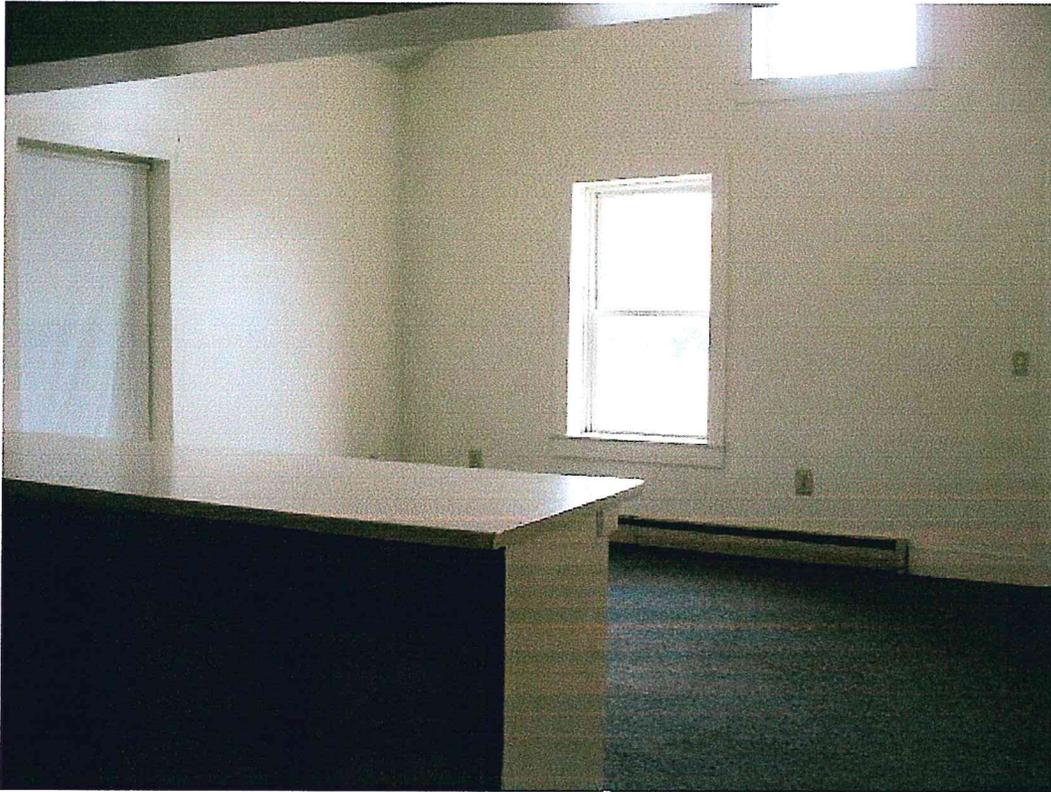
Photo 31. Living Room of apartment (#1) west side, second floor. Note that the tall space also shows the window at the attic level.

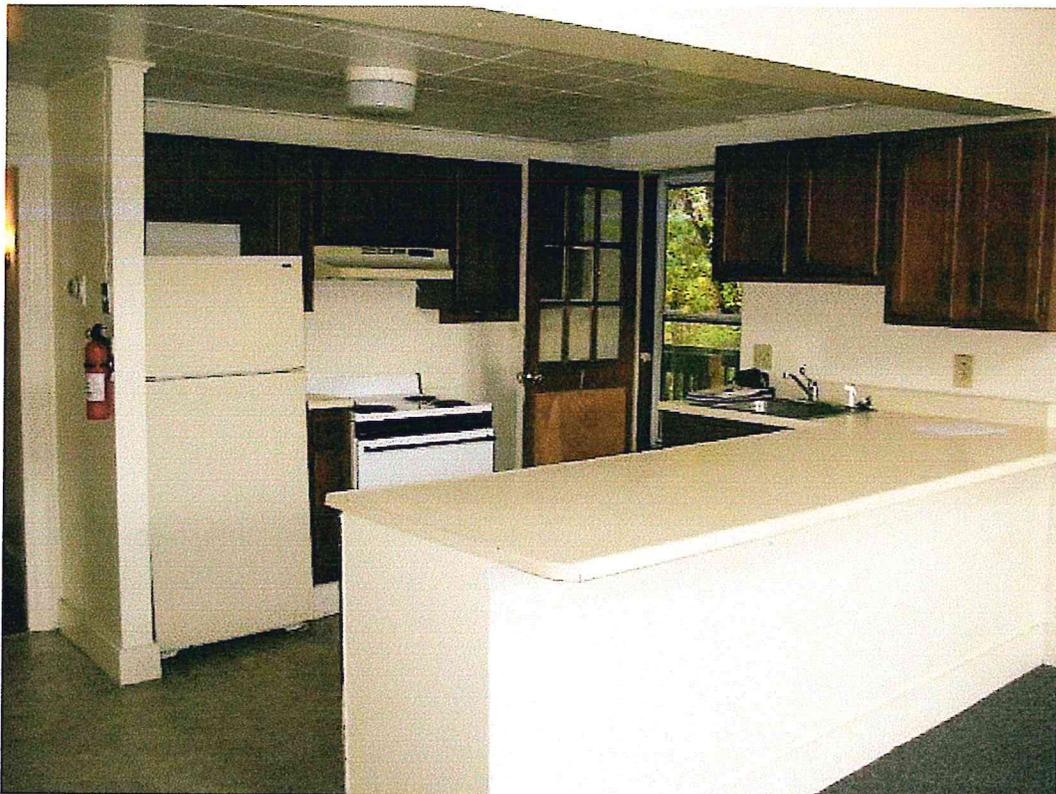
Photo 32. Kitchen of apartment (#1) at west end of Second Floor. Beam in foreground is one of the original 8x8 framing timbers, now wrapped in Sheetrock. No historic fabric exists at the interior of the first or second floors.

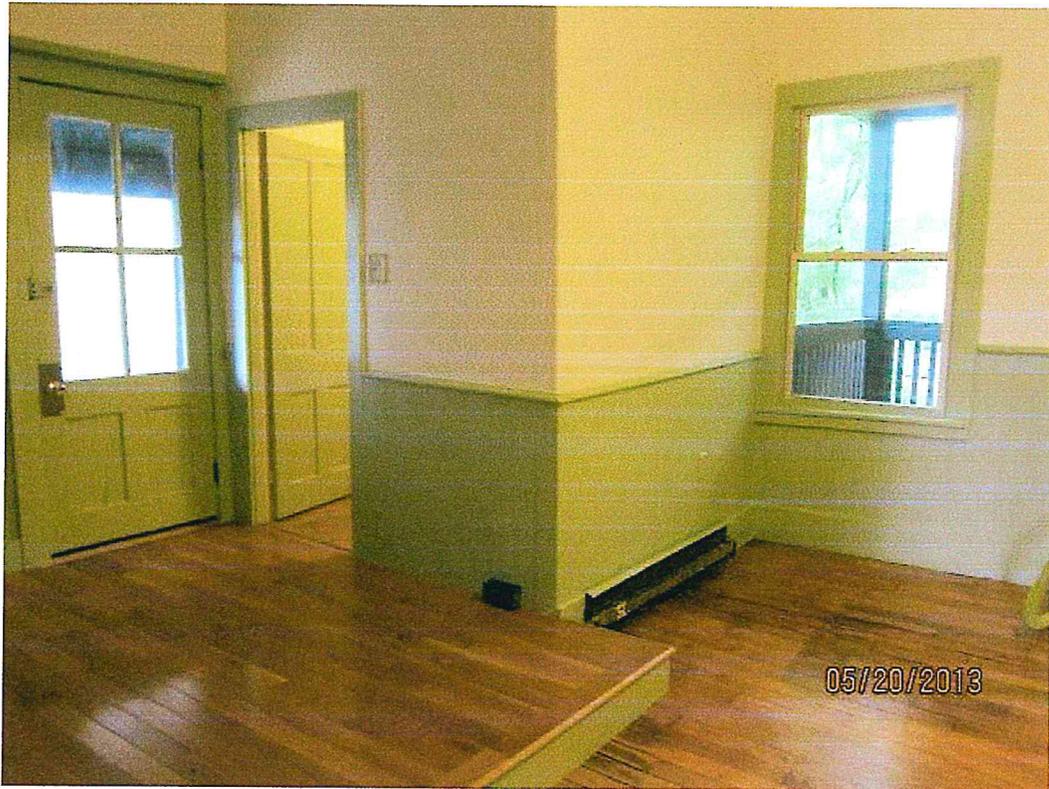
Photo 33. Kitchen (on raised platform) and living space of apartment (#2) at east end of Second Floor. Door with glass leading to the mostly-enclosed east porch replaces an historic window.

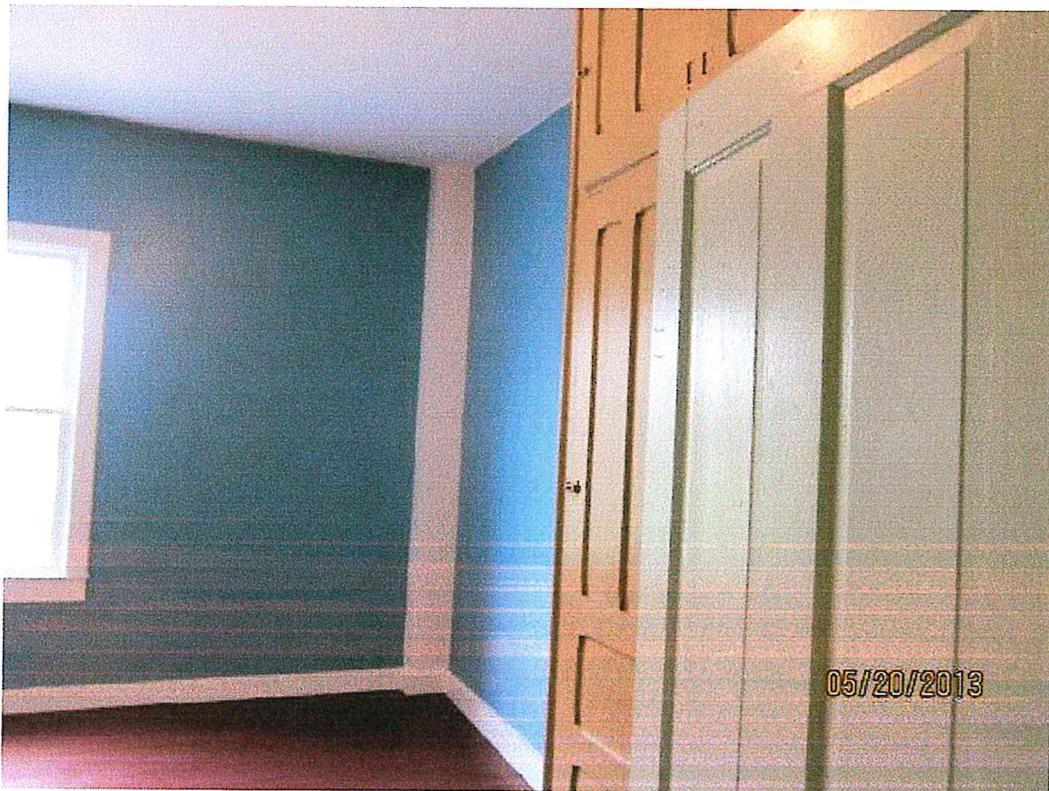
Photo 34. One of the three bedrooms of the east end apartment (#2) on the Second Floor. Note the corner post that is part of the 8x8 heavy timber frame of the building.

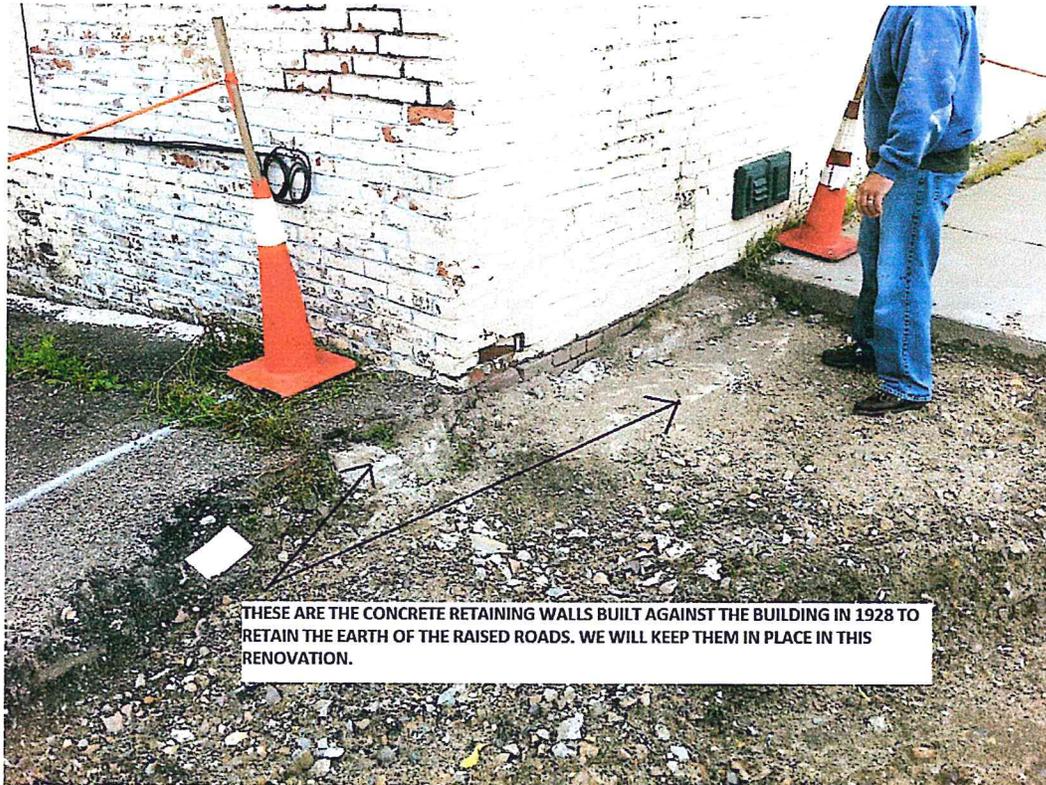
Photo 35. Retaining walls built in 1928 to retain the earth of the raised roads. Wall is poured directly against the brick veneer of the building, and is causing damaging rising damp to the façade. Note that original color of building was unpainted dark red/maroon colored bricks.

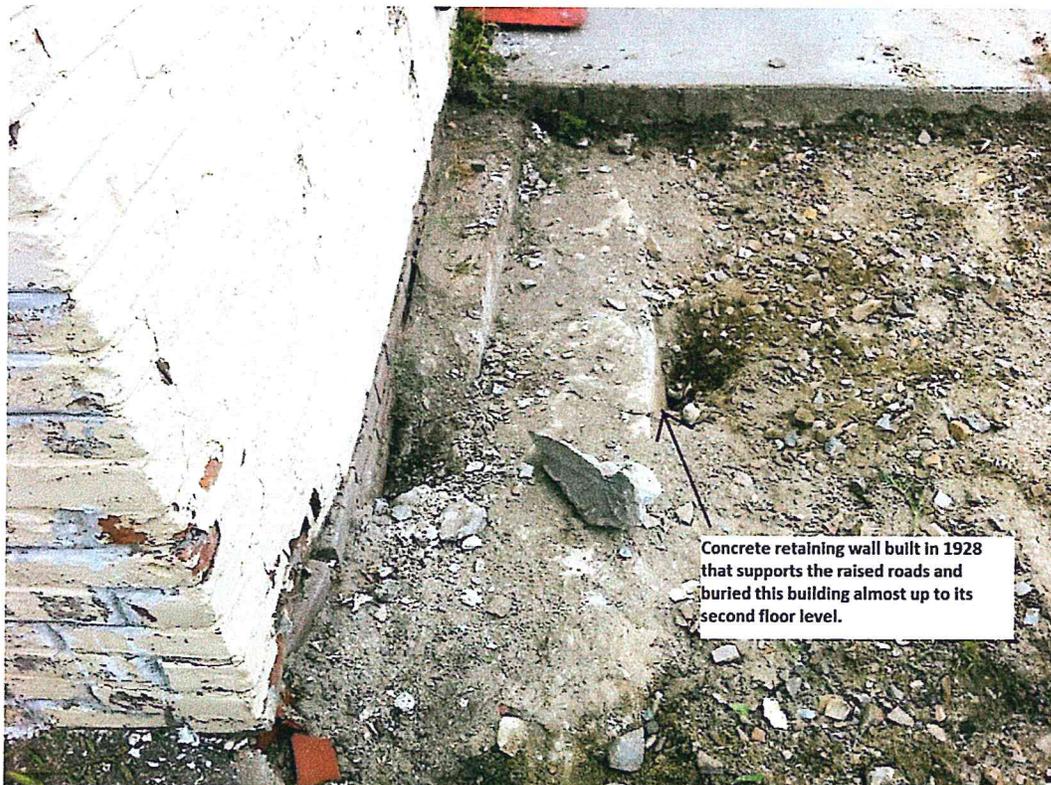
Photo 36. Detail at top of retaining wall at west side of building.

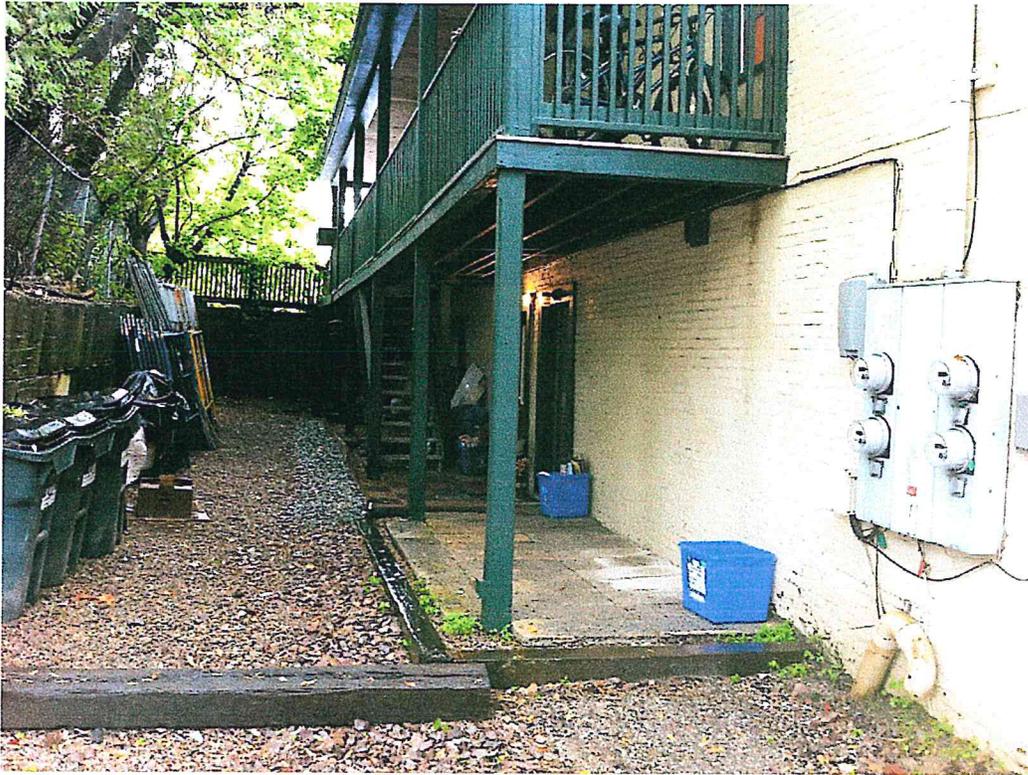
Photo 39. Location of existing meters on east end of south elevation. Intent is to move these to the west end of the south elevation after the building is lifted and service the building with an underground primary feed from the existing power pole near that location. One additional meter will be included for the Café. If possible, all meters may be put inside the building is Green Mountain Power can accept "smart metering" at this location with a remote reading ability for each meter.
