FACILITY CONDITION ASSESSMENT AND ENERGY AUDIT

LEDDY PARK AND ARENA

Leddy Park Road
Burlington, Vermont 05408

EMG Project #: 110226.14R-010.294
Date of Report: October 1, 2014
On-Site Date: August 25, 2014 and August 29, 2014

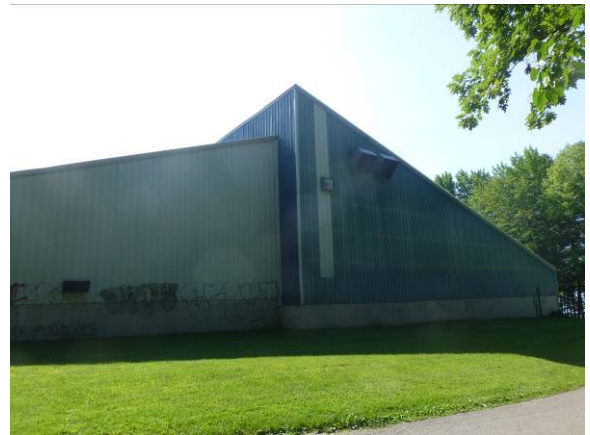
- **Leddy arena** - The exterior finishes are in fair condition. The painted metal panels on the building have faded in color and some areas have graffiti on them. Painting will be required during the assessment period. The cost of this work is included in the Replacement Reserves Cost Estimate (Table 2).

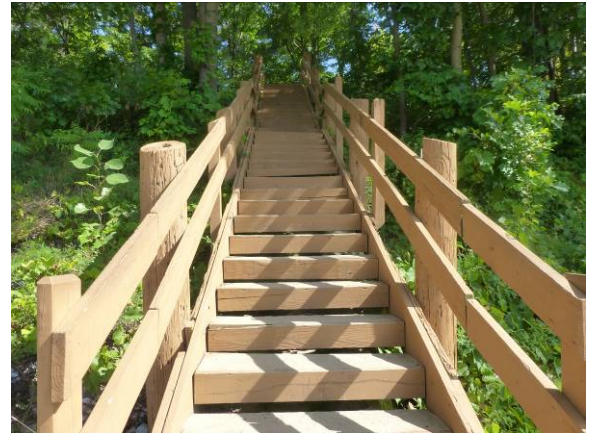
- The interior stairs, balusters, and handrails are in good condition and will require routine maintenance during the assessment period.
- The exterior stairs that led down to the beach are in poor condition. Many of the wooden treads are loose and have become offset from level thus resulting in a tripping hazard. As a result of the loose boards many nails have become exposed safety hazards. The wooden handrails are loose as well and there are areas of deteriorated wood in localized places. Based on the stair's current condition it will require replacement during the assessment period. The cost of this work is included in the Replacement Reserves Cost Estimate (Table 2).

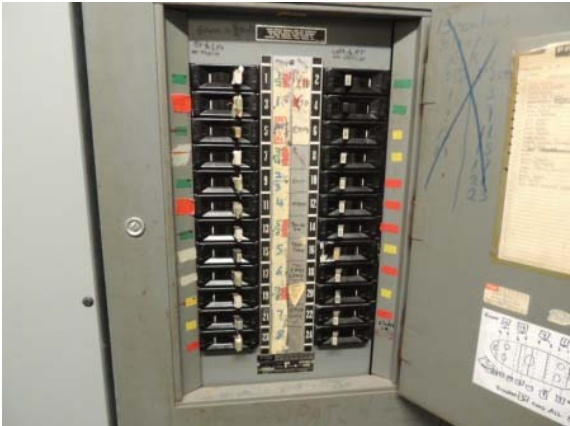
Photo #7:	Original Federal Pacific Secondary Panel (typical throughout the building) in Need of Replacement
-----------	---

- The on-site electrical systems up to the meters are owned and maintained by the respective utility company.
- The electrical service and capacity appear to be adequate for the property's demands.
- The switchgear, circuit breaker panels, and electrical meters appear to be in good to poor condition and will require routine maintenance during the assessment period. The main switchgear, disconnects, and main panels were upgraded in February 2014. The majority of the remaining electrical system is original to the building and nearing the end of its useful life. Most of this equipment was manufactured by Federal Pacific (FPE) which is no longer in business with replacement parts hard to obtain. It is our recommendation that the Federal Pacific (FPE) be replaced.

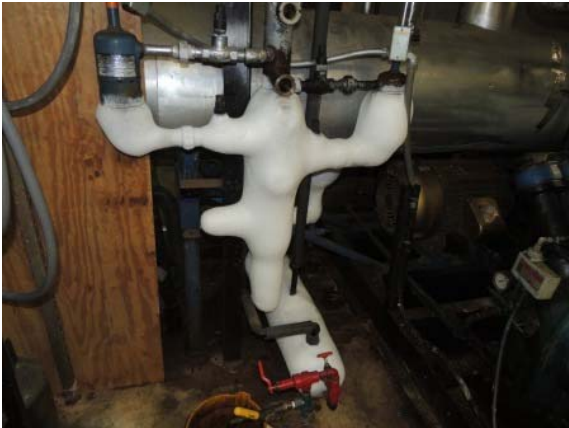
Photo #19:	Ice Build-up on the Ice Making Equipment
------------	--

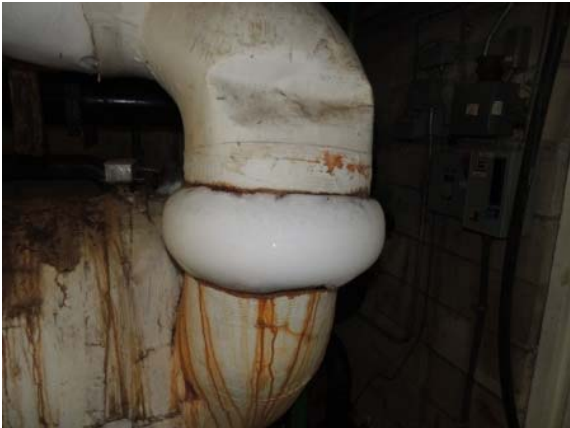
Photo #20:	Ice Build-up on the Ice Making Equipment Piping
------------	---

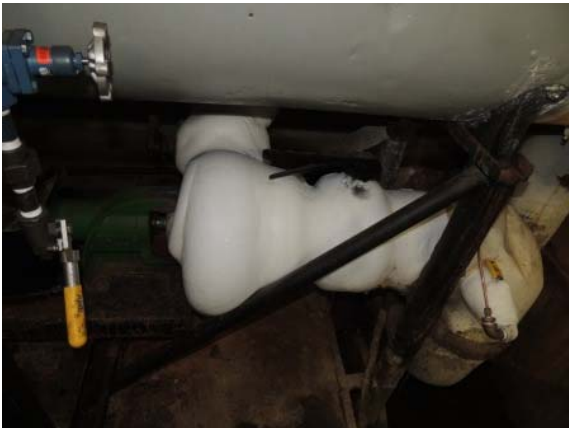
Photo #21:	Ice Build-up on the Ice Making Equipment Pump
------------	---

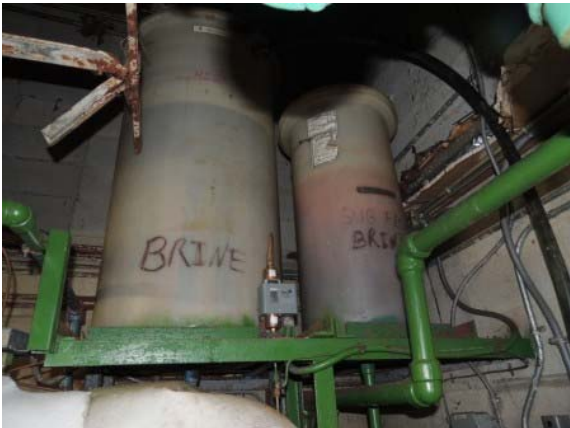
Photo #22:	Brine Tanks for the Ice Making Equipment which Leak
------------	---

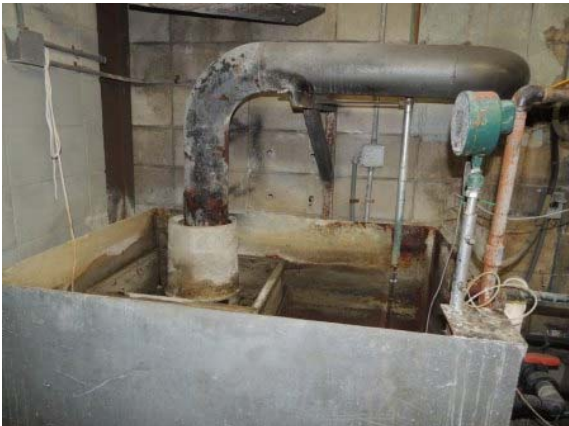
Photo #23:	Ice Making Equipment Sump which is Severely Corroded
------------	--

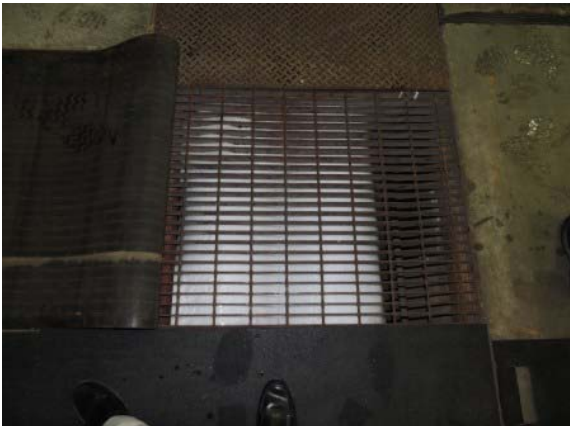
Photo #24:	Ice Build-Up on Ice Making Supply Piping located in a Floor Trench
------------	--
