WINDOW CONDITION ASSESSMENT

BCA CENTER
BURLINGTON, VERMONT
AUGUST 2014

PREPARED FOR THE CITY OF BURLINGTON
PUBLIC WORKS DEPARTMENT
BY JACKSON EVANS

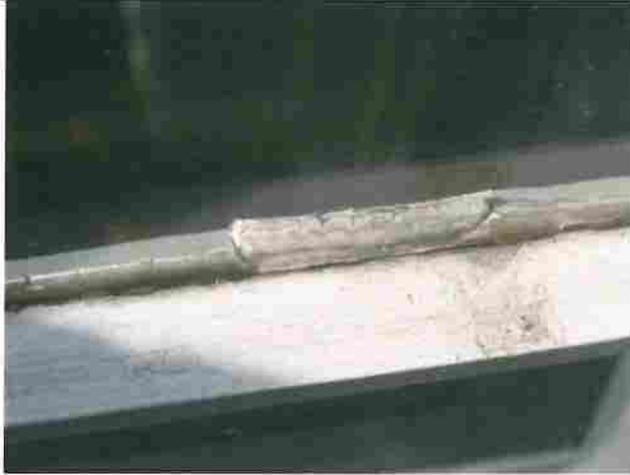
Figure 4 Failed glazing putty

- iv) After repairs are made, the glazing rabbets will be brushed with a coat of shellac and the glass will be re-glazed with an oil-based glazing compound. The glass will be set into the glazing rabbet on a bed of glazing putty. The glass will be held in place with appropriate, non-ferrous glazing points. Broken panes will be replaced with new double-strength glass.

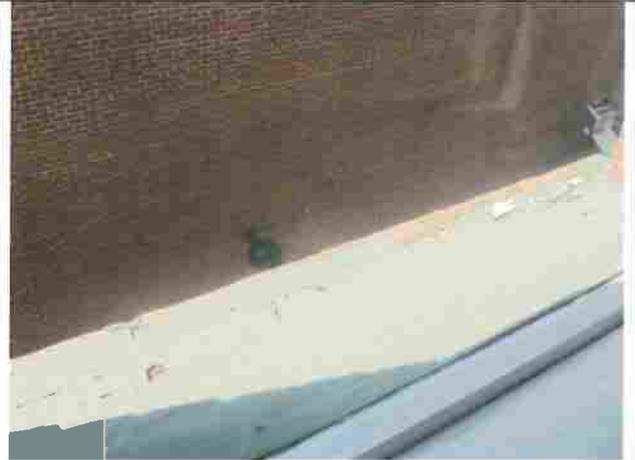
Figure 5 Flaking failed paint

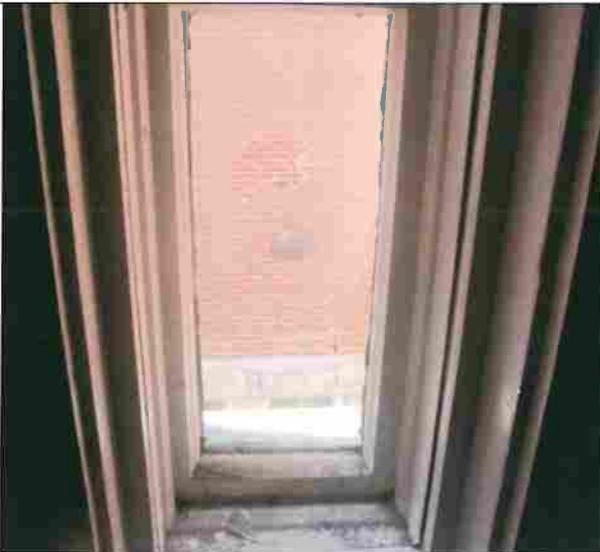
Figure 6 Broken glass

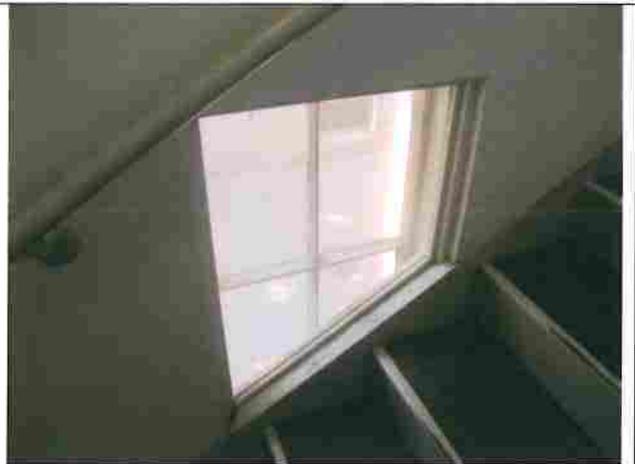
Figure 7 Stairway built over existing window

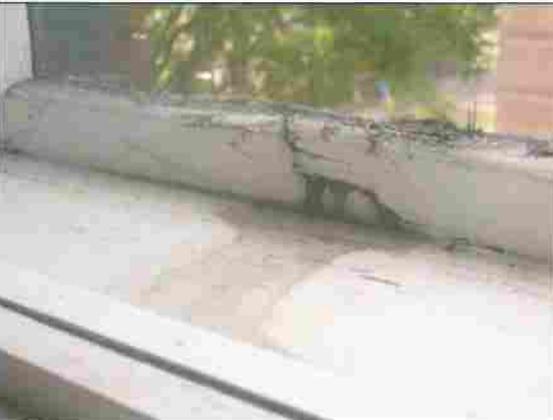
Figure 8 Rotted bottom rail

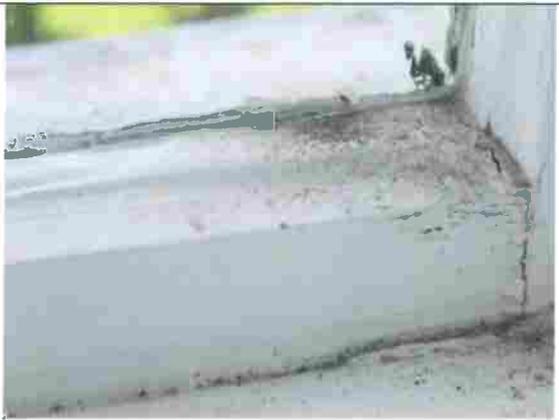
Figure 9 deterioration and likely rot at joint

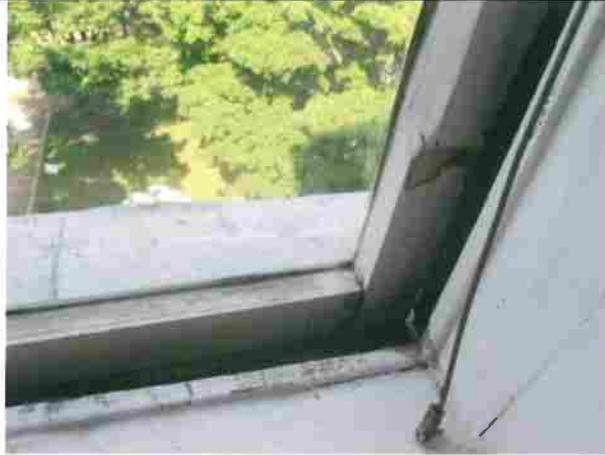
Figure 10 Failing older repairs to 4th floor casement

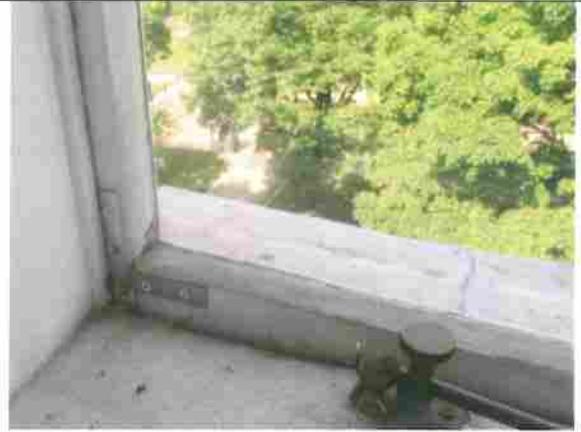
Figure 11 temporary repairs with L bracket

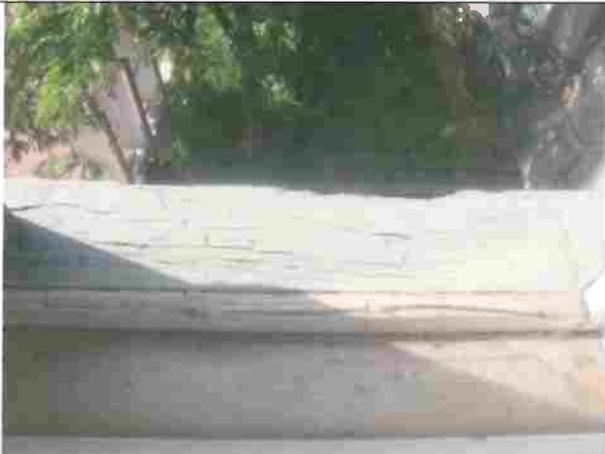
Figure 12 Failed paint on sill – South Elev.

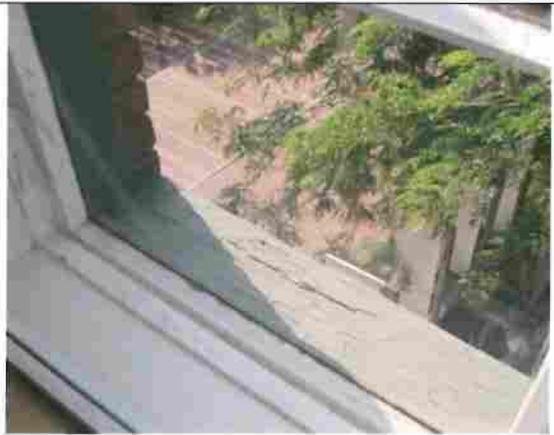
Figure 13 cracked and damaged sill

- b) All exterior window trim, casing and sills, as well as mullions and spandrels will be inspected and any needed repairs will be made. Repairs will consist of epoxy or Dutchman-type wood patches. Exterior brick mold caulking, where failing, will be removed, the cracks cleaned and new non-sag elastomeric sealant installed and tooled to a smooth and uniform surface.
