2.0 MEMORIAL AUDITORIUM

2.1 Existing Conditions

This study was prepared by Bargmann Hendrie + Archetype, inc. for the **City of Burlington, Department of Parks and Recreation**. It is intended to investigate the agency's capital needs, evaluate alternatives, and recommend solutions for the Burlington Community Recreation Center's two proposed locations, Memorial Auditorium and Leddy Park.

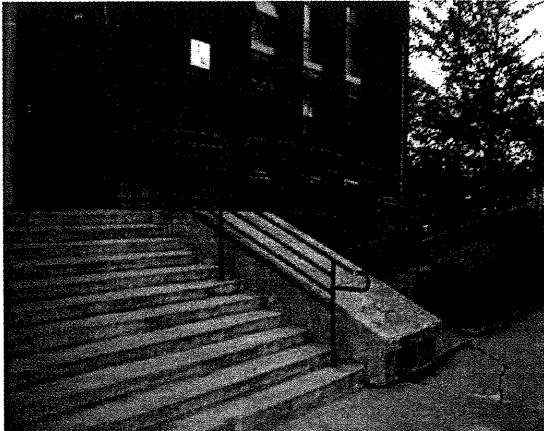
Fig. 5: Main Entry stairs & wheelchair ramp (east elevation)

- Remove and reconstruct non conforming wheelchair ramp at west elevation
- Repair, patch and refinish concrete and other surfaces
- Reconstruct masonry stair buttresses at north and south entry stair. Main entry stair at east elevation was already resolved.

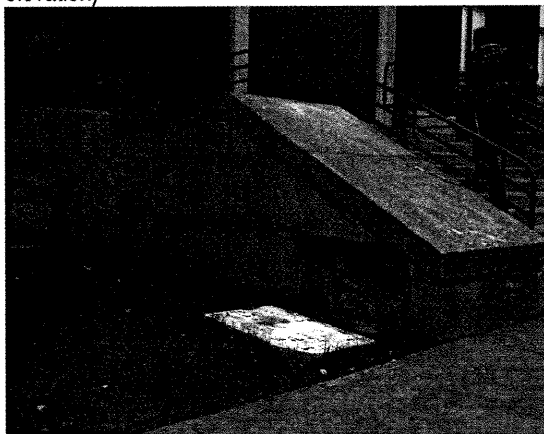
Fig. 6: North Entry stairs – deteriorated buttress

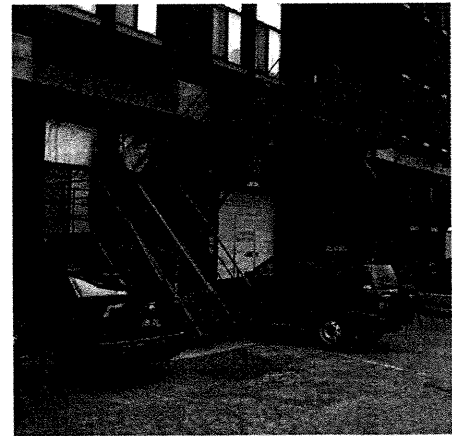
Fig. 9: North side fire escape

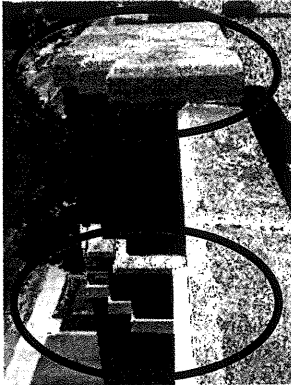
Fig. 10: Coping & cornice deterioration

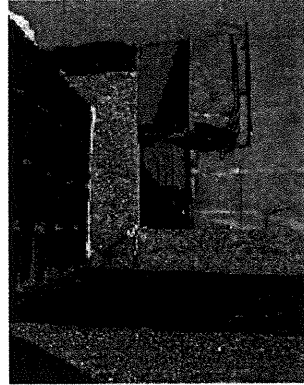
Fig. 11: Parapet weathering

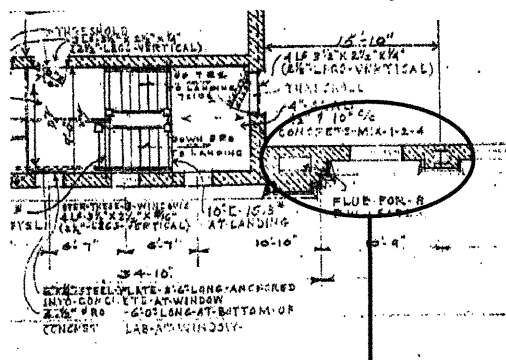
The red brick masonry walls and parapets enclosing Memorial Auditorium incorporate precast concrete ("cast stone") trim in several areas, including belt courses, cornices and copings. While most of these elements appear to be in fair to good condition, some have disintegrated and others exist in an advanced stage of decay. In each case, the damage occurs along the cornice, just below the parapet. Water infiltration from the roof through the parapet wall might appear at first glance to have caused the problems, but a look at the original floor plans shows that flues housing the rainwater leaders coincide in several places with the areas of damage; therefore, leaks and/or condensation related to the ductile iron roof drains may be the principal culprit. Temporary openings into the flues should be created where the drainpipes enter in order to investigate further. It is also possible that poor quality control during casting of the cornice components may have contributed to the problem. Recent roof work included the installation of a membrane that was carried partially up the back of the parapets, so that any leakage from the roof surface into the parapets has been curtailed, if it was a past problem.

AREA REQUIRING RECONSTRUCTION OF "CAST STONE" TRIM AT CORNICE LEVEL; NOTE RAIN LEADER FLUE LOCATION

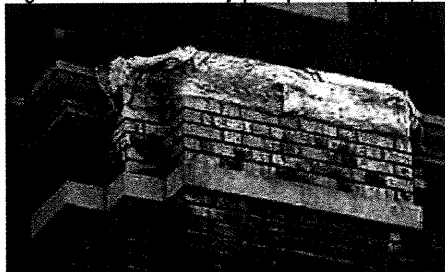
Fig. 16: Disintegrated "cast stone" cornice has stained the brick. The white residue is probably calcium carbonate.

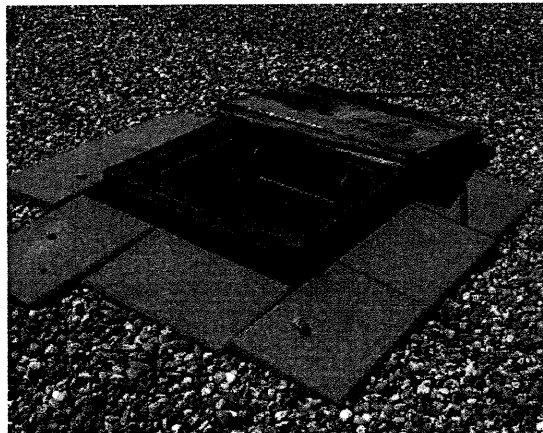
Fig. 22: Roof access hatch - original

- Replace original roof access hatch
- Six exhaust fans were part of the original roof system. Two have been replaced with new fans; the remaining four have been physically blocked off.
- Add dampers and relief vents as needed.

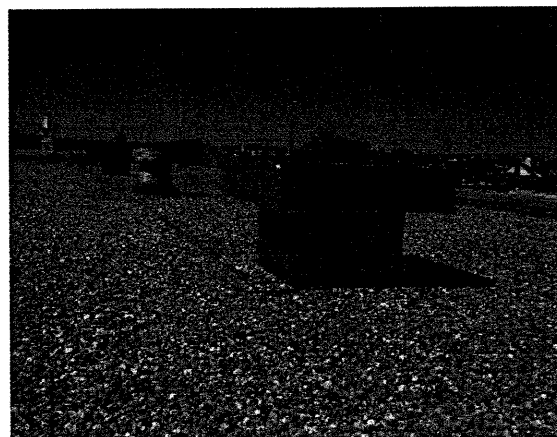
Fig. 23: Rooftop exhaust fan

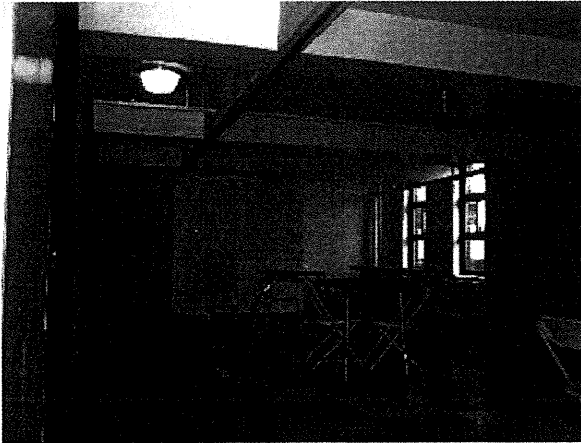
Fig. 42: Dressing room– note low ceiling, poor lighting

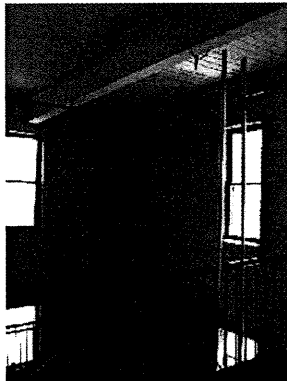
Fig. 52: Evidence of water damage at corner

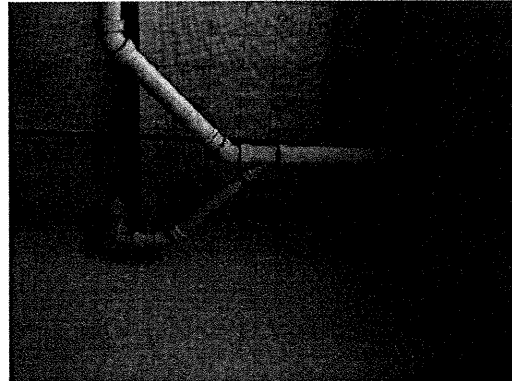
Fig. 53: Auditorium ceiling - interior roof drain creates condensation problems, insulation recommended.

Occasionally, water will drip from the roof drain piping routed along the ceiling of the auditorium when cold rainwater is running through the piping and a lot of people are present. The warm, humid air in the auditorium will condense on the piping and drip, creating a nuisance to people and damage to the floor and seats. This piping should be insulated to prevent condensation from taking place.

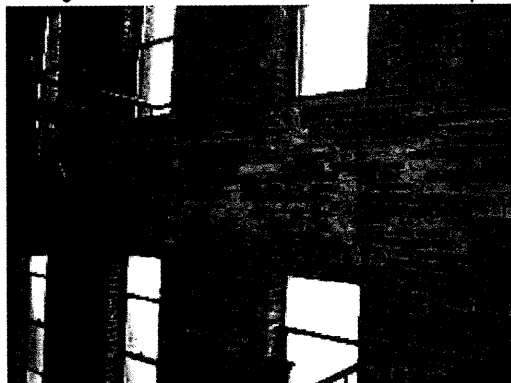
Several areas along the stairwell masonry suffer from moisture problems and have developed paint deterioration and efflorescence patches.

Fig. 54: Efflorescence at interior face of masonry, stairwell

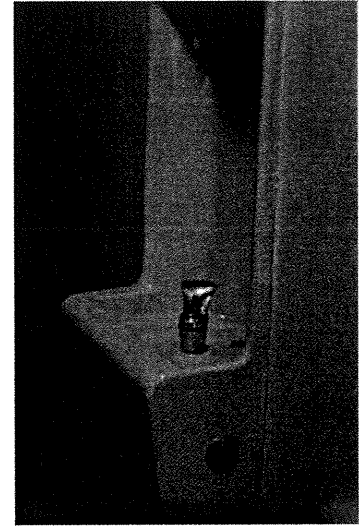
The plumbing fixtures in the annex toilet rooms are modern and seem to comply with ADA standards. However, most of the plumbing fixtures throughout the remainder of the building, including the changing area, do not appear to comply.

Non-ADA compliant Water
Fountain in Changing Rooms

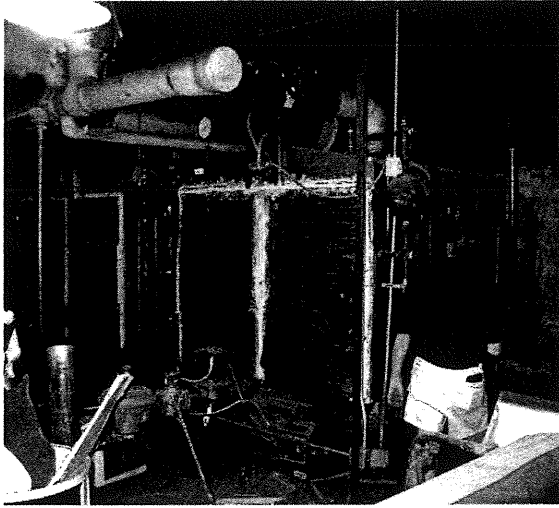
The steam heat in the building is provided by two Smith gas fired low pressure boilers. Each boiler has 11 sections and provides 1723 MBH of steam heating. The burners on these boilers date from the mid-1970's and are similar to an atmospheric burner. The boilers and the burners are probably at least 10% less efficient than a modern power-burner system and can use substantially more fuel. The boiler technician reported that the boilers have had no major problems but he does not know how much longer they will last.

Gas Fired Boilers

Many problems are associated with steam heating systems, including boiler and piping corrosion and noise from pipe expansion. Steam systems also consume about 10-20% more fuel than hot water systems. However, this is a large building and many of the existing radiators and heaters cannot be converted to a hot water system. Since the cost of replacing all the heaters, the boilers and the piping could be large, we do not recommend converting this system to a hot water system without additional study. Also, no major dissatisfaction with the existing steam heating system was reported to us. Although the boilers are old, we have seen no evidence that they will fail soon. If budget allows, they should be replaced with modern boilers and burners to increase heating efficiency. If this is not possible, we recommend replacing the burners.

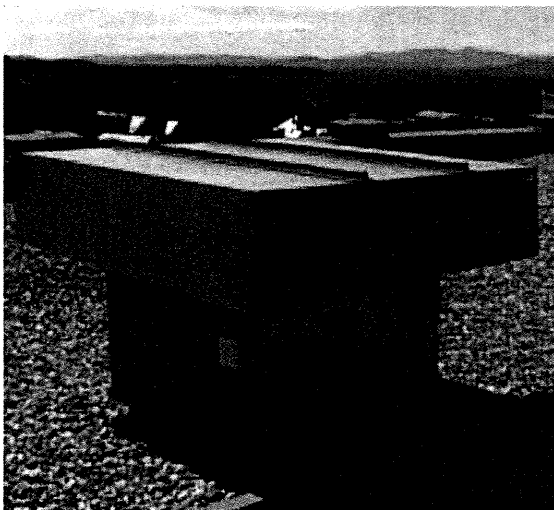
Roof Fan for Auditorium

Backdraft damper sometimes stick open as corrosion accumulates.

Recommend replacing the backdraft dampers with motorized dampers which will open automatically when the fans are in use and close when they are not. While closed, they have less leakage than backdraft dampers. Relief vents should also be equipped with these units.

The roof fans should be inspected to see if they need replacing. Many of the roof vents look quite worn and should be replaced.

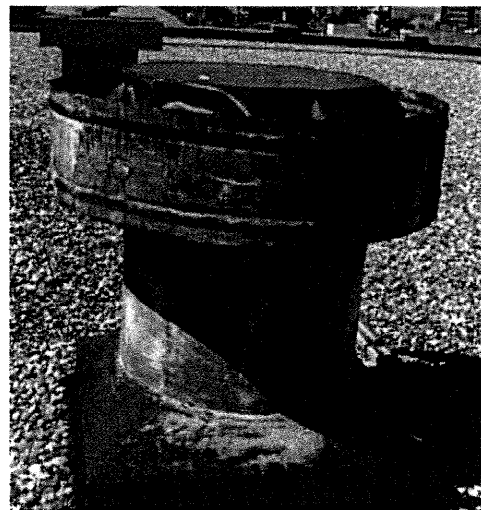
Roof Vent for Auditorium

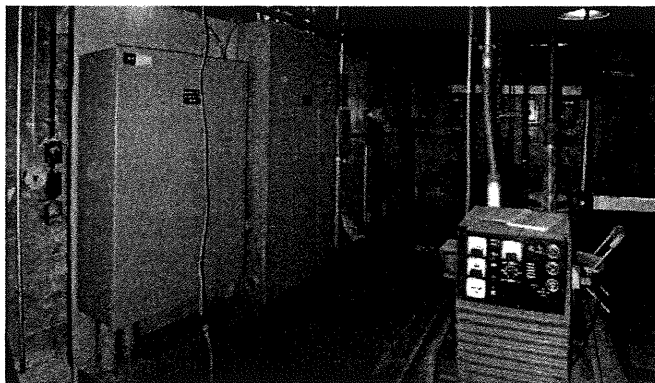
800A Service Entrance & 30KW Generator

Generator, 30KW, 104A, 120/208V, 3Ø, is used for backup of critical systems only.

Generator does not meet protected location requirements of Life Safety code.
(See *Emergency Lighting* in following sections.)

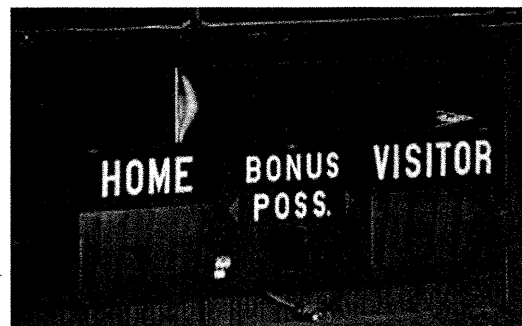
Auditorium Score Clock

The auditorium score clock is a late 1970's vintage design.

It was noted that parts were available for recent repairs; however, the unit is nearing the end of its useful life and replacement may be necessary within the next five to ten years.

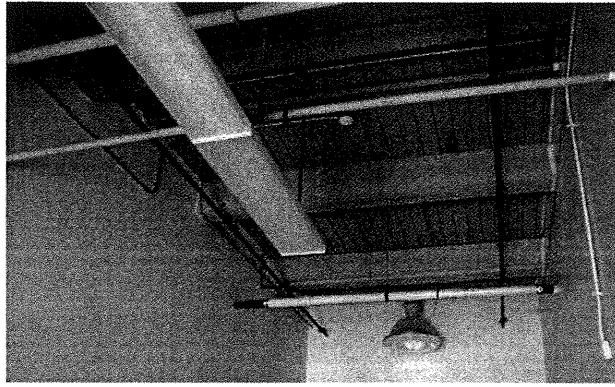
Annex Entryway

Especially disappointing is the uninviting lighting of the entrance to the Annex.

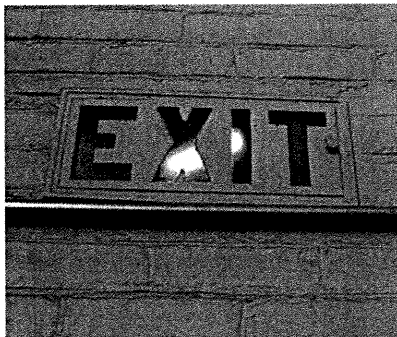
Auditorium EXIT light with
Retrofitted Fluorescent Lamp

All should be replaced with LED type units to meet Vermont's energy codes.
