Assessment of City Parking Garage Structures College Street Garage

Hoyle, Tanner
& Associates, Inc.

Prepared for:
City of Burlington, Vermont

July 2014

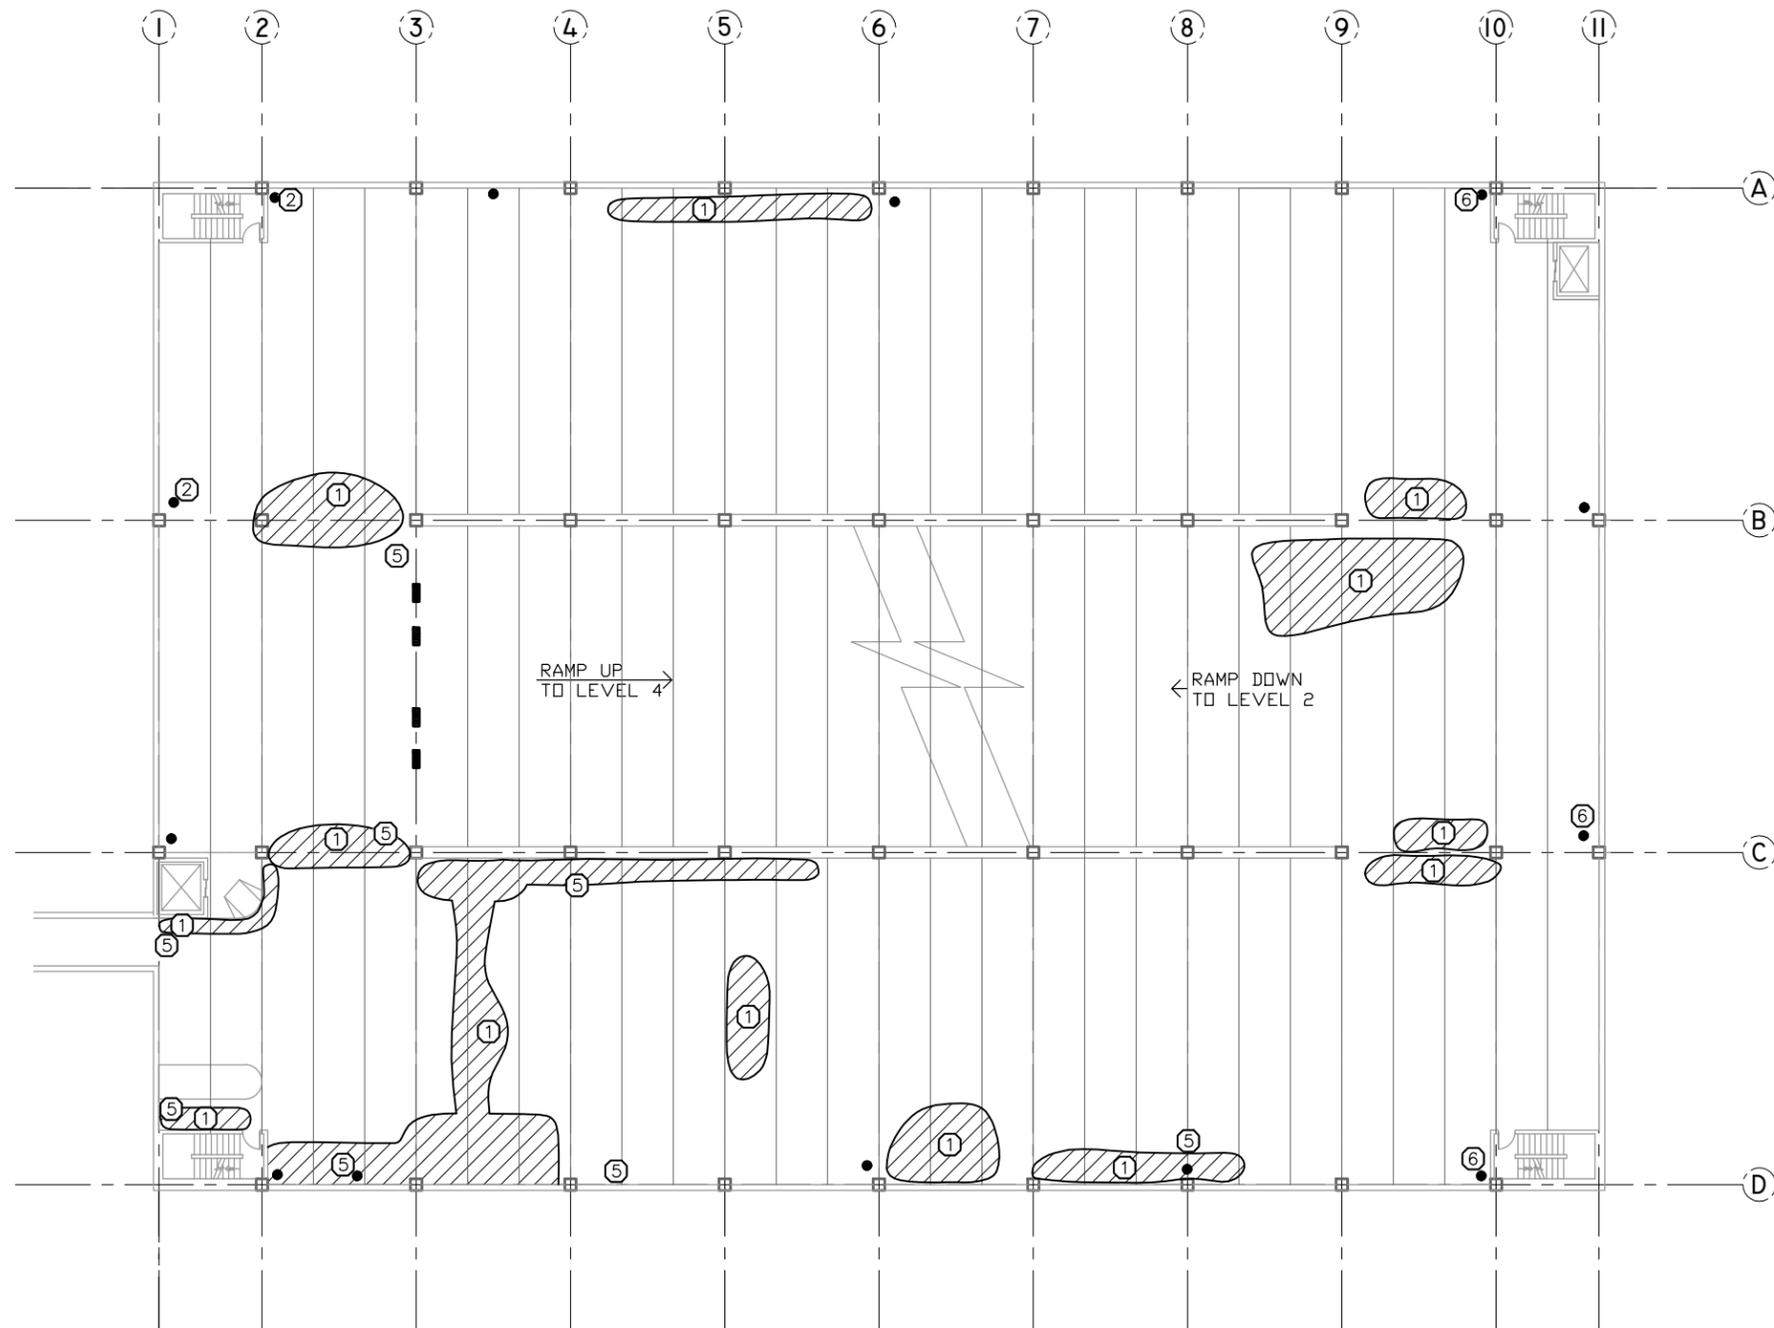
CITY OF BURLINGTON
 BURLINGTON, VERMONT
 COLLEGE STREET PARKING GARAGE
 LEVEL 3 PLAN
 INSPECTION NOTES

- ① STANDING WATER (OBSERVED DURING INSPECTION ON 5/23/14)
- ② PLUGGED STORM DRAIN
- ③ CONCRETE SPALL IN BEAM
- ④ STORM DRAIN NOT LOCATED DUE TO DEBRIS COVER
- ⑤ POTENTIAL STORM DRAIN LOCATIONS (FURTHER DESIGN REQUIRED FOR OPTIMUM LOCATION)
- ⑥ DAMAGED STORM DRAIN TO BE REPLACED
- ⑦ DAMAGED/DETERIORATED TRENCH DRAIN
- ⑧ HOLES CORED IN PRECAST BEAM (REPAIR 'PC-5')
- ⑨ GAPS AT COLUMN WALLS
- ⑩ DOUBLE-TEE BEAM WITH BEARING ISSUE (REPAIR 'PC-9')

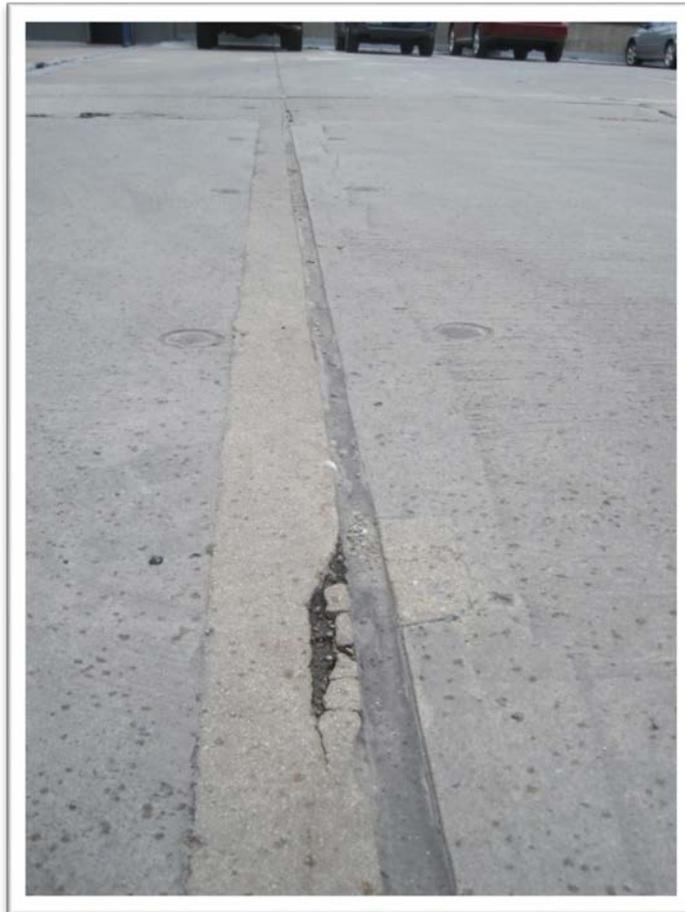
JS-2	Issue:	Joint Sealant Failure at Level 3 and 4
	Cause:	Mainly due to spalled concrete adjacent to joint locations.
	Effect/Consequence:	See JS-1
	Repair Recommendation:	Replace failed sealant locations. Replace spalled concrete to create uniform flange edge (see spalled concrete patching under Precast section of this report). Repair concrete cracks. Clean and prepare bonding surface prior to installation
	Repair Timeframe:	Short Term

JS-2: Joint Sealant Failure at Level 4

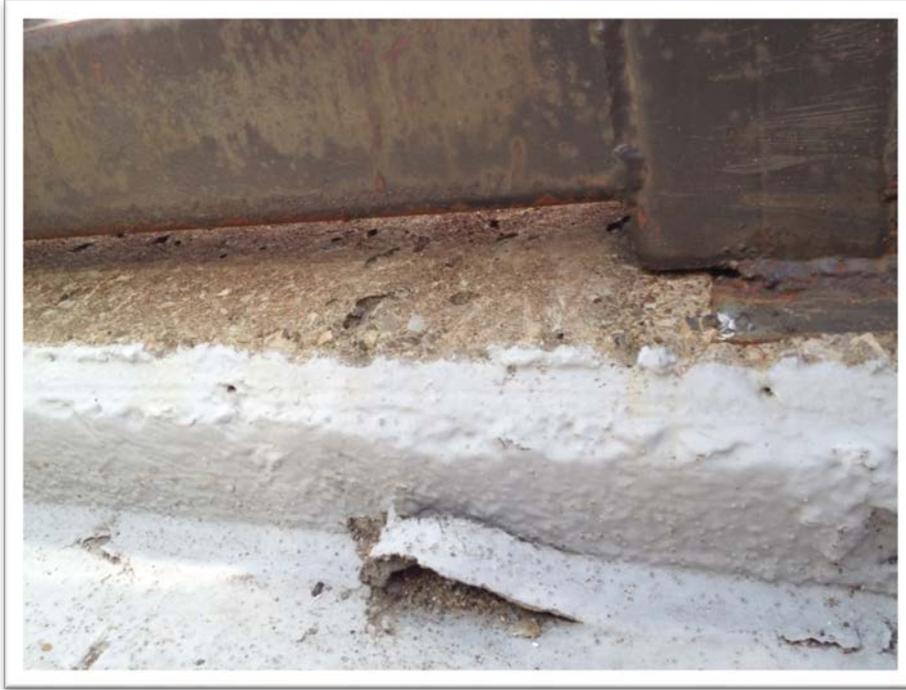
CS-1	Issue:	Floor level perimeter sealant failures (debonding, tears)
	Cause:	Age
	Effect/Consequence:	Water penetration to levels below
	Repair Recommendation:	Replace perimeter sealant at repair locations on level 4 and at all locations on levels 2 and 3, and ramps.
	Repair Timeframe:	Short Term

CS-1: Floor Level Perimeter Sealant (Level 4, Grid D)

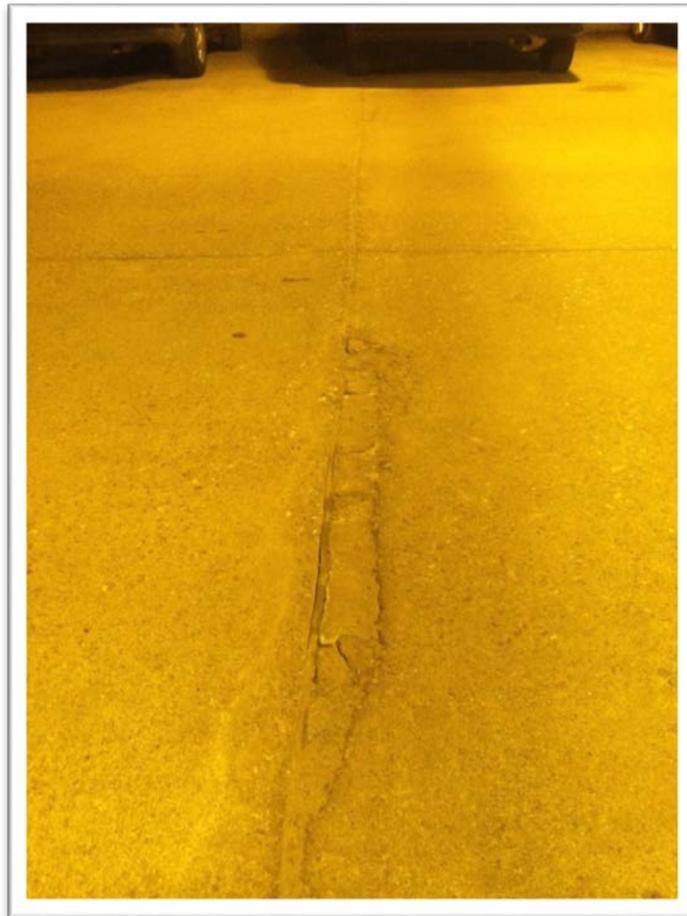
Slabs on-grade are located at Levels 1 and 2. Control joints appear to be functioning well, with some spall repairs needed in a few locations. The sealant in these joints is in need of replacement at all slab joints as it is failing in along the majority of its length.

CS-2	Issue:	Control joint sealant failure at slabs on-grade
	Cause:	Age
	Effect/Consequence:	Water penetration into slab joints. Spalling, concrete degradation
	Repair Recommendation:	Replace joint sealant
	Repair Timeframe:	Mid Term

CS-2: Control Joint Sealant at slab on-grade

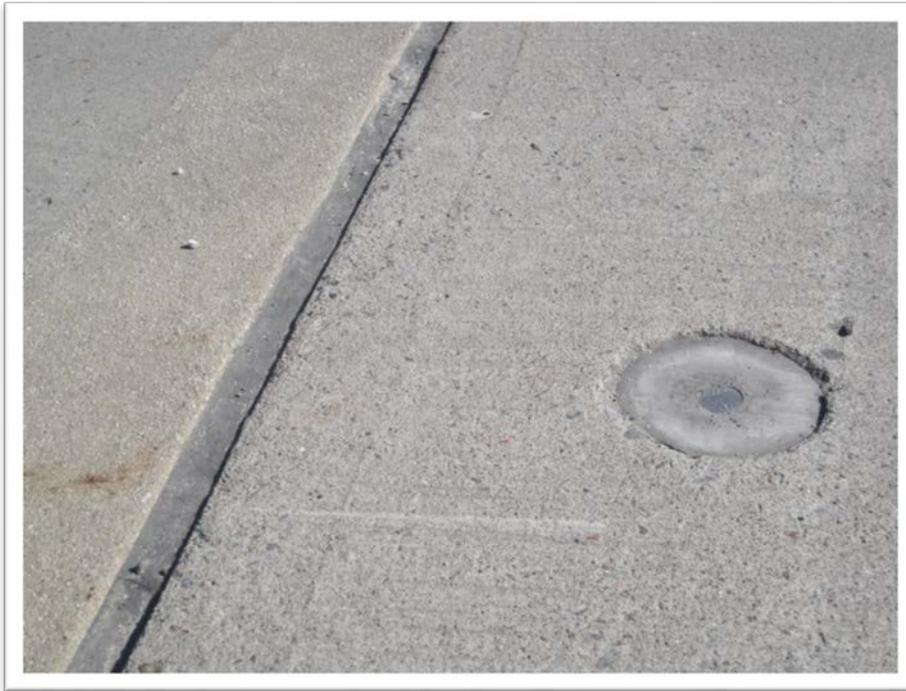
The existing double-tee flange repairs at Levels 3 and 4 have a 4" diameter sealant patch at each bolt location. The majority of these sealants are in good condition. Approximately 10% of patches were worn through or have tears and are in need of replacement. Since these sealant patches were installed in 2006, 8 years old, they are approaching their typical lifespan of approximately 10 years. It should be anticipated to replace all of these patches within the next 5 years.

CS-3	Issue:	4" diameter sealant patch failures
	Cause:	Age, vehicular wear
	Effect/Consequence:	Water penetration into bolt locations. Potential corrosion of bolts and steel angle at double-tee flange connectors
	Repair Recommendation:	Replace sealant patches
	Repair Timeframe:	Mid Term

CS-3: 4" Diameter Sealant Patch at 4th floor beam (bolt head showing)

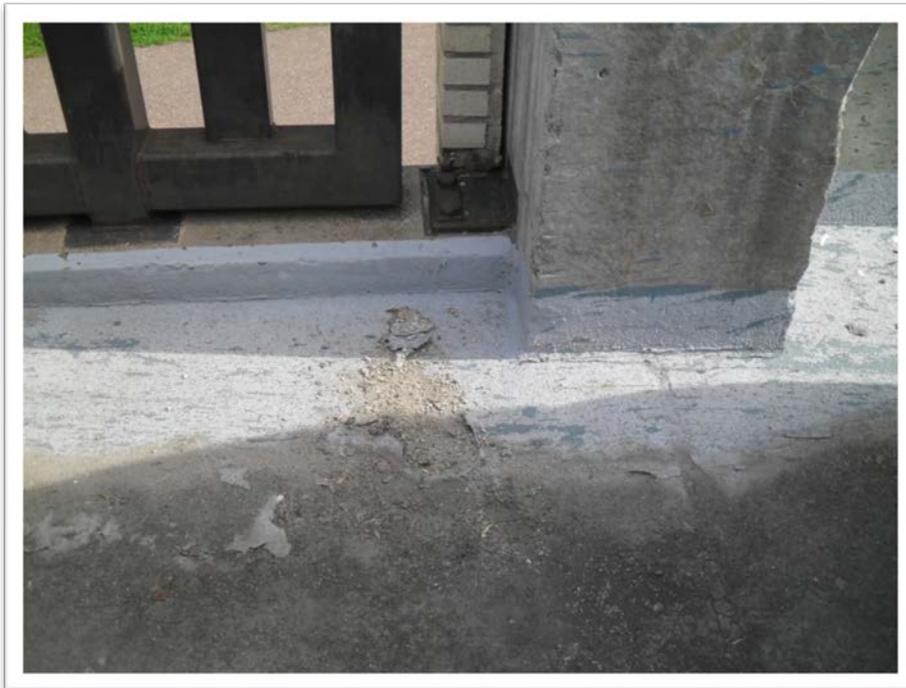
Office (located on Level 2). Where membranes were installed, and are away from heavy traffic, they do appear to be performing their purpose, which is to not allow water to penetrate, however the surface water has found other paths adjacent to the membrane locations, and the membrane at Grid 10 does not withstand the frequent vehicular traffic and winter plowing operations.

MB-1	Issue:	Membrane Failure
	Cause:	Age, Water penetration, Vehicular Traffic and Plowing Operations
	Effect/Consequence:	Age, Water penetration, Vehicular Wear and Plowing Operations
	Repair Recommendation:	Clean concrete surface and apply new liquid membrane.
	Repair Timeframe:	Mid Term

MB-1: Membrane Failure at Level 4, Grid A (localized concrete wash area disintegration)

The membranes installed have met their intended life expectancy and should be replaced at all currently installed locations, with the exception of Grid 10 on the roof level. Though this location has significant surface water issues they should be remedied with additional drain locations and joint sealant maintenance. Due to the poor drainage pitch of this garage it should be budgeted under long-term maintenance to replace membranes at Level's 3 and 4 within their recommended lifespan.

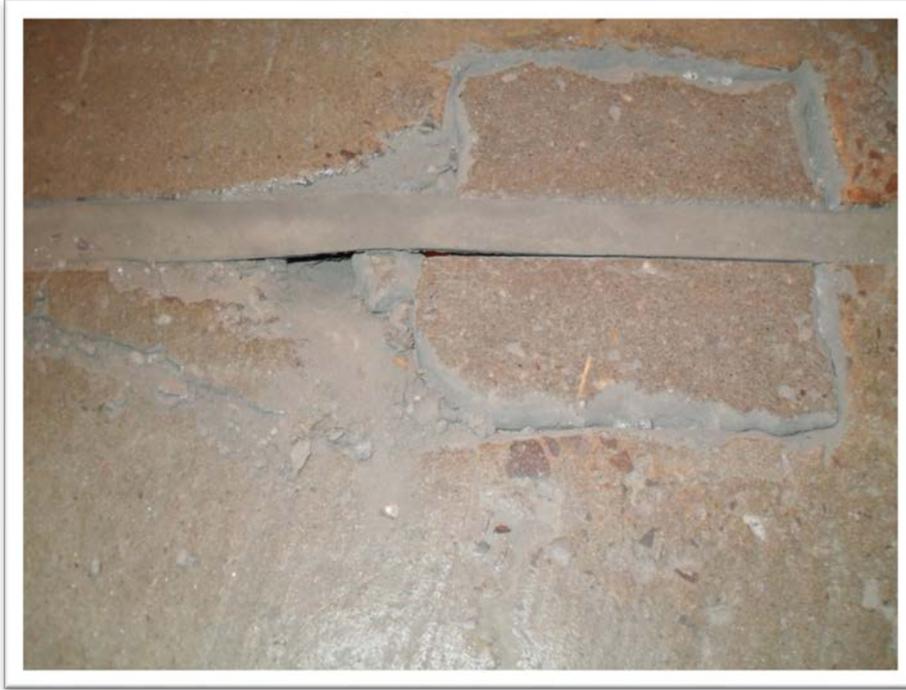
DT-1	Issue:	Grout patch failure at Shear Tabs
	Cause:	Age, Water penetration, Improper Installation
	Effect/Consequence:	Further damage to Double-Tee Beam flanges.
	Repair Recommendation:	Replace failed grout patches. When patches are removed, chip out unsound portions of beam flanges. Clean exposed steel and protect from corrosion while exposed during repair. Install quality non-shrink grout patch per manufacturers' instructions. Clean existing surface, and apply scrub coat for improved patch bonding. Aggregate may be required in the grout mix for larger patch locations. Patches need to be installed flush with the beam flange edges and surface level. Coordinate patch repair with joint sealant replacement.
	Repair Timeframe:	Short Term

DT-1: Double-Tee Beam Grout Patch Failure (Level 2)

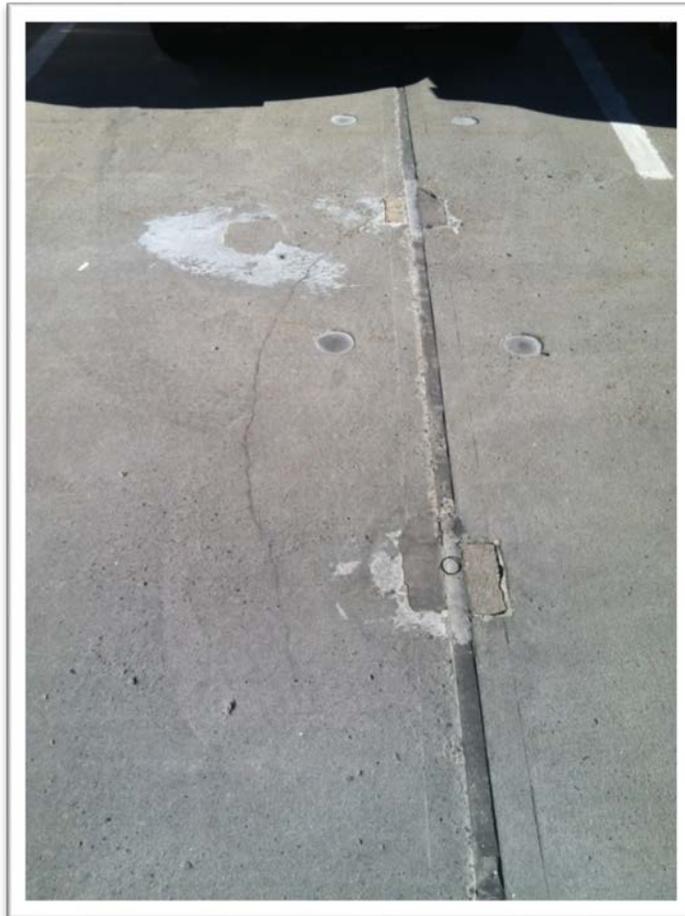
DT-2	Issue:	Double-Tee Beam flange cracks - Hairline
	Cause:	Majority of cracks found on Level 4 – potentially from sun exposure on beams. Cracks could have also developed due to warping stresses during installation
	Effect/Consequence:	Water can penetrate into beam cause potential flange reinforcement corrosion, and eventual extensive beam damage
	Repair Recommendation:	Cracks should be repaired with a self-penetrating crack healer/sealer
	Repair Timeframe:	Mid Term

DT-2: Double-Tee Beam Flange Crack (Level 4)

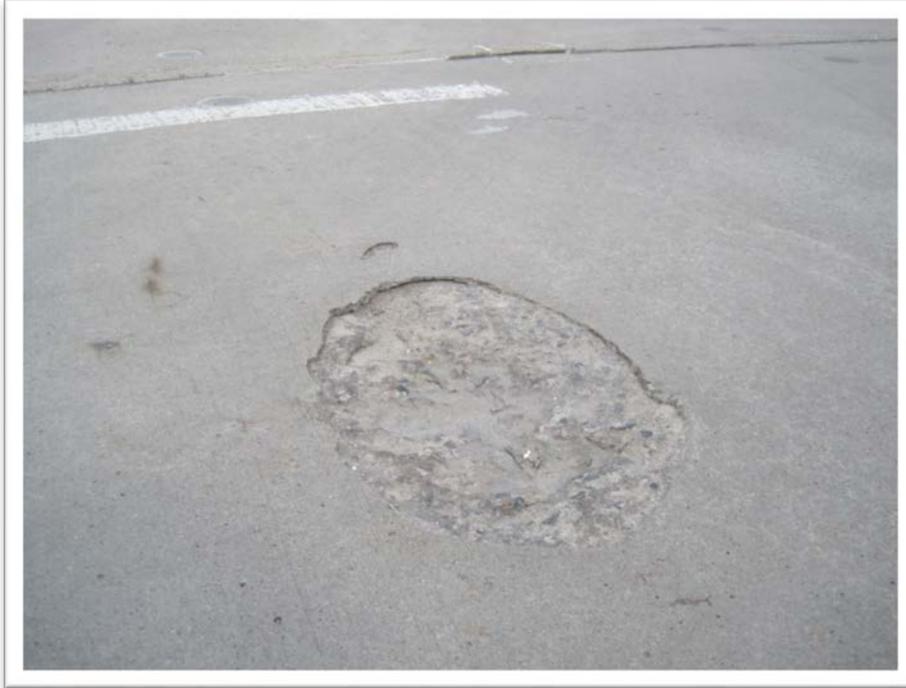
DT-3	Issue:	Surface Spalls
	Cause:	Typically associated with rebar corrosion / expansion
	Effect/Consequence:	Water can penetrate into beam cause potential flange reinforcement corrosion, and eventual extensive beam damage
	Repair Recommendation:	Surface grout patch. Similar installation requirements to PC-1
	Repair Timeframe:	Short Term

DT-3: Double-Tee Beam Surface Spall (Level 4)

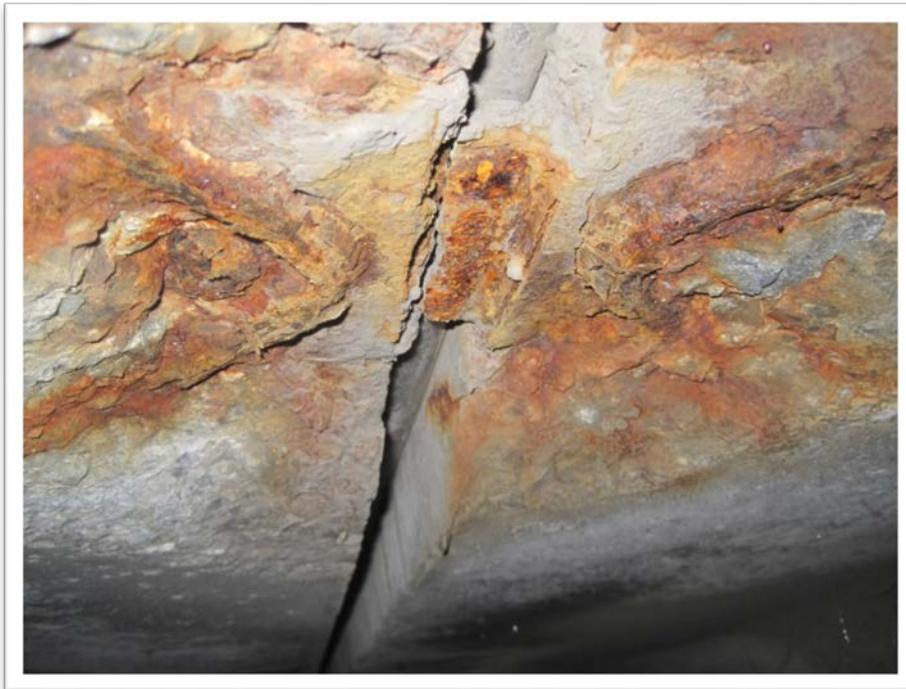
DT-4	Issue:	Shear Tab Failure (Level 2 Beams)
	Cause:	Joint sealant failure, corrosion of shear tabs
	Effect/Consequence:	Large differential deflection between Double-Tee beams caused impacts to each beam as vehicles move on the floor level, and prevents sealants from maintaining bond as they cannot support that level of movement. Shear tabs also provide structural qualities for the transfer of lateral loads during a wind or seismic event.
	Repair Recommendation:	Install bolted angle repair as previously installed at levels 3 and 4.
	Repair Timeframe:	Short Term
DT-5	Issue:	Cored Holes on Level 2 Beam 1.1. Proximity of holes is close and removes majority of interior beam flange.
	Cause:	Installation of piping post construction completion
	Effect/Consequence:	Beam appears in good condition. Cores left flange reinforcing exposed. Reinforcing could rust, causing concrete spalls and further beam damage.

DT-4a: Double-Tee Beam Flange Shear Tab Connection Failure (Level 2)

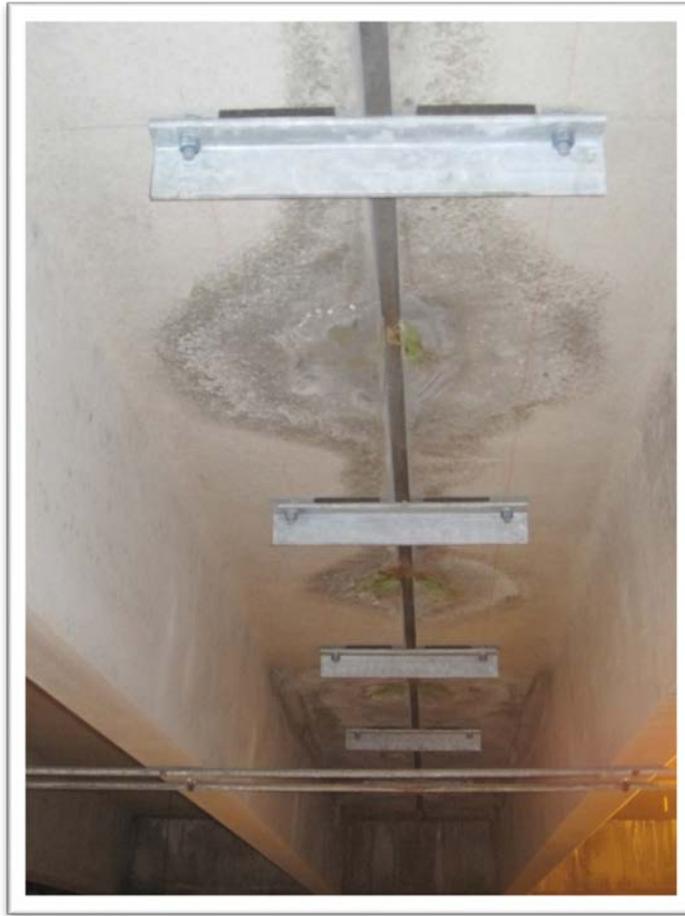
DT-4b: Double-Tee Beam Flange Connection Repair – Constructed 2006 (Level 3)

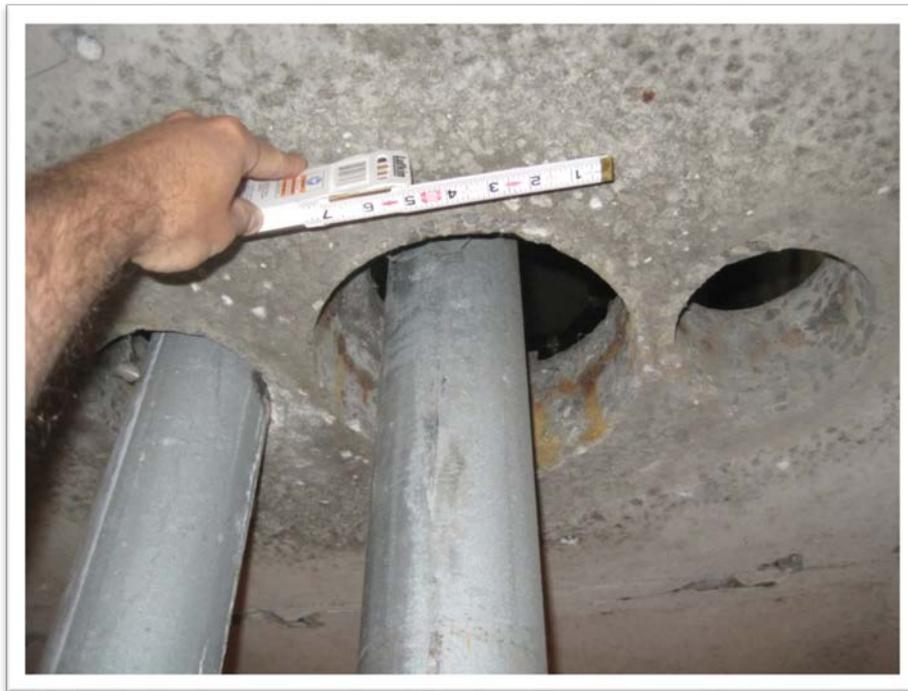
DT-5: Double-Tee Beam - Existing Cored Holes on Beam 1.1 (Level 2)

Repair Recommendation:	Wire brush exposed reinforcing and apply spray coat epoxy. Fill or Cover (with pipe boot) annular space.
	Repair Timeframe:	Minor repair. At DPW convenience.
DT-6	Issue:	Beam End Spalls and Flange Spalls
	Cause:	Water draining down ends of Double-Tee beams. Related to wash area concrete failures.
	Effect/Consequence:	Continued beam damage.
	Repair Recommendation:	Chip out spalled, un-sound concrete. Clean exposed steel free of rust. Depending on extent of damage, splicing repair steel bars may be required. Apply grout patch, form vertical edges (reference PC-1 for installation instructions). Coordinate repair with Wash Area repair above.
	Repair Timeframe:	Short Term
DT-7	Issue:	Double-Tee Beam Bearing Pads – Frayed, Heavily Compressed
	Cause:	Age, water damage, improper design load
	Effect/Consequence:	Potential restriction of beam expansion/contraction and rotation resulting in beam cracking or damage to beam support member.

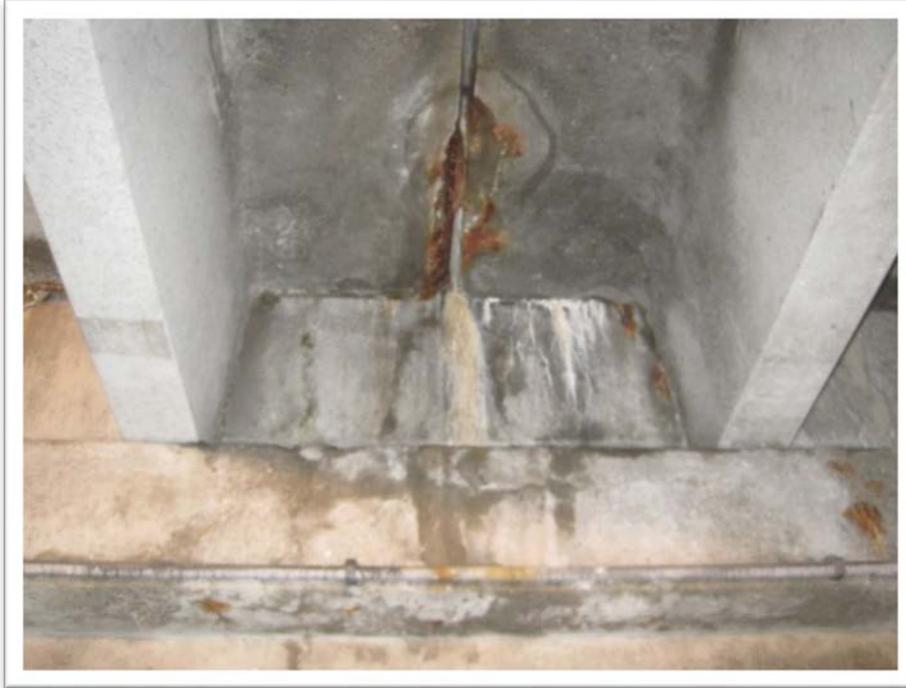
DT-6: Double-Tee Beam End – Flange Spalls and Reinforcing Corrosion

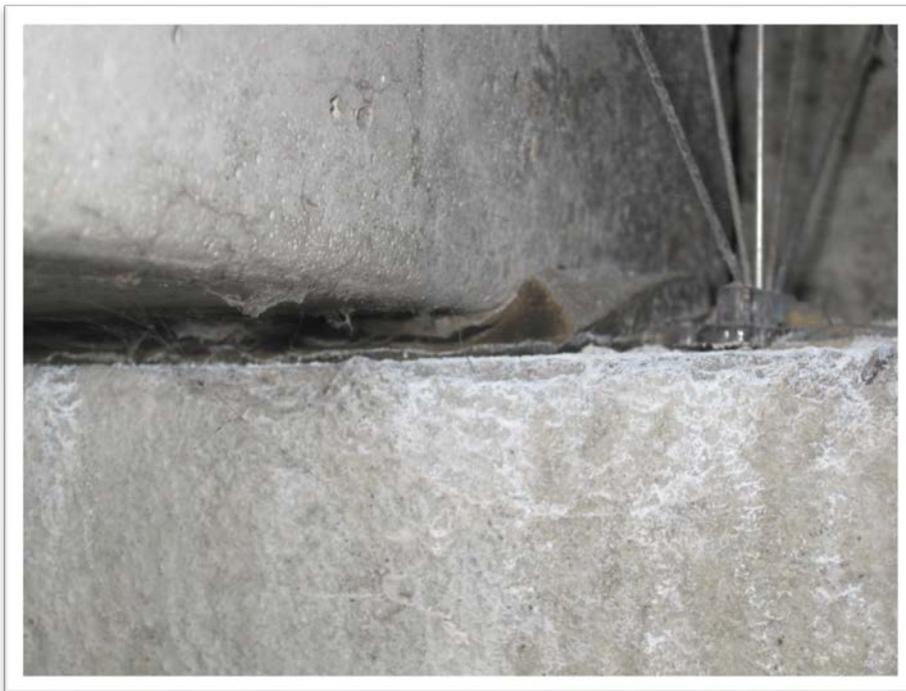
DT-7: Double-Tee Beam Bearing Pad Damage (frayed)

Repair Recommendation:	Replace bearing pads. Note: Each beam end will need to be jacked to remove and install new bearing pad.
	Repair Timeframe:	Long Term

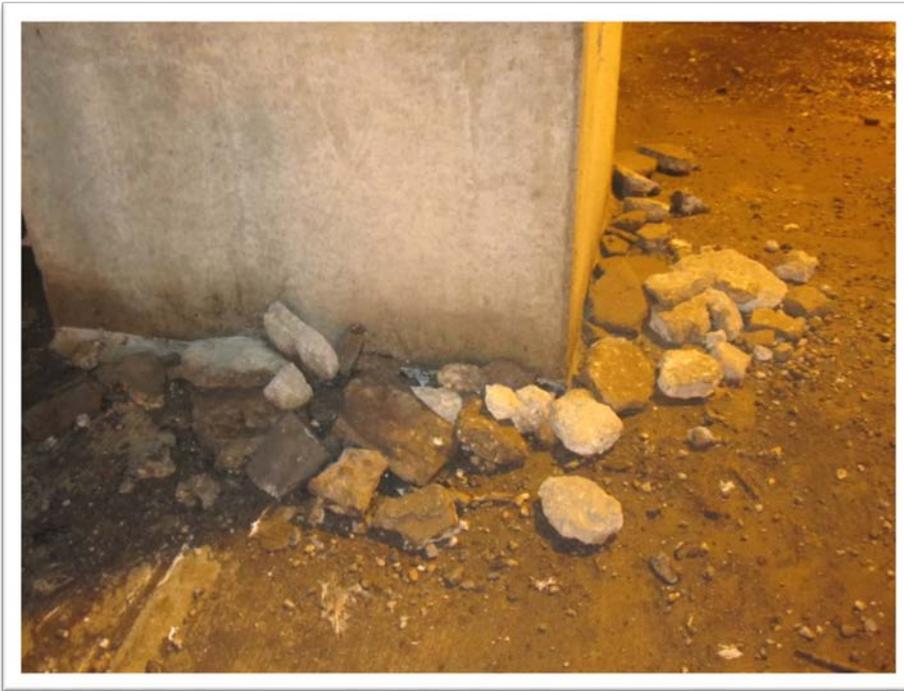
DT-8	Issue:	Double Tee Beam Overhead Flange Spalls
	Cause:	Spalls at shear tabs at Level 2. Overhead patch failure at Levels 3 and 4.
	Effect/Consequence:	Public Safety Risk
	Repair Recommendation:	Remove all loose overhead concrete.
	Repair Timeframe:	IMMEDIATE

DT-8: Double-Tee Beam –Debris from Fallen Overhead Spalled Concrete

1. Remove loose overhead concrete from spalled areas on double tee beams and inverted tee beams. Particularly prevalent on the underside of Level 2 framing this presents a hazard to pedestrians and vehicles below. (DT-8: this nomenclature is used with the report to key identified issues and is further explained in the Conditions Assessment Section of the report)
2. Repair beam bearing condition on Level 2 framing at Grid B/2. (DT-9)

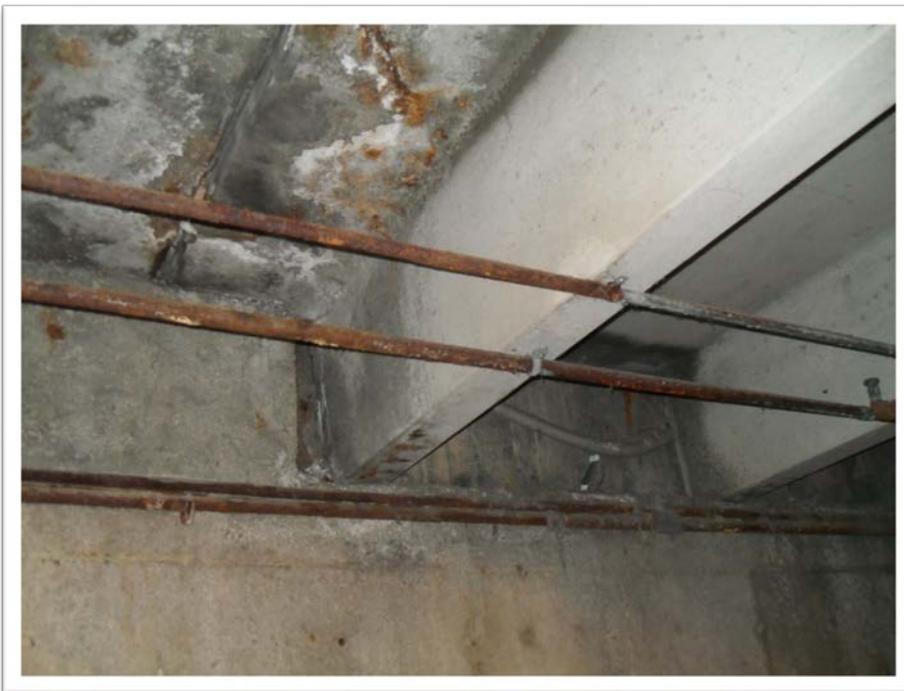
DT-9	Issue:	Double-Tee Beam Bearing Issue (Level 2 – Beam 2.1 at Grid B)
	Cause:	Water damage, spalled concrete on beam and on top of wall at bearing location
	Effect/Consequence:	Beam has dropped and bearing is now taken through its flange on the wall.
	Repair Recommendation:	Repair bearing location and end of beam. Top of wall: chip out concrete to expose longitudinal bar, chip flat shelf for patch, install grout patch (wrapping around exposed reinforcing bar). End of beam: confirm limits of beam damage, verify adequate bearing area can be provided, protect exposed reinforcing and prestressing strands. Engineering calculations and repair development is required.
	Repair Timeframe:	IMMEDIATE

DT-9: Double-Tee Beam Bearing Issue at Beam 2.1 (Level 2)

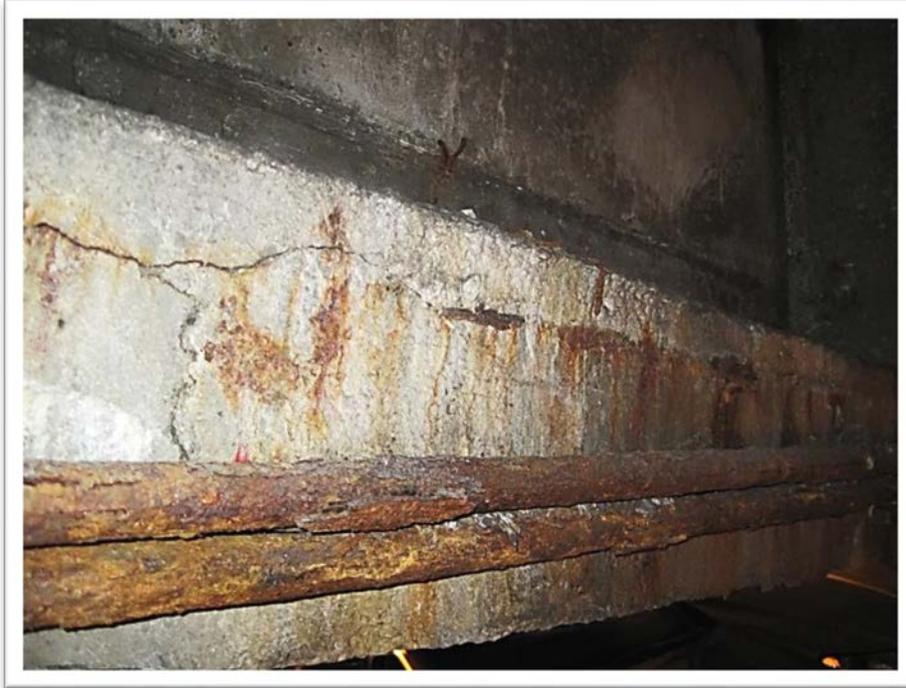
PC-1	Issue:	Spandrel Beam Support Shelf Cracks / Spalls
	Cause:	Water down ends of Double-Tee beams causing rebar corrosion and cracks and spalling of concrete.
	Effect/Consequence:	Beam support damage.
	Repair Recommendation:	Remove spalled concrete, clean reinforcing steel, patch with approved grout (PC-1a). At locations where shelf supports have cracks less than ¼" in width and the concrete has not spalled, the recommended repair is epoxy injection (PC-1b).
	Repair Timeframe:	Short Term

PC-1: Spandrel Beam Support Shelf Damage (Inverted-Tee Beam Shelf Shown – Similar)

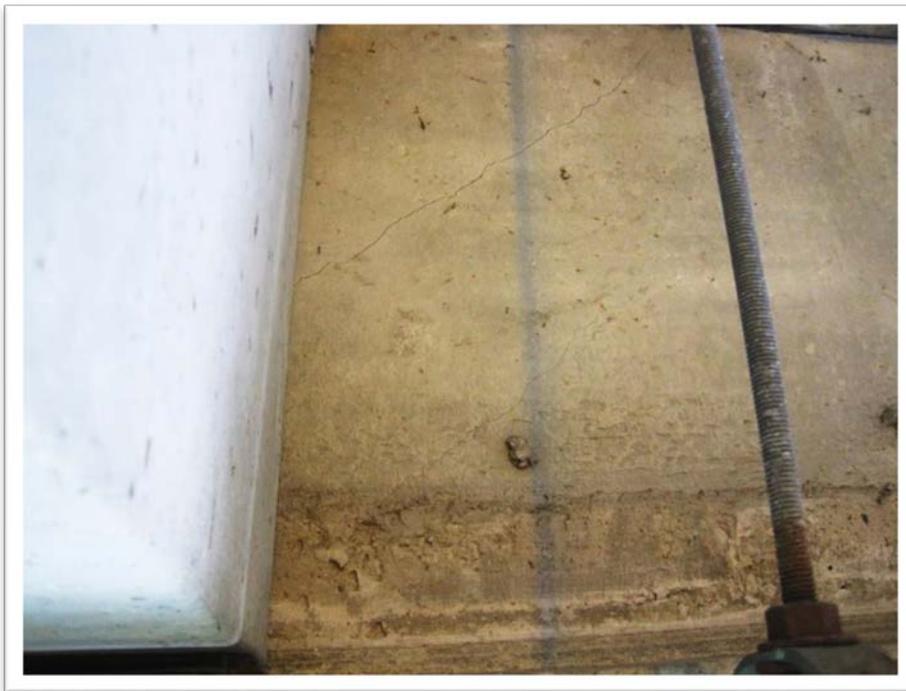
PC-2	Issue:	Spandrel Beam Web Shear Crack
	Cause:	Notched beam bearing. Original design did not provide sufficient crack control reinforcing to account for the reduction in beam web depth
	Effect/Consequence:	Currently cracks are relatively small, measured at 1/64". If cracks are left exposed water can penetrate, damaging reinforcing and concrete beam integrity
	Repair Recommendation:	Epoxy Inject crack
	Repair Timeframe:	Mid Term

PC-2: Spandrel Beam Web Shear Crack (Level 4, Grid D)

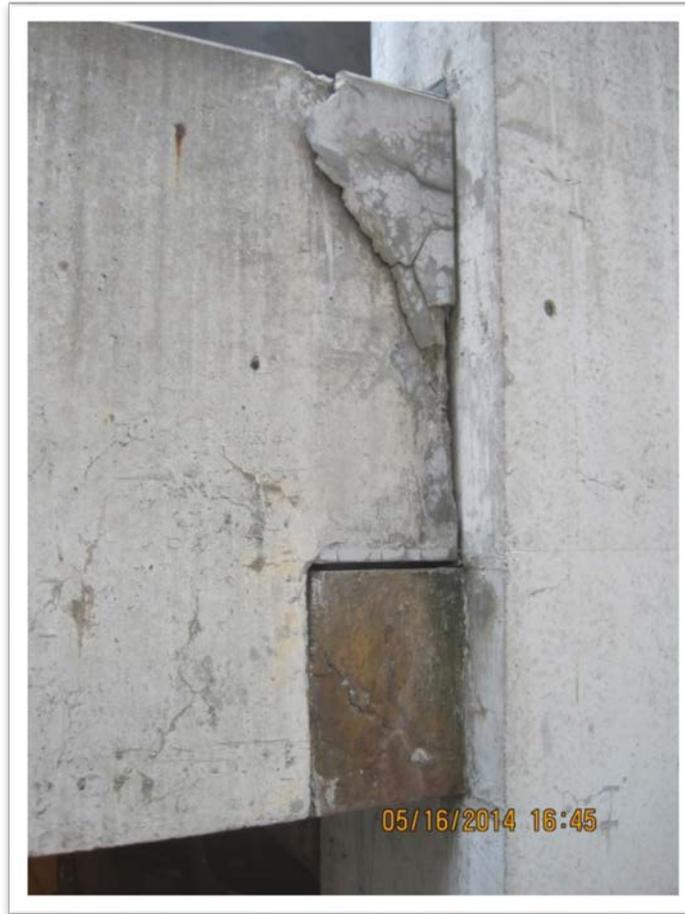
PC-3	Issue:	Spandrel Beam – Column Corbel Damage
	Cause:	Water penetration causing reinforcing steel corrosion and concrete cracking. It appears that the corbels were repaired with an epoxy injection repair method, which has since become brittle due to age and exposure.
	Effect/Consequence:	Spandrel Beam support issues – large structural consequences
	Repair Recommendation:	Completely chip out and remove existing damaged corbels. Install galvanized steel shelf similar to the repair completed at Floor 4 framing, Column D/2 (adjacent to Southwest Stair Tower). Note: for corbels with single small width cracks, epoxy injection repair methods may be considered. Repair required temporarily supporting beam weight during construction.
	Repair Timeframe:	Short Term

PC-3: Spandrel Beam Bearing at Damaged Column Corbel (Level 4 Framing, Grid A)

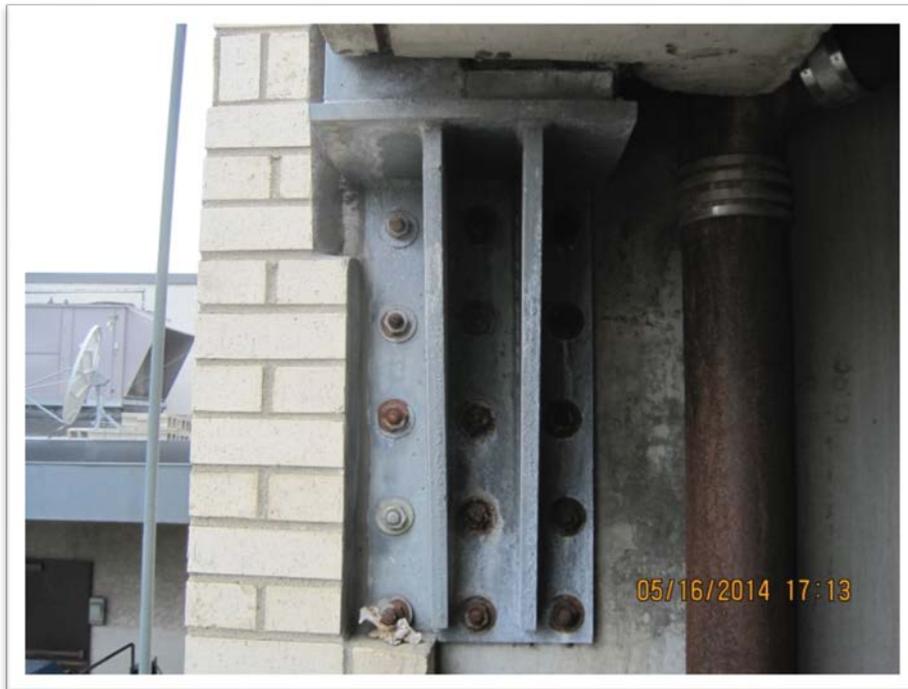
PC-3b: Spandrel Beam Bearing – Existing Column Corbel Repair (Level 4 Framing, Grid D)

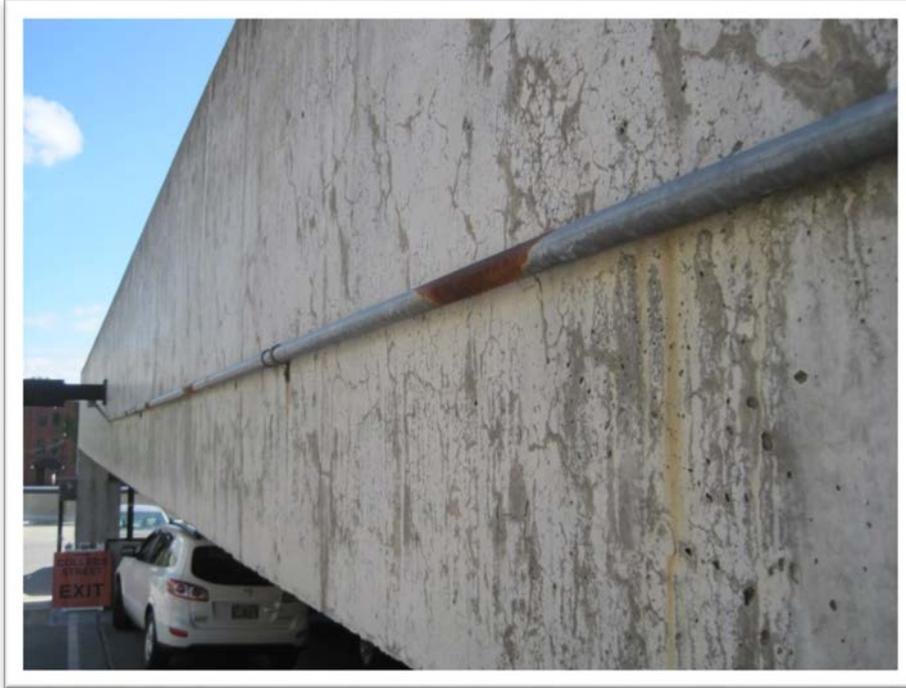
PC-4	Issue:	Spandrel Beam – Map Pattern Cracking (Level 5, Grid 9)
	Cause:	Potentially due to thermal cambering of beam. East face of beam receives sun exposure, heating it, while the west face of beam remains cooler underneath Level 5 – thus inducing a camber effect and pattern cracking of concrete. This effect is called “sun cambering”
	Effect/Consequence:	Potential long term beam damage.
	Repair Recommendation:	Routine application of penetrating sealer. Coordinated with remainder of garage
	Repair Timeframe:	See Maintenance Section of this Report

PC-4: Spandrel Beam Map Cracking (Level 5)

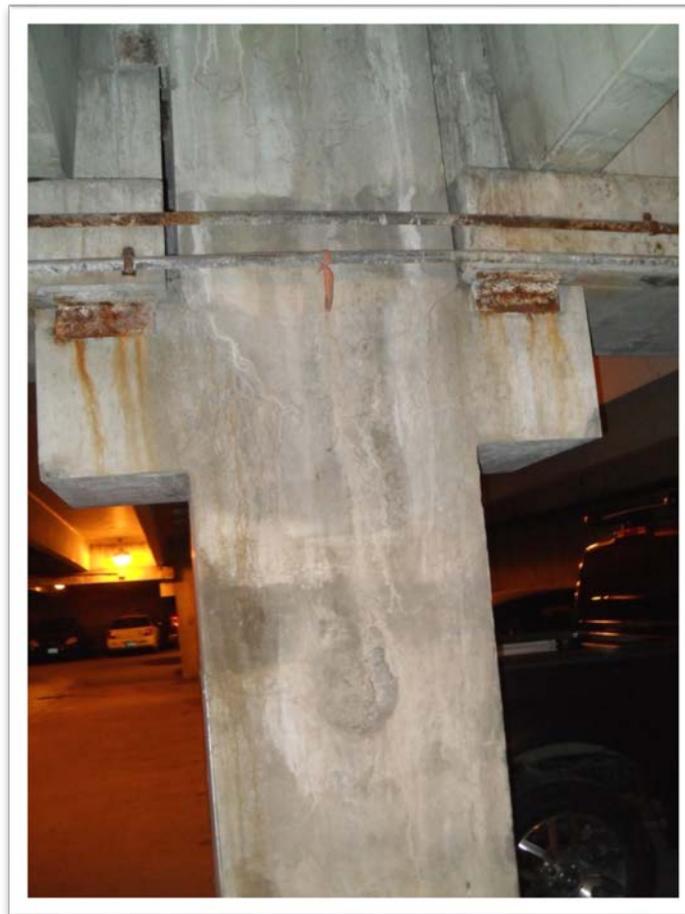
PC-5	Issue:	Interior Inverted-Tee Beam – Steel Lateral Restraints at Bearing - Floor 4 framing Column B/10
	Cause:	Water damage from ponding issues above
	Effect/Consequence:	Later restraint compromised for Inverted-Tee Beam – large structural consequences in lateral event (wind or seismic).
	Repair Recommendation:	Coordinate with surface drainage repair at level 4. Clean existing steel and verify remaining section of steel angle and weld connection is suitable for continued use (evaluate reduced section structural capacity). Clean and Paint.
	Repair Timeframe:	Short Term

PC-5: Inverted-Tee Beam – Steel Lateral Restraint Damage

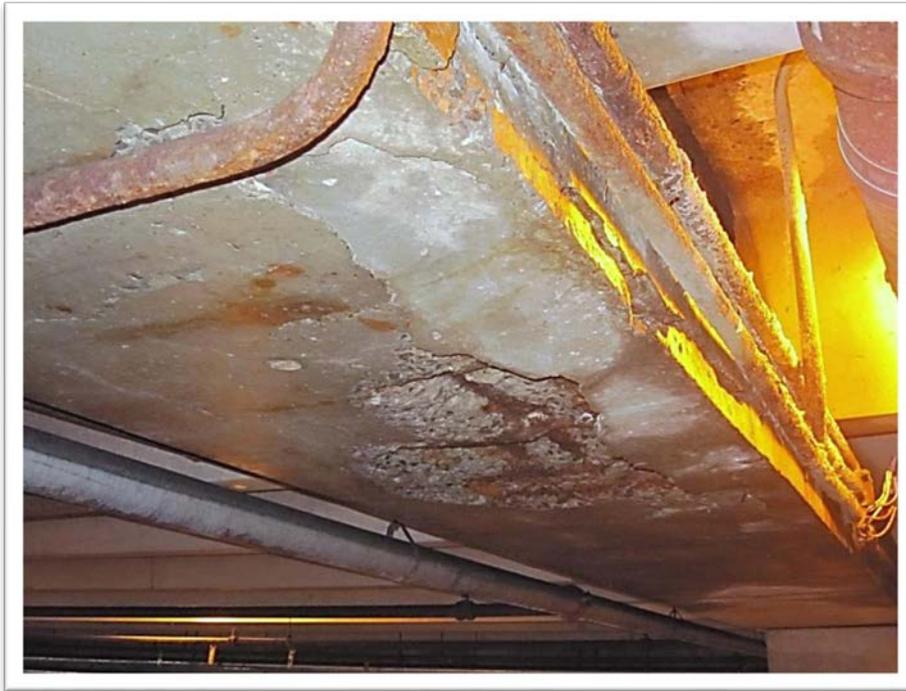
Inverted-Tee Beams support the double-tee beams at interior bearing grids B and C. These beams were cast with shelves on both sides forming an inverted-tee shape. The majority of these beams have significant structural issues consisting of spalled bottom cover concrete and substantial reinforcing bar corrosion and section loss.

PC-6: Inverted-Tee Beam – Extensive Beam Damage

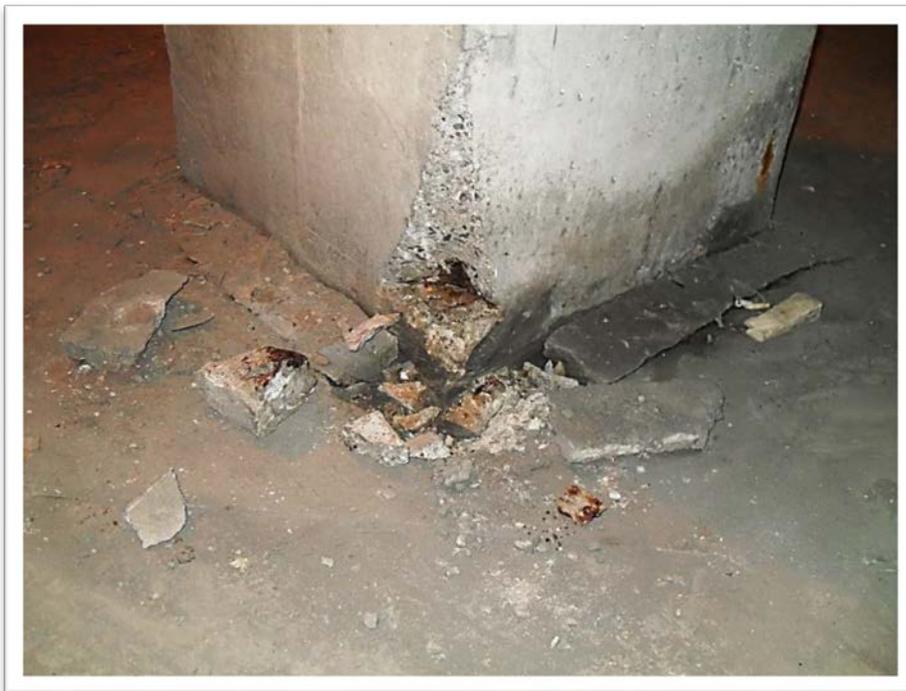
PC-7: Column Corner Spall

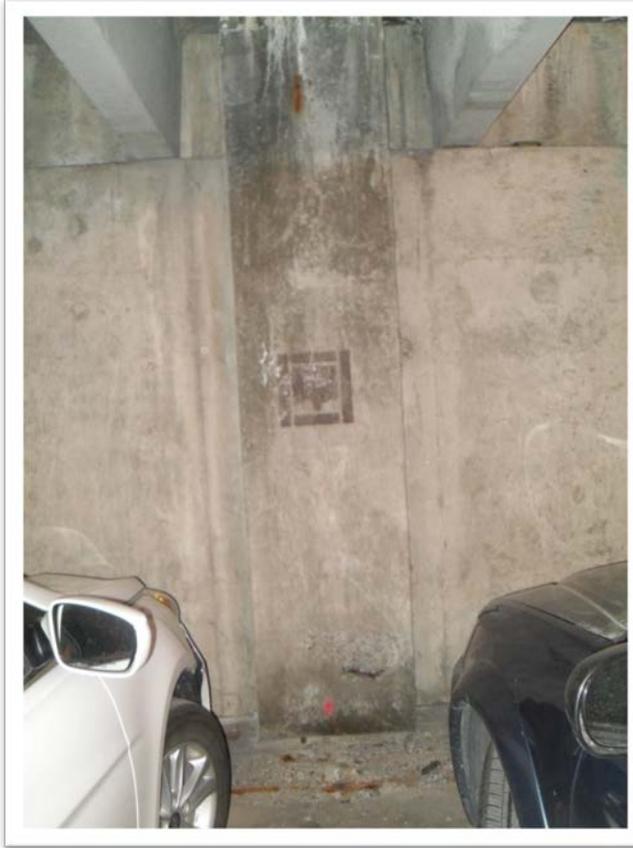
PC-8: Column Face Spall

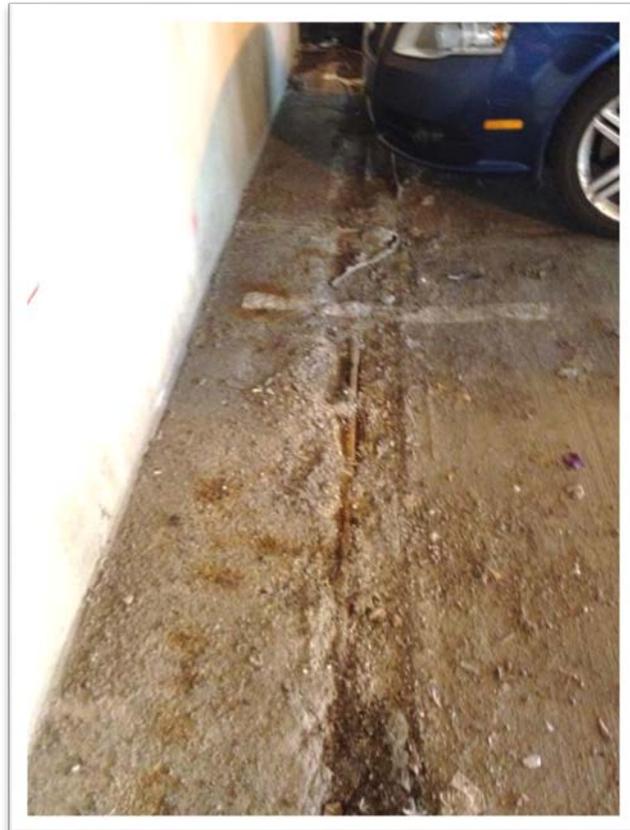
CIP-1: Wash Area Concrete Disintegration (exposed rebar corrosion)

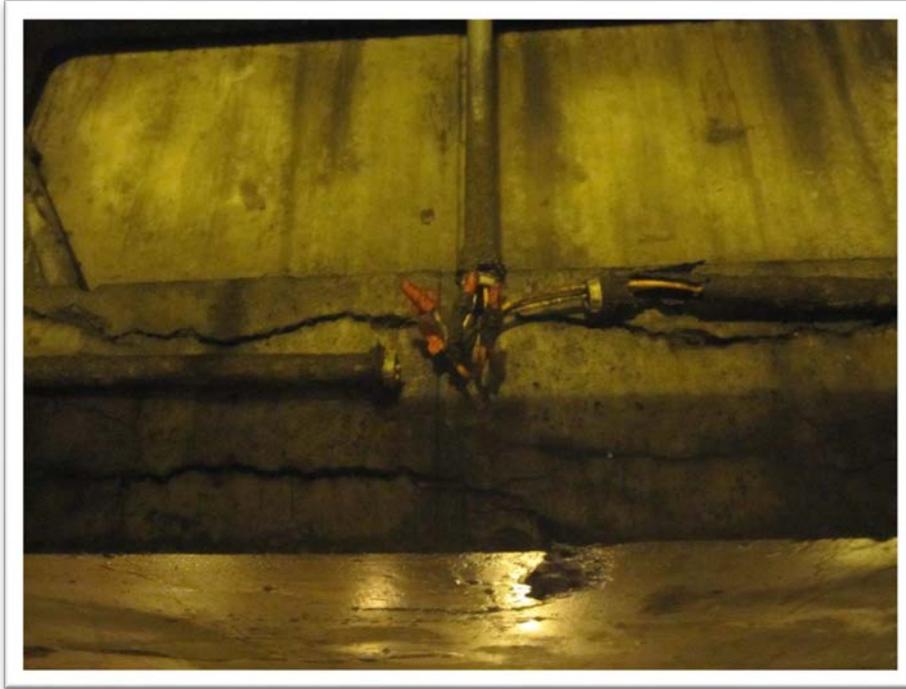
ED-1: Electrical System Distribution Wiring (Missing Junction Box)

3. Cover and protect exposed wiring connections (ED-1)
4. Repair surface spalls on stair treads. These present a dangerous tripping hazard. (ST-1)
5. Replace concrete pedestrian ramp on Level 4 by the Northeast stair tower. Accelerated concrete failure and voids present pedestrian hazard. (RA-1)

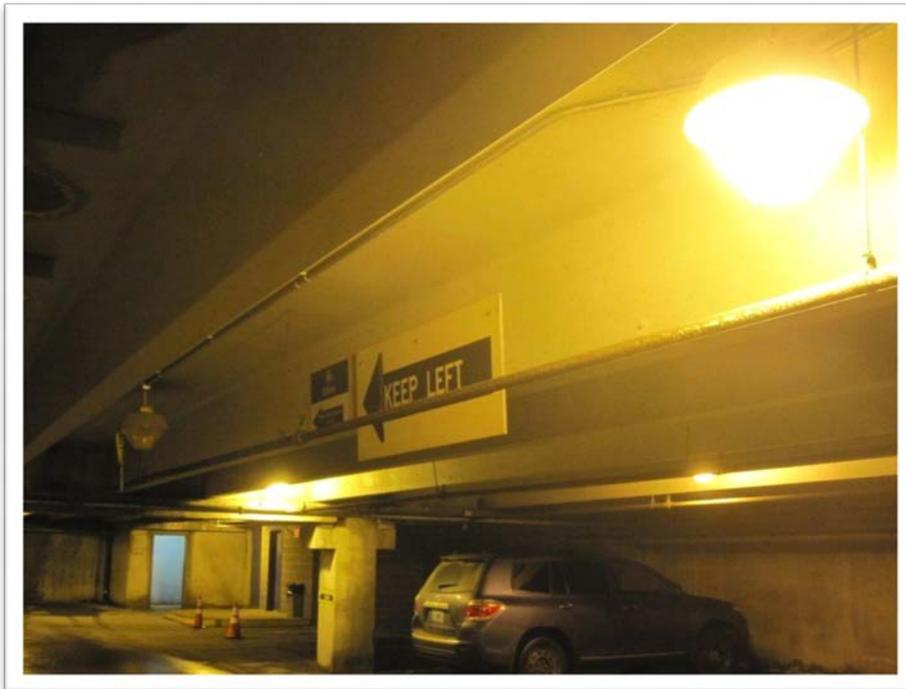
EL-1: Existing Lighting
