Assessment of City Parking Garage Structures College Street Garage

Hoyle, Tanner
& Associates, Inc.

Prepared for:
City of Burlington, Vermont

July 2014

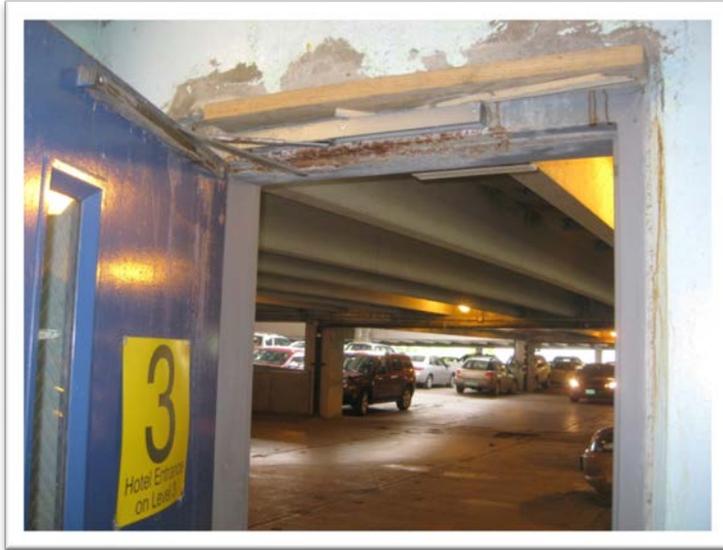
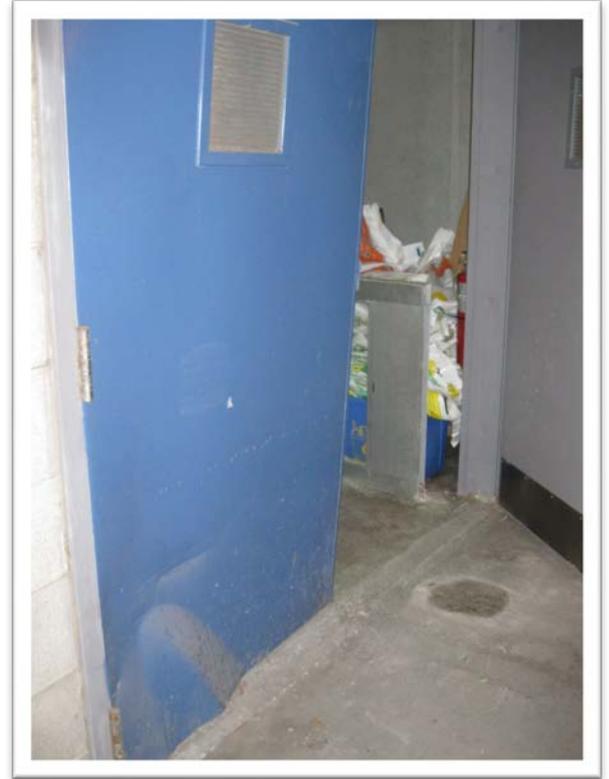
OP-1: Doors and Hardware are in Generally Poor Condition

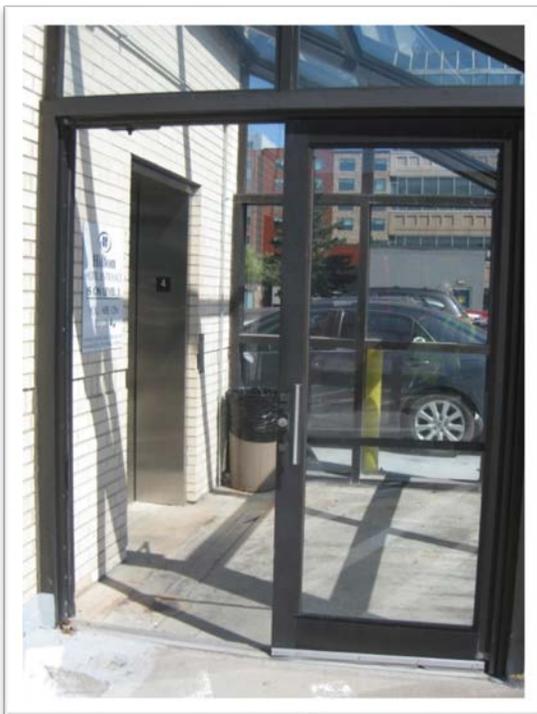
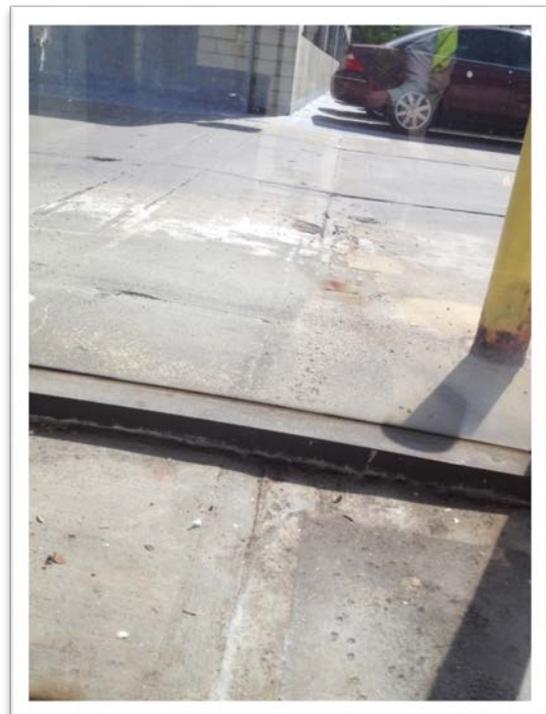
OP-2: Door Missing and Storefront Failure at Elevator Vestibule

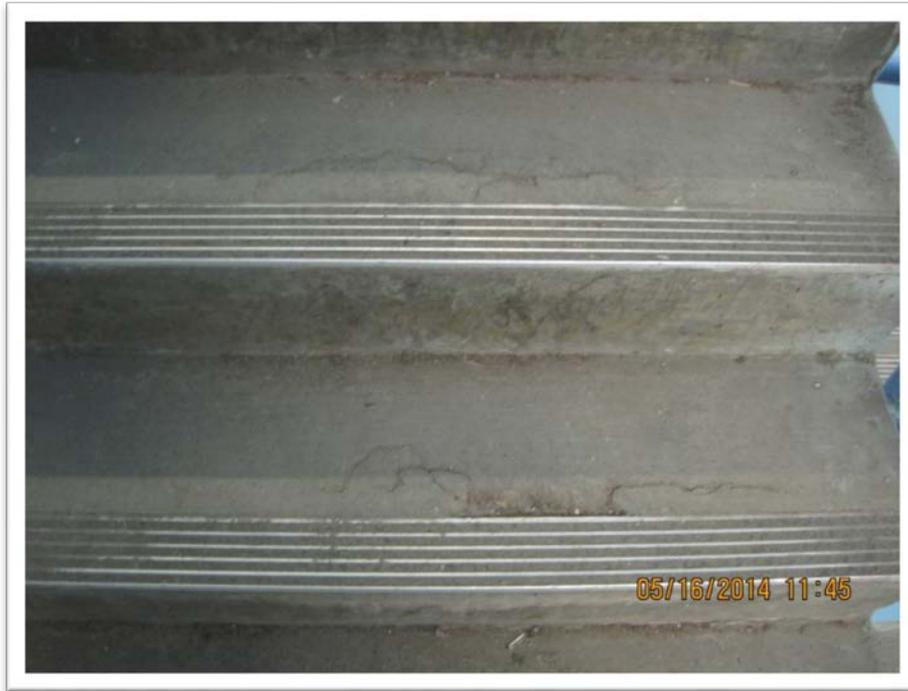
ST-1: Stair Tread Spall

3. Cover and protect exposed wiring connections (ED-1)
4. Repair surface spalls on stair treads. These present a dangerous tripping hazard. (ST-1)
5. Replace concrete pedestrian ramp on Level 4 by the Northeast stair tower. Accelerated concrete failure and voids present pedestrian hazard. (RA-1)

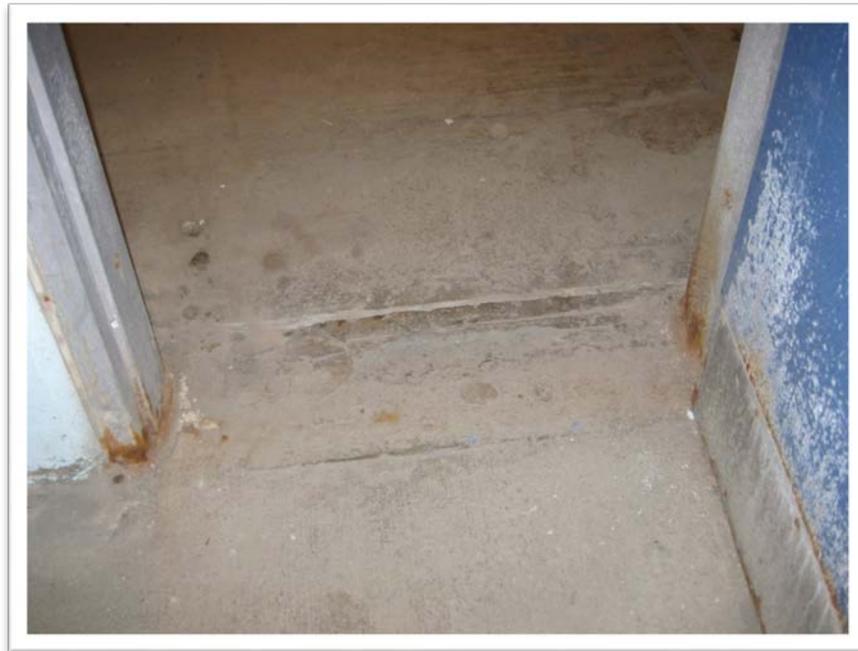
ST-1: Stair 2 (Northeast), Level 2 – Trip Hazard

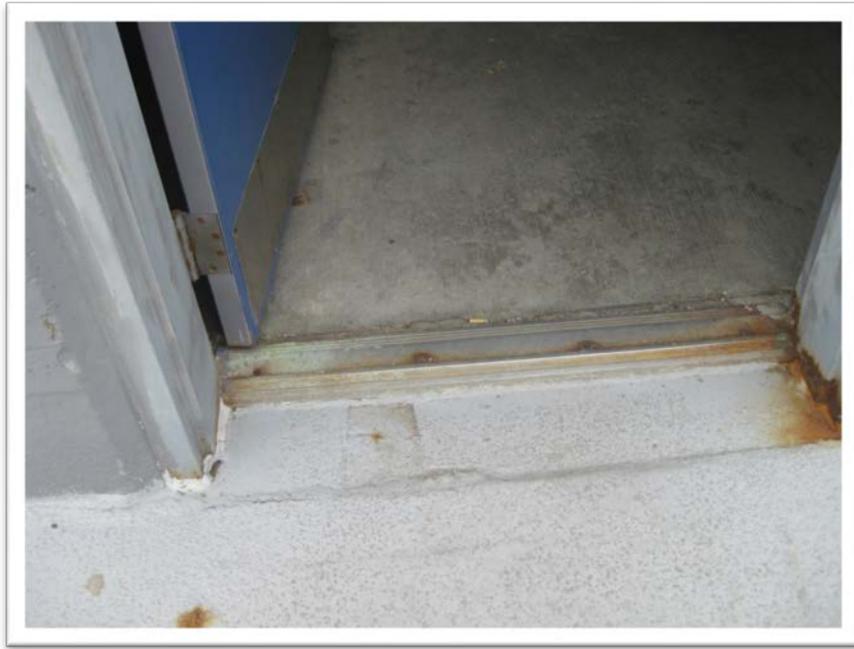
ST-1: Trip Hazard/Accessibility Deficiency at Stairwell Approaches

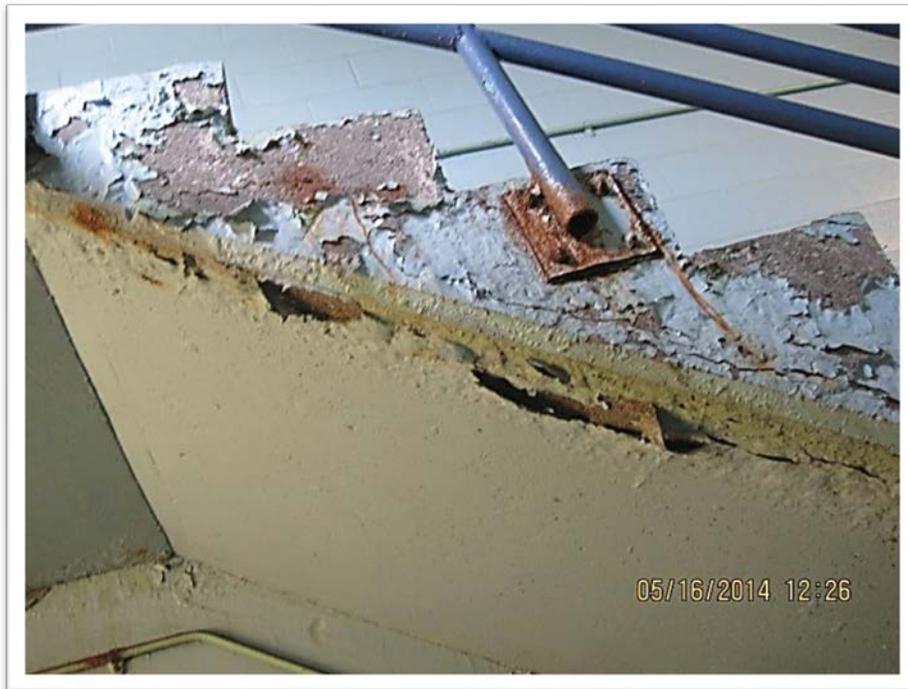
ST-2: Stair Crack

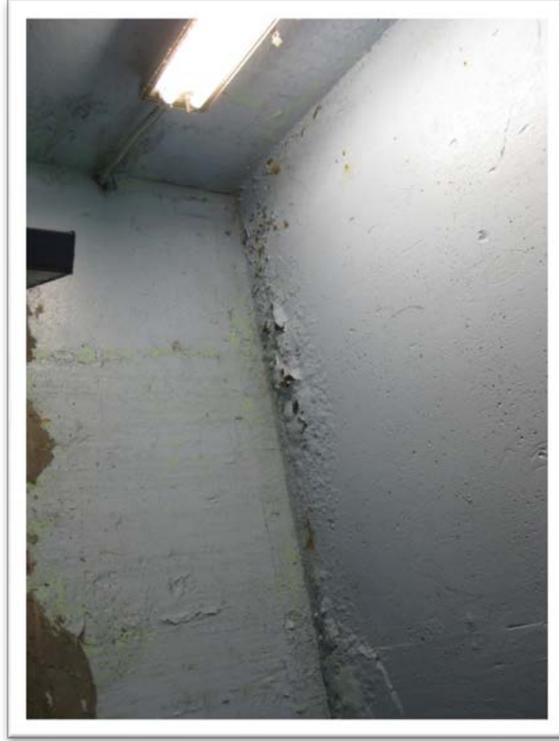
ST-3: Rust and Peeling Paint at Stairwells

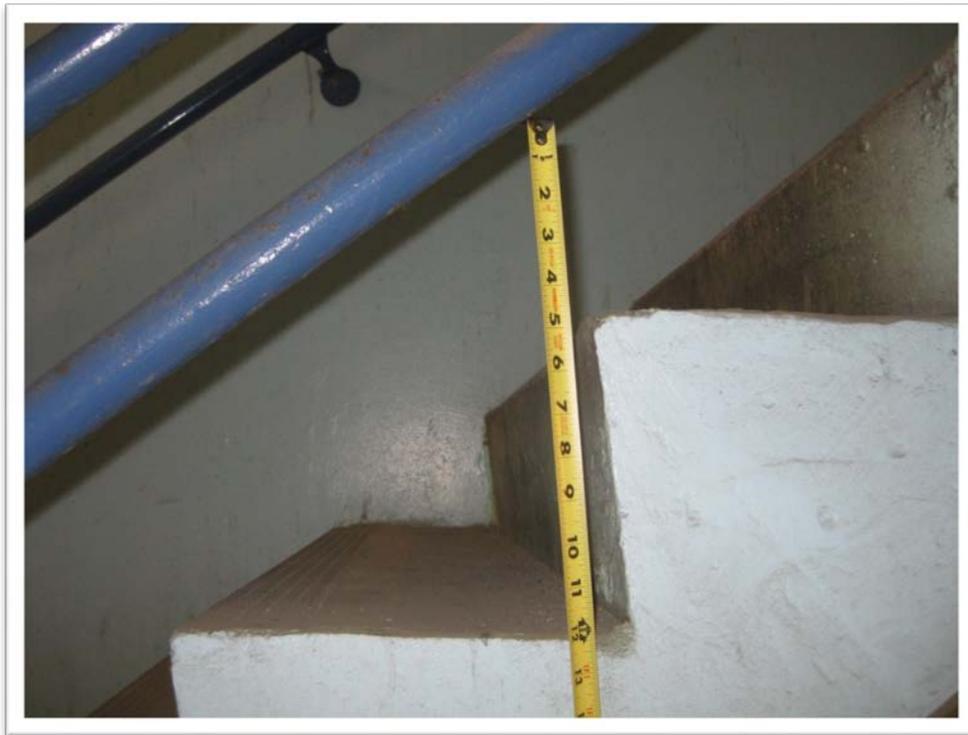
ST: Railing and Stair Code Deficiencies

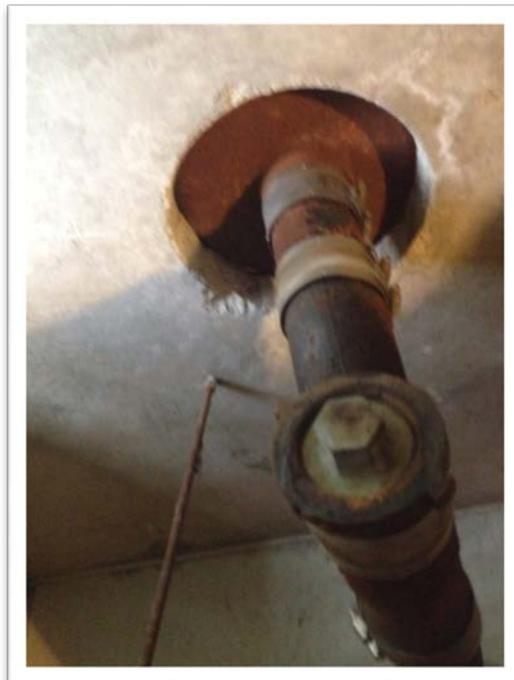
RM-2: Elevator #2 Roof Drain Leaking at Failed Sealant.

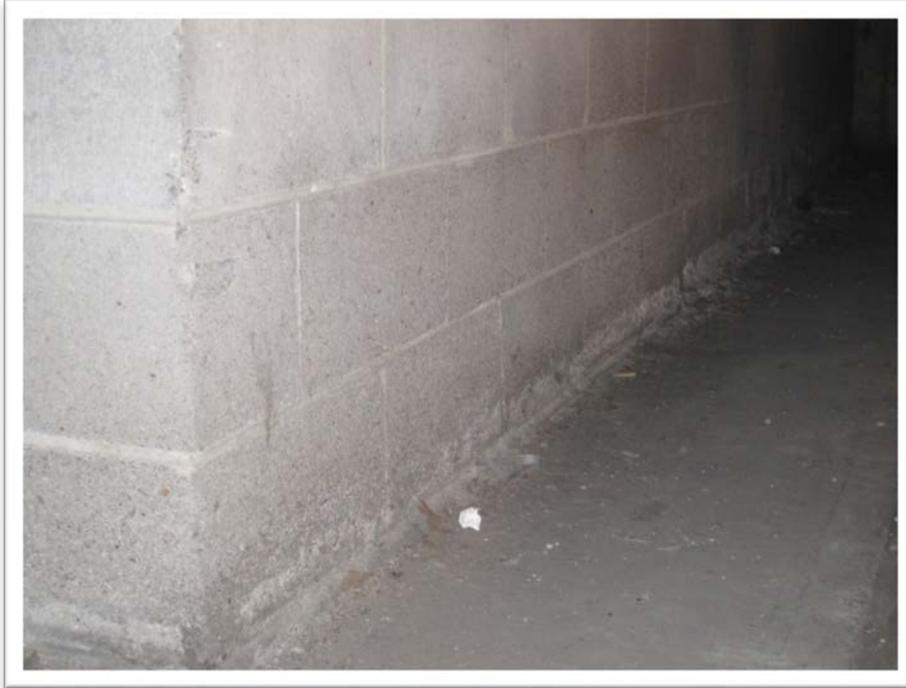
ME-2: Mechanical Room CMU wall patch (Level 2 shown)

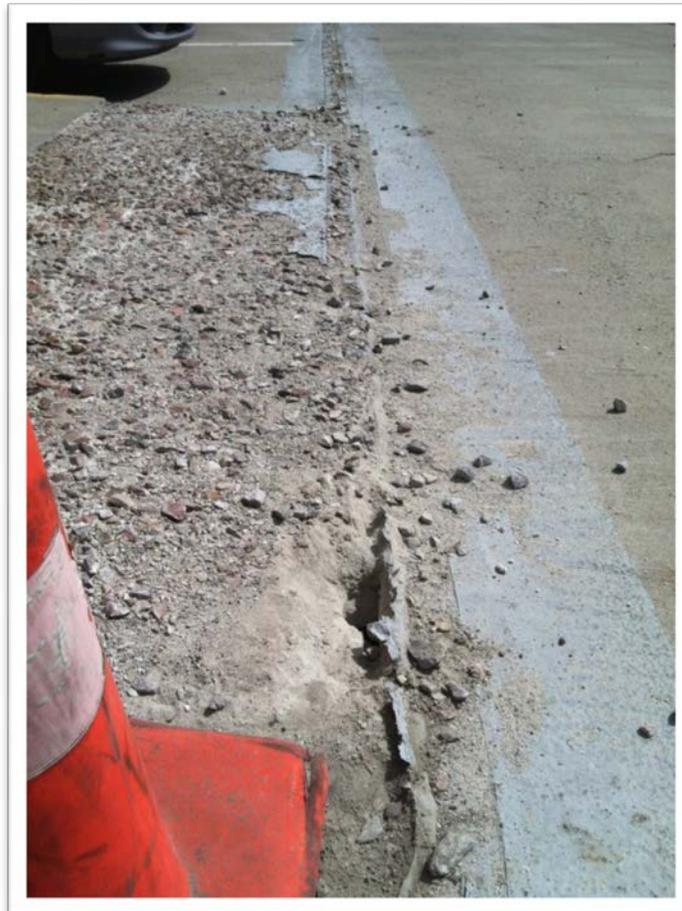
RA-1: Level 4 Concrete Ramp Degradation

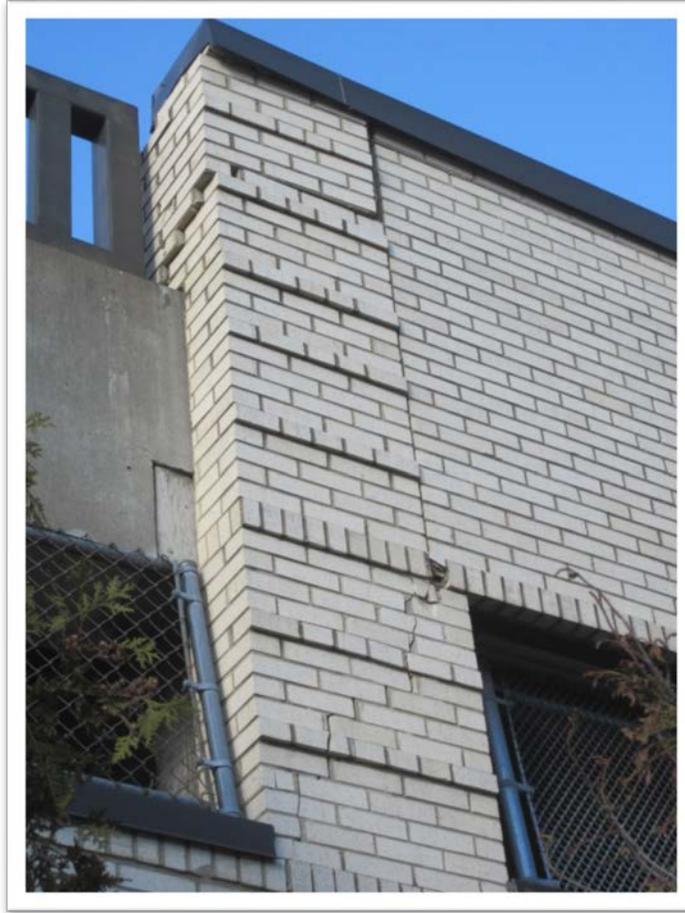
FA-1: Façade Damage at Level 4, Grid D/7

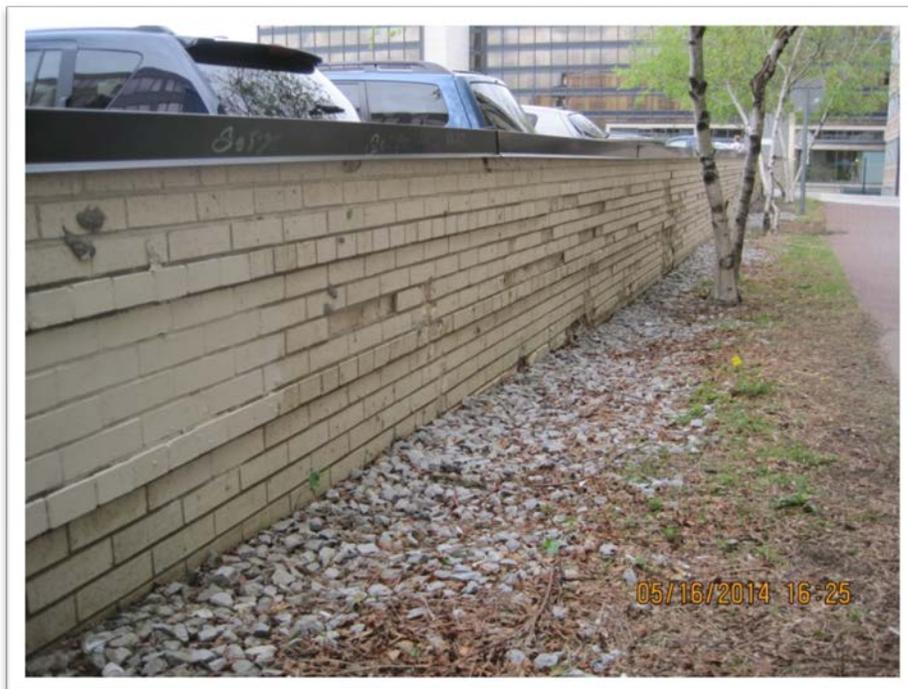
FA-2: General Façade Damage

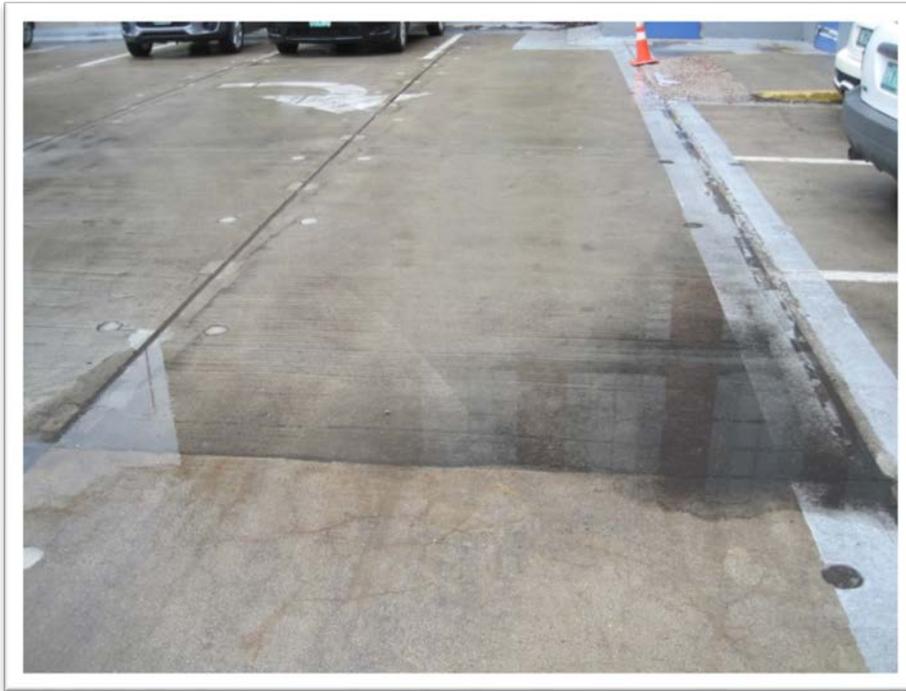
SD-1: Ponding Issues where Additional Floor Drain is Necessary (Level 4, Grid 10)

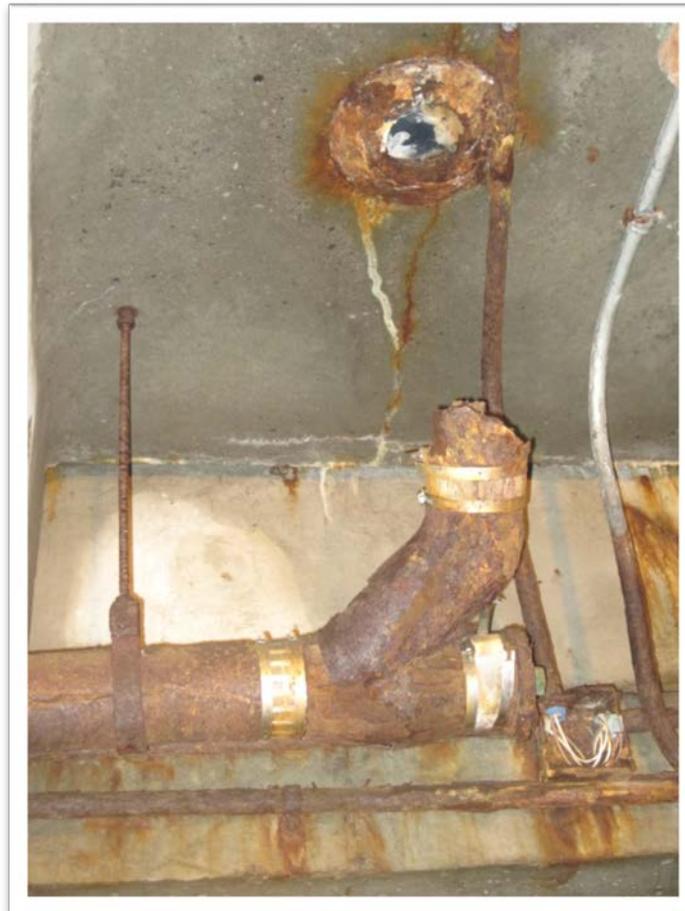
SD-3: Failed Storm Drain (Level 2, missing piping)

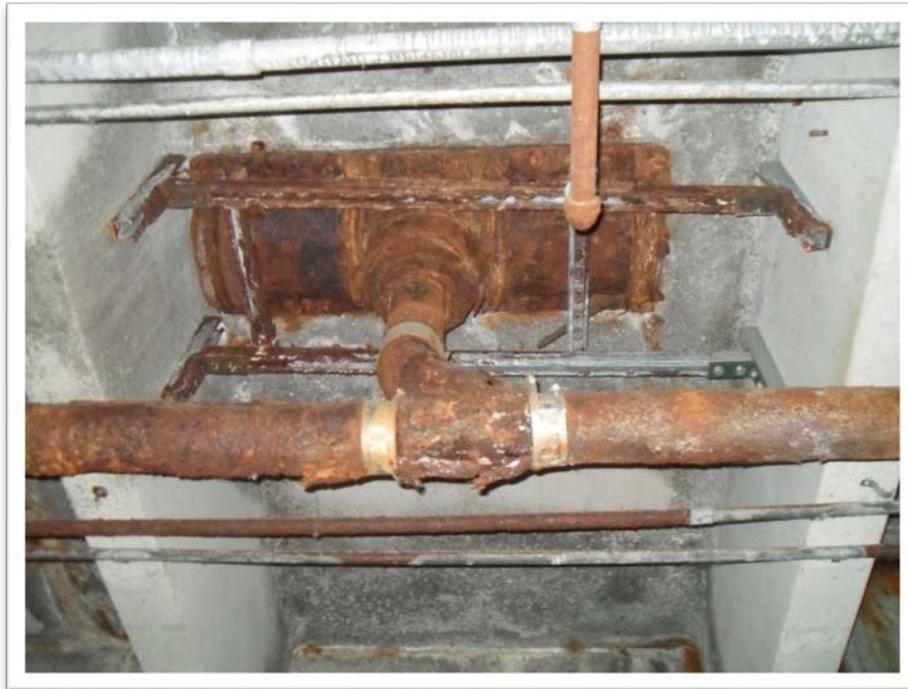
SD-4: Failed Trench Drain (Level 2)

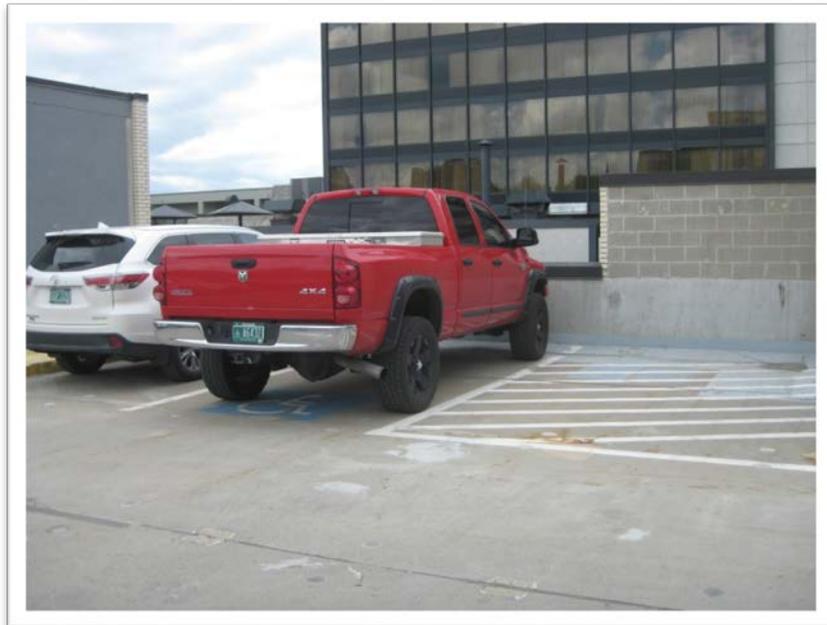
ADA-1: Accessibility and Accessible Parking Spaces
