Assessment of City Parking Garage Structures Lakeview Garage

Hoyle, Tanner
& Associates, Inc.

Prepared for:
City of Burlington, Vermont

July 2014

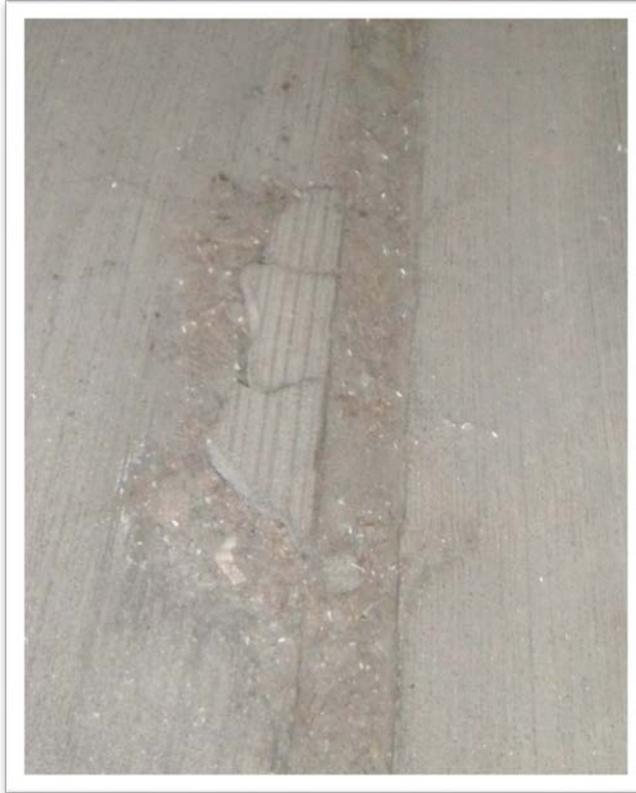
JS-1	Issue:	Joint Sealant Failure at Level 2, 3, 4, and 5
	Cause:	Spalled concrete adjacent to joint locations or debonding from concrete.
	Effect/Consequence:	Surface water travels between double-tee flanges, increasing the potential for beam damage and joint connection failure.
	Repair Recommendation:	Replace failed sealant locations. Replace spalled concrete to create uniform flange edge (see spalled concrete patching under Precast section of this report). Repair concrete cracks. Clean and prepare bonding surface prior to installation
	Repair Timeframe:	Short Term

JS-1: Spalled Concrete Adjacent to Joint Locations

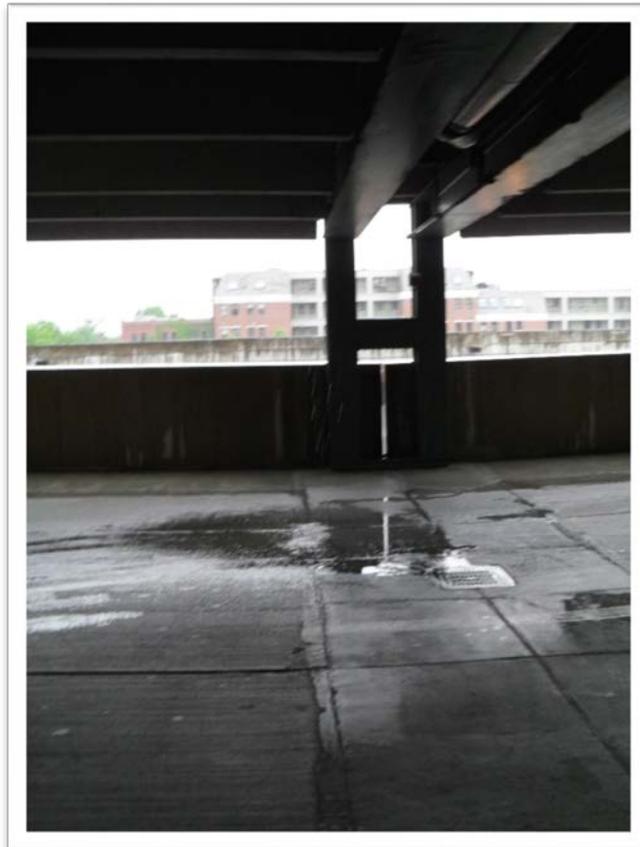
Inspection of the garage during periods of light rain revealed several locations where moisture was present on the underside of the Double-Tee beam joint lines indicating joint sealant failure. Where joint sealant failures have occurred, water is allowed to penetrate down the sides of beams causing potential damage to the beam shear tabs, flanges, and steel framing below. Most joint sealant failure locations are associated with either spalled concrete or debonding of the sealant. On level 3 at column line 'C.1' between grid lines '8' and '9' there is a substantial gap at the joint line between the flanges of the Double-Tees due to sealant failure and flange spall; flow was observed at the corresponding location below (level 2) pouring through the opening into the travel way.

JS-1: Water Leaking Through Gap at Double-Tee Joint (Level 3 – Column Line C.1, Grids 8 to 9)

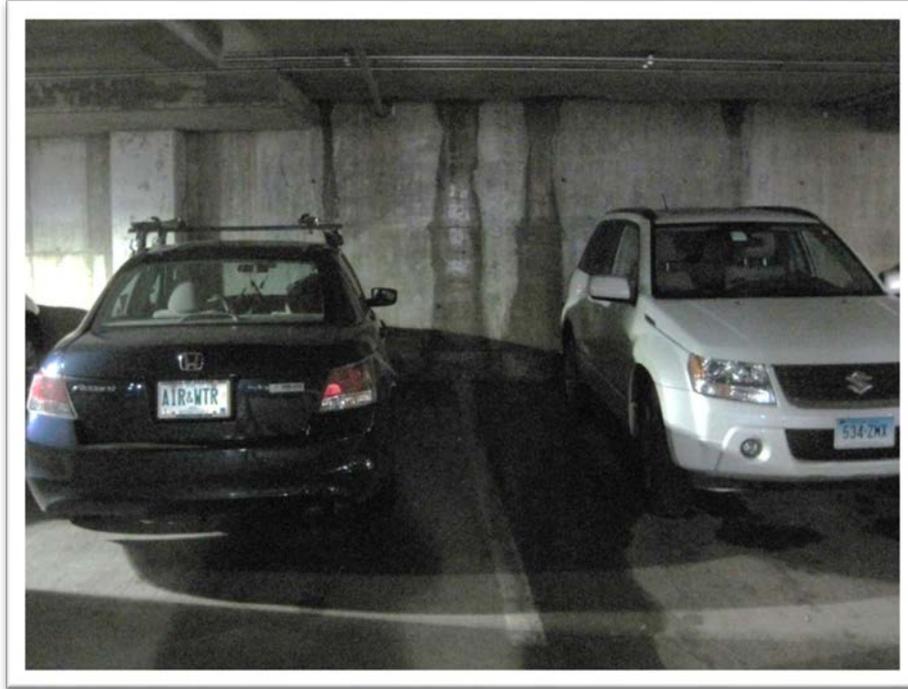
WCS-2	Issue:	Roof level perimeter sealant failures at West and North Walls
	Cause:	Water
	Effect/Consequence:	Water penetration to levels below, eventual structural damage
	Repair Recommendation:	Repair perimeter sealant at leaking locations. Install flashing at building perimeter to direct drainage away from this joint
	Repair Timeframe:	Mid Term

WCS-2: Leaking at North Wall of Westlake Garage

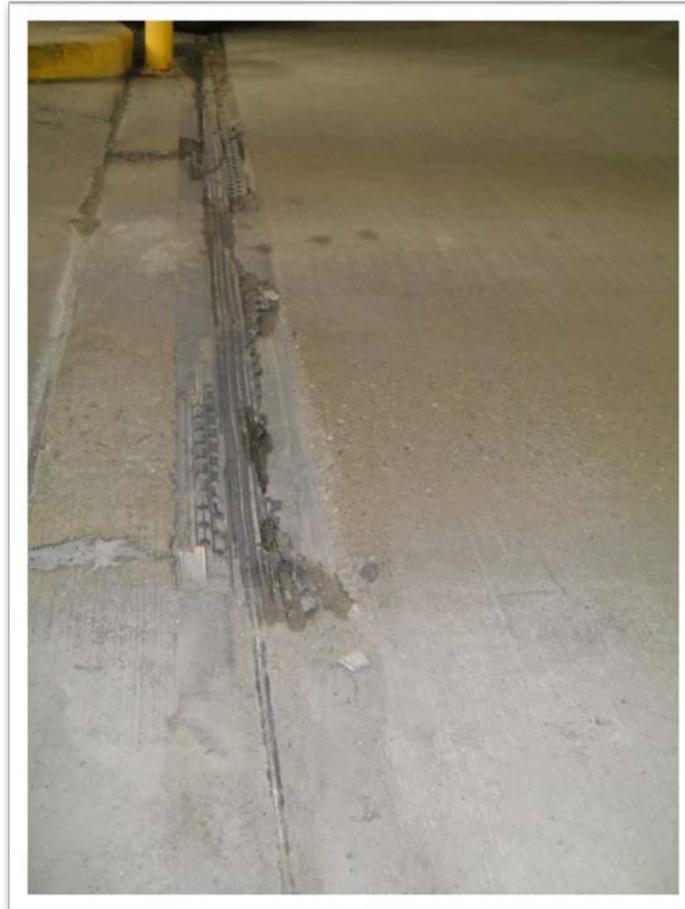
The expansion joint on level 2 at the garage entrance/exit experiences heavy traffic flow and has become worn, and separated in many locations. The expansion joint is in need of replacement across its full length.

EJ-2	Issue:	Expansion joint failure.
	Cause:	Heavy wear at garage entrance and exit.
	Effect/Consequence:	Damage/corrosion to adjacent Double-Tee Beams, water penetration issues to levels below
	Repair Recommendation:	Full replacement. A 'heavy duty' expansion joint should be considered for this area.
	Repair Timeframe:	Short Term

EJ-2: Expansion Joint at Cherry Street Entrance

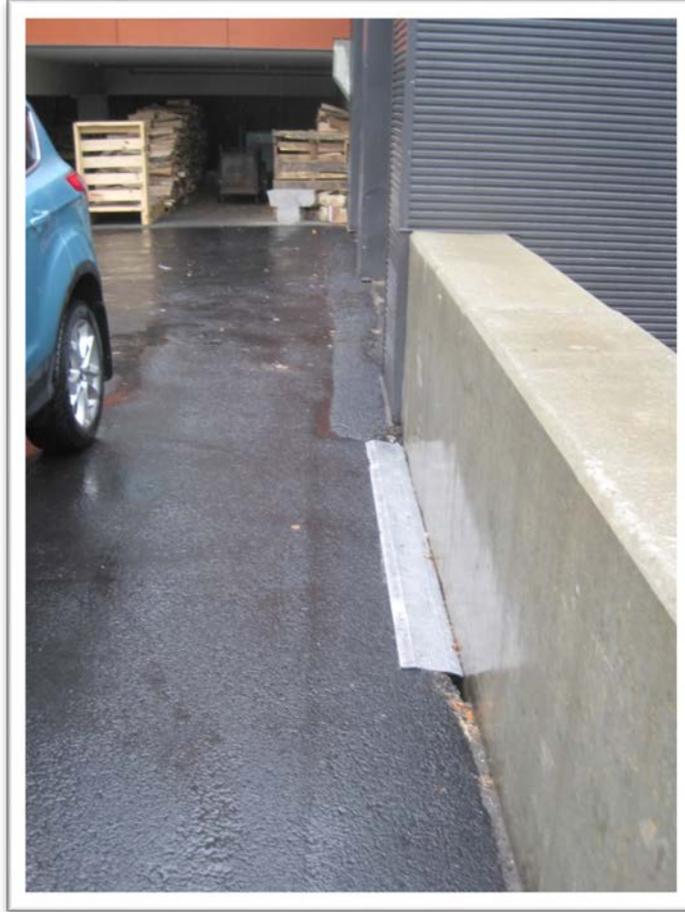
Where expansion joints are present they appear to be functioning per design intent. An expansion joint is missing along the west slab/wall interface on the East wall length. Some patch metal flashing and asphalt ramp has been installed at the roof level to cover this gap, but is a substandard repair. A compression seal is needed along this wall length.

WEJ-1	Issue:	Roof Level Expansion joint missing
	Cause:	Original construction
	Effect/Consequence:	Water, debris penetration to level below
	Repair Recommendation:	Install new compression seal along wall length
	Repair Timeframe:	Mid Term

WEJ-1: Missing Expansion Joint at East Wall

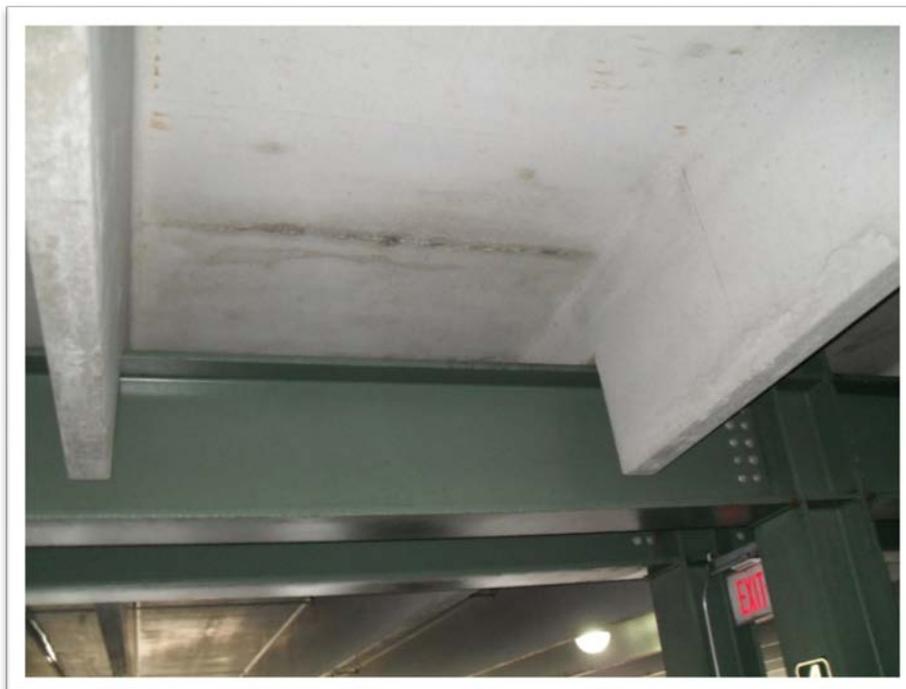
DT-3	Issue:	Double-Tee Beam flange cracks - Hairline
	Cause:	Potential causes: natural aging of concrete including shrinkage and creep, quality control issues during original construction
	Effect/Consequence:	Water can penetrate into beam causing potential flange reinforcement corrosion, and eventual extensive beam damage
	Repair Recommendation:	Cracks should be repaired with a self-penetrating crack healer/sealer
	Repair Timeframe:	Mid Term

DT-3: Transverse Crack in Double-Tee Flange

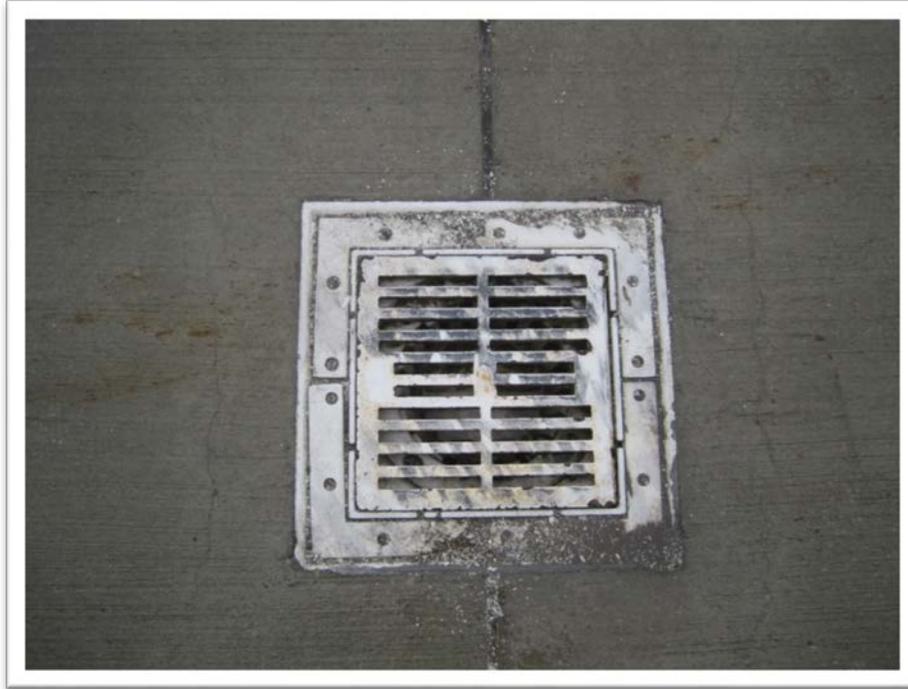
CIP-2: Cracks in CIP Wash Area Adjacent to Drain on Roof Level

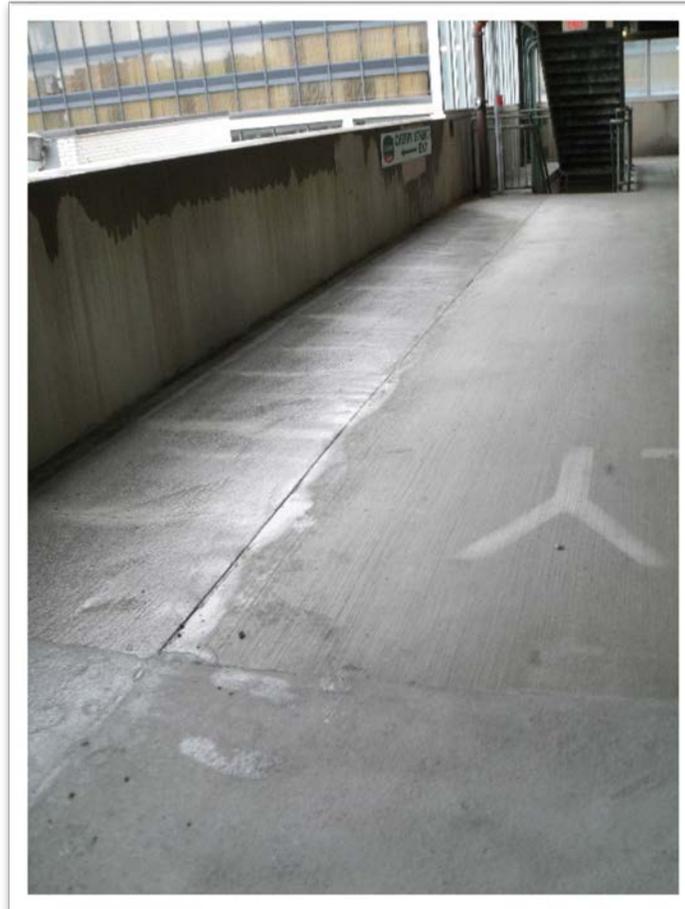
The Cast-In-Place (CIP) Concrete wash areas inspected by our team were found to be in good condition with the exception of some minor cracks that were located on Level 2 at Grid 11 between Column lines C and D that shall be repaired with a penetrating crack healer/sealer. For each of the stair towers on the roof level the CIP concrete threshold is cracked and sections of concrete has broken off that is in need of repair.

CIP-1	Issue:	Cracks in CIP Concrete Wash Area
	Cause:	Age, water penetration (coordinate with repair MB-1)
	Effect/Consequence:	Water damage to structural members below.
	Repair Recommendation:	Cracks should be repaired with a self-penetrating crack healer/sealer
	Repair Timeframe:	Short Term

CIP-1: Cracks in Raised Concrete Wash Area

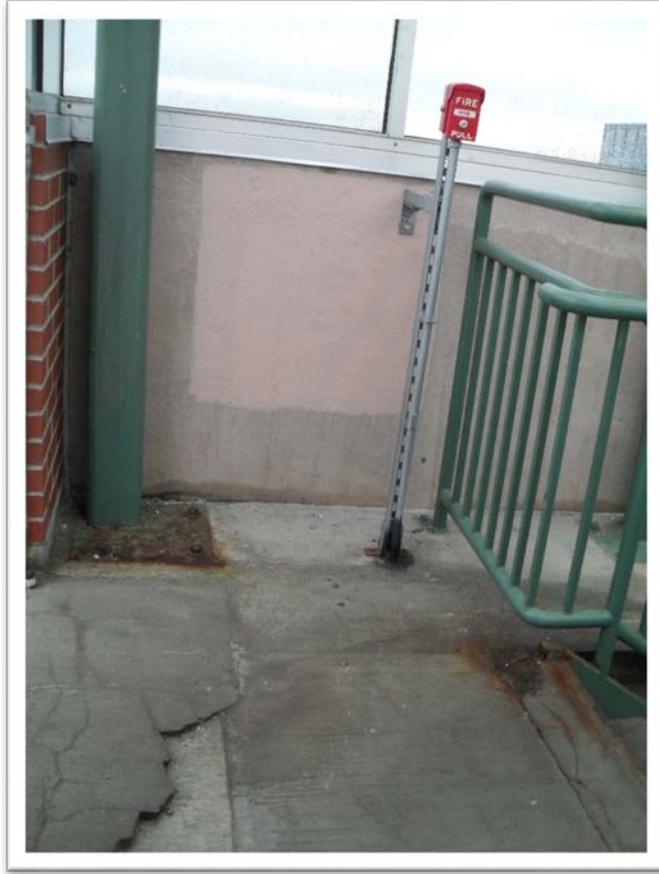
CIP-2	Issue:	Damaged CIP concrete threshold at both Stair Towers on Level 5 (roof)
	Cause:	Age, water penetration
	Effect/Consequence:	Potential tripping hazard.
	Repair Recommendation:	Concrete patch
	Repair Timeframe:	Short Term

CIP-2: Damaged CIP Concrete at Threshold

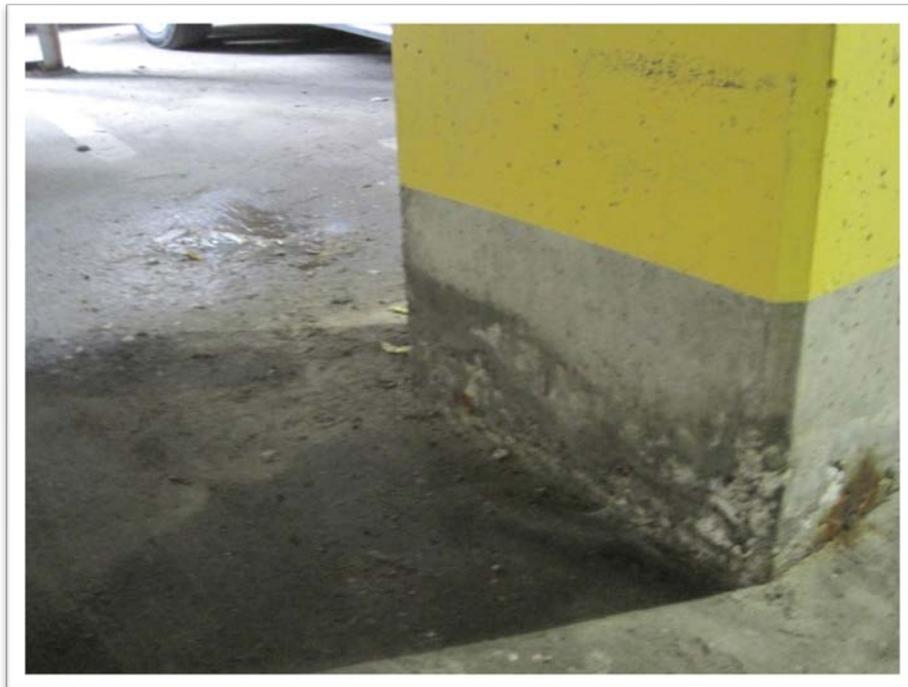
WCIP-1	Issue:	Surface water flow in Westlake Garage public parking level 2 travels adjacent to columns at drain locations
	Cause:	Original Design/Construction
	Effect/Consequence:	Over time this surface flow will erode the concrete columns at these locations.
	Repair Recommendation:	Install 2" grout chamfer around base of columns at drain locations. Roughen floor surface to ensure good bond between grout chamfer and floor.
	Repair Timeframe:	Mid Term

WCIP-1: Surface Flow against Westlake Garage Concrete Column

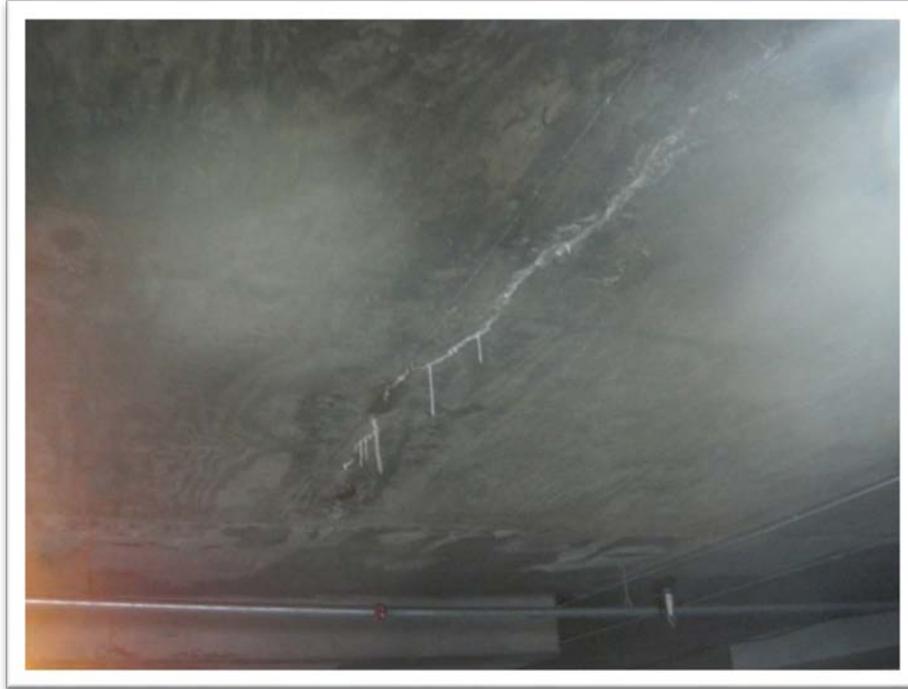
WCIP-2	Issue:	Crack in roof slab
	Cause:	Water penetration likely associated with the landscape masonry wall separating the paved drive from the landscaped terrace.
	Effect/Consequence:	Structural damage to roof slab concrete and reinforcing
	Repair Recommendation:	The roof needs to be exposed from above. A crack healer/sealer product should be installed at the crack from above. The roof condition should be assessed to determine if the wall is preventing drainage flow and remedied either with a new drain at this location or a tapered insulation below the roofing membrane to direct drainage flow. The membrane will need to be repaired at this location.
	Repair Timeframe:	Short Term

WCIP-2: Crack in Westlake Garage Roof Slab

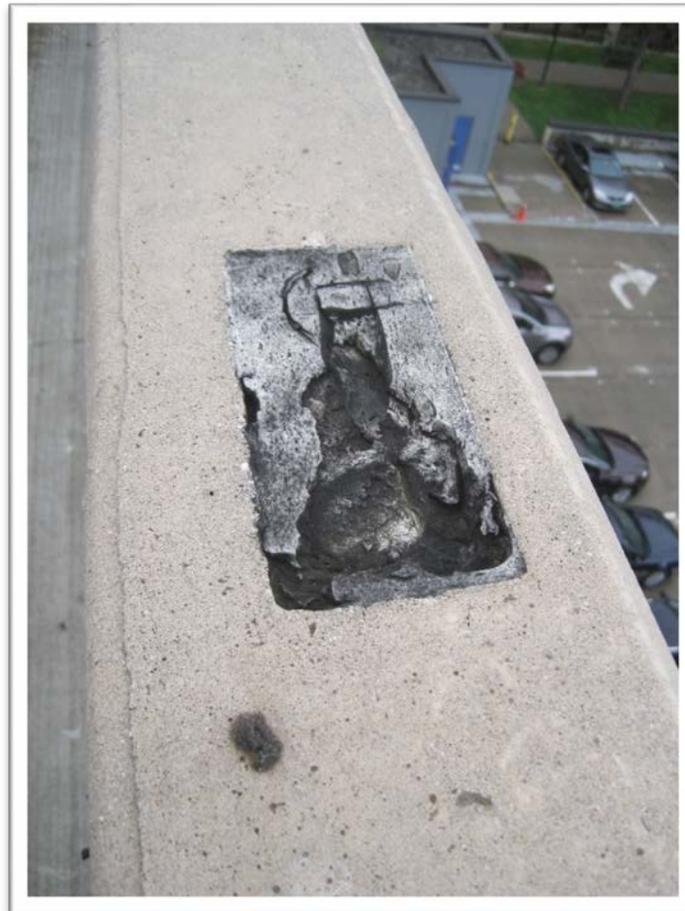
PC-1	Issue:	Missing lift anchor sealant patches.
	Cause:	Potential cause: Age or poor installation.
	Effect/Consequence:	Missing sealant patch allows water to pond and potentially cause internal damage to precast members
	Repair Recommendation:	Clean and reapply sealant patch.
	Repair Timeframe:	Mid Term

PC-1: Missing Lift Anchor Sealant Patch in Precast Spandrel Beam

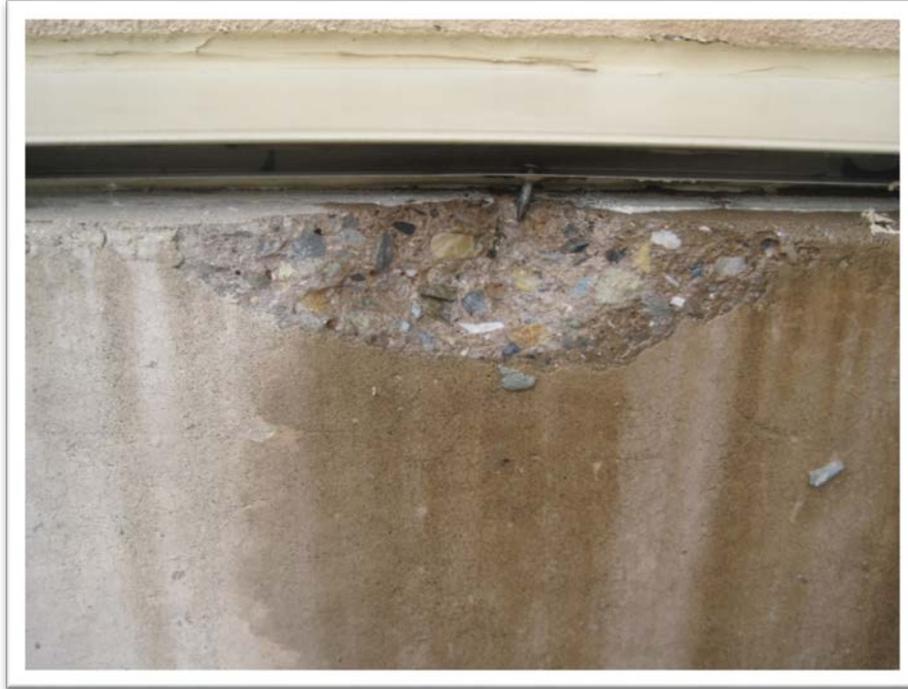
PC-2	Issue:	Minor spalls under flashing attachment. (Ramp 4/5)
	Cause:	Potential cause: Poor installation.
	Effect/Consequence:	Water can penetrate into beam cause potential flange reinforcement corrosion, and eventual extensive beam damage
	Repair Recommendation:	Surface grout patch. Remove spalled concrete, clean reinforcing steel, patch with approved grout.
	Repair Timeframe:	Mid Term

PC-2: Spalled Concrete at Top of Precast Spandrel Beam Under Flashing Attachment

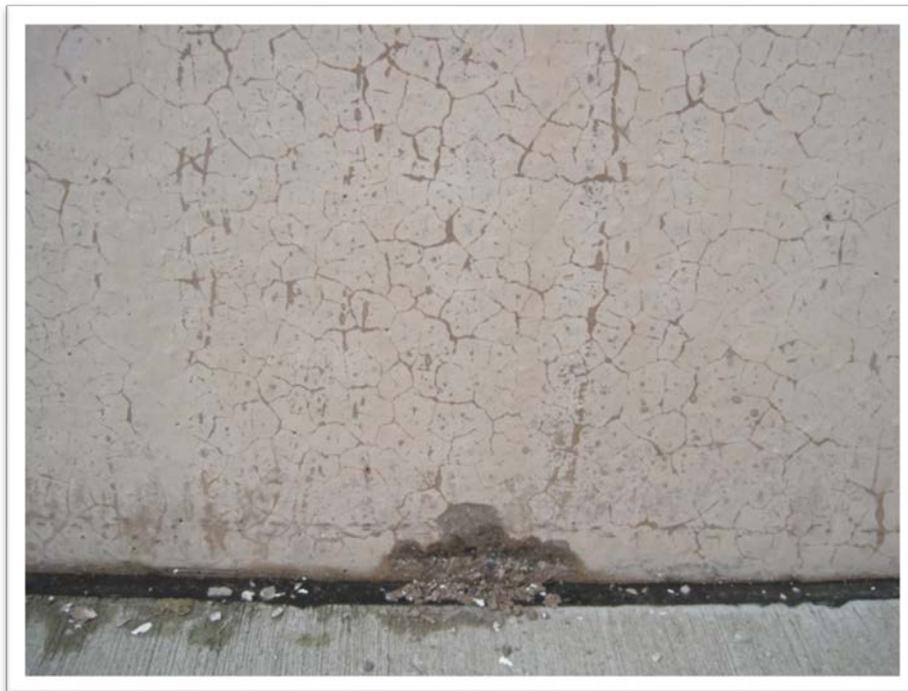
PC-3	Issue:	Spandrel Beam – Map Pattern Cracking (Level 5)
	Cause:	Sun exposure.
	Effect/Consequence:	Potential long term beam damage from crack widening and water penetration
	Repair Recommendation:	Routine application of penetrating sealer.
	Repair Timeframe:	See Maintenance Section of this Report

PC-3: Map Cracking in Precast Spandrel Beam on Level 5

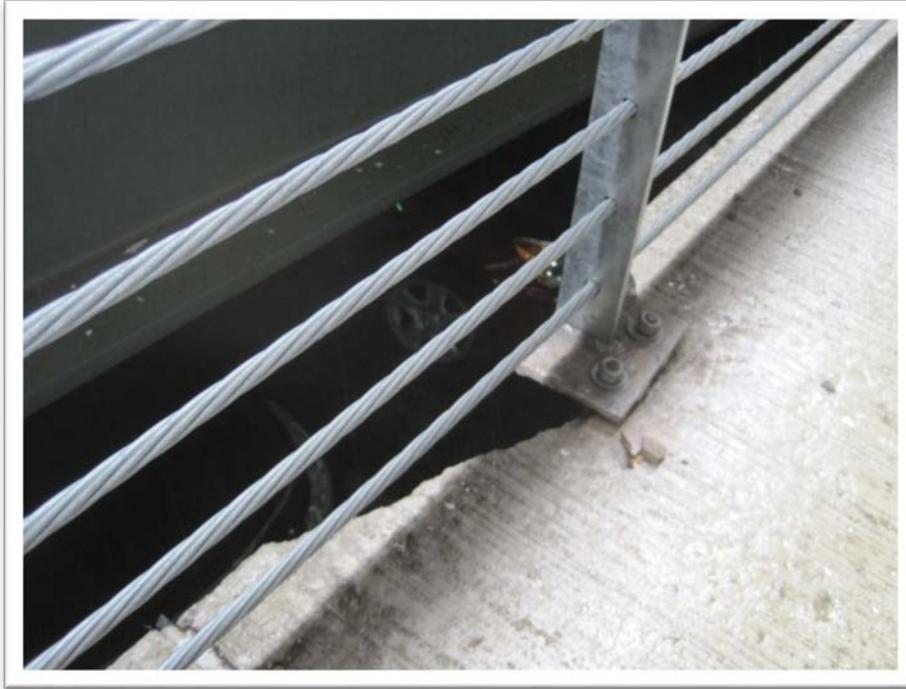
There is cable guardrail at grids B and B.1 all levels. In general the cable guardrail is in good condition however in at least two locations the rail post base plates had become detached from the Double-Tee beam and the concrete flange of the Double-Tee beam is damaged. The damaged concrete in the Double-Tee beam flange should be patched and the rail posts shall be reattached; it is suggested to shift the rail attachment location to outside of the patched concrete area and anchor into the existing Double-Tee beam flange.

CG-1	Issue:	Detached cable guardrail posts
	Cause:	Possible Cause: Collision or improper installation.
	Effect/Consequence:	Cable guardrail at damaged locations is less effective with missing posts. Potential for additional posts to become detached in the event of a collision.
	Repair Recommendation:	Patch damaged concrete in Double-Tee beam flange. Reattach posts.
	Repair Timeframe:	Short Term

CG-1: Damaged Cable Guardrail Connection

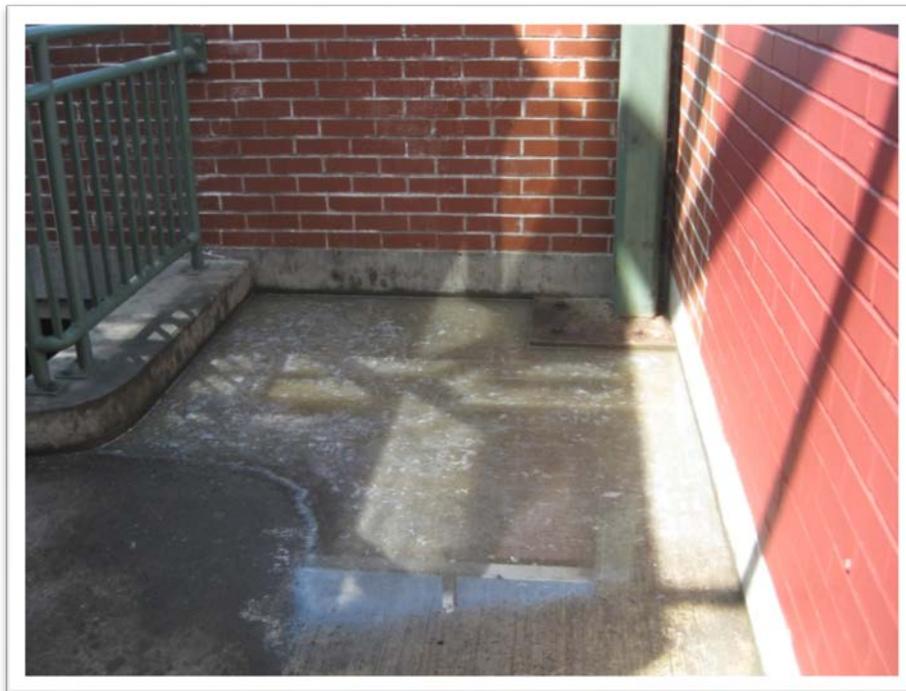
OP-1 Standing Water at East (Macy's) Stairwell Roof Enclosure

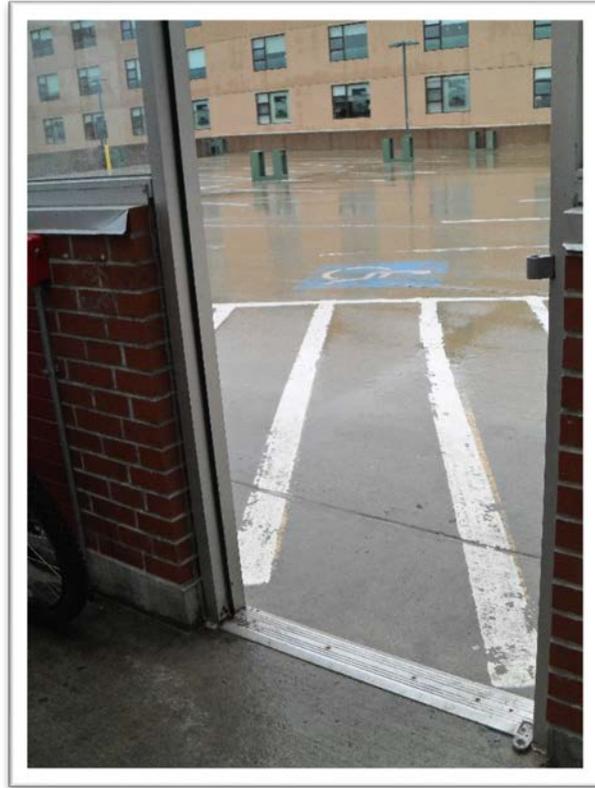
ST-1: Entrance to Stair Tower on Roof Level

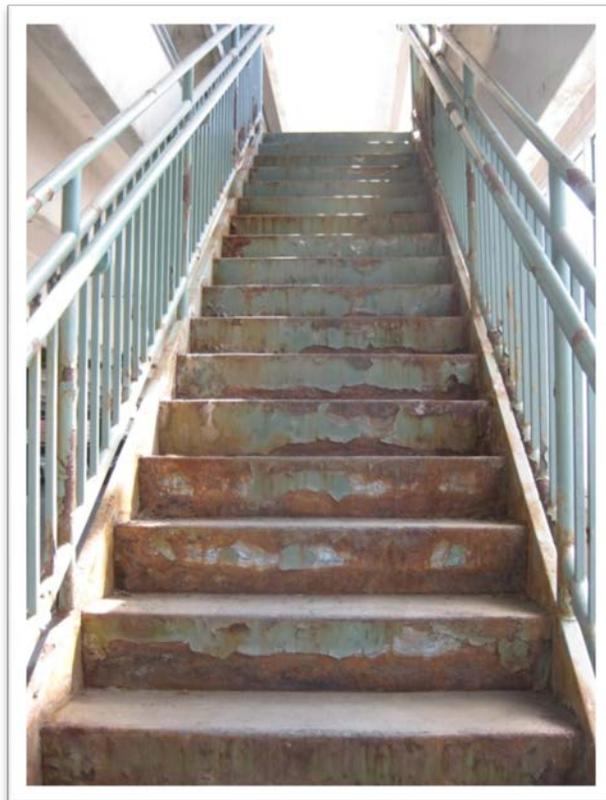
ST-2: Southwest Stair Corrosion and Rust

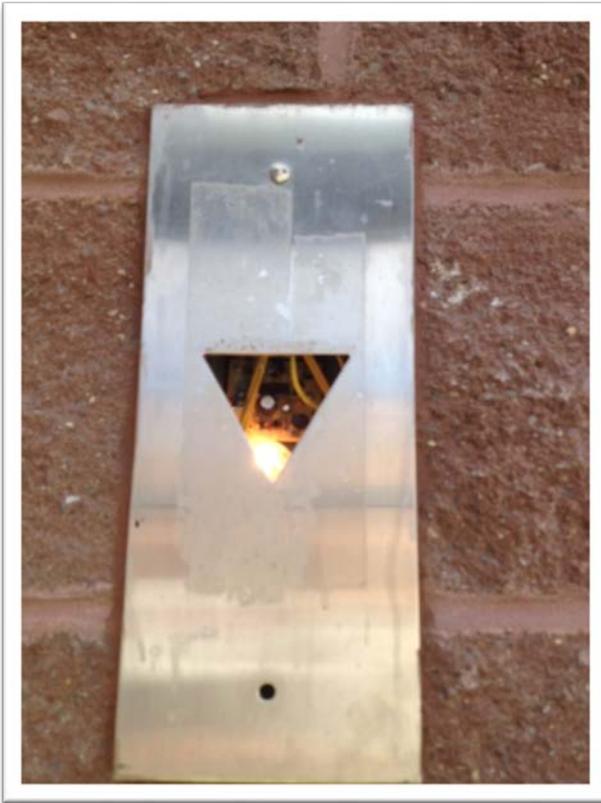
ST-3: Elevator Indicator light Glass is Broken

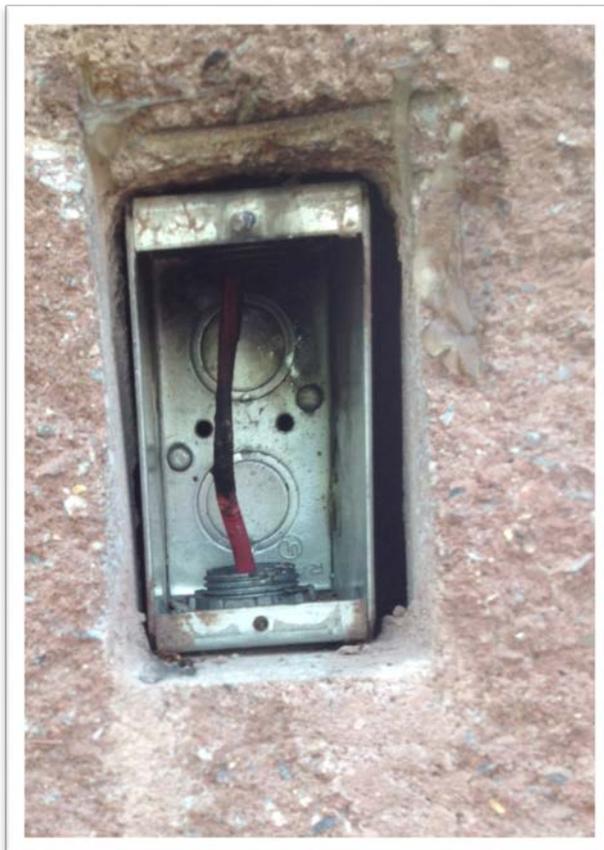
ST-4: Multiple Electrical Box Covers at Stairs Have Been Vandalized / Removed & Contents Burned.

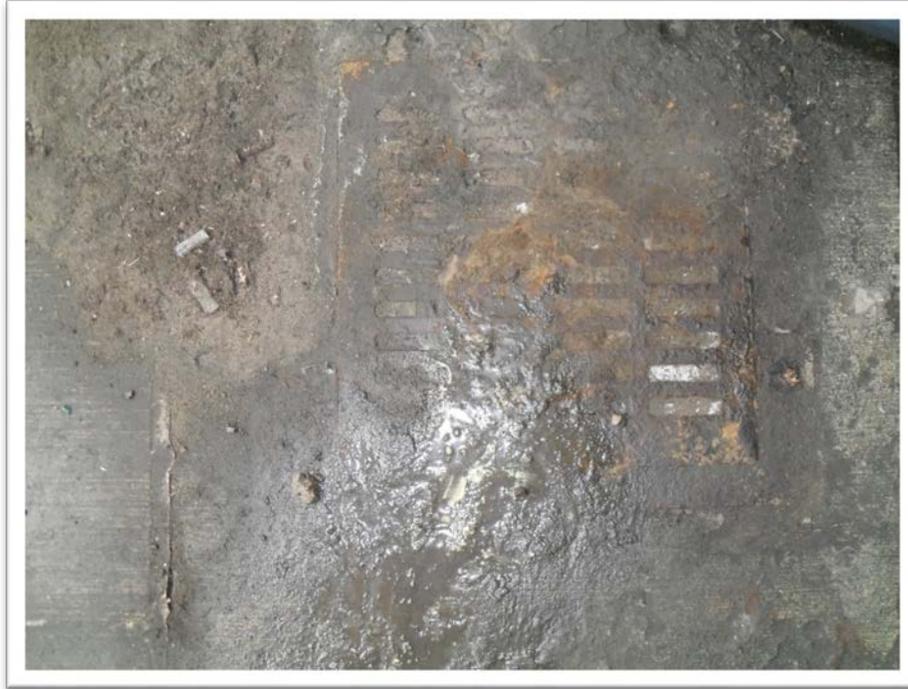
SD-1: Plugged Drain

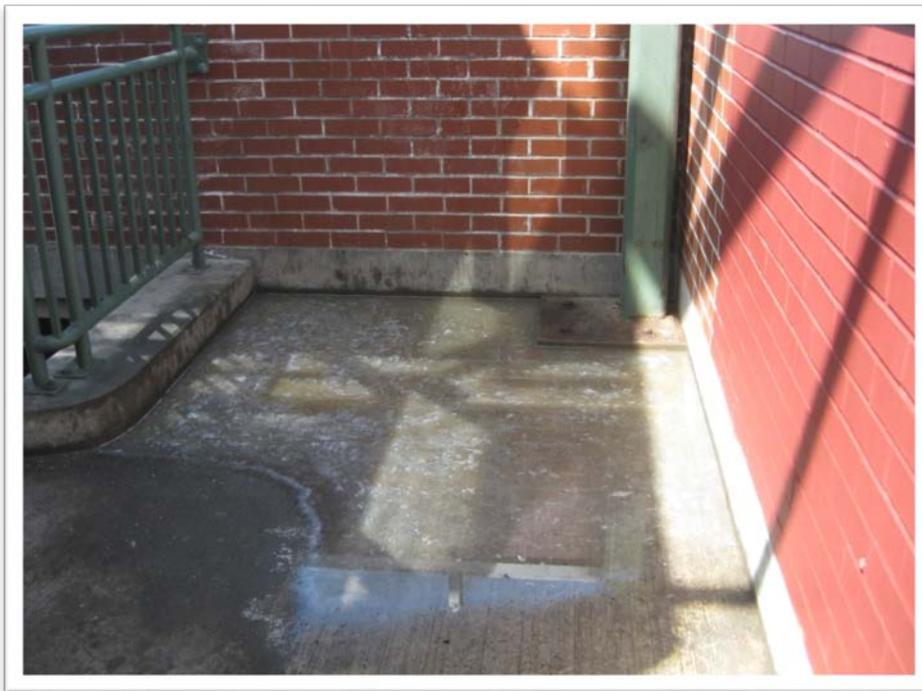
SD-2: Ponding Water Not Reaching Existing Drain (Elevator Stair Tower at Roof Level)

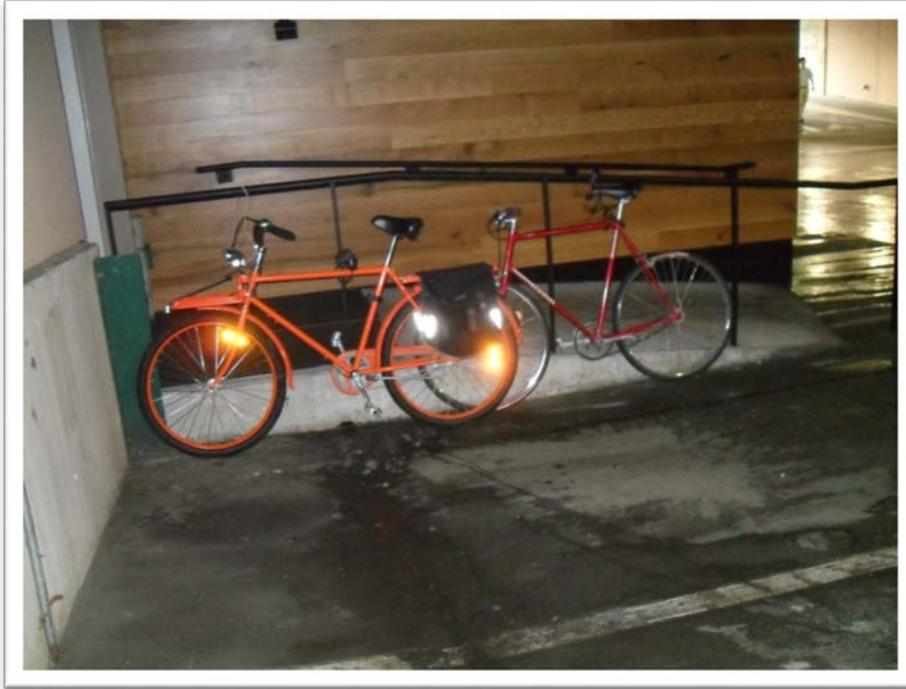
SD-2: Drain at Bottom of Ramp at Hotel Vermont

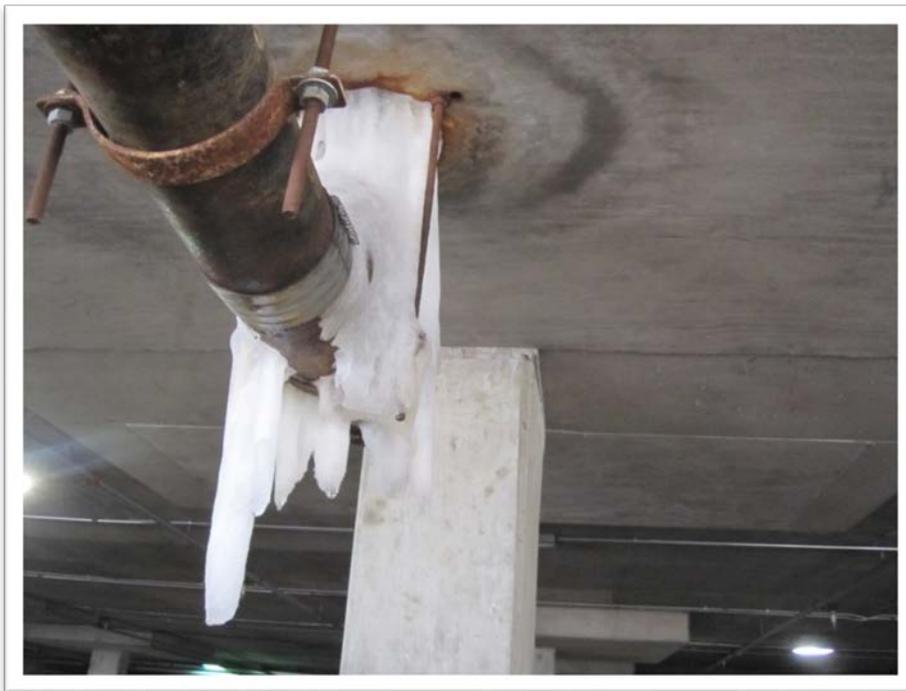
WSD-1: Leaking at Roof Drain Locations
