# JOSEPH S. ZAJCHOWSKI

September 19, 1991

RE: Memorial Auditorium Weathering Analysis

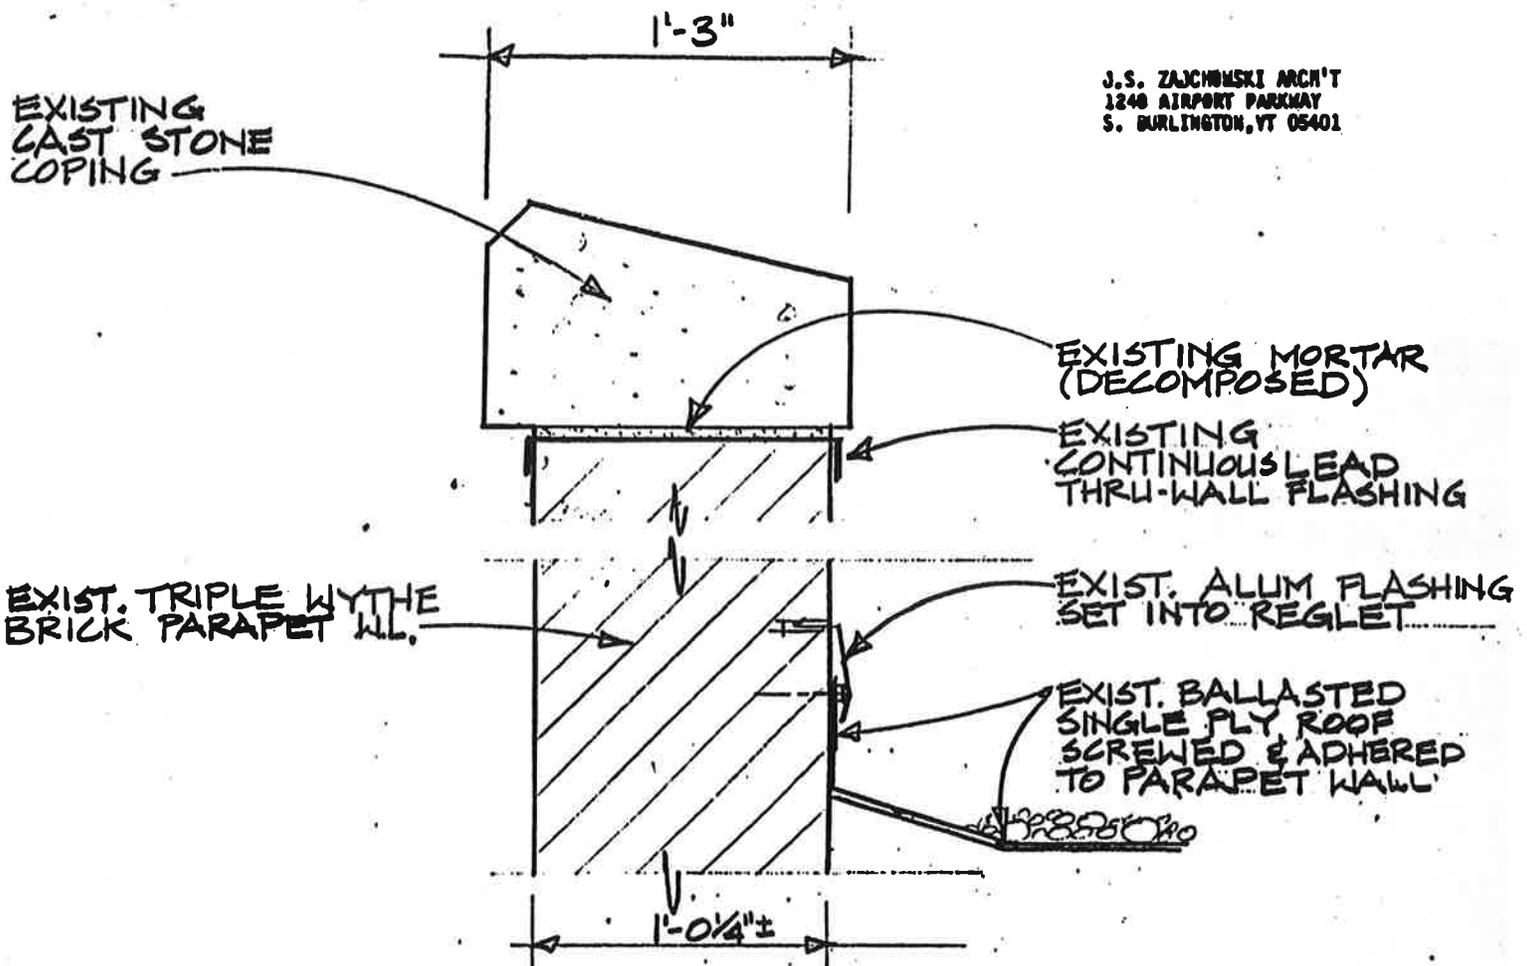
**(A) TYPICAL PARAPET WALL**  
SCALE: 1/2" = 1'-0"

- Parapet wall is constructed of solid brick and is a nominal 12" thick wall. (Photo 1 and 2, and Sketch A ).
- Wall is capped with a continuous through wall lead cap flashing turned down approximately 1 1/4" at each face of wall, creating a drip edge. (Sketch A and B ).

- The through wall flashing is continuous over entire parapet, that is over both horizontal and vertical planes of parapet. It is jointed by interlocking U joints forming a continuous piece.

- Re-set all cast stone coping and repair pieces that are damaged.
- Repair all portions of cast stone bands that are decomposed.
- Re-mortar all joints in cast stone coping and bands and seal with a long life sealant.
- Re-point any masonry mortar joints that require pointing.
- Replace steel lintels whose condition dictates replacement.
- Replace or repair steel windows as necessary - many are rusted, many are leaking.
- After cleaning all masonry by a non abrasive cleaning method, seal all masonry and cast stone with a water repellent coating.
- Perform corrective work to single ply roofing, especially at wall flashing where material is pulling away from wall attachment.

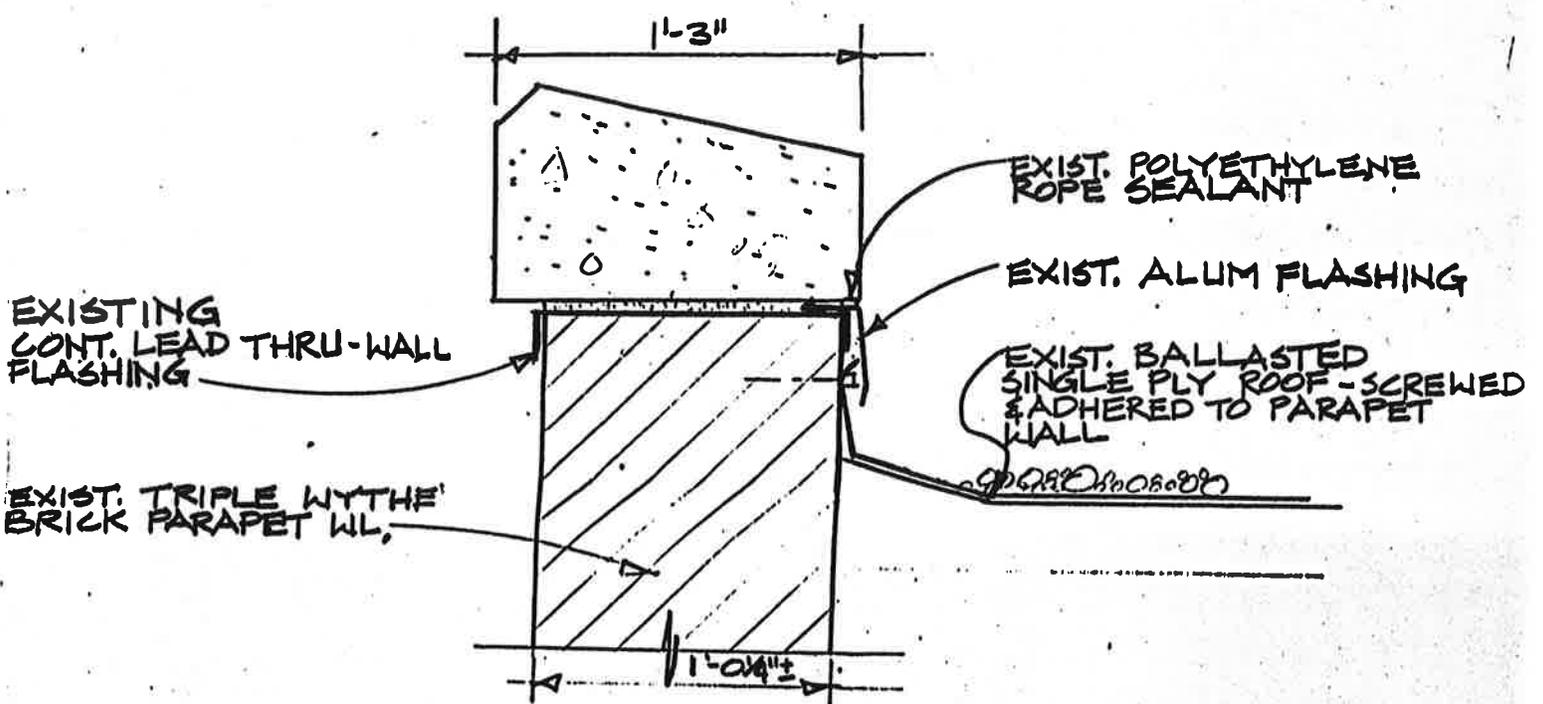
**(B) TYPICAL LOW PARAPET WL. - SOUTH SIDE**  
SCALE: 1/2" = 1'-0"

- In nearly all instances the joints between sections of coping were in very poor condition, with deteriorated mortar, and those that had been caulked, with split caulking and poor improper caulking. (Photo 5 and 6 ).
- At the coping removed at the south wall, the aluminum counter flashing installed during the single ply roofing installation had been placed over the lead through wall flashing. This would allow water seeping through the coping and coping joints to run down behind the single ply roofing where it has pulled away from the building wall. (Sketch B and Photo 7 ).
