Re: Memorial Auditorium Restoration

Memorial Auditorium 08

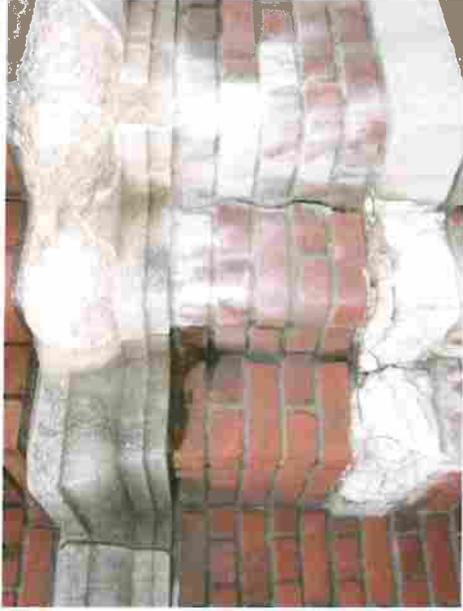
This structure suffers from sever neglect, and several architectural details that are now resulting in large quantities of water damage in the forms of liquid, ice and rust. Water saturation of the masonry has been allowed to make long-term contact with the unprotected structural steel elements imbedded in the masonry walls and pylons, including I-beams and angle iron window lintels resulting in high-pressure expansion and sever masonry failure of the surrounding areas. The results are large portions of the masonry pylons and pre-cast stone cornice detail becoming unstable fall hazards. (See **photo 1**)

Photo #1
Masonry fall hazards

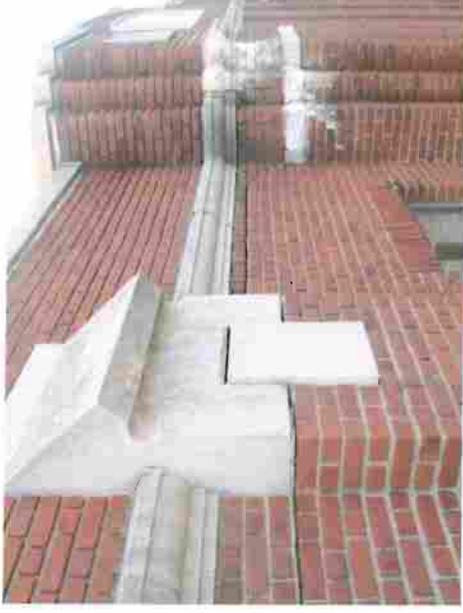
are the main pylons and top level window header areas, and the masonry above these areas including the pre-cast cornice and copping stones at the top of the parapet wall at the roof level. (See photo 2, 3)

Photo #2
Unstable masonry window
headers masonry above
including pre-cast stone

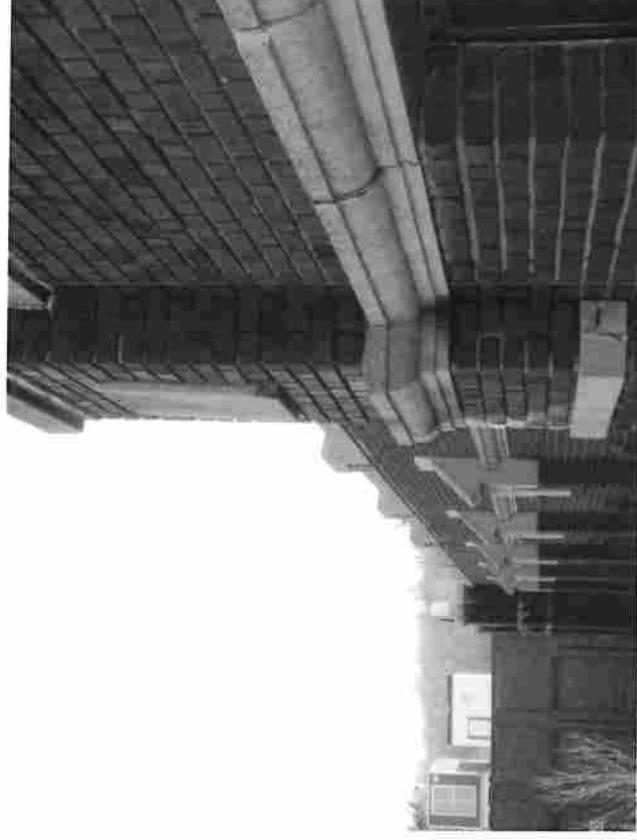
Photo # 3

North side

Unstable pre-cast stone and brick

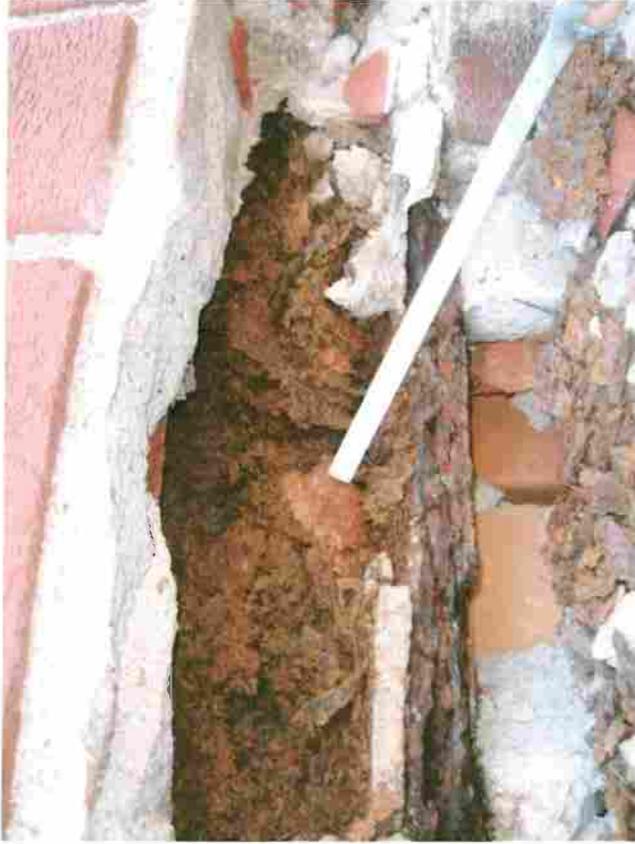
Photo # 4

Expanding rust of an embedded horizontal I-beam unit (See photo 4) that ties the main roof truss system together at the top has pushed the upper 10' (+/-) masonry $\frac{3}{4}$ inch up from its original position. This has produced a continuous opening that runs the length of the building on both the north and south elevations from pylon #2 to pylon #9 as indicated on the drawings. (See photo 5) In addition to this, each pylon that contains vertical steel I-beam has corroded/rusted from the top down approximately 15 feet through the pylon, resulting in masonry failure in the form of a large vertical fracture through the center of each pylon. (See photo 6)

North side

Rusted horizontal I-Beam

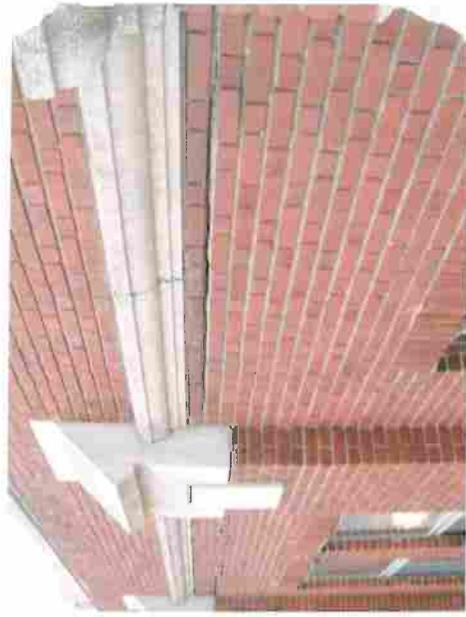
Photo # 5 rusted I-Beam lifting masonry

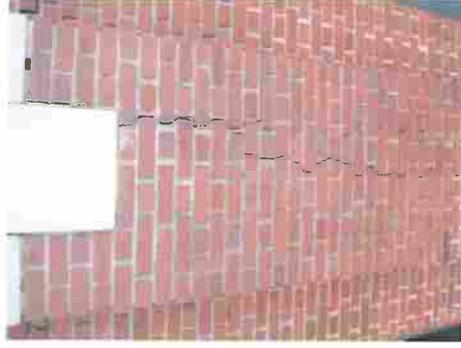
Photo #6 vertical crack in each pylon, caused by rusting vertical I-Beam

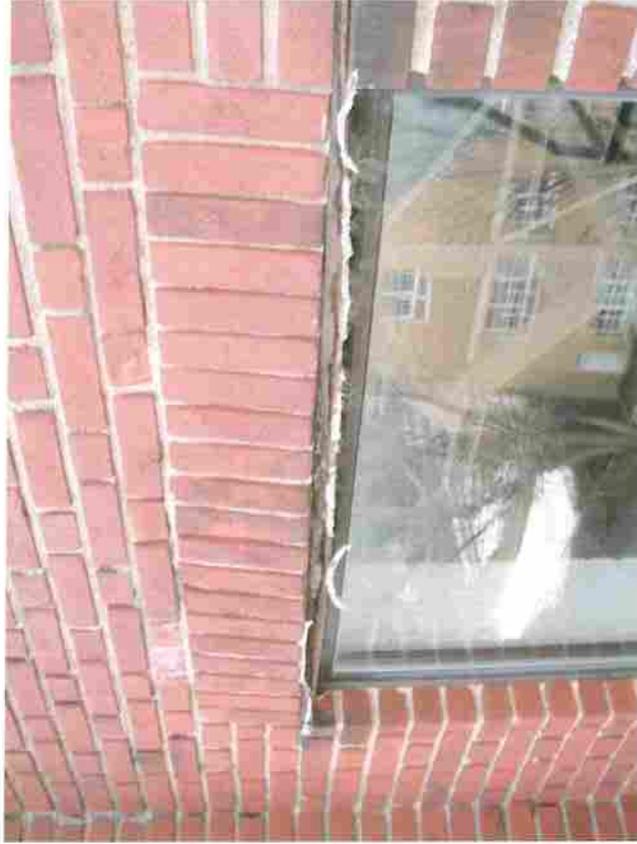
Photo #7

Additionally, the window lintels at the top floor have severe corrosion damage and are exerting destructive pressure on the window units and have caused the complete masonry failure of the header course over each window and these failed brick units and those above them are an immediate fall hazard. (See photo 7)

Rusted window lintel Failing masonry header
