Assessment of City Parking Garage Structures Marketplace Garage

Hoyle, Tanner
& Associates, Inc.

Prepared for:
City of Burlington, Vermont

July 2014

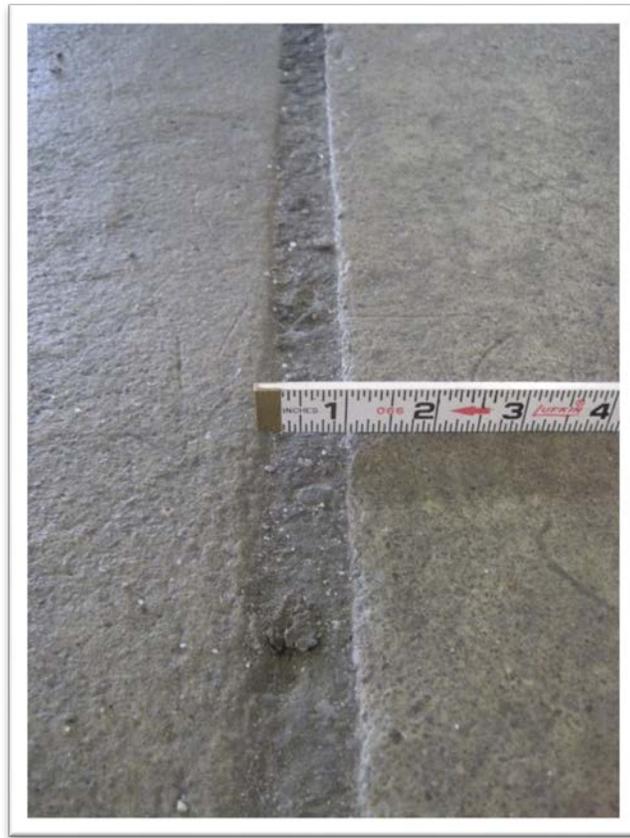
JS-2	Issue:	Joint Sealant Failure at Levels 1, 2 and 3.
	Cause:	Service Life Expired.
	Effect/Consequence:	See JS-1.
	Repair Recommendation:	See JS-1.
	Repair Timeframe:	Short Term

JS-2: Construction Joint Sealant Failure

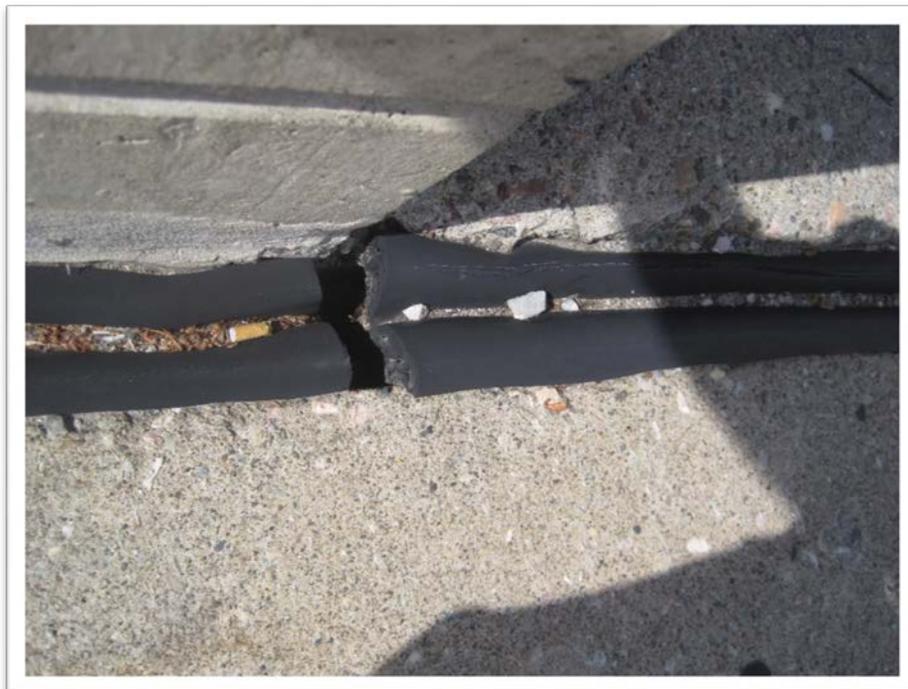
EJ-1	Issue:	Expansion Joint Failure at Cross Over (Column Line C9-D)
	Cause:	Age, Debris Buildup.
	Effect/Consequence:	Water penetration causing damage to structural elements below.
	Repair Recommendation:	Remove and repair all unsound concrete at joint location and replace all expansion joints (all levels) in kind. Alternatively, replace with in-kind joint that includes asphaltic concrete seal. This involves grinding the concrete surface to create a block out that will accommodate an asphaltic concrete nosing.
	Repair Timeframe:	Short Term
EJ-2	Issue:	Expansion Joint Failure at Transition Between Slab on Grade and Elevated Slab Sections (Column Line E10 – E8 on the first level and B9 – C11 on the second level).
	Cause:	Age, Debris Buildup.
	Effect/Consequence:	See EJ-1.
	Repair Recommendation:	See EJ-1.
	Repair Timeframe:	Short Term
EJ-3	Issue:	Expansion Joint Failure at Transition Between Stair Tower Ramps and Parking Garage at All Three Stair Towers

EJ-1: Expansion Joint Failure at Level 5

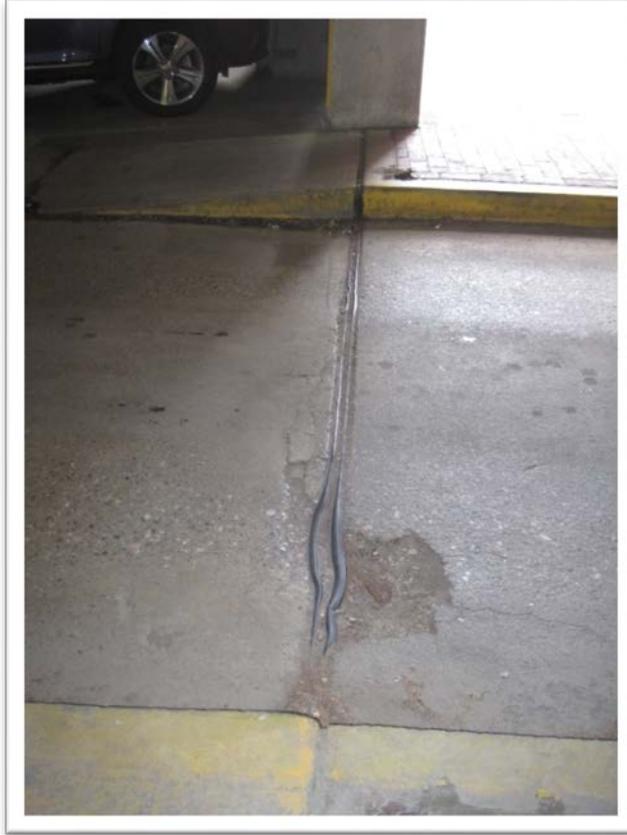
Cause:	Age, Debris Buildup.
	Effect/Consequence:	See EJ-1.
	Repair Recommendation:	See EJ-1.
	Repair Timeframe:	Short Term

EJ-2: Expansion Joint Failure at Transition to Elevated Slab

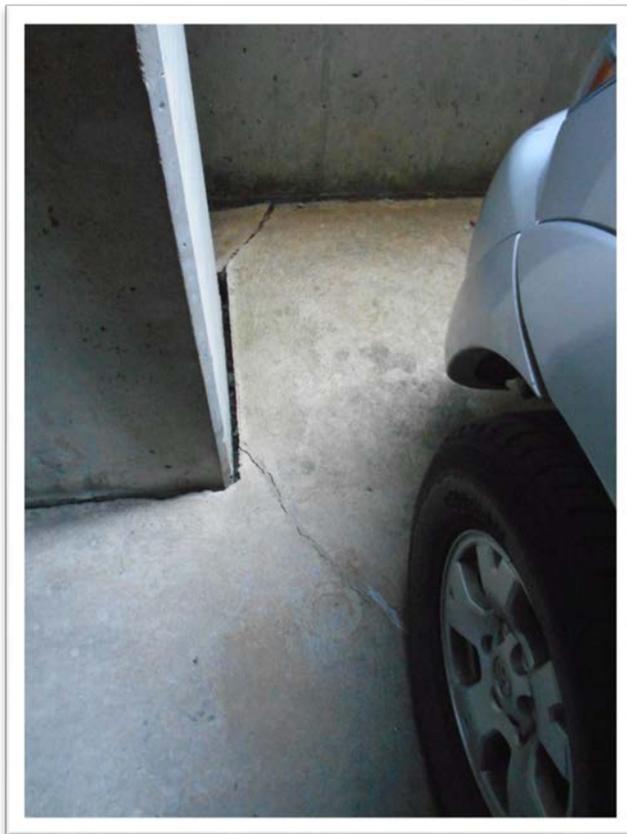
CIP-1	Issue:	Slab-On-Grade Surface Cracks
	Cause:	Differential settlement of the slabs and natural concrete aging processes such as shrinkage and creep.
	Effect/Consequence:	Susceptibility for water infiltration and reinforcing corrosion.
	Repair Recommendation:	Route cracks to a v-notch shape and seal with a silicone based joint sealant.
	Repair Timeframe:	Mid Term (unsealed cracks) Long Term (sealed cracks)

CIP-1: Slab on Grade Cracks

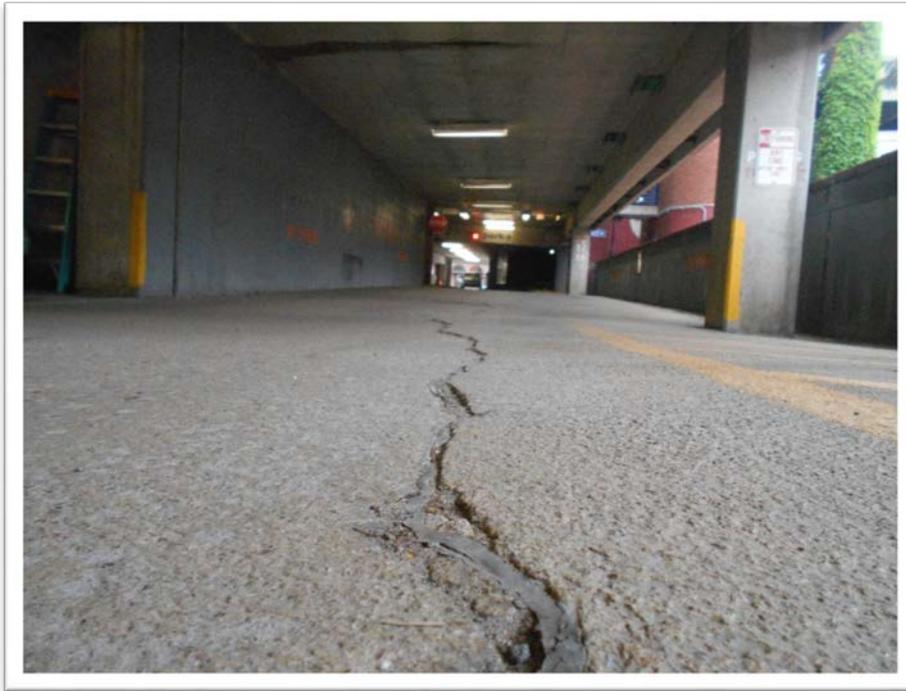
CIP-2	Issue:	Surface Cracks at Entrances
	Cause:	Differential settlement of the slabs and natural concrete aging processes such as shrinkage and creep. Heavy Traffic and corrosive salts.
	Effect/Consequence:	Susceptibility for water infiltration and reinforcing corrosion.
	Repair Recommendation:	Grind protruding edges of slabs to decrease elevation difference, route cracks to a v-notch shape and seal with a silicone based joint sealant. Long term should consider more extension portions of slab replacement.
	Repair Timeframe:	Short Term

CIP-2: Surface Cracks at Cherry Street Entrance

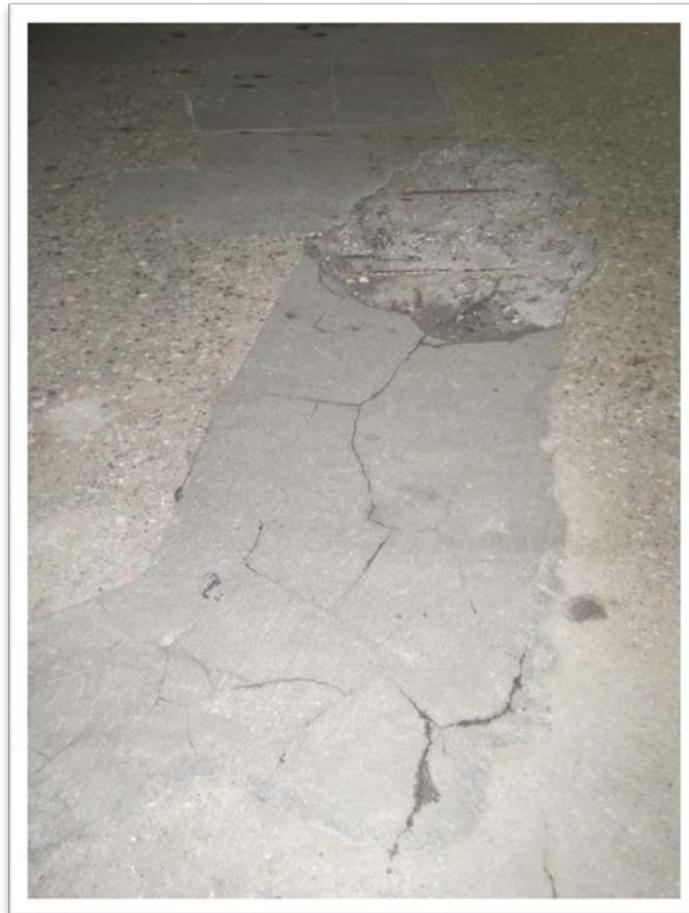
CIP-3	Issue:	Concrete Spalls With Exposed Reinforcing Steel.
	Cause:	Typically associated with rebar corrosion / expansion.
	Effect/Consequence:	Water can penetrate into the slab to cause more extensive beam damage to reinforcing and post tensioning stands. Over time, these spalls compromise the structural integrity of the slab. Spalls also present a hazard to pedestrians and vehicles.
	Repair Recommendation:	Fill spalls with asphalt cold patch prior to completing short term repairs (see CS-5 and CS-6) to limit the ingress of water and prevent further damage to reinforcing and post tensioning tendons.
	Repair Timeframe:	IMMEDIATE

CIP-3: Concrete Spall with Exposed Rebar (Level 1, D_E Ramp)

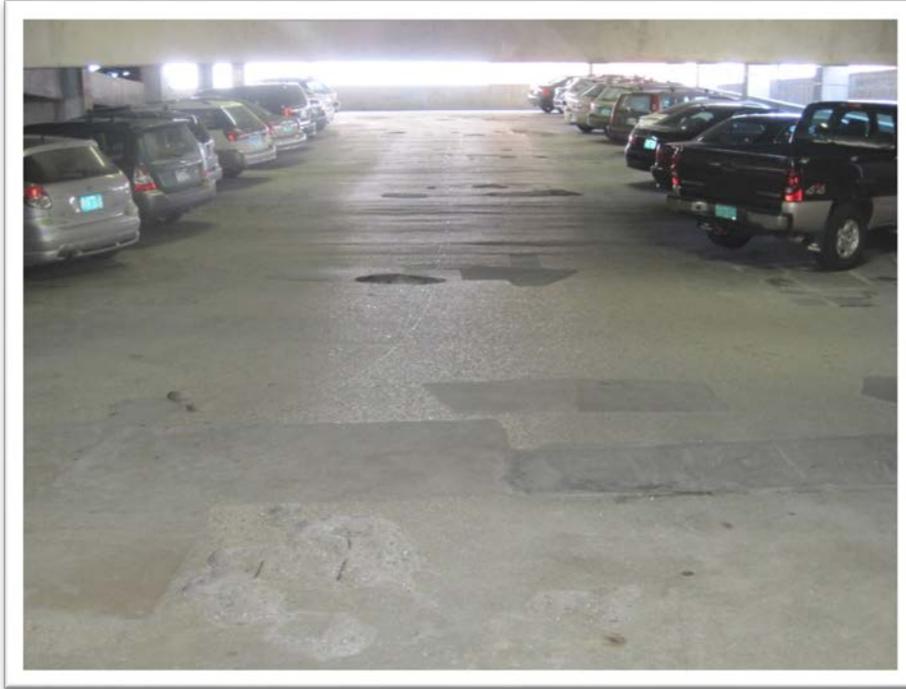
CIP-3: Level 1 D-E Ramp Spalls and Patching

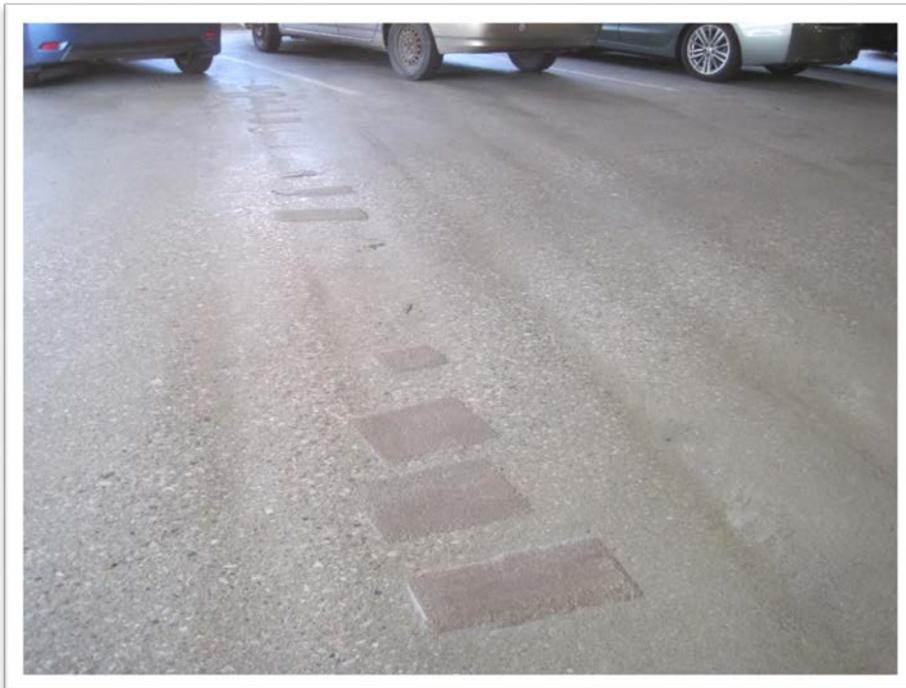
CIP-5	Issue:	Level 1 D-E Ramp, Level 1-2 Crossover and Level 2 E-F Ramp Spalls.
	Cause:	Typically associated with rebar corrosion / expansion.
	Effect/Consequence:	Water can penetrate into the slab to cause more extensive beam damage which over time will compromise the structural integrity of the slab.
	Repair Recommendation:	Removal all patches, chip out all surface concrete to a depth of 1"-2" over a width of 30' centered on the ramp and re-pour the concrete surface. Note: Contractor to take caution during slab removal and protect embedded electrical service and PT strands
	Repair Timeframe:	Short Term

CIP-5: Typical Elevated Ramp Spalls over Beam Line

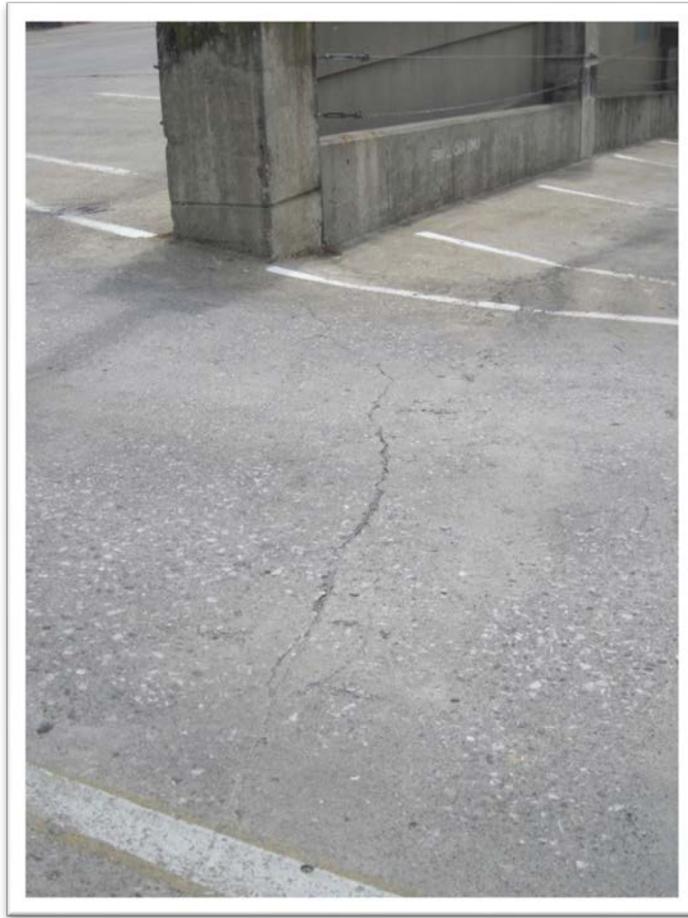
CIP-7	Issue:	Longitudinal and Transverse Cracking of Elevated Slabs.
	Cause:	Potential causes: natural aging of concrete including shrinkage and creep, quality control issues during original construction
	Effect/Consequence:	Water can penetrate into the slab to cause more extensive slab damage which over time will compromise the structural integrity of the slab.
	Repair Recommendation:	Route cracks to a v-notch shape and seal with a silicone based joint sealant.
	Repair Timeframe:	Short Term

CIP-7: Cracking at 4th Level at Column Line B

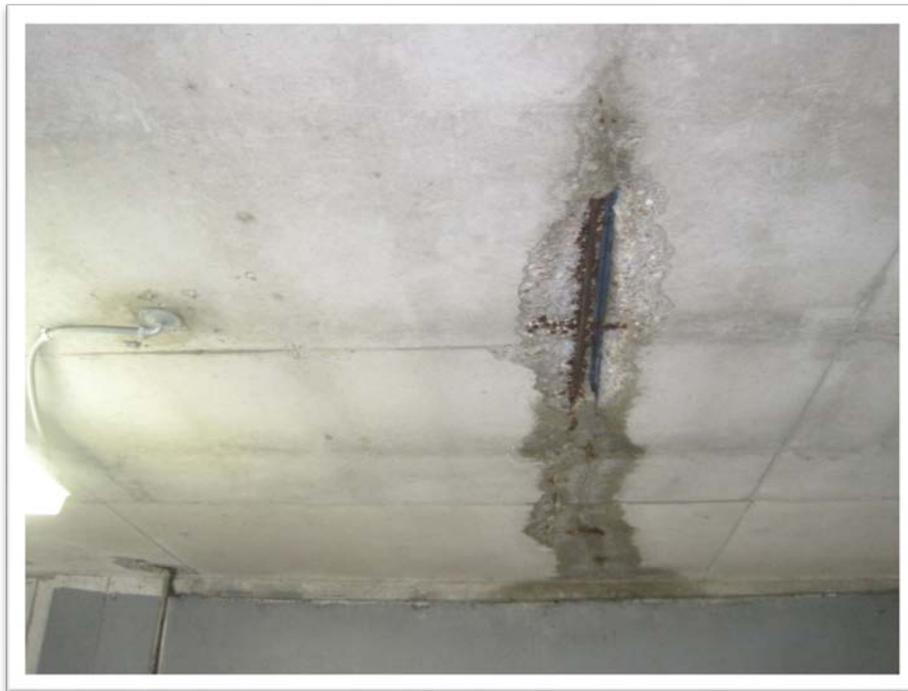
CIP-8	Issue:	Concrete Spall and Exposed Post Tensioning Tendon at Bottom Face of Slab at B7 – B9 on the Second Level.
	Cause:	Concrete cracking above has allowed water to infiltrate the slab and corrode the reinforcing steel.
	Effect/Consequence:	Spalling of the slab and eventual corrosion of the post tensioning strands.
	Repair Recommendation:	From Above: Route cracks to a v-notch shape and seal with a silicone based joint sealant above. From Below: Chip out deteriorated concrete, install headed screws into slab form up a 6" deep repair "beam" and inject self-consolidating concrete (SCC) into cored ports through the existing slab (include vent locations as well).
	Repair Timeframe:	Short Term

CIP-8: Exposed Post Tensioning Strand

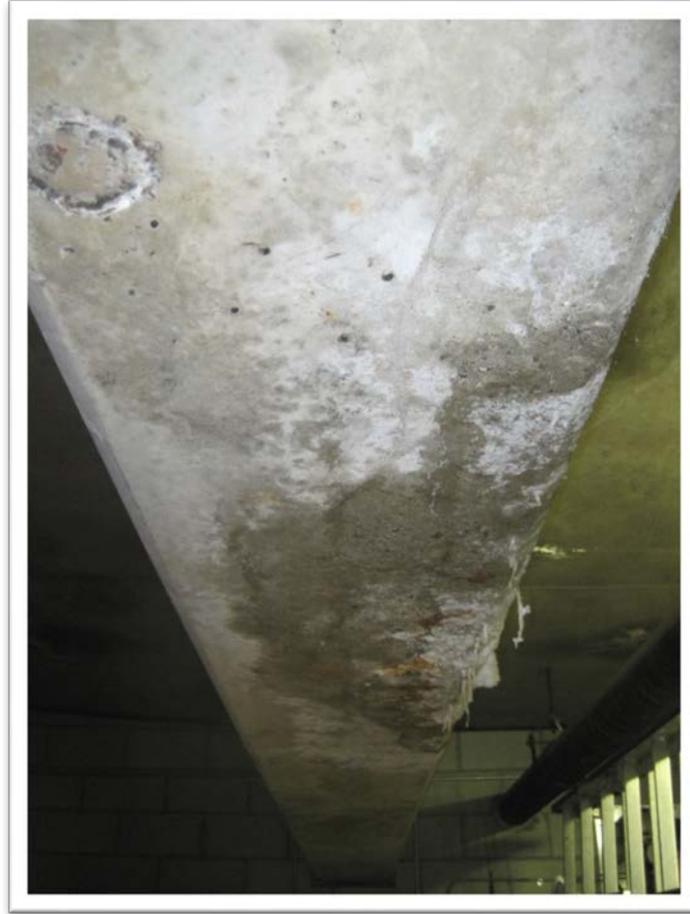
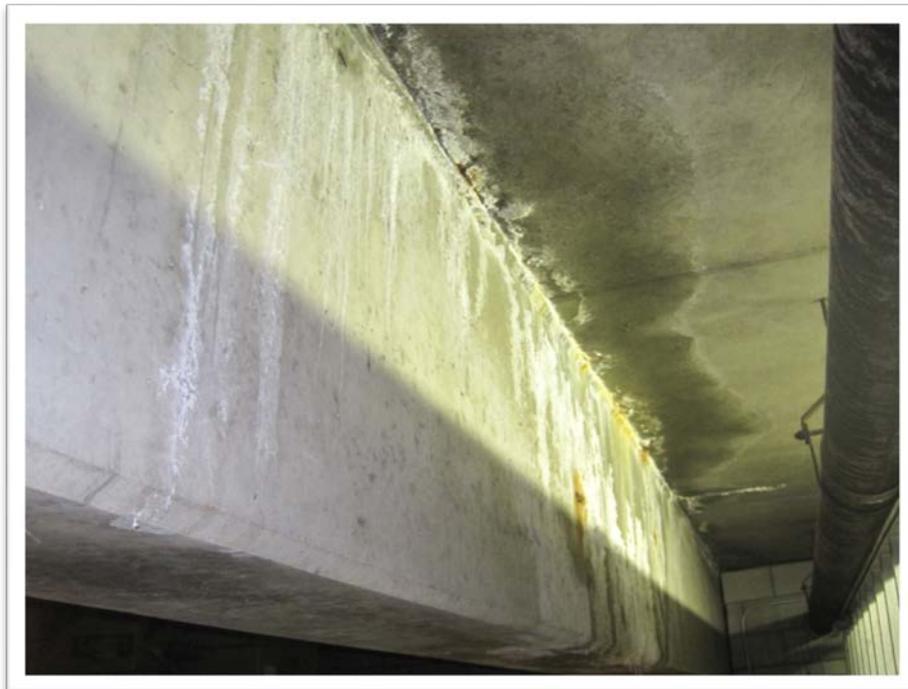
CB-1	Issue:	Delaminated Concrete, Reinforcing Steel Corrosion at Level 1 Grid E-F Beams 6 and 8
	Cause:	Failed expansion joint above, high vehicular traffic, slab deterioration above.
	Effect/Consequence:	Reduced beam capacity.
	Repair Recommendation:	Remove sections of delaminated concrete. Wire brush and coat reinforcing steel, patch repair area with a high strength concrete patching material, wrap beam with fiber reinforced polymer to increase beam capacity.
	Repair Timeframe:	Short Term

CB-1: Level 1 Beam E-F 8

CB-1a: Level 1 Beam E-F 8

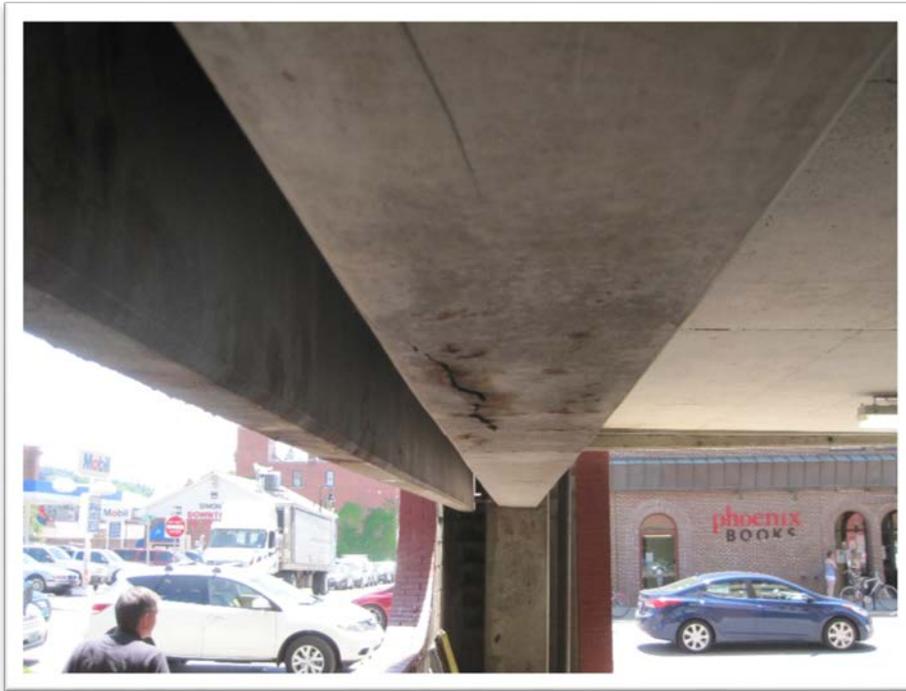
CB-2	Issue:	Longitudinal Crack at Midspan of the Beam at Level 2 Grid E-F Beam 10
	Cause:	Failed joint at interface between stair ramp and garage above causing water leakage.
	Effect/Consequence:	See CB-1.
	Repair Recommendation:	See CB-1.
	Repair Timeframe:	Short Term

CB-2: Longitudinal Crack in Level 2 Beam E-F 10

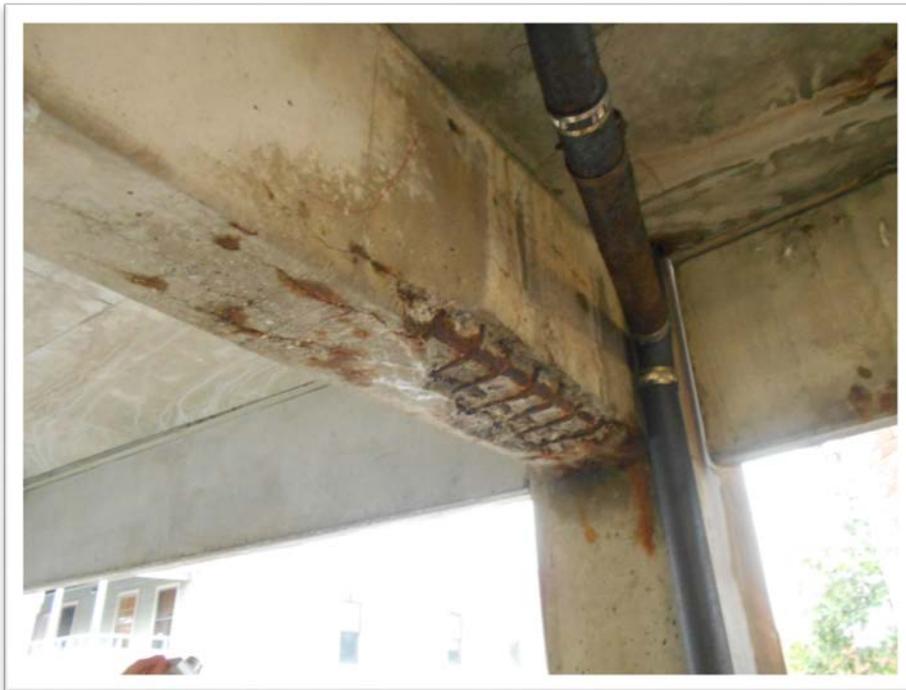
CB-3	Issue:	Concrete Spalls and Reinforcing Steel Corrosion at the End of the Beam, at Level 2 Grid A-B Beam 9
	Cause:	Water leakage from roof drainage (See SD-3)
	Effect/Consequence:	See CB-1.
	Repair Recommendation:	See CB-1.
	Repair Timeframe:	Short Term

CB-3: Concrete Spall and Reinforcing Steel Corrosion at End of Beam (2nd Level Beam at A-9)

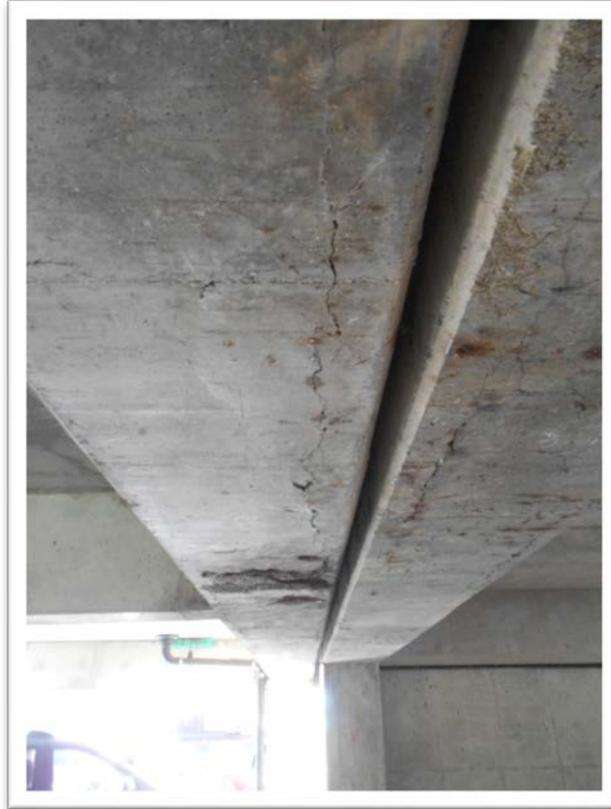
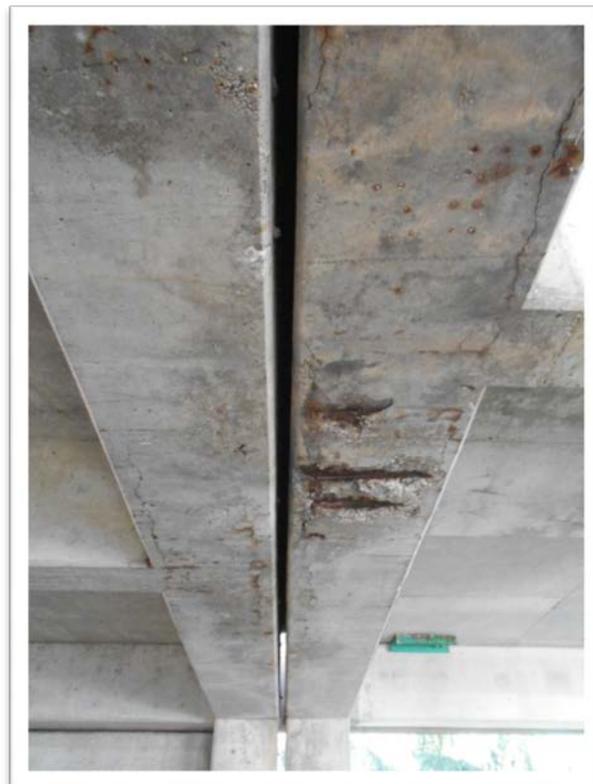
CB-4	Issue:	Concrete Delamination and Reinforcing Steel Corrosion Along Length of the Beam at Level 5 Grid C9-D Beams
	Cause:	Leaking Expansion joint above.
	Effect/Consequence:	See CB-1.
	Repair Recommendation:	See CB-1.
	Repair Timeframe:	Short Term

CB-4a: Concrete Spalls and Corrosion at 5th Floor Expansion Joint

CB-4b: Concrete Spalls and Corrosion at 5th Floor Expansion Joint

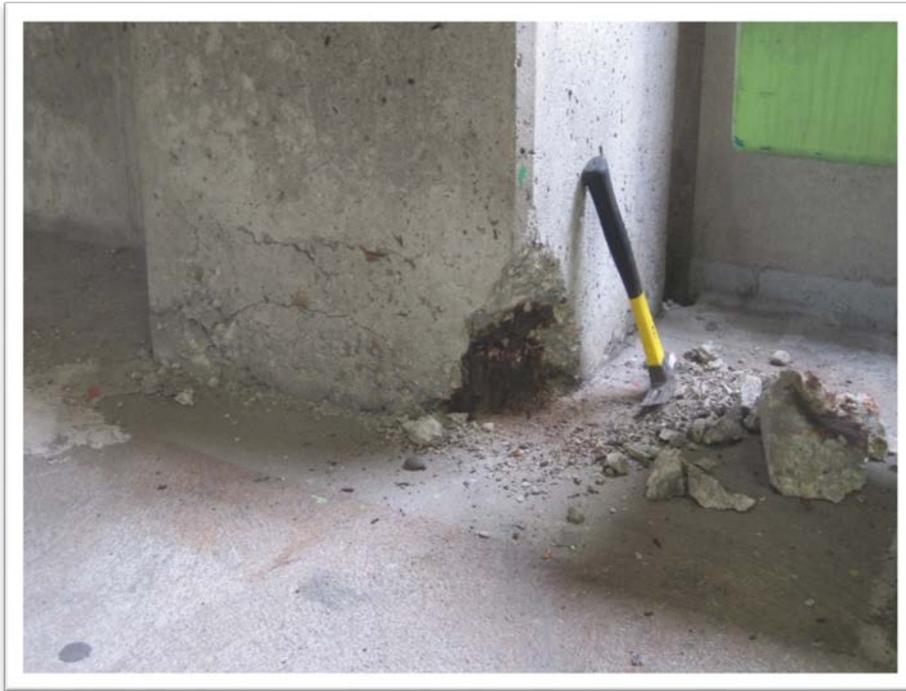
concrete had to be dropped into the forms from a height equal to the level above. During our inspection, we observed many corner spalls at the interface of the column and the slab due to segregation of the concrete at the time of placement. In total, we observed 11 instances of this spalling at the base of the columns.

CC-1: Typical Column Spall at Slab Interface

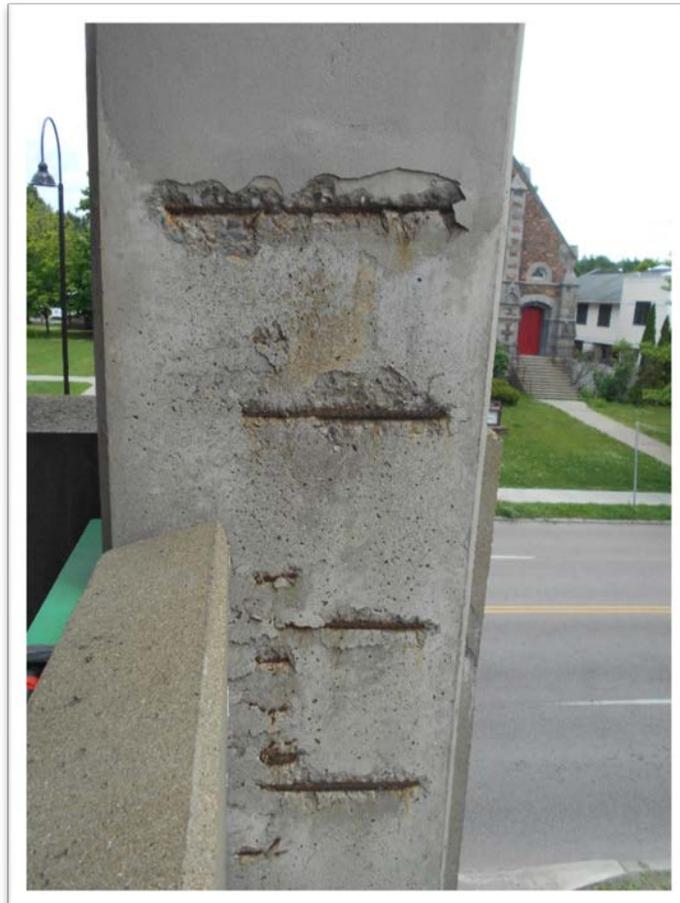
CC-2: Exposed Reinforcing Steel (3rd Level Column C-16)

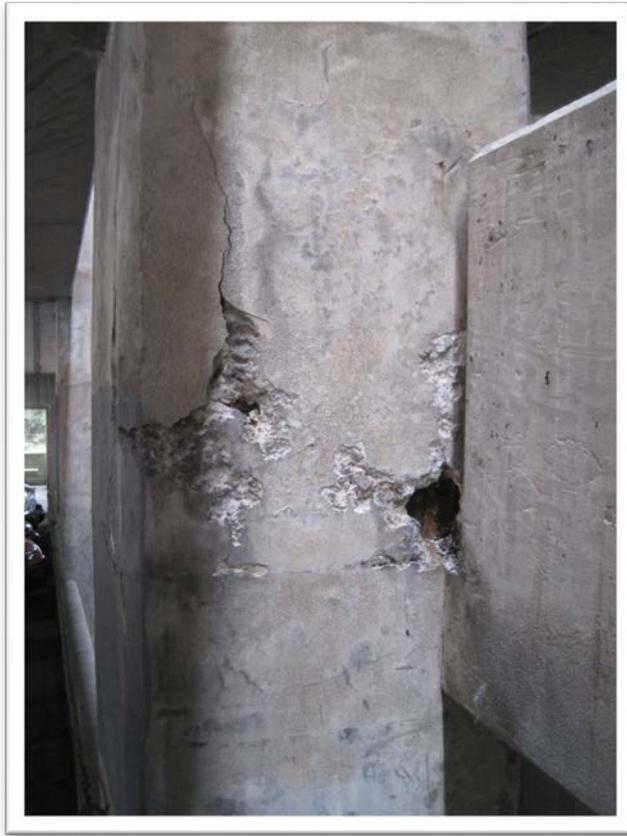
CC-3: Concrete Spalls at Construction Joint (2nd Level Column E-4)

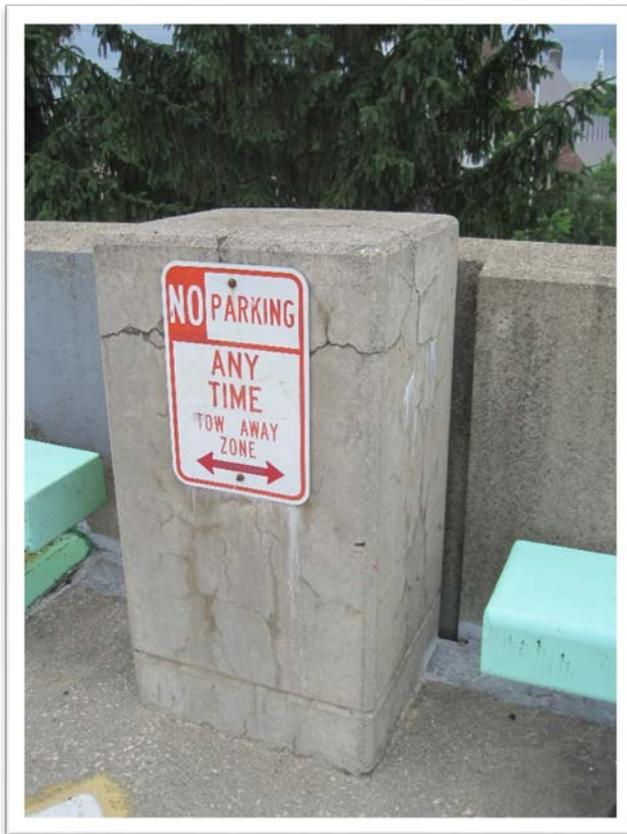
CC-4: Typical Top of Column Cracking

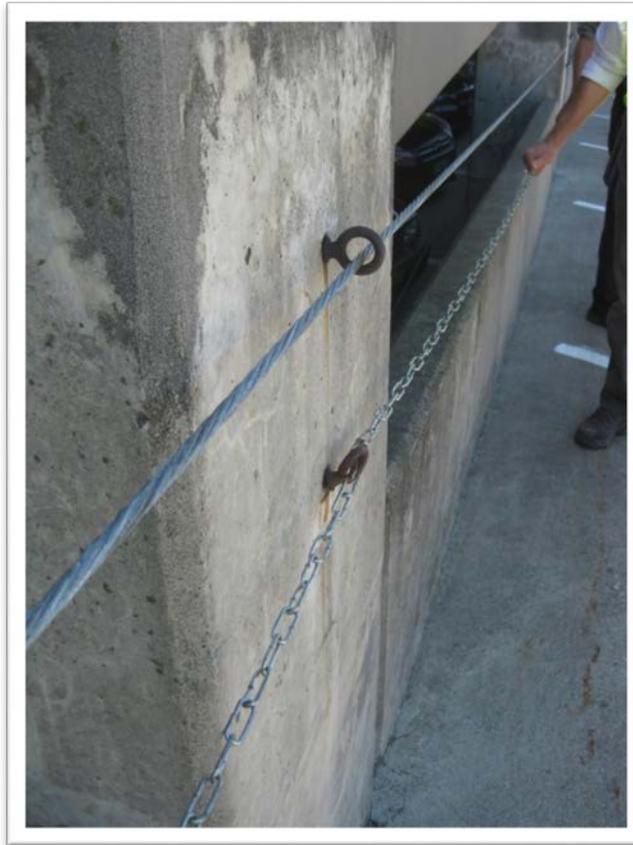
MS-2: Roof to Level 4 Chain Guardrail at North Structure Broken

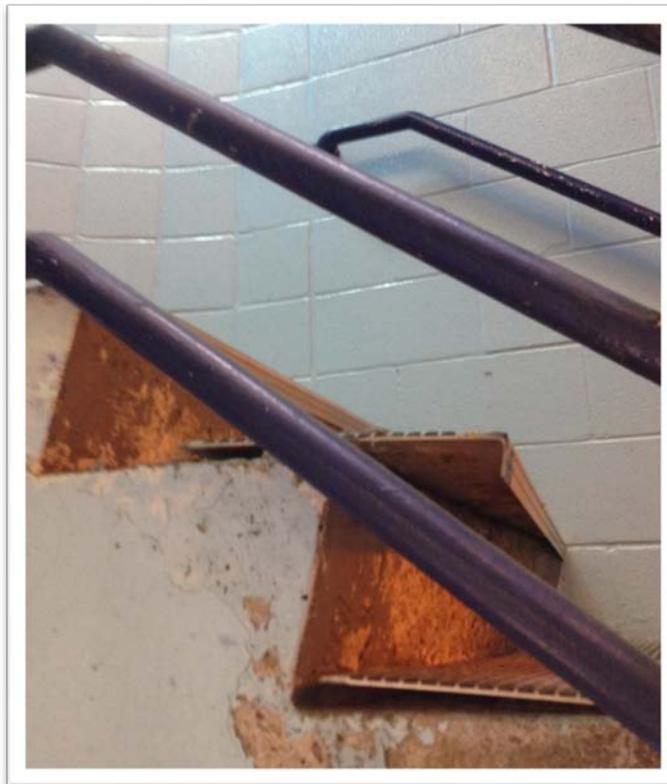
ST-1: All stairwells (Particularly Stair "A") – Loose Treads

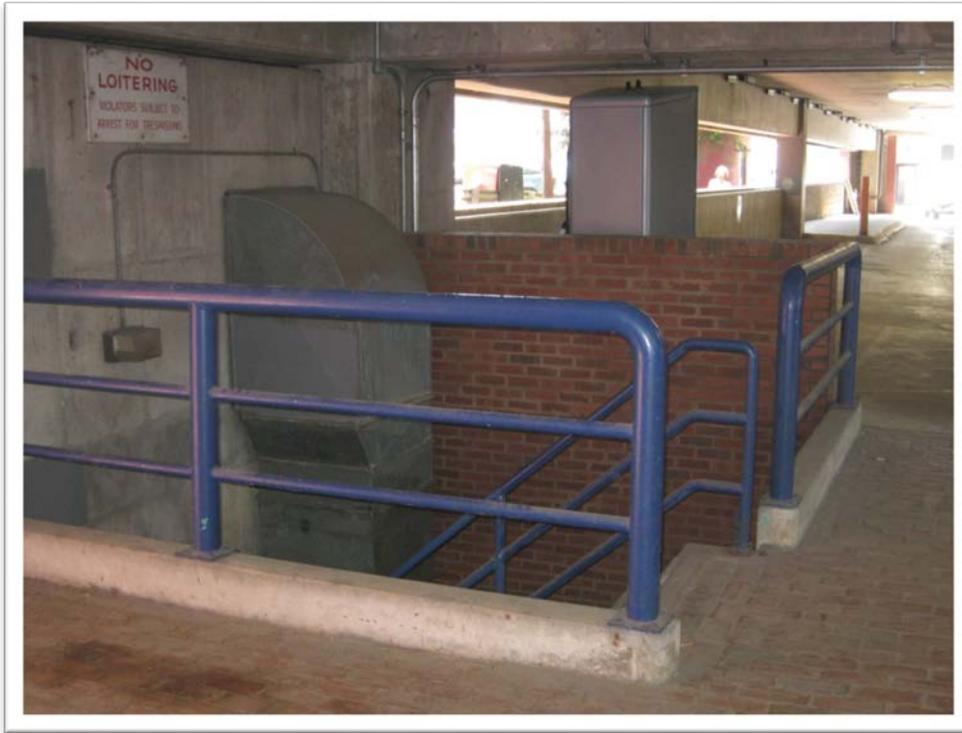
ST-4: No Guardrail on Stair "D"

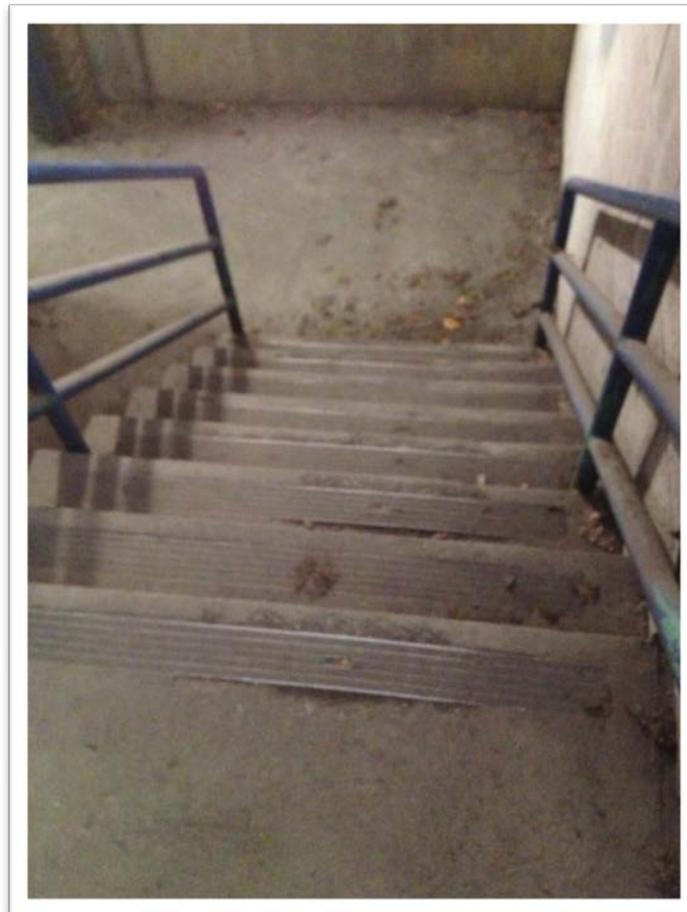
ST-5: Spacing between horizontal bars in guardrails

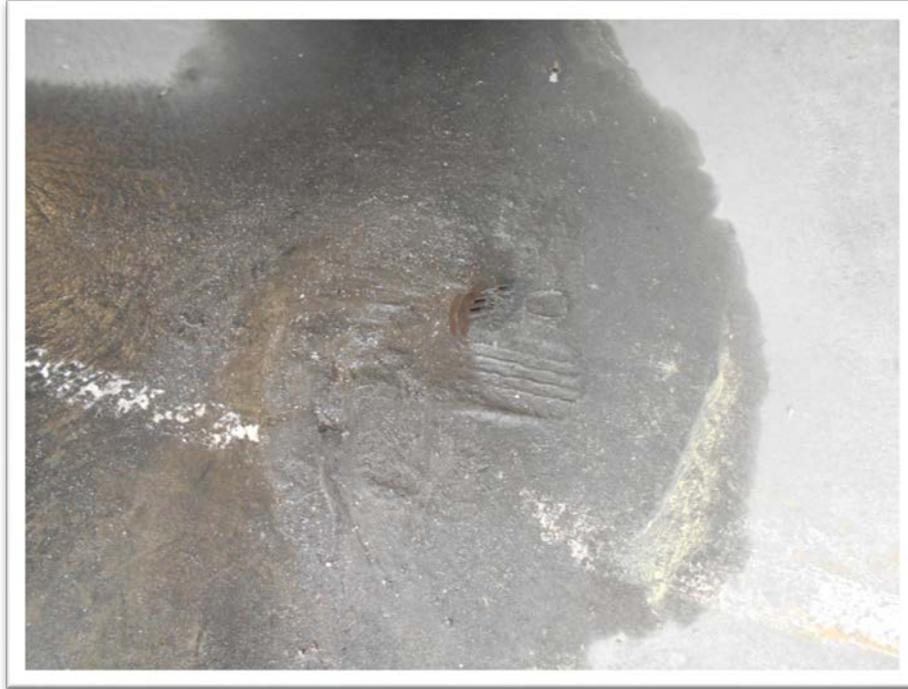
SD-1: Typical Plugged Floor Drain

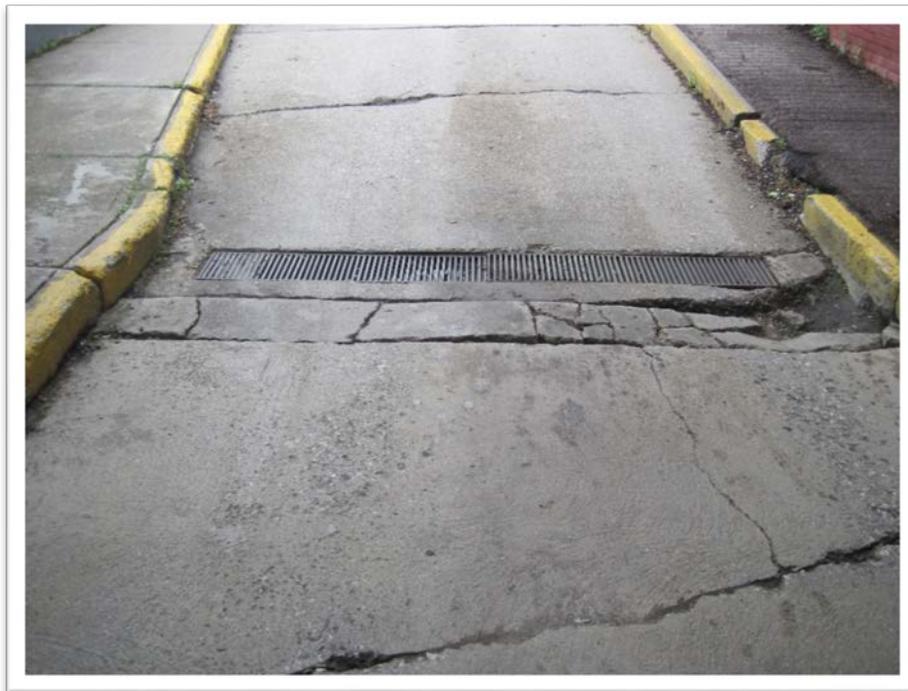
SD-2: Trench Drain at Cherry Street Entrance

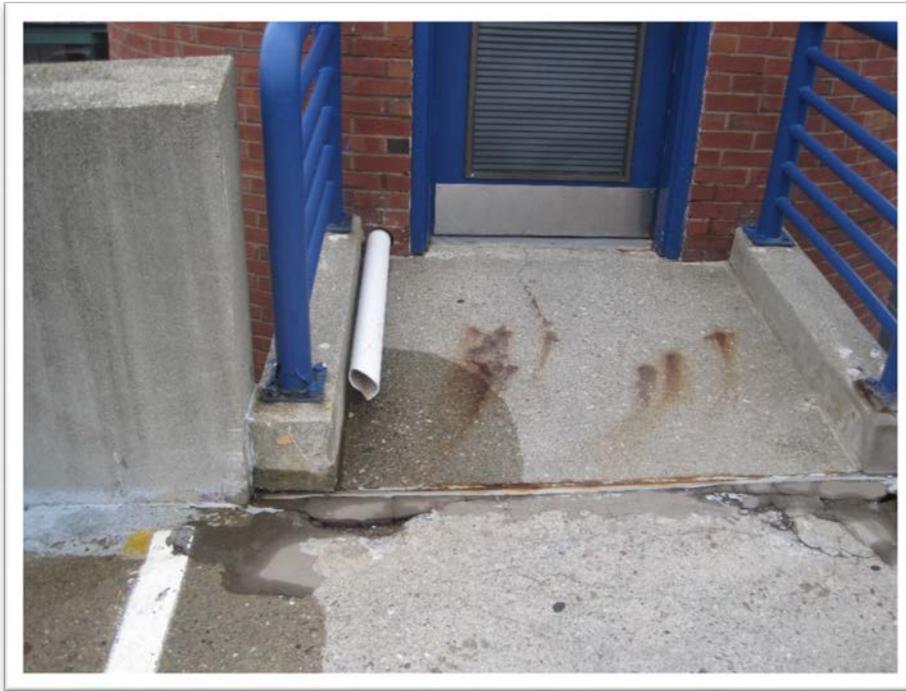
SD-3: Broken Drain Pipe at Cherry Street (Stair Tower A) 4th Level

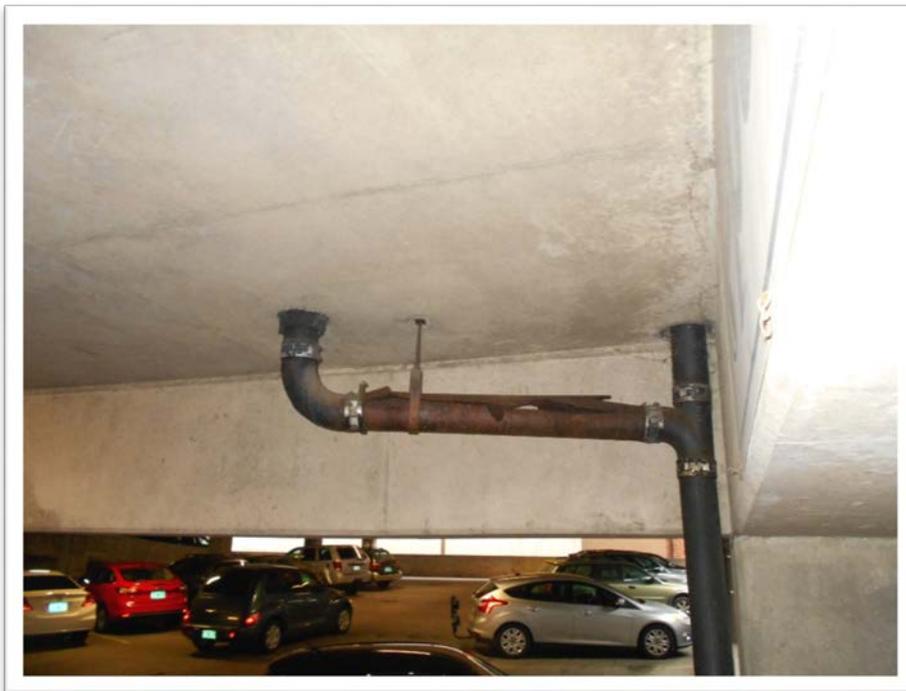
DS-1: Typical Failed Drain Pipe

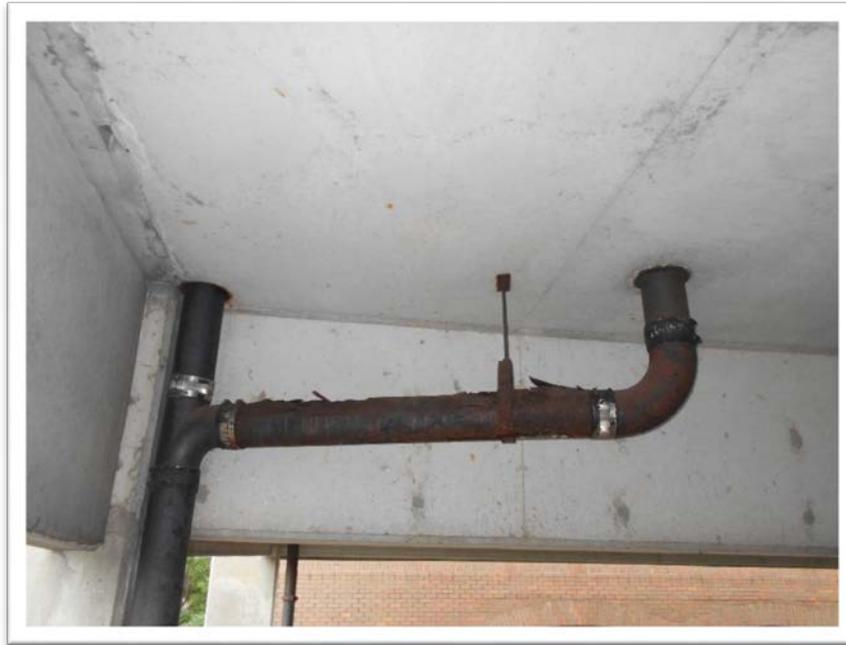
DS-1a & DS-2: Drain Pipe Failure with Elbow Corrosion

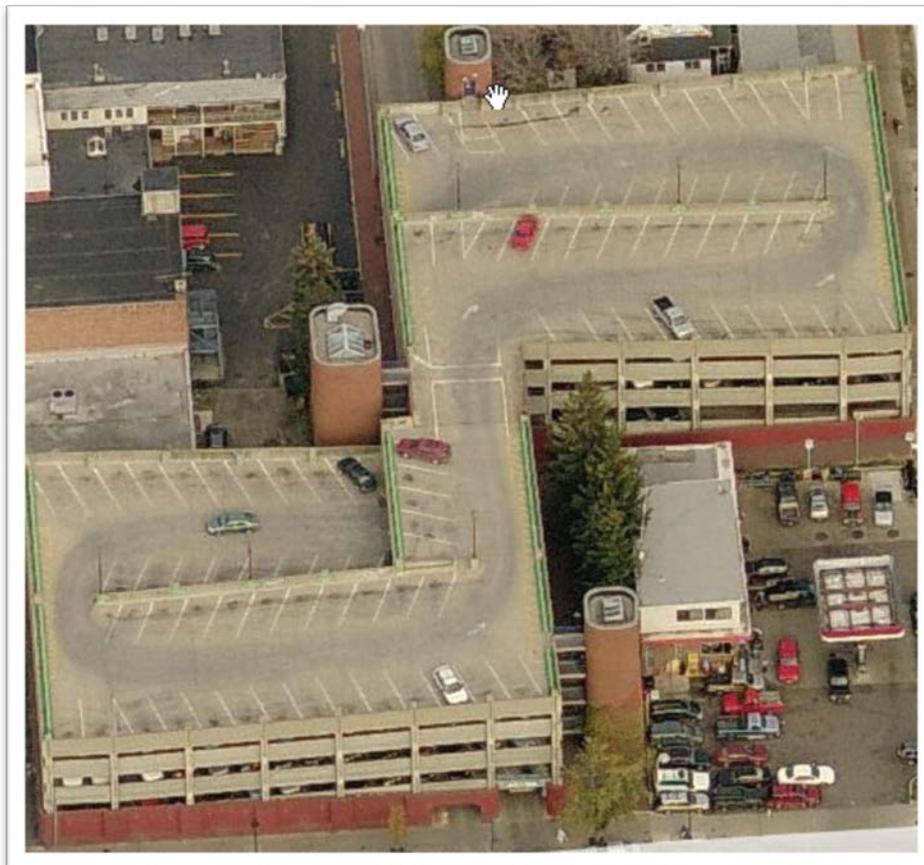
RM- 1: Exceeds Expected Life Span of Room System.
