FACILITY CONDITION ASSESSMENT AND LEVEL I ENERGY AUDIT

of FIRE STATION #5

23 Ferguson Avenue
Burlington, Vermont 05401

EMG Project #: 110226.14R-005.294
Date of Report: February 27, 2015
On site Date: September 24, 2014

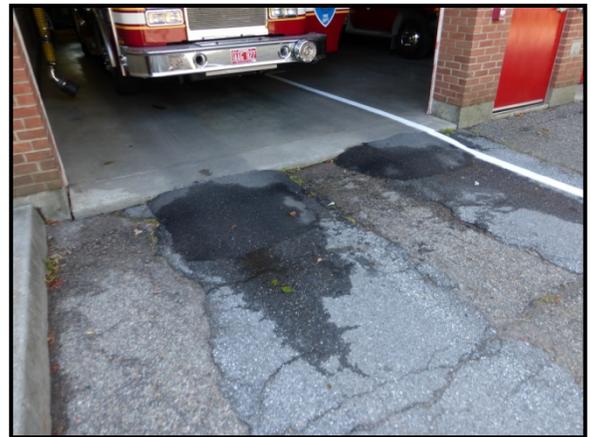
- The property does not have a dedicated paving repair and maintenance contractor. On site personnel maintain the paving and flatwork or a contractor is retained when required.
- Service drive and parking area - The asphalt pavement is in good to fair condition. There are no significant signs of cracks or surface deterioration. In order to maximize the pavement life, pothole patching, crack sealing, seal coating, and re-striping of the asphalt paving will be required during the assessment period. The cost of this work is included in the Replacement Reserves Report.

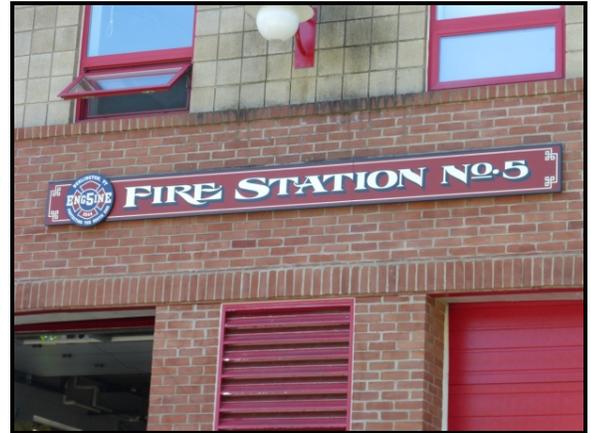
- The property and tenant identification signs are in good condition. Routine maintenance will be required during the assessment period.
- The exterior site and building light fixtures are in good condition. Routine maintenance will be required during the assessment period.
- The site fencing is in good condition and will require routine maintenance during the assessment period. Painting is considered to be routine maintenance.

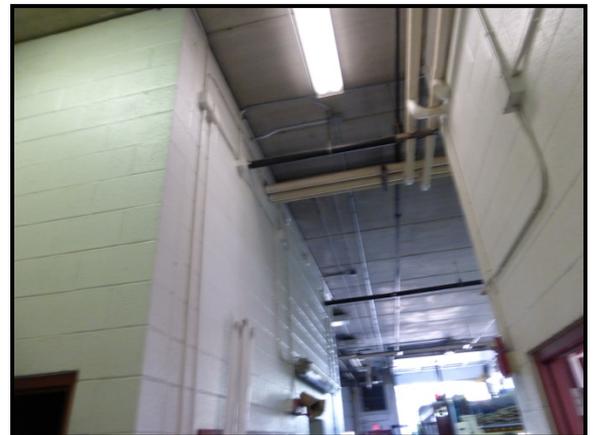
- The superstructure is exposed in some locations, which allows for limited observation. Walls and floors appear to be plumb, level, and stable. There are no significant signs of deflection or movement.

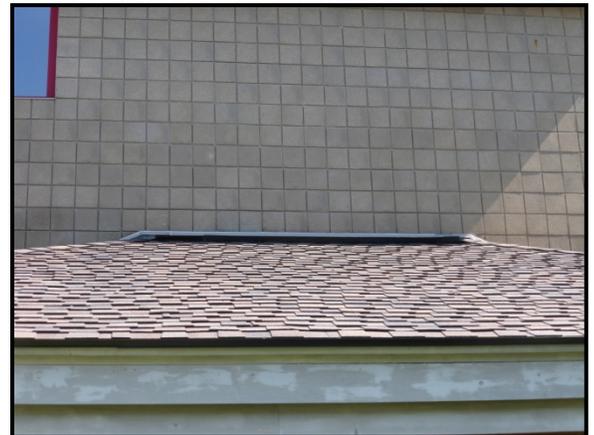
- The exterior finishes are in good condition. Painting and patching will be required during the assessment period. The cost of this work is included in the Replacement Reserves Report.
- The exterior walls of stained and weathered will require pressure washing during the assessment period. The cost of this work is included in the Replacement Reserves Report.
- The sealant is in good condition and will require replacement during the assessment period. The cost of this work is included in the Replacement Reserves Report.

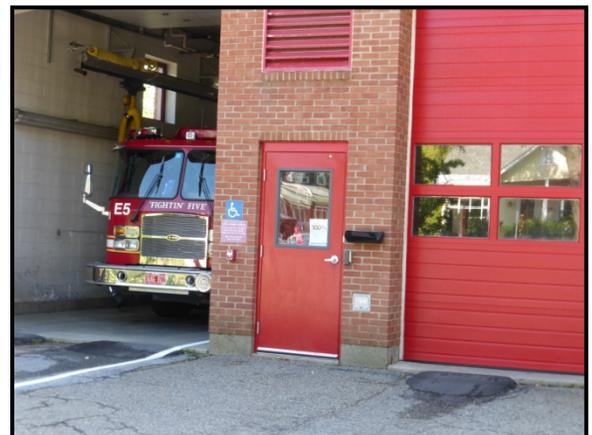
- There is no evidence of window leaks or window condensation. The windows are in good to fair condition and based on their estimated useful life, they will require replacement during the assessment period. The cost of this work is included in the Replacement Reserves Report.
- The exterior doors and door hardware are in good condition and will require repainting during the assessment period. The cost of this work is included in the Replacement Reserves Report.
- The overhead doors are in good condition and will require repainting during the assessment period. The cost of this work is included in the Replacement Reserves Report.

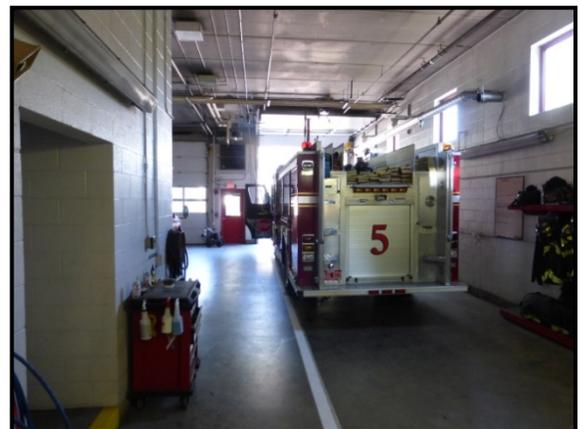
- The interior finishes are good to fair condition. Repainting and some of the interior finishes will require replacement during the assessment period. The cost of this work is included in the Replacement Reserves Report.
