Site Inspection Report

FILE 195310193

Report No. 2

Owner: City of Burlington, Vermont

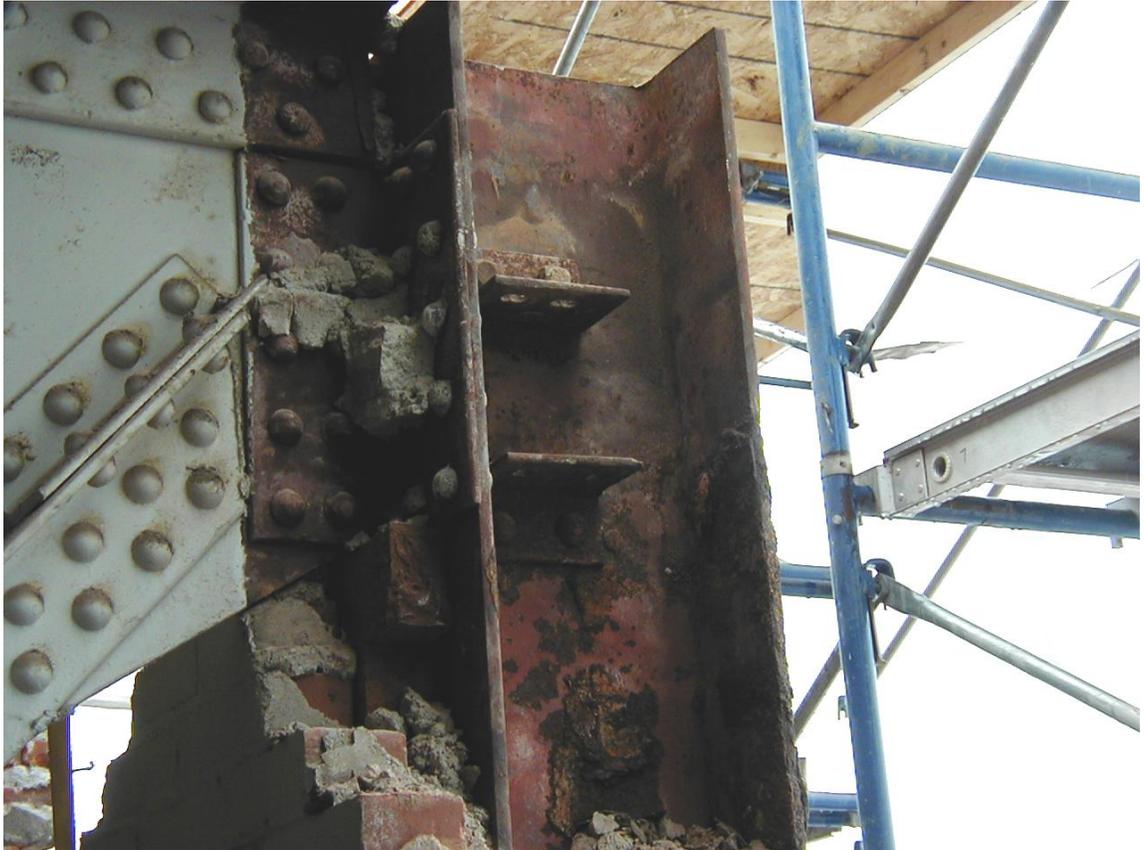
Steel column in Pylon #8 connection point for horizontal member. Top ear will be removed.

The replacement horizontal S6x12.5 beams were being painted today. They are receiving two coats of D.T.M. Alkyd Gloss Enamel Pastel Base M26 1B by Benjamin Moore & Co. These are to be welded in place as per a telephone conversation with Martin W. Hain from Knights Consulting Engineers who had inspected the original beams and had determined that they would need to be replaced. The top ears of the original connectors will be removed and the new beams welded in place resting on the lower ears.

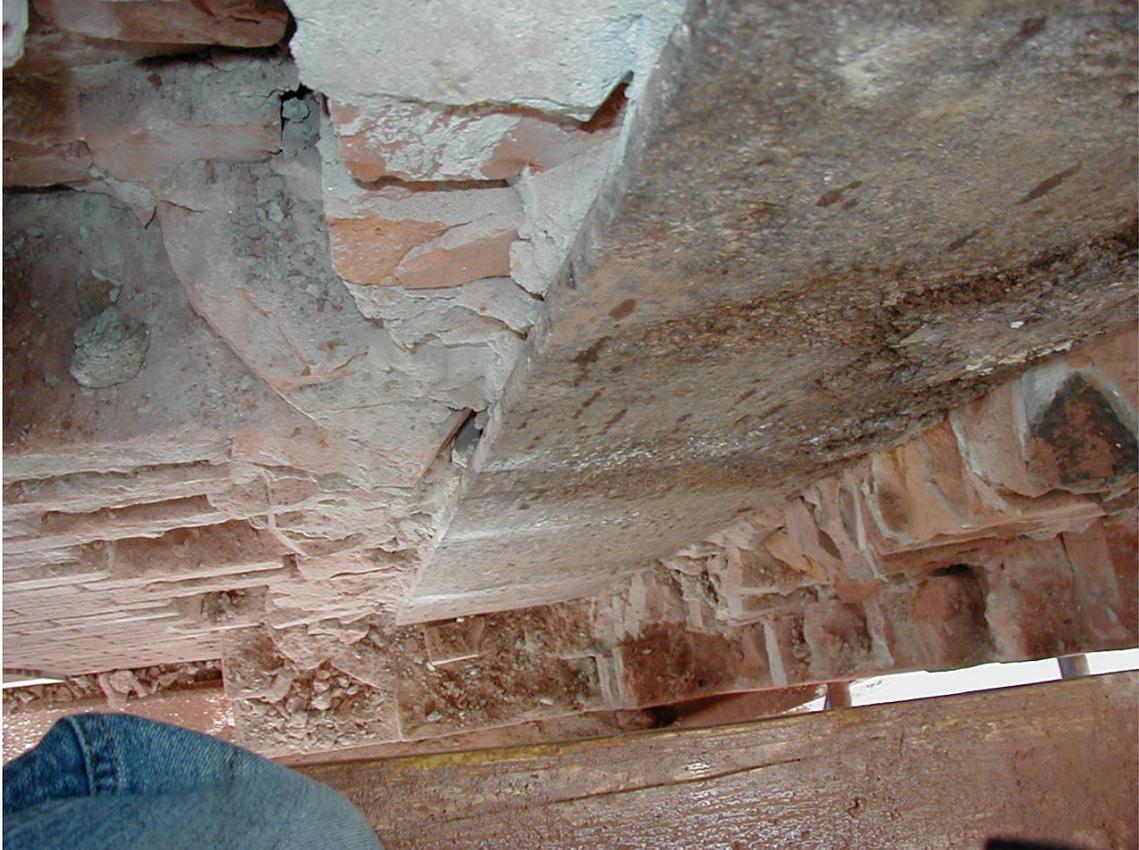
The contractor has also exposed the steel column in Pylon #8 to a point where the column steel is smooth and nearly blemish free. This point was measured and found to be $18' \pm 7"$ from the top of the steel column. It has been observed, during the demolition process, that in the area where corrosion is not so prevalent, the wythe is much less densely packed. Some of the bricks were found to be finger loose and it was apparent that the bricks had not been mortared to the column. Paul surmised that this feature allowed water and moisture to drain away from the steel, preventing corrosion from occurring at such a rate as higher up on the column.

Looking down the exposed steel column of Pylon #8. Notice much smoother steel at the base of the exposure.

Paul proposes that some type of spacer/sealing material be placed over the column before it is covered up in brick to help seal off the steel from outside moisture and allow any moisture that reached the steel to drain out. He will be submitting samples.
