Final Draft Preliminary Engineering Report
Stormwater Outfall Repair Project | City of Burlington
Capital Improvement Plan 2018

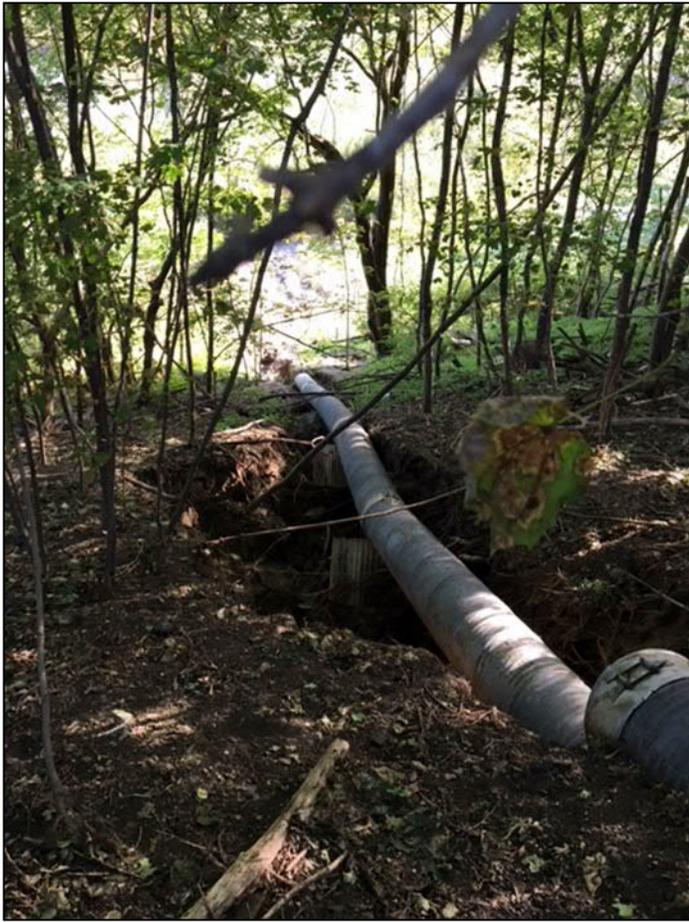
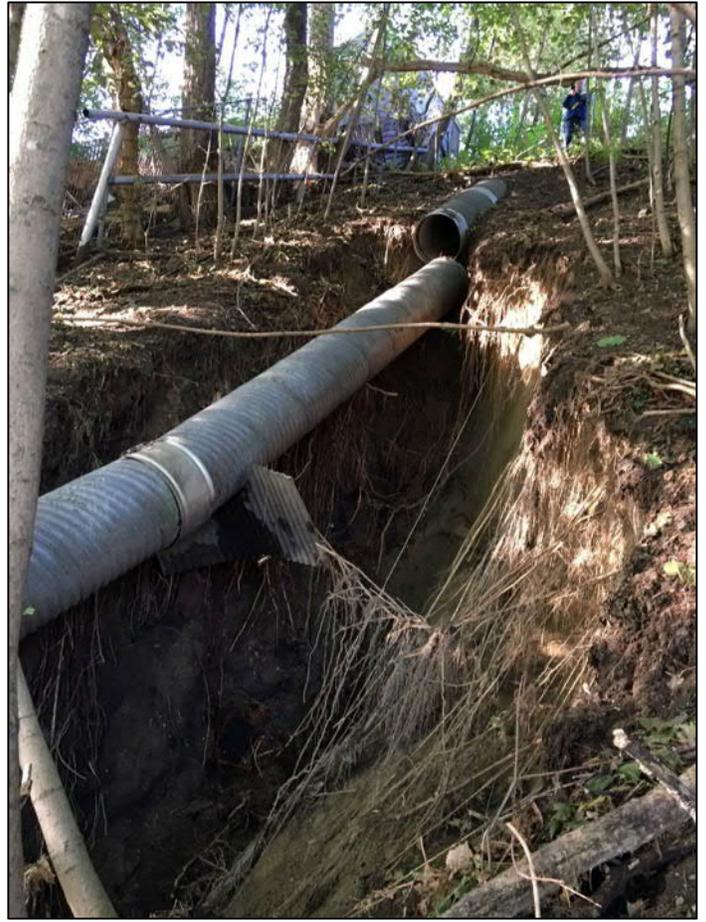
Outfalls IV8.0, IV9.0 and IV10.0 are in various degrees of disrepair, with the worst erosion existing between outfalls IV9.0 and IV10.0. While the pipes serving IV10.0 and IV9.0 are HDPE, IV8.0 was constructed using several sections of corrugated metal pipe that were fastened together using collars set on risers anchored to the slope. In the fall of 2018, the areas of the pipe that were joined began to separate, resulting in rapid erosion under the pipe structure. DPW staff initially proposed to stop the erosion issue by installing a Cured-In-Place-Pipe (CIPP) liner. However, erosion under the pipe accelerated rapidly over the next 24 hours resulting in the pipe separating completely, with a roughly 12-15 foot gully opening up underneath.

Gully erosion at IV8.0 – Fall 2018 (prior to emergency repair work)

An emergency repair was completed over the following days, which included filling the gullied area with crushed stone, and raising / reattaching the separated pipe sections. To ensure the pipe would not separate again in the future, a CIPP liner was installed on December 19, 2018 by Green Mountain Pipeline Services.

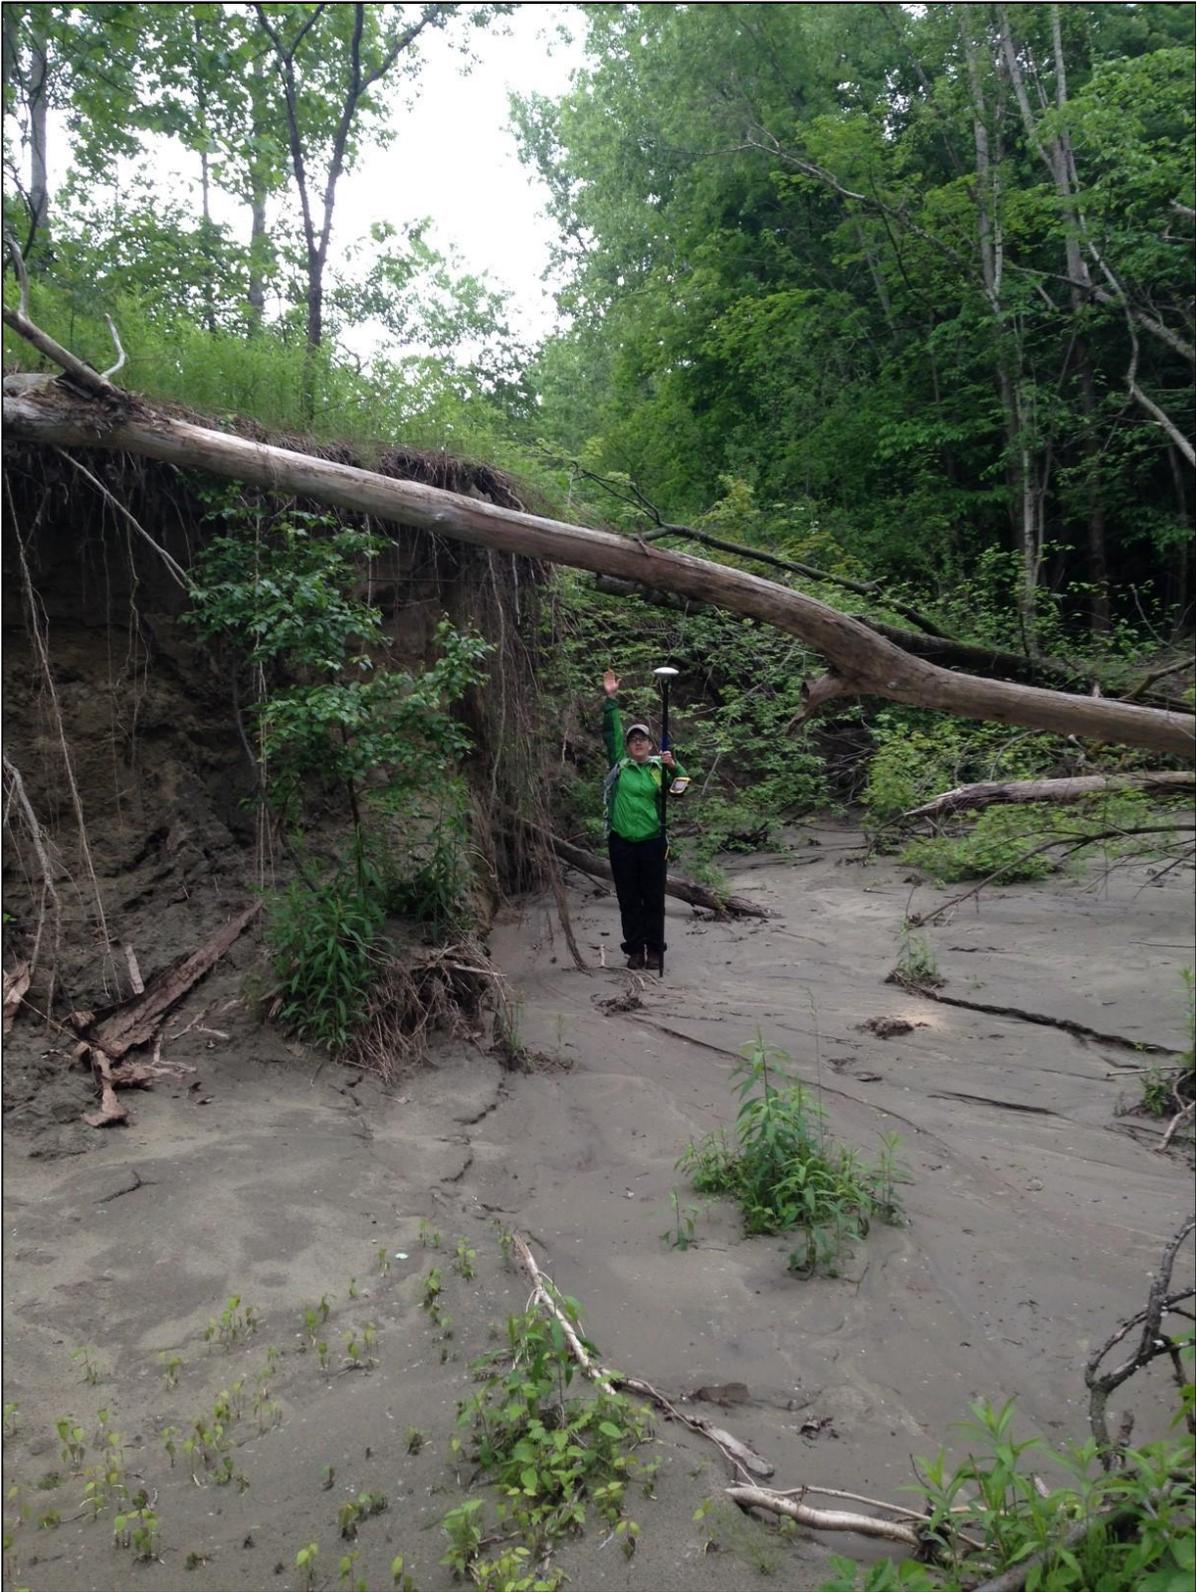
Channelized erosion between outfalls IV10.0 and IV9.0 – Summer 2015

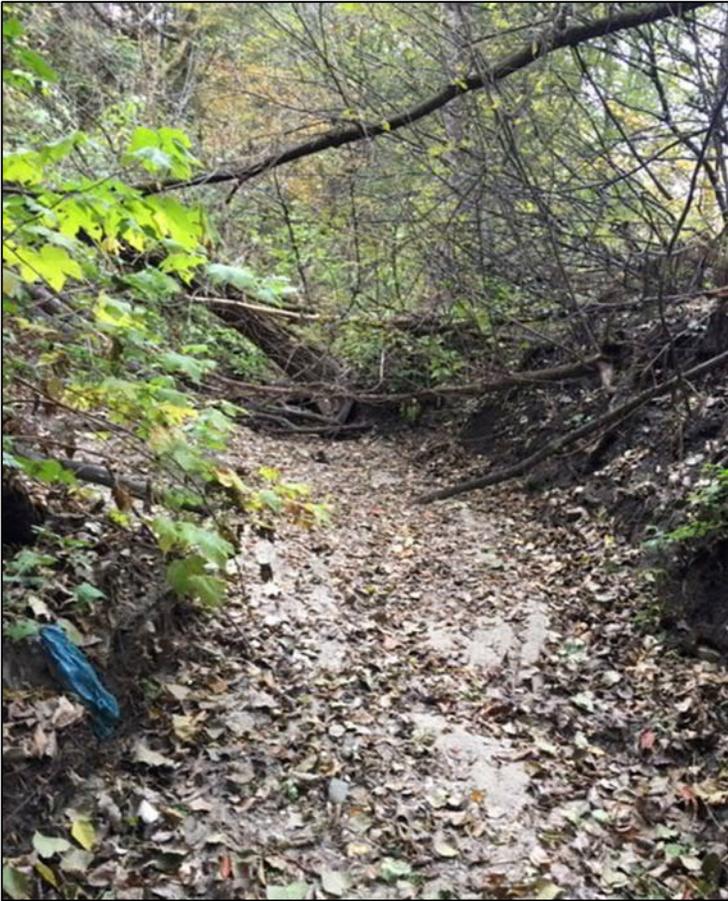
Channelized erosion facing north of IV9.0 – Fall 2018

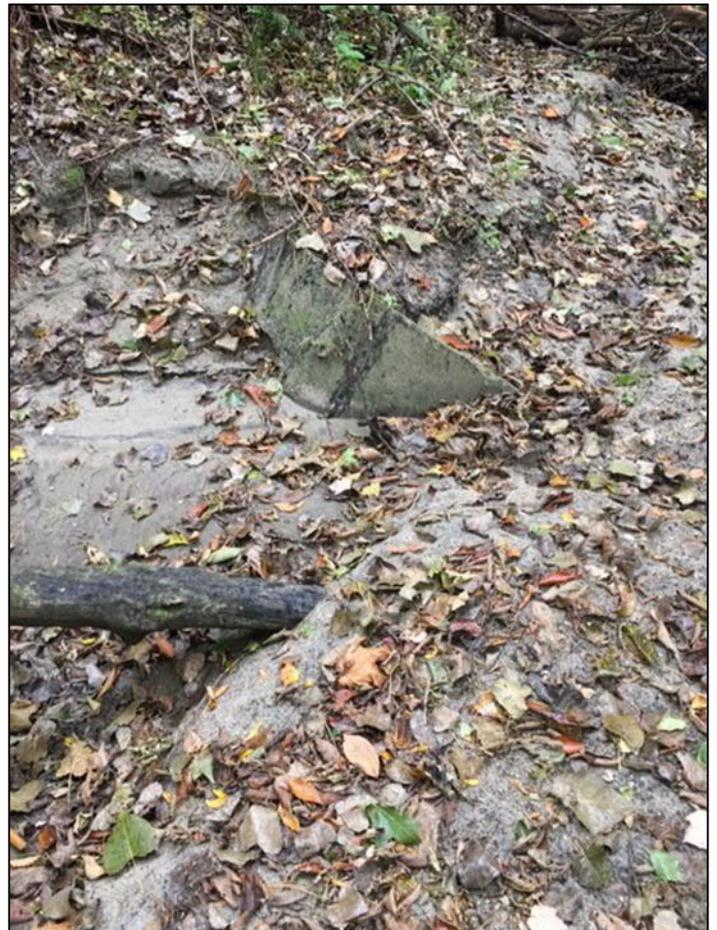
Buried outfall energy dissipation structure, formerly located at IV9.0 – Fall 2018
