August 10, 2012

Re: 847/851 Pine St. Howard Center (11-0618CA/MA)

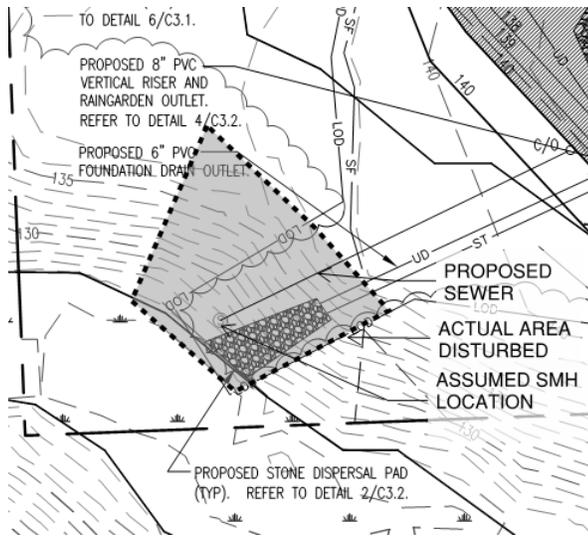
1- Permitted plan (actual disturbed area dashed)

1-Permitted Plan:

The original permitted plan indicated the proposed sewer and stormwater pipes parallel to each other, within a narrow limit of disturbance (LOD). The sewer pipe was originally intended to serve only the new building and discharged to an assumed location of the existing sewer manhole (SMH), based on City sewer mapping. The SMH was buried with several feet of soil, and was not accurately located until construction began.

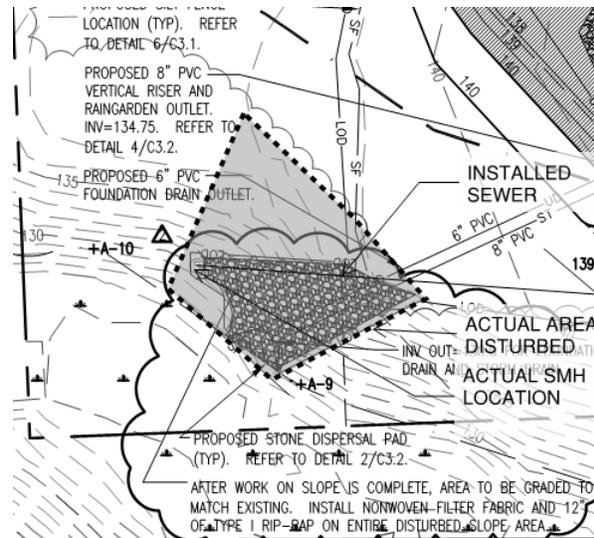
2- Revised plan (actual disturbed area dashed)

2-Revised Plan:

As construction was beginning a few things occurred which led to the changes in the sewer line routing and corresponding extents of disturbance along Englesby Brook.

1. The existing sewer line for 847 South Pine St (the existing house) backed up prior to construction. This had been a re-occurring issue related to the poor condition of the city sewer within the Englesby Ravine, and had required repeated excavation within the Englesby Ravine over the years to unclog. This city sewer provided service only to 847 South Pine St. In order to abandon this problematic sewer, Steve Roy (BDPW) requested The Howard Center to re-route the 847 South Pine St sewer service to connect with the proposed sewer service and discharge into the SMH as shown in the above revised plan.

2. With the assistance of the BDPW, the existing SMH was un-earthed below a few feet of soil. It was determined that the SMH was further northwest as shown in the Revised Plan above. The combined 847 and 851 sewer service needed to run diagonally across the disturbed area to reach the actual location of the SMH, resulting in a wider swath of disturbance than originally anticipated.

4. As construction proceeded with the new sewer routing and actual SMH location, based on the depth of the sewer line and steepness of the bank, additional excavation and vegetation removal uphill of the sewer line was necessary to facilitate its construction and provide adequate contractor safety. That area is apparent in the Revised Plan as the shaded triangular area above the rip-rap hatched area.

1. The revised sewer routing was requested and reviewed by the BDPW and will result in an improved system, reducing the need for ongoing future excavation and maintenance in the Englesby Ravine.

2. The existing SMH rim was raised above the high waterline of Englesby Brook reducing the chance of discharge from one to the other and again reducing future maintenance in the Englesby Ravine.

7. Vegetation has started to grow in the rip-rap area and will be allowed to continue to grow.
