# FINAL REPORT

## planBTV South End | Phase 1 Existing Conditions Report

PREPARED FOR  
City of Burlington  
Chittenden County Regional Planning Commission

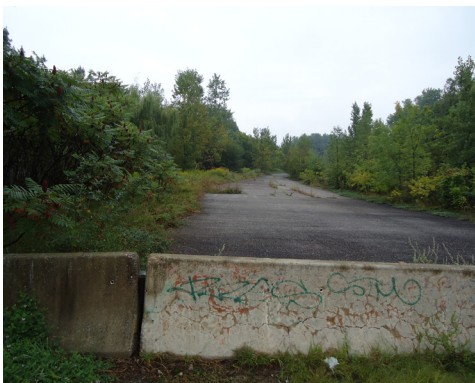
**Figure 1-2:** The Champlain Parkway abandoned alignment just west of Pine Street near the southern boundary of the Study Area.

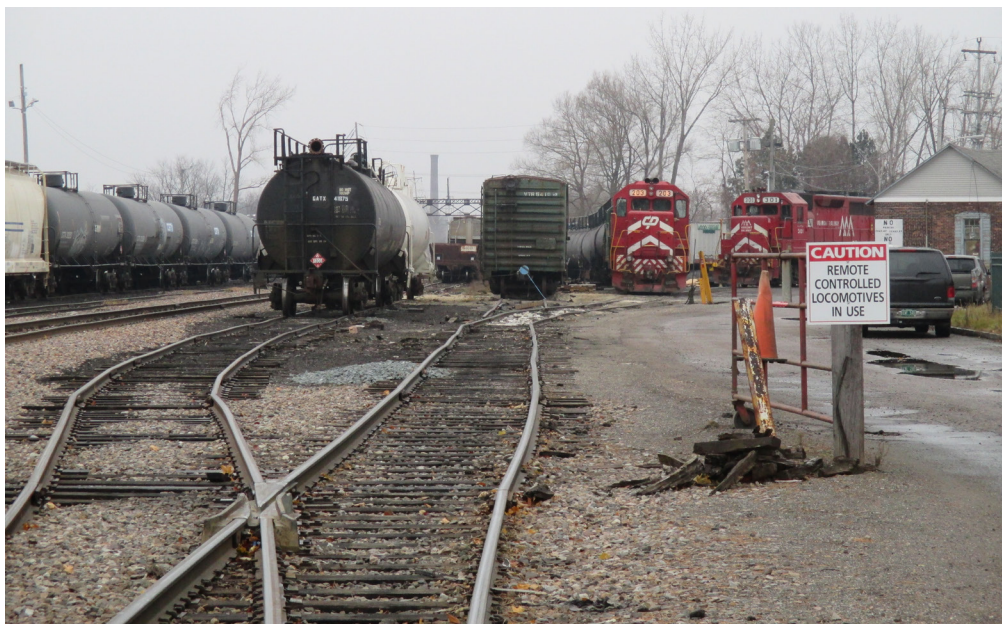
**Figure 1-3:** The Vermont Railways Railyard at the northern boundary of the Study Area where multiple transportation alternatives are being evaluated.

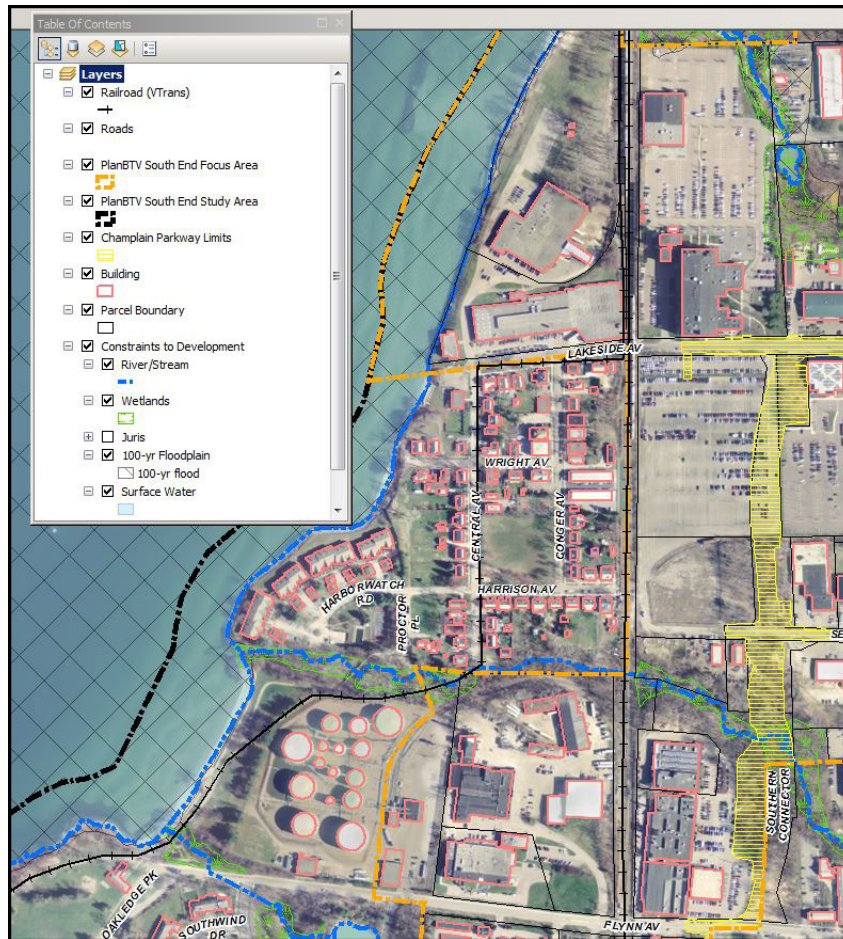
**Figure 2-3:** Example of development constraints in the Study Area.

It is important to remember that the buildout analysis did not factor in parking requirements, or site level analysis. Therefore, the buildout results represent only an approximation of what may be built under the current regulatory scheme. A complete buildout of the South End Focus Area, as presented by this analysis, is neither necessarily possible, nor expected. The results of the buildout analysis are only relevant when existing and maximum buildout is considered relative to one-another, and the purpose of the analysis was for planning purposes only. This approach was discussed and agreed upon with the City on September 9, 2014. The following constraints to development were taken into consideration in the buildout analysis:

- » Wetlands and Surface Waters
- » Champlain Valley Parkway project footprint
- » 250-foot buffer zone of Lake Champlain
- » 100-foot buffer zone from Englesby Brook
- » 80 percent maximum lot coverage area

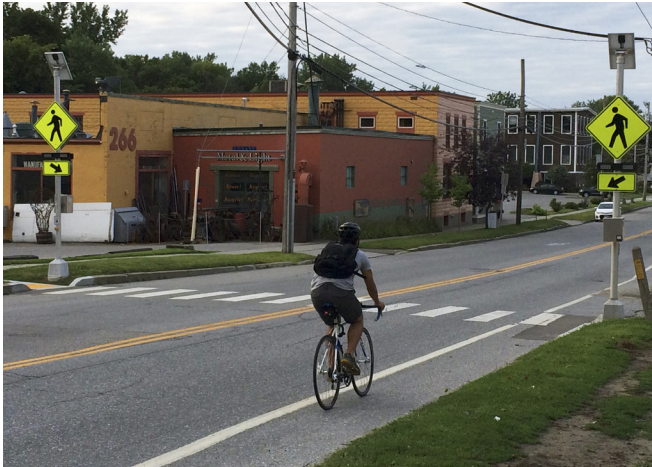
**Figure 3-3:** Rectangular Rapid Flashing Beacons were recently installed along Pine Street at pedestrian crossings and a 5' bike lane is provided along the south bound lane of the road.

Pine Street currently has “Share the Road” bicycle signage in the northbound direction with painted sharrows in the travel lane and a five foot bike lane from Maple Street to Flynn Avenue southbound. Issues exist with the current configuration including inconsistent southbound bike lanes which do not traverse throughout all of Pine Street and bicyclists contending with parked cars on the east side. For bicyclists traveling southbound through the Lakeside Avenue intersection on Pine Street, the bicycle lane is dropped due to a right-hand turning lane and insufficient curb to curb width to accommodate the bike lane.

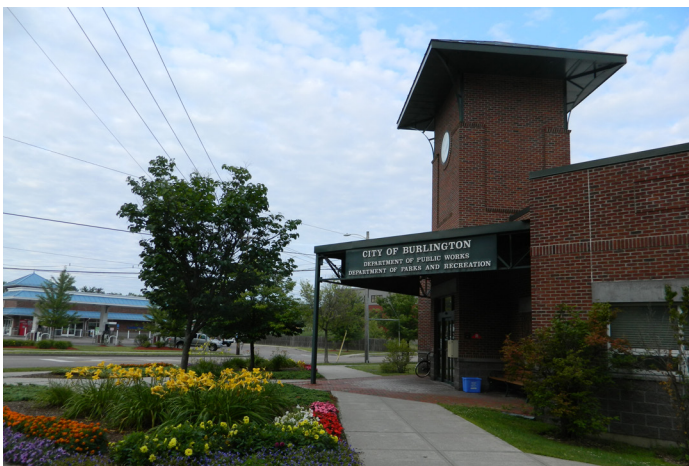
The City of Burlington Department of Public Works (DPW), which is located at 645 Pine Street, operates a compressed natural gas vehicle (CNG) fueling station at the back of the building. City of Burlington fleet vehicles and the University of Vermont Buses currently utilize the fueling station, as well as public and private fleets.

Figure 3-8: The Burlington DPW and Parks, Recreation & Waterfront are located at 645 Pine Street and behind the building is the CNG fueling station.

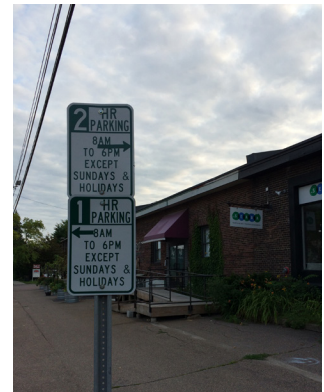
**Figure 3-9:** Example of on-street parking restrictions along Pine Street.

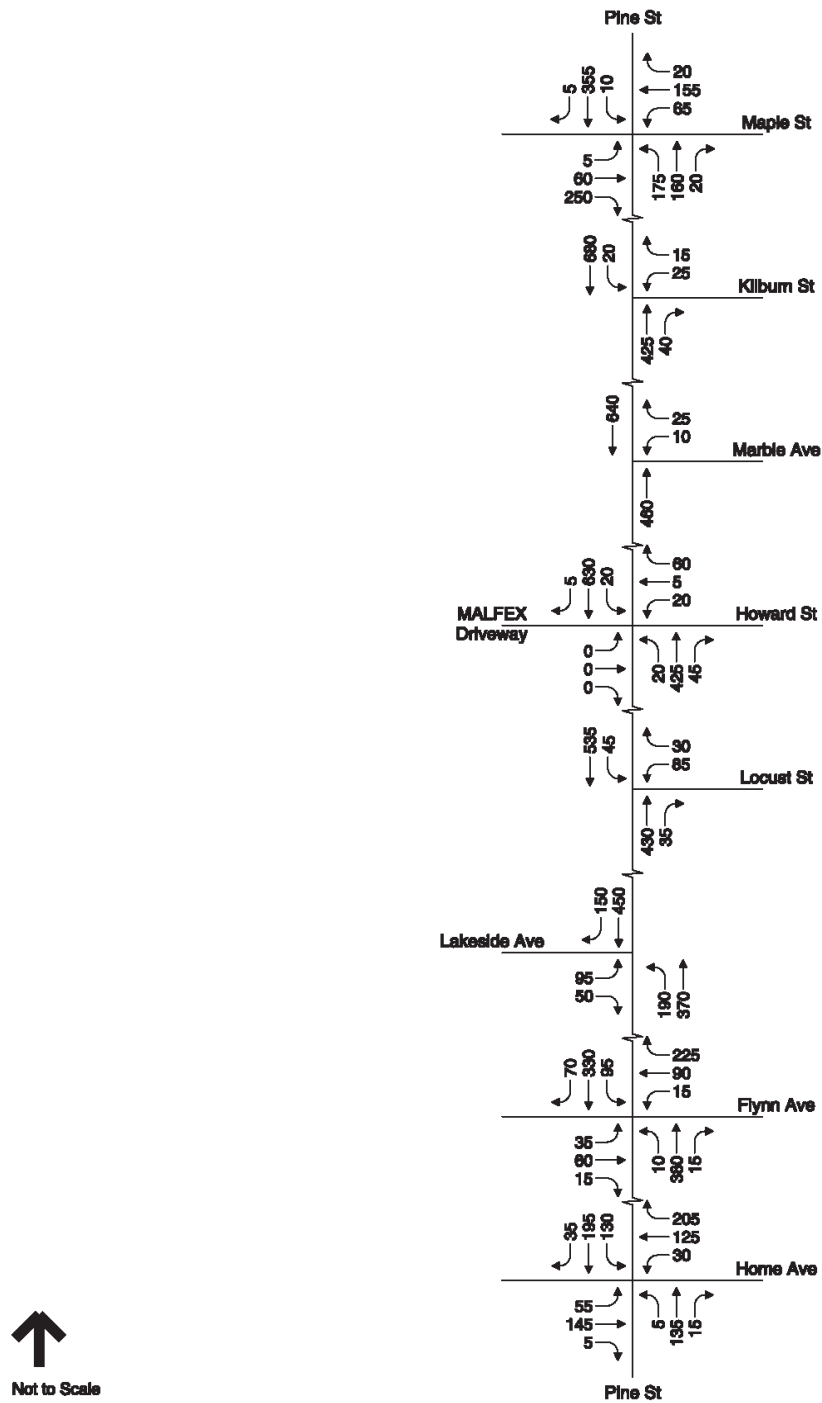
Figure 3-14: 2014 Weekday AM Network Diagram

2014 Weekday Morning  
Peak Hour Traffic Volumes

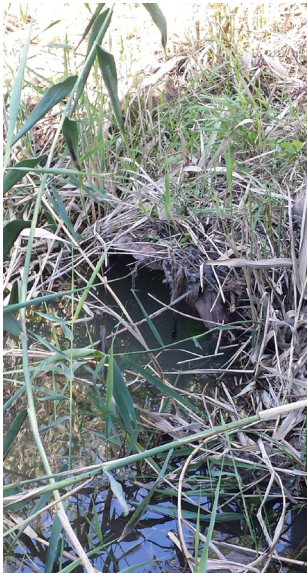
- » **BED Outfall:** The City indicated that the lower portion of the drainage system tributary to the outfall behind BED, outfall BC1.0, floods during larger storm events. When the field investigation took place on September 19, 2014, the outfall was observed to be more than half submerged (**see Figure 6-1**).

**Figure 6-1.** Outfall BC1.0. Photo taken by VHB on September 22, 2014, with approximate stage in Lake Champlain at 24.6 feet NGVD29.

The 2008 Final NAPL<sup>1</sup> Investigation Report for the Barge Canal, reviewed as part of the Brownfields assessment (Chapter 5), indicates that the weir, installed presumably to prevent erosion of the soils cap within the canal, is set at elevation of 96.5 feet. Water levels in the impounded area behind the weir only become lower than that elevation due to evapotranspiration; no supplemental outlets exist. Water levels very closely track lake elevations above 96.5 feet. There are no required water levels recorded in the easement, but the invert of the weir dictates a minimum water level in the Barge Canal.

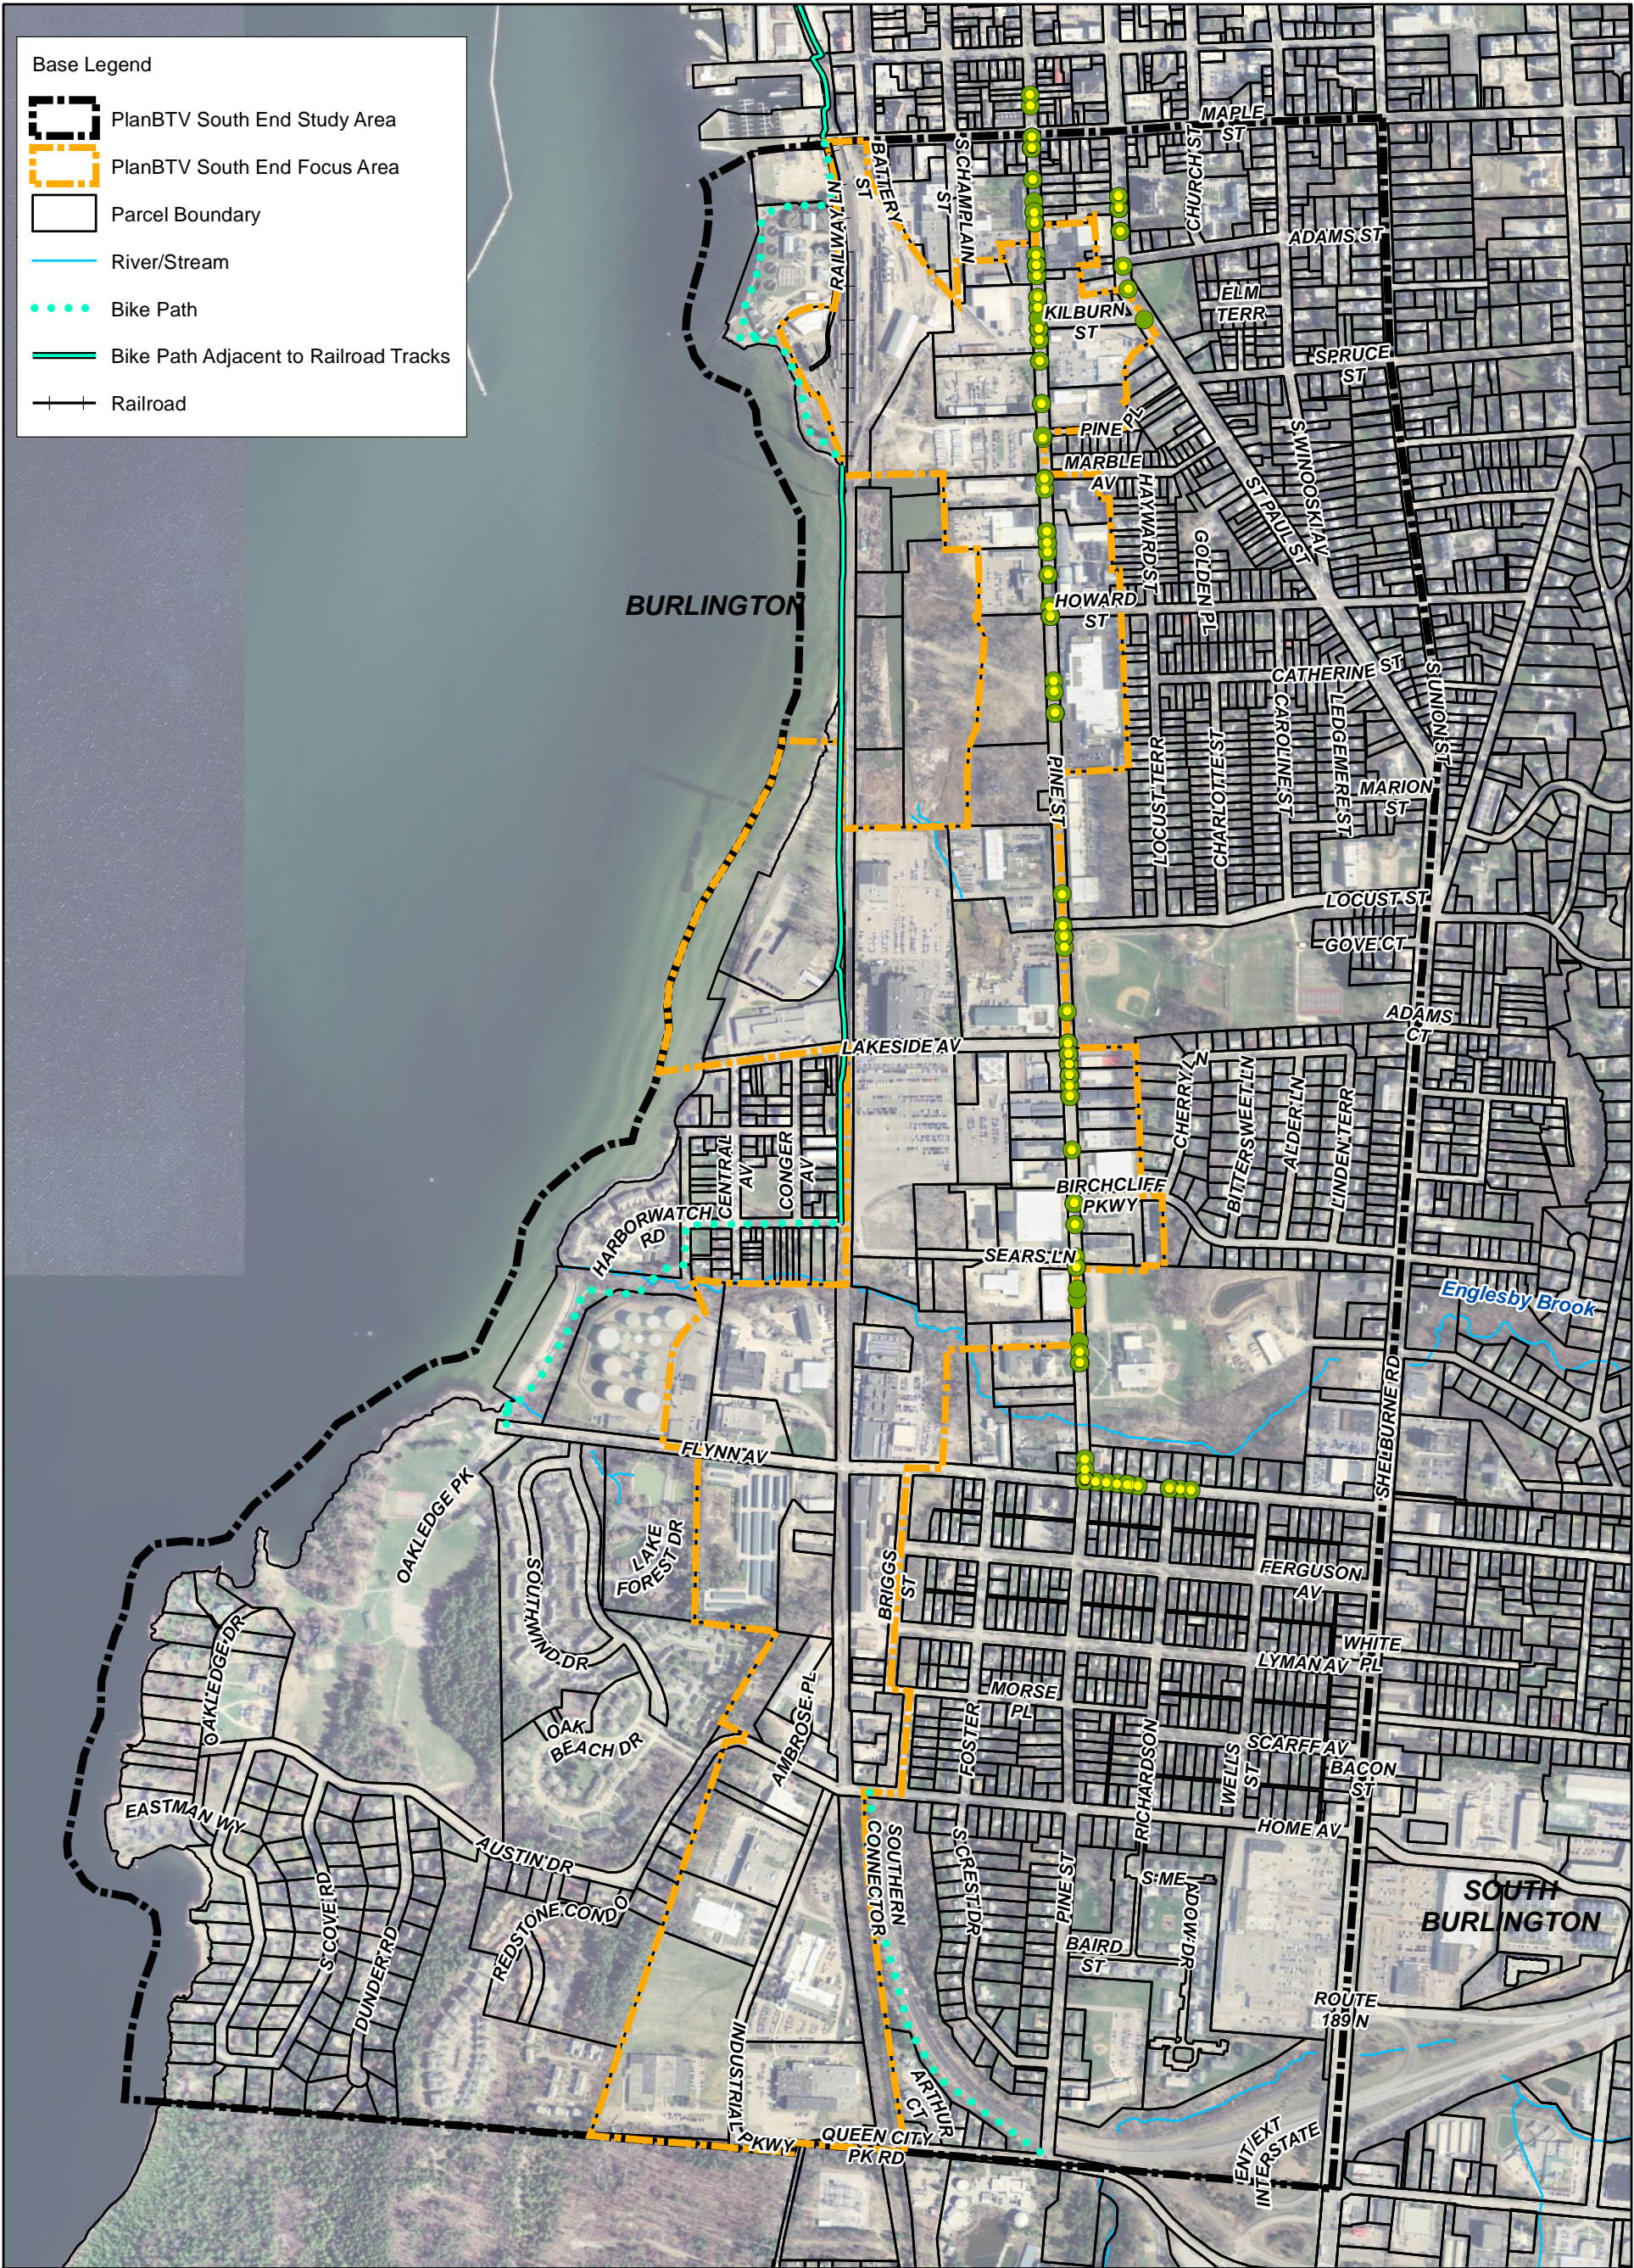
- Legend**
- Crash Location- No Injuries (167 Crashes)
  - Crash Location- Injuries Reported (36 Crashes)

## PlanBTV South End Crash Summary (2009- 2014) Burlington, VT
