REQUEST FOR PROPOSALS **Phase I Environmental Site Assessment:** **99 Intervale Road**

**PHASE I
ENVIRONMENTAL
SITE ASSESSMENT**

**RIVERSIDE ECO-PARK
0 INTERVALE ROAD
BURLINGTON, VERMONT**

Griffin Project #3995347

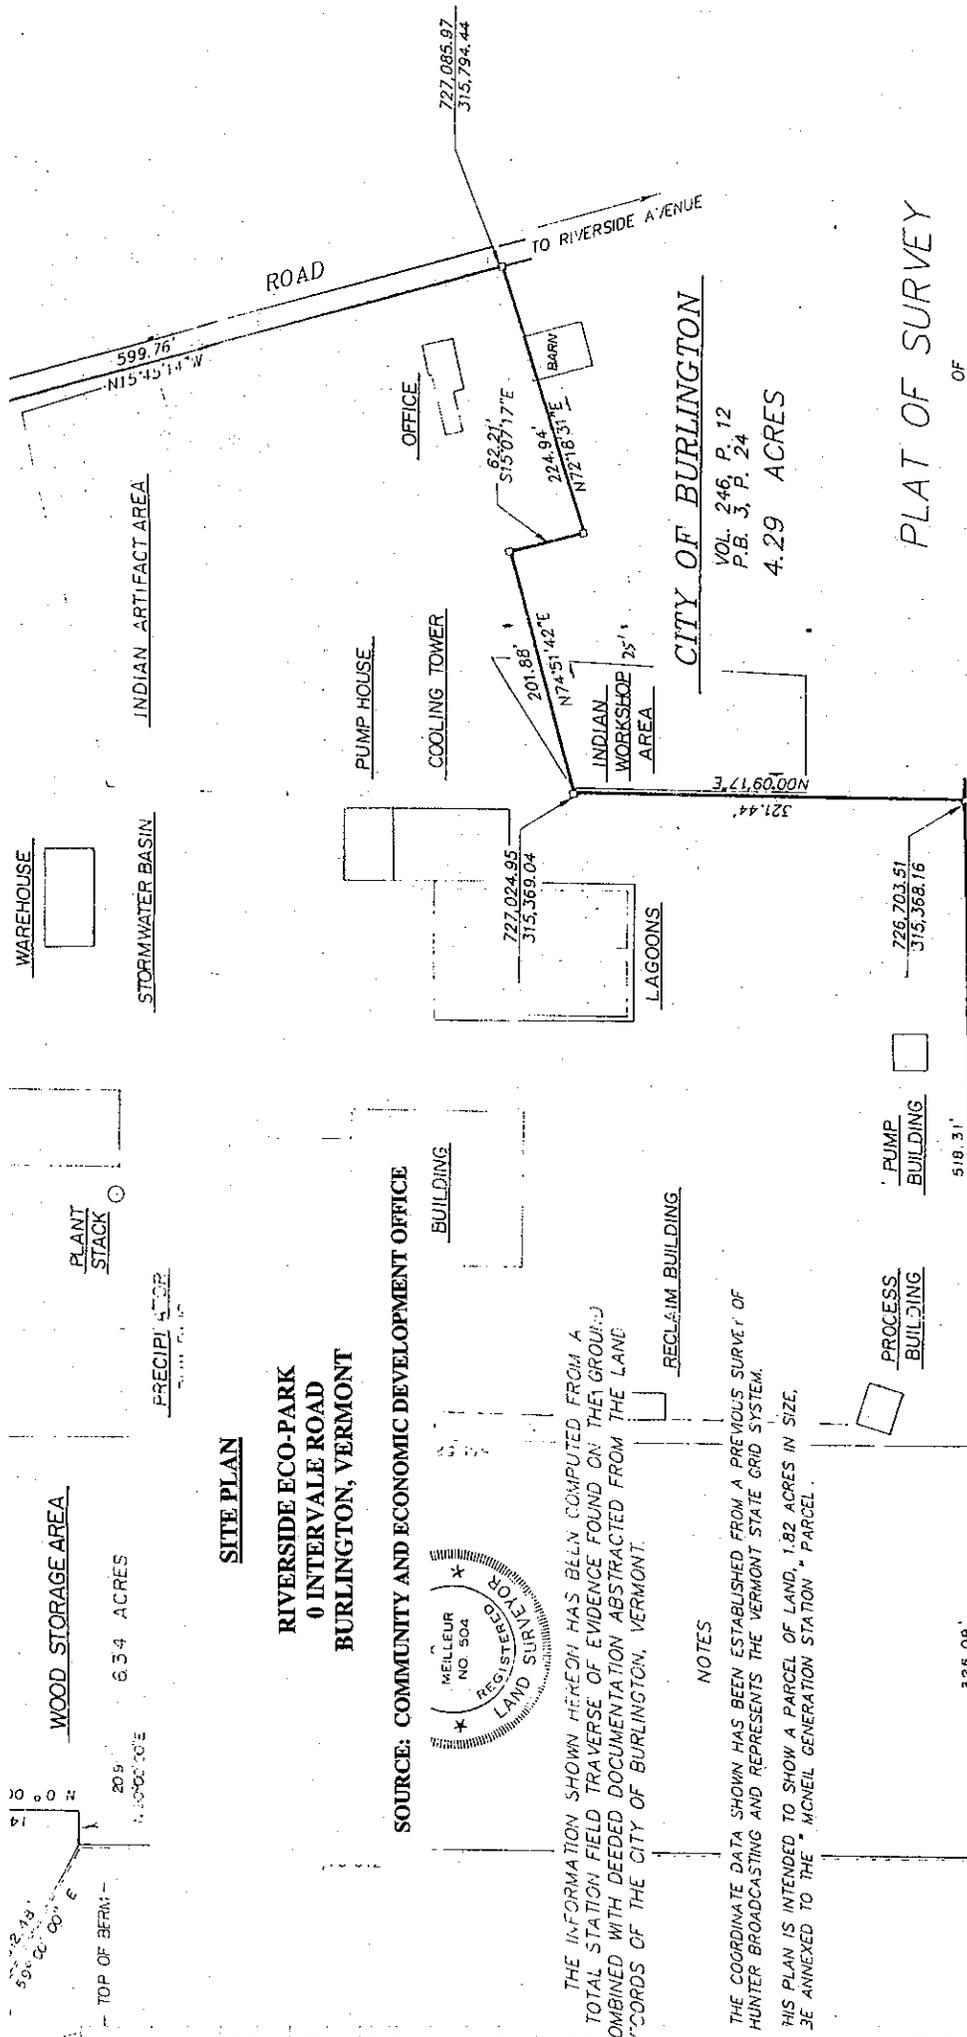
SITE PLAN

The majority of the subject property is overgrown with vegetation and is not actively used for any purpose. A Site Sketch, provided to Griffin by the Community and Economic Development Office (CEDO) of the City of Burlington, shows the subject property relative to the surrounding properties (see Attachment 2).

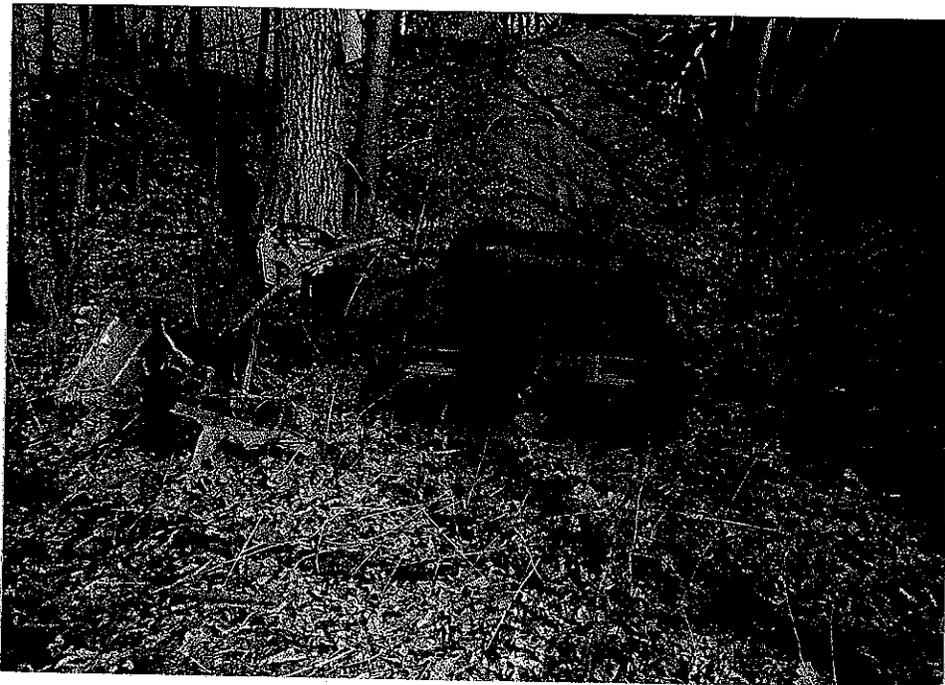
None of the vegetation which was observed at the subject property appeared to be stressed. Signs of corrosion were observed on some of the remaining metal structures near the old dairy barn (fences, machinery, etc.). A corroded vehicle was observed near the southern border of the property along the railroad tracks (see photograph).

Abandoned Vehicle at South End of Subject Property
