MEMORANDUM

To: The Design Advisory Board
From: Mary O'Neil, AICP, Associate Planner *MO*
RE: ZP 11-0996CA, 7-45 Kilburn Street
Date: June 14, 2011

Request: Replace existing deteriorated wooden trim on windows, doors, corner boards, etc with PVC composite trimboard in same dimensions.

Re: Kilburn and Gates Building, Kilburn Street, Burlington:
Trim Replacement.

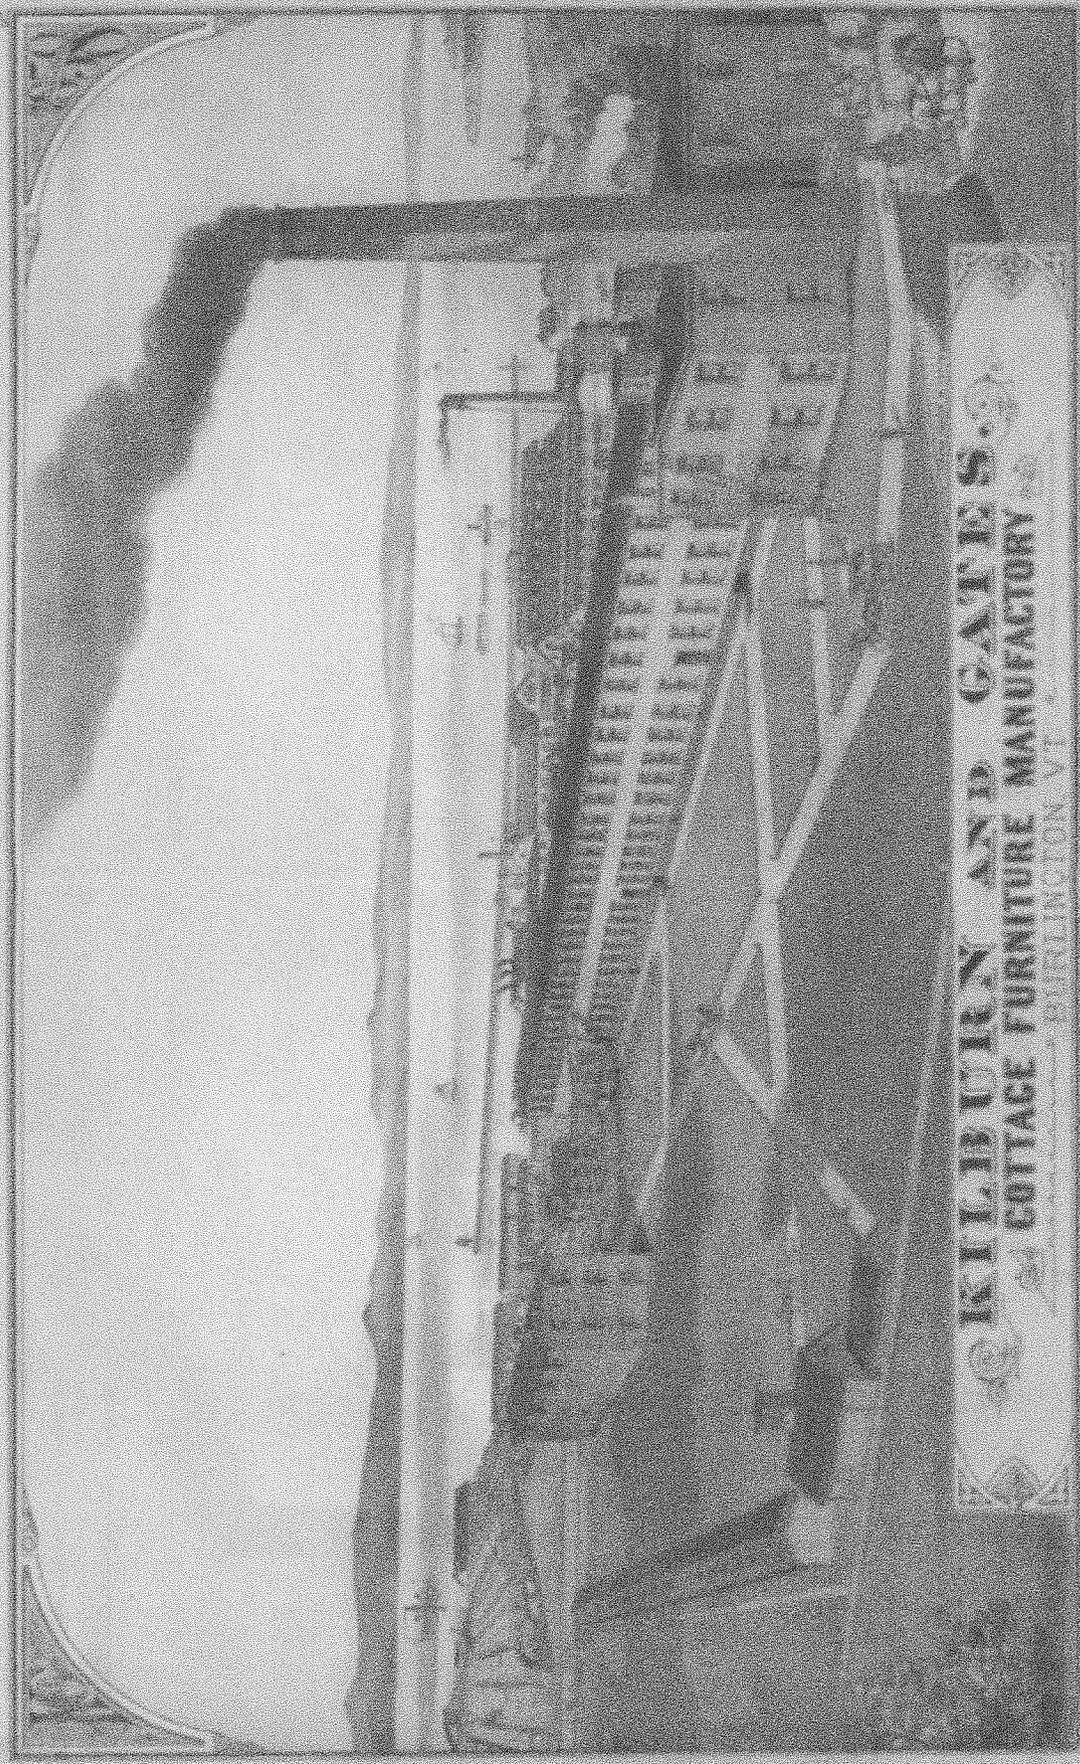
EXHIBIT
A

A picture of the original Kilburn and Gates building built in 1869. It is hard to tell, but we believe it had wide wood clapboards and painted wood trim.

KILLBUCK AND GATES
COTTAGE FURNITURE MANUFACTORY
BURLINGTON, VT.

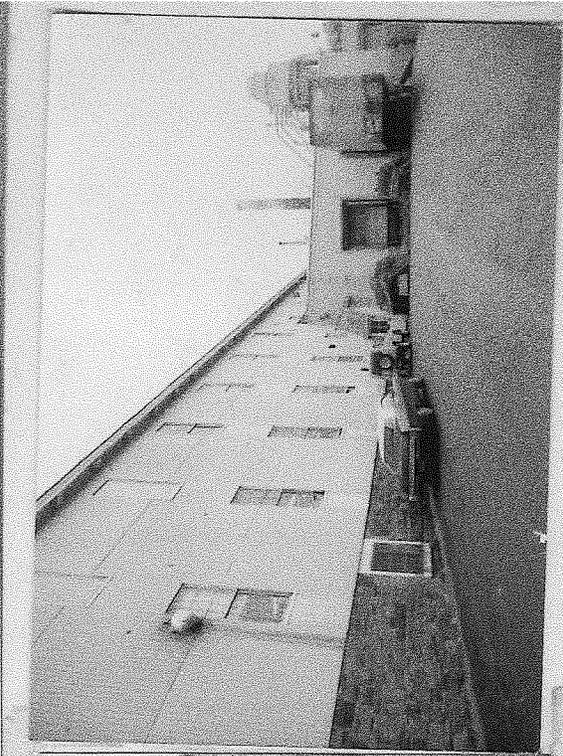
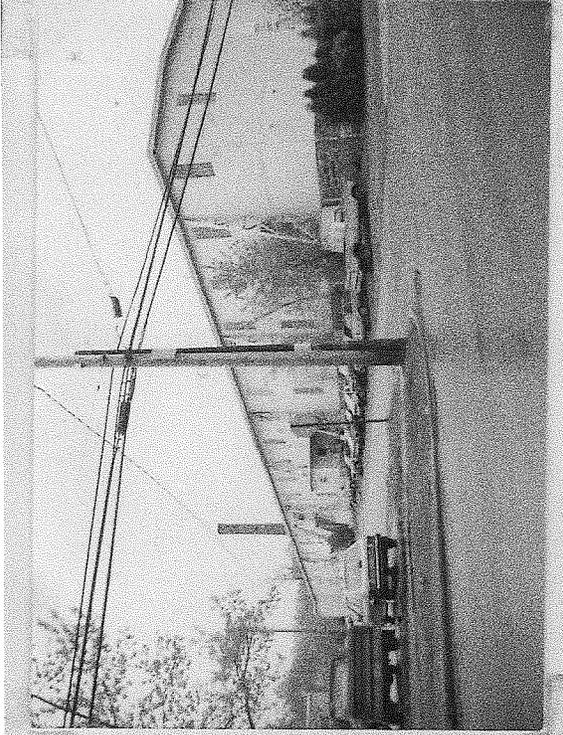
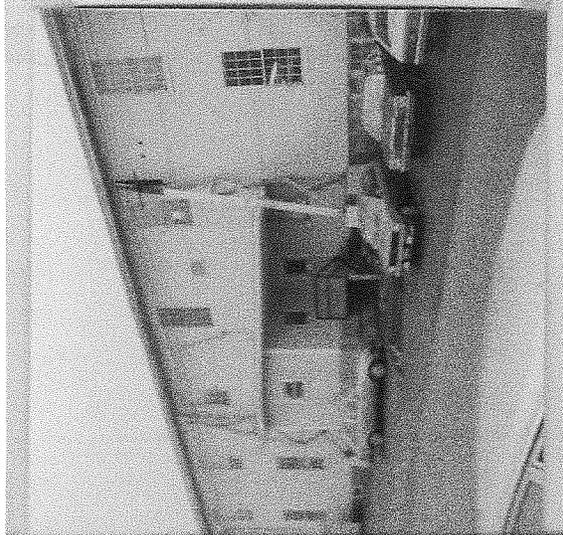
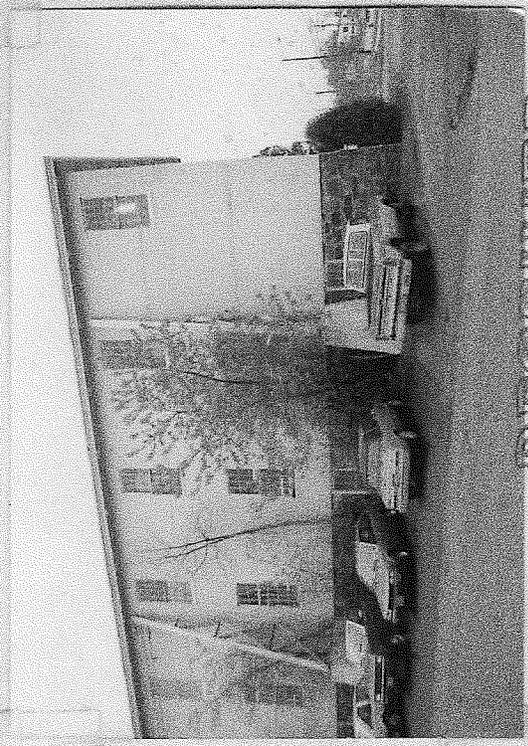
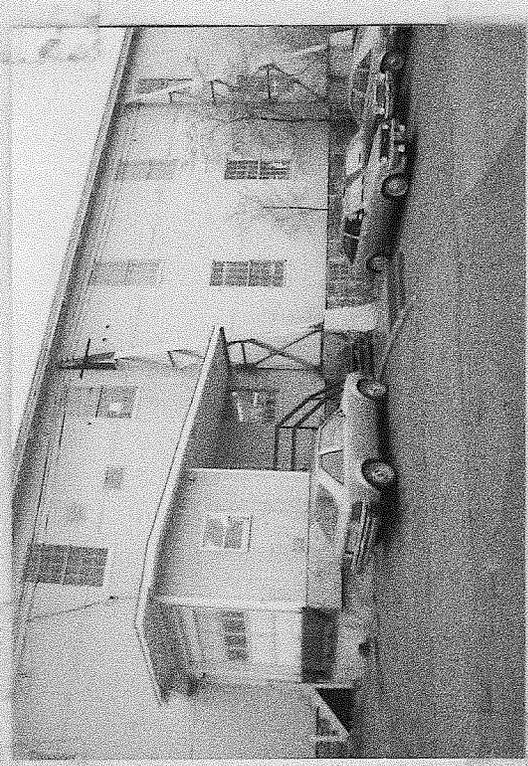
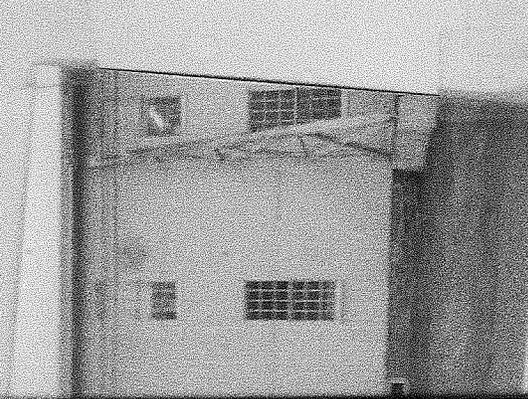
EXHIBIT
B

A picture of the building as it was just before being renovated in 1986. Of note: the original window trim and clapboard siding had been removed. Metal siding was installed and no window trim, corner boards or water table boards were installed. It appears, however, that the original wood roof overhang remained as originally built.

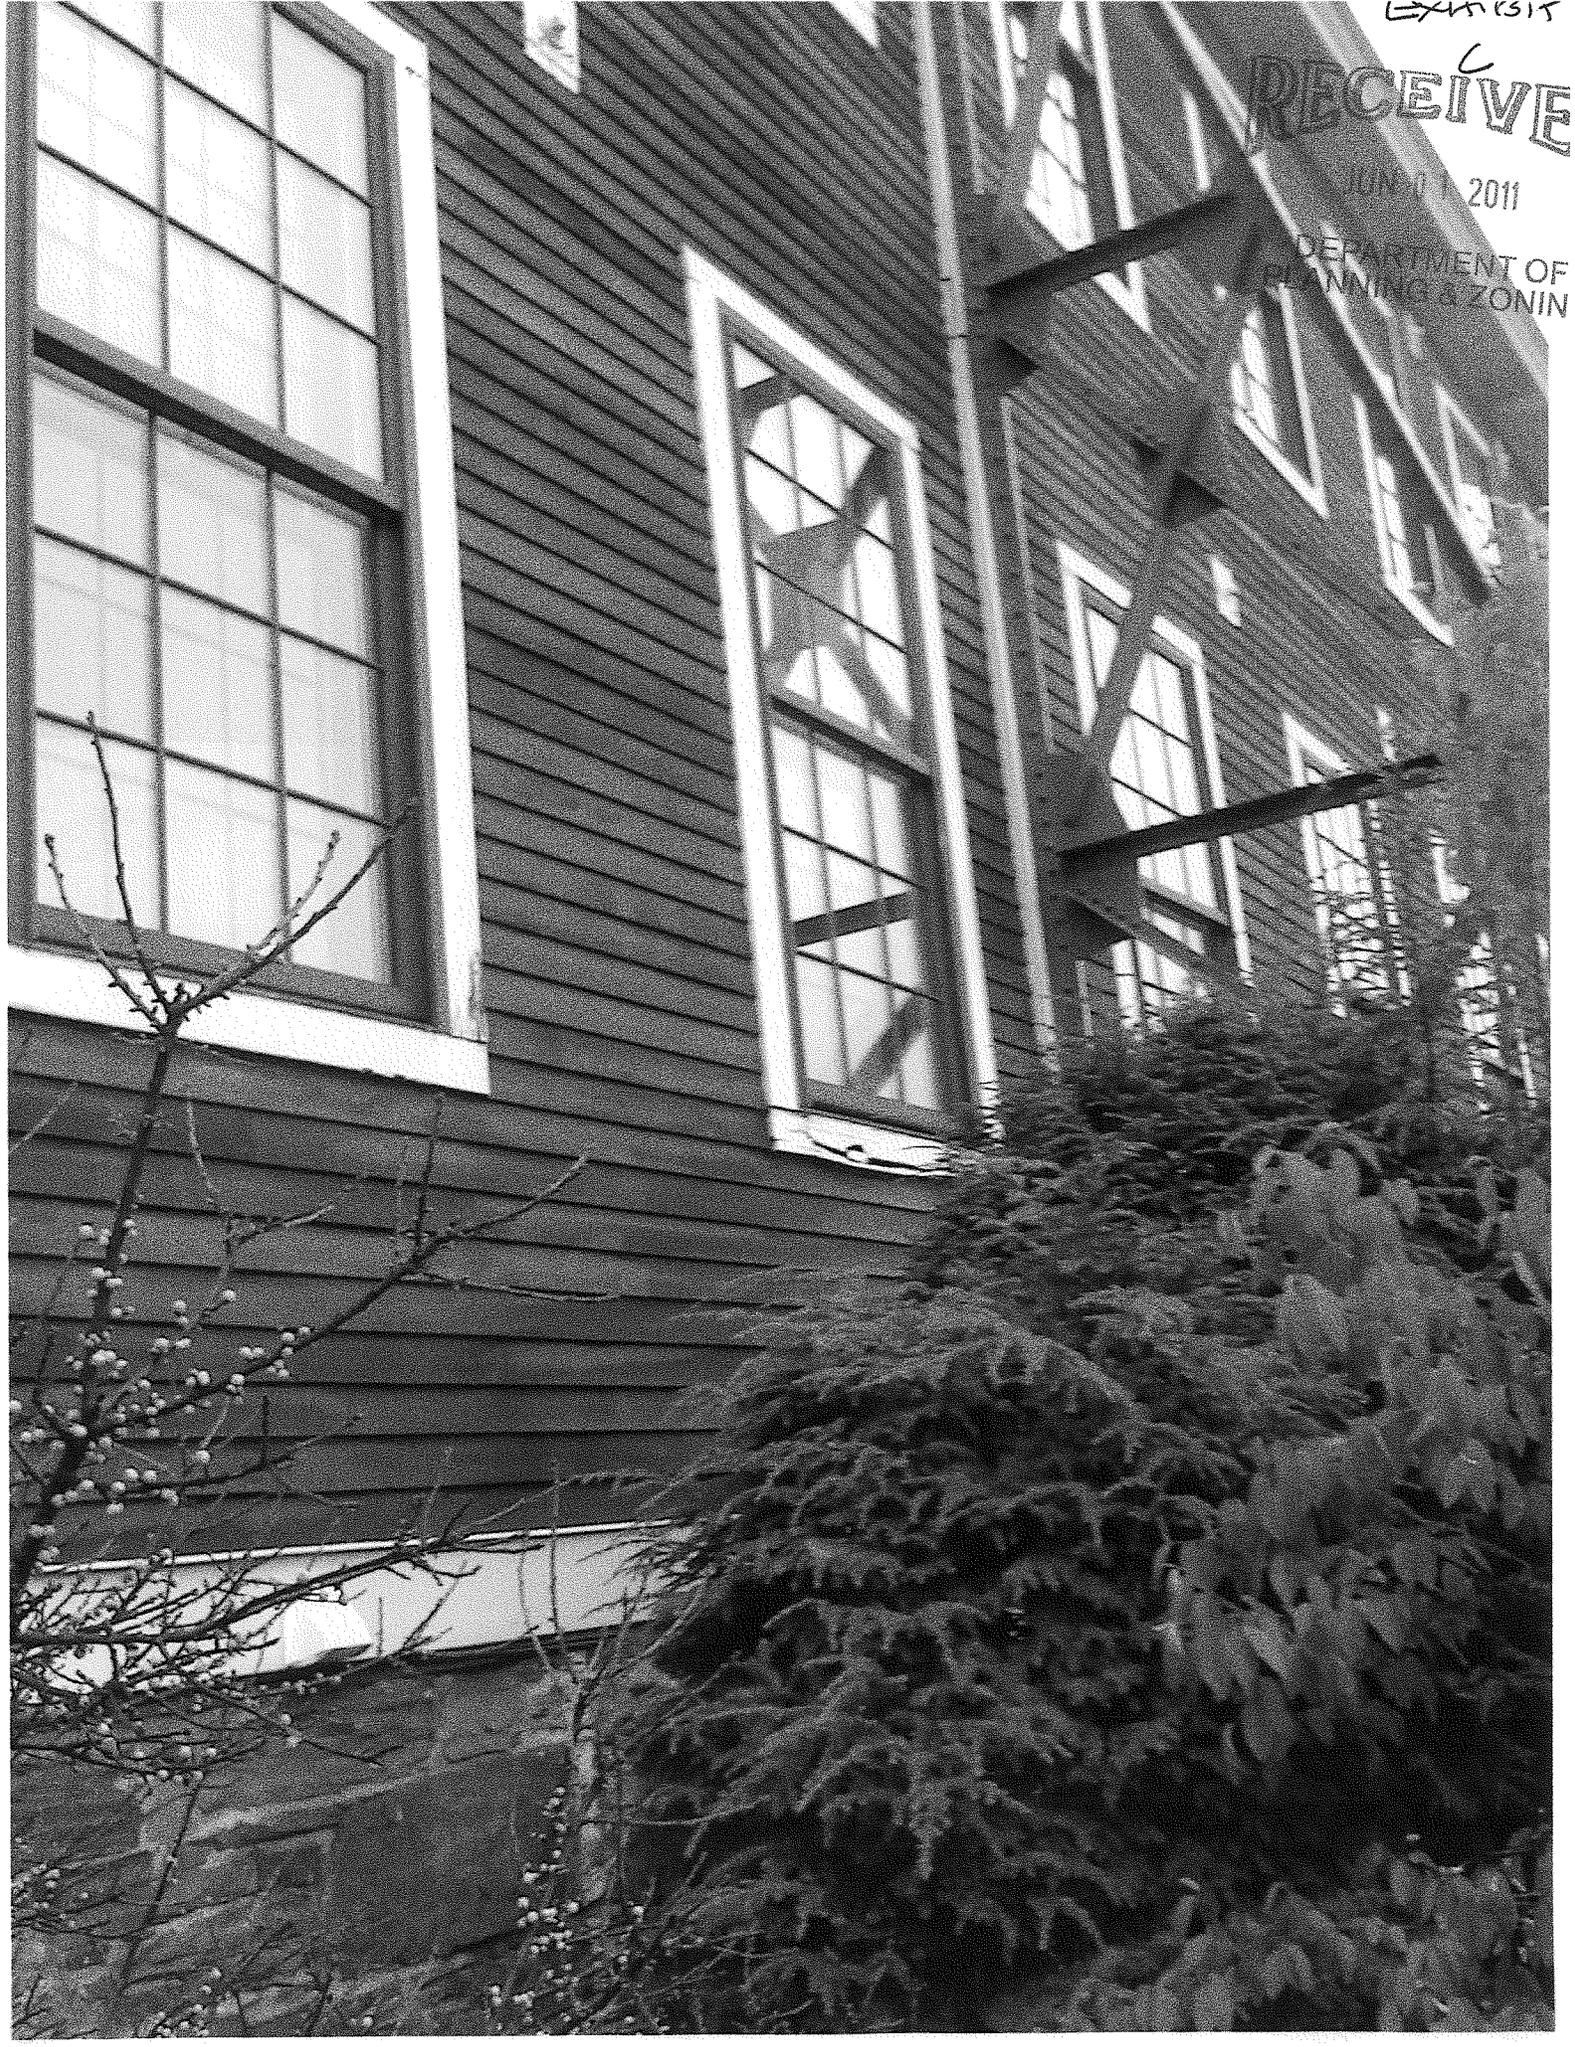
EXHIBIT

Photographs of existing conditions underline the failure of the wood trim. The question is relative to what exactly has deteriorated: Original trimwork, or 1989 replacement trim? It is quite possible to replace the trim with wood (*the new feature will match the old in design, color, texture, and where possible, materials...*); however the ordinance provision allows the consideration of materials produced from modern technologies. The appropriateness of the proposal is at the interpretation of this board.

A picture of the current façade installed in 1987. Of note, the metal siding was removed and trim and clapboards installed in an effort to bring the façade back to it's original configuration. Also of note is the failing painted white wood trim. It appears, again, that the original wood roof overhang remains as originally built.

Even if the existing wood material is a replacement of an original, the replication of composition more closely aligns with the original building component as constructed. Staff recommends **denial** of the request in viewing with strict conformance to the ordinance, and offers a recommendation to replace existing building trim with wood and only to the extent that failure demands.

It is our intention to replace the non historic wood trim around windows and doors as well as failing corner boards and water table boards with a sustainable AZEK white trim that has the look and feel of painted white wood trim. Since the original historic trim was removed previously it can no longer be repaired (per Sec. 5.4.8 (b) 6. Of the Ordinance) but replaced with a new technology product that we feel should be allowed. We have every intention of maintaining the wood roof overhang that is original and historic in nature. Should you have any questions or concerns feel free to contact me.
