# North Beach Campground Amenity Siting Study & Conceptual Master Plan

Burlington, Vermont

AUGUST 2017

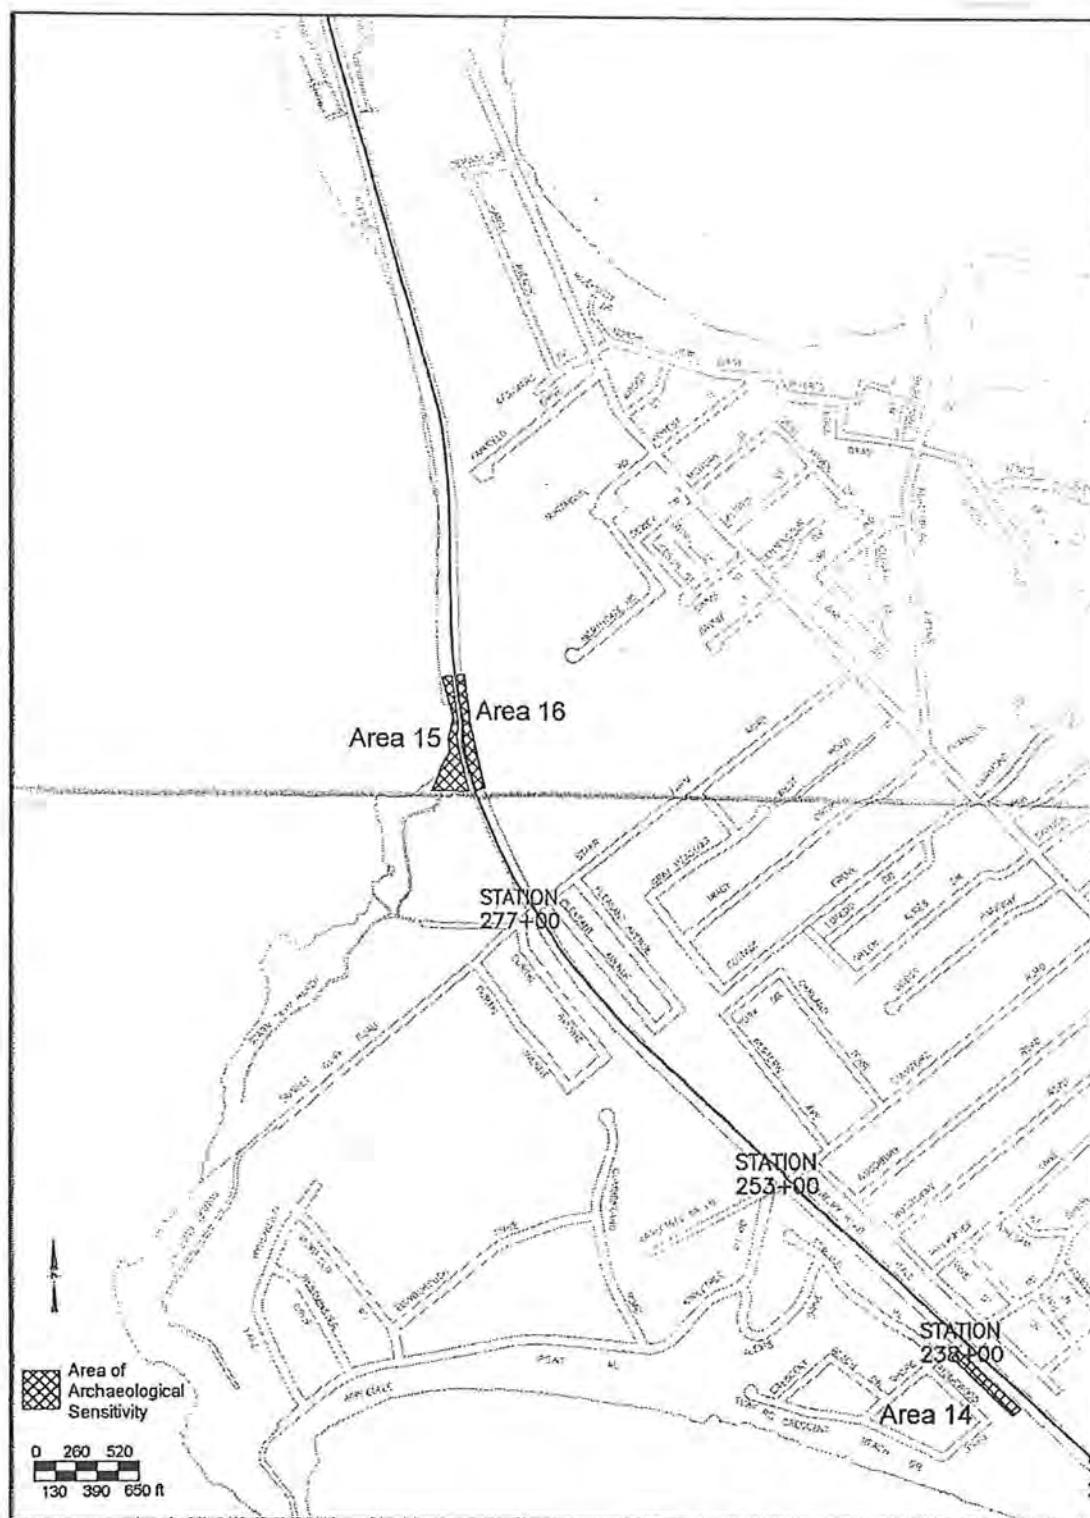
Figure 7. Location of Archaeological Sensitive Areas 14 - 16, along the Waterfront Bike Path, Burlington, Vermont.
