MEMORANDUM

RE: ZP 14-1064CA/CU 65 Charlotte Street

Request: Demolish existing one car garage/shed; replace with new shed in a different location on the lot.

RE: Garage Structural Conditions Assessment
EV# 14228

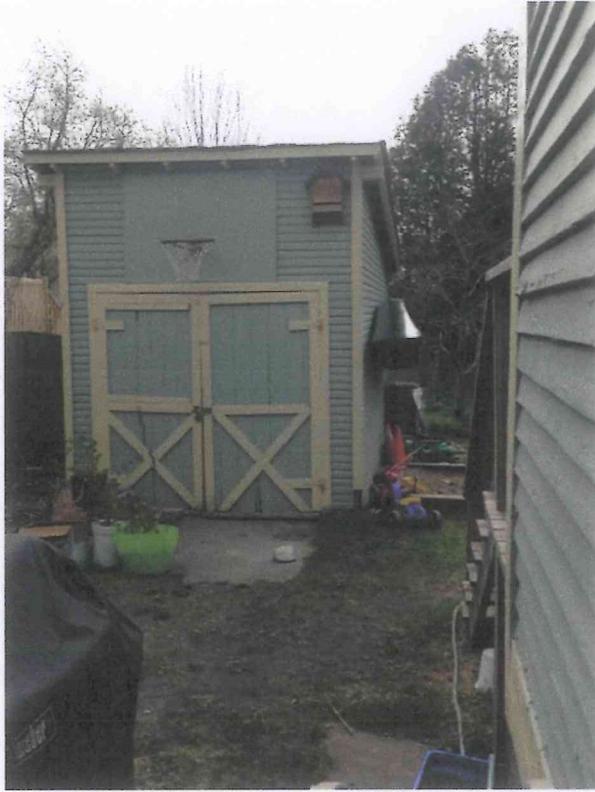
The proposed location of the new shed would be at the back of the lot with its rear wall at the same position as the back edge of the raised bed garden, 12' from the back fence.

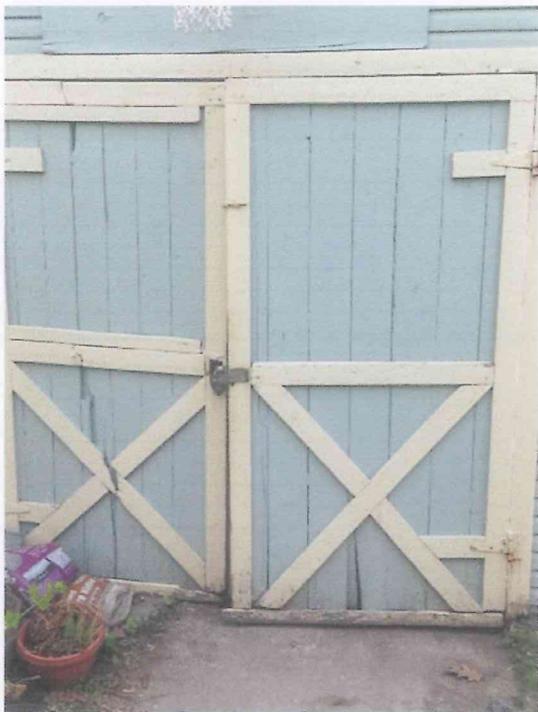
The structure sits on a crumbling concrete slab, which has sunk below grade over its lifetime. As a result, water flows into the shed pooling in the areas of the slab where the concrete is cracked, missing, and exposing dirt. This sunken slab is especially problematic in the winter when rain or melt water pools at the entrance to the shed and freezes, making entrance impossible until the ice is chopped away.

Cracks run throughout entire slab.

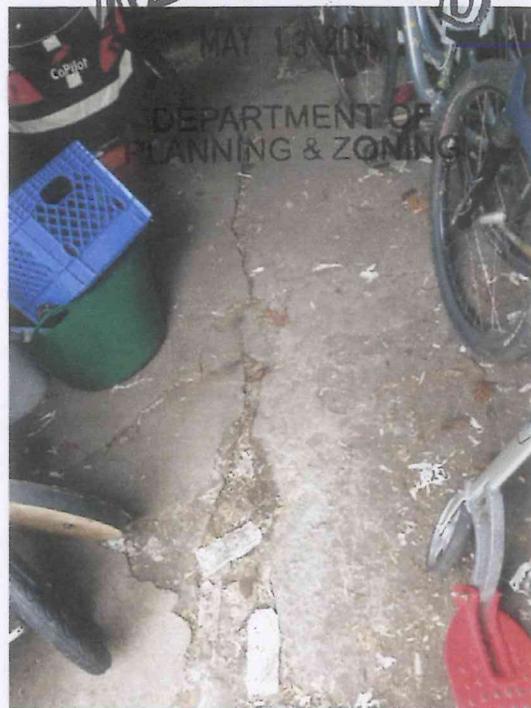
The low spot at the center of the photo is bare dirt.

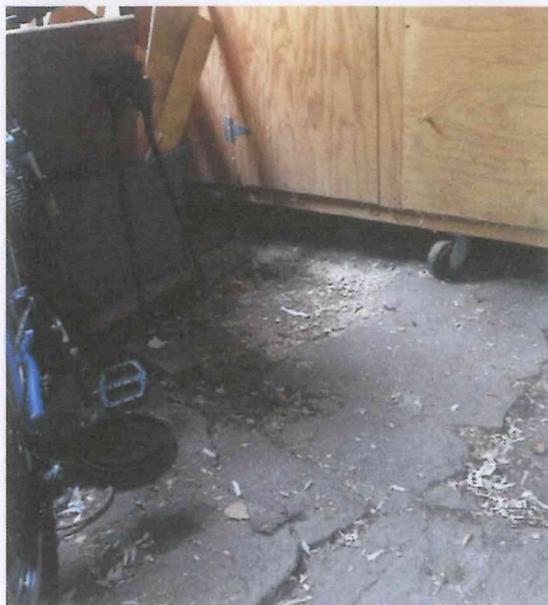
Doors sag a bit. A large crack in the left door was repaired before our ownership. Doors continue to be damaged at the bottom by winter ice.

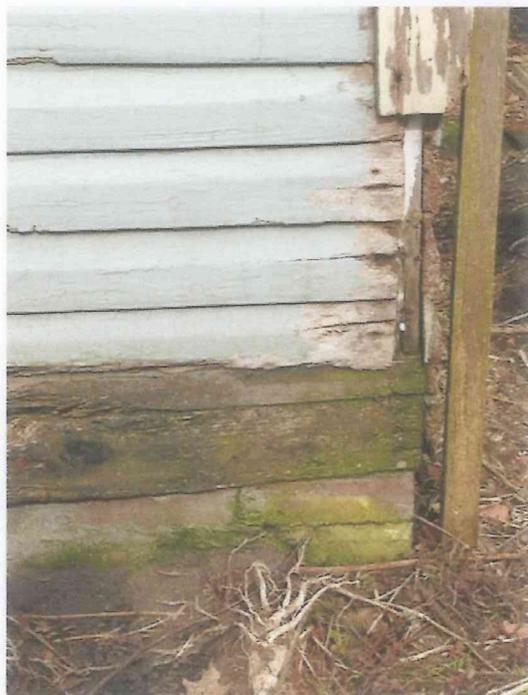
General deterioration.

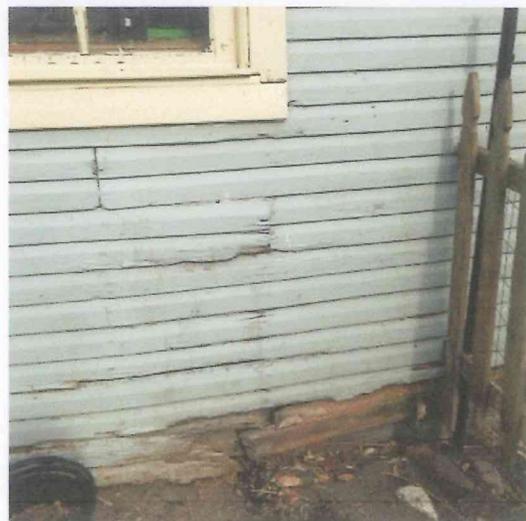
- It appears that areas of rot exist along some of the wall sill plates at the foundation level.
- The back wall of the garage is bulging out and appears to have been hit by a vehicle. Exterior siding is broken and we speculate that some of the wall studs are also broken

due to the extent of the bulge. The chicken coop obstructed our view of the interior framing.

The cracked and bowed back wall mentioned in the engineer's report.

- Roof rafters need to be reinforced.
- Reinforce the roof beam.
- Reinforce the header over the garage door.
- Rebuild a portion of the back wall that was damaged.
- Provide diagonal bracing or sheathing on the interior walls to lateral stabilize the structure.
- Replace any rotted sill plates.
- Investigate the condition of the existing foundation below the bricks. If a foundation does not exist below the bricks, then we recommend a constructing new concrete foundation around the perimeter of the garage.

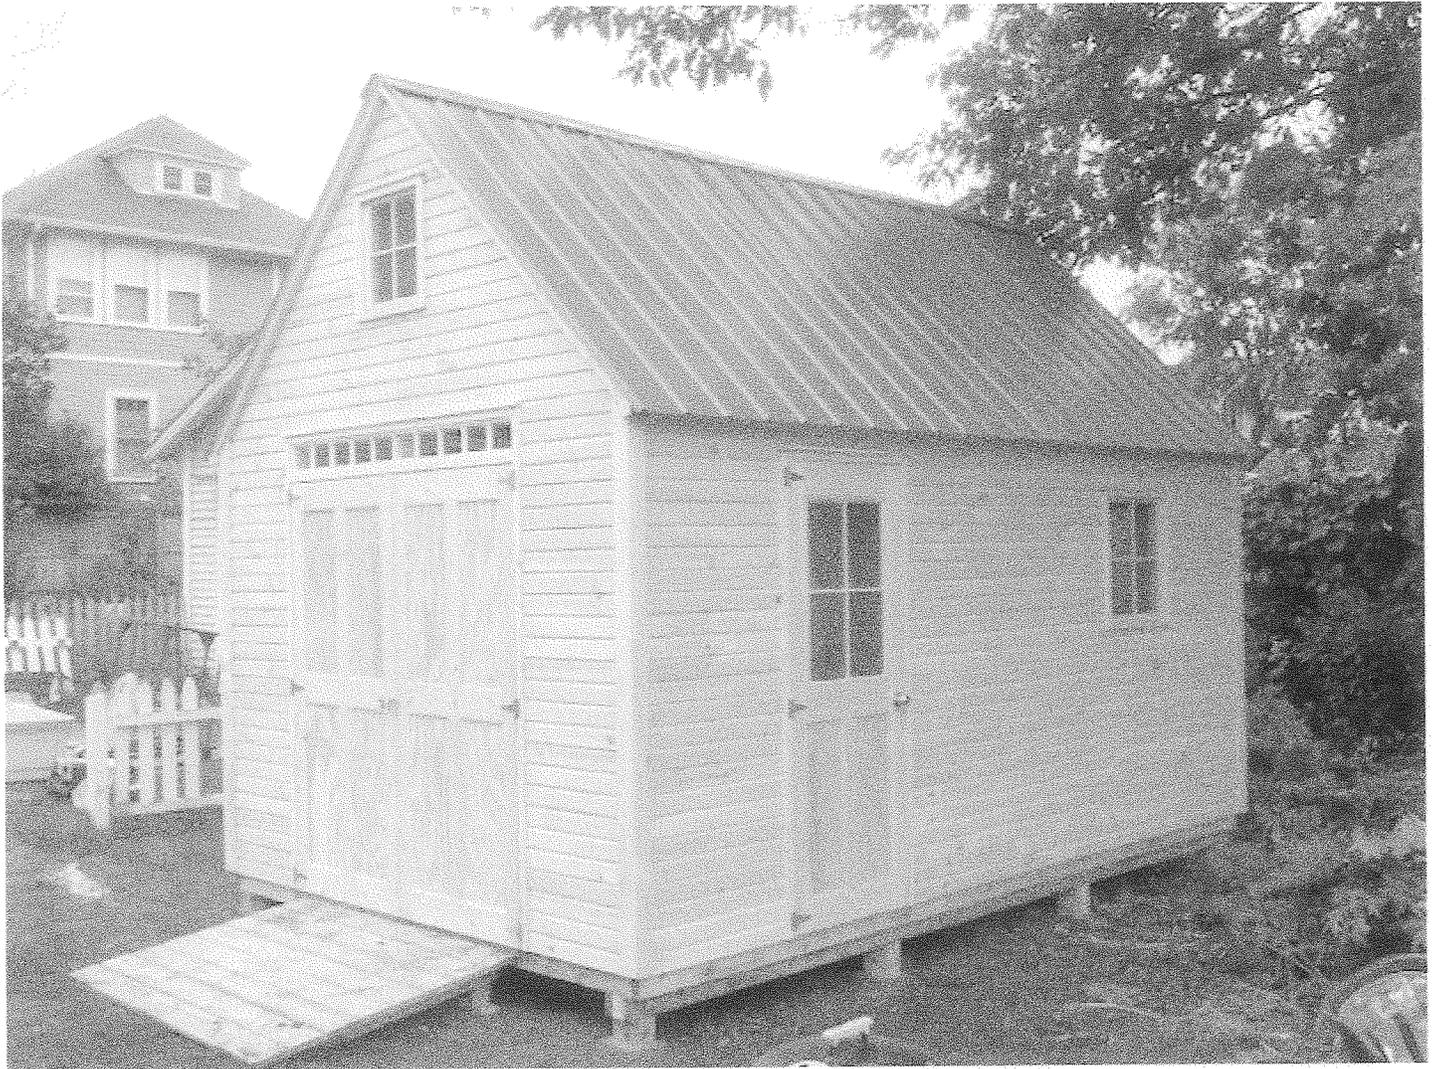
10 x 16 Foot Shed Model: 062_1016

Size: 10 x 16 feet, Walls: 7 feet, Roof color: (7) Red, Roof pitch: 12/12, Location: Burlington, VT

Similar design to proposed, new shed.

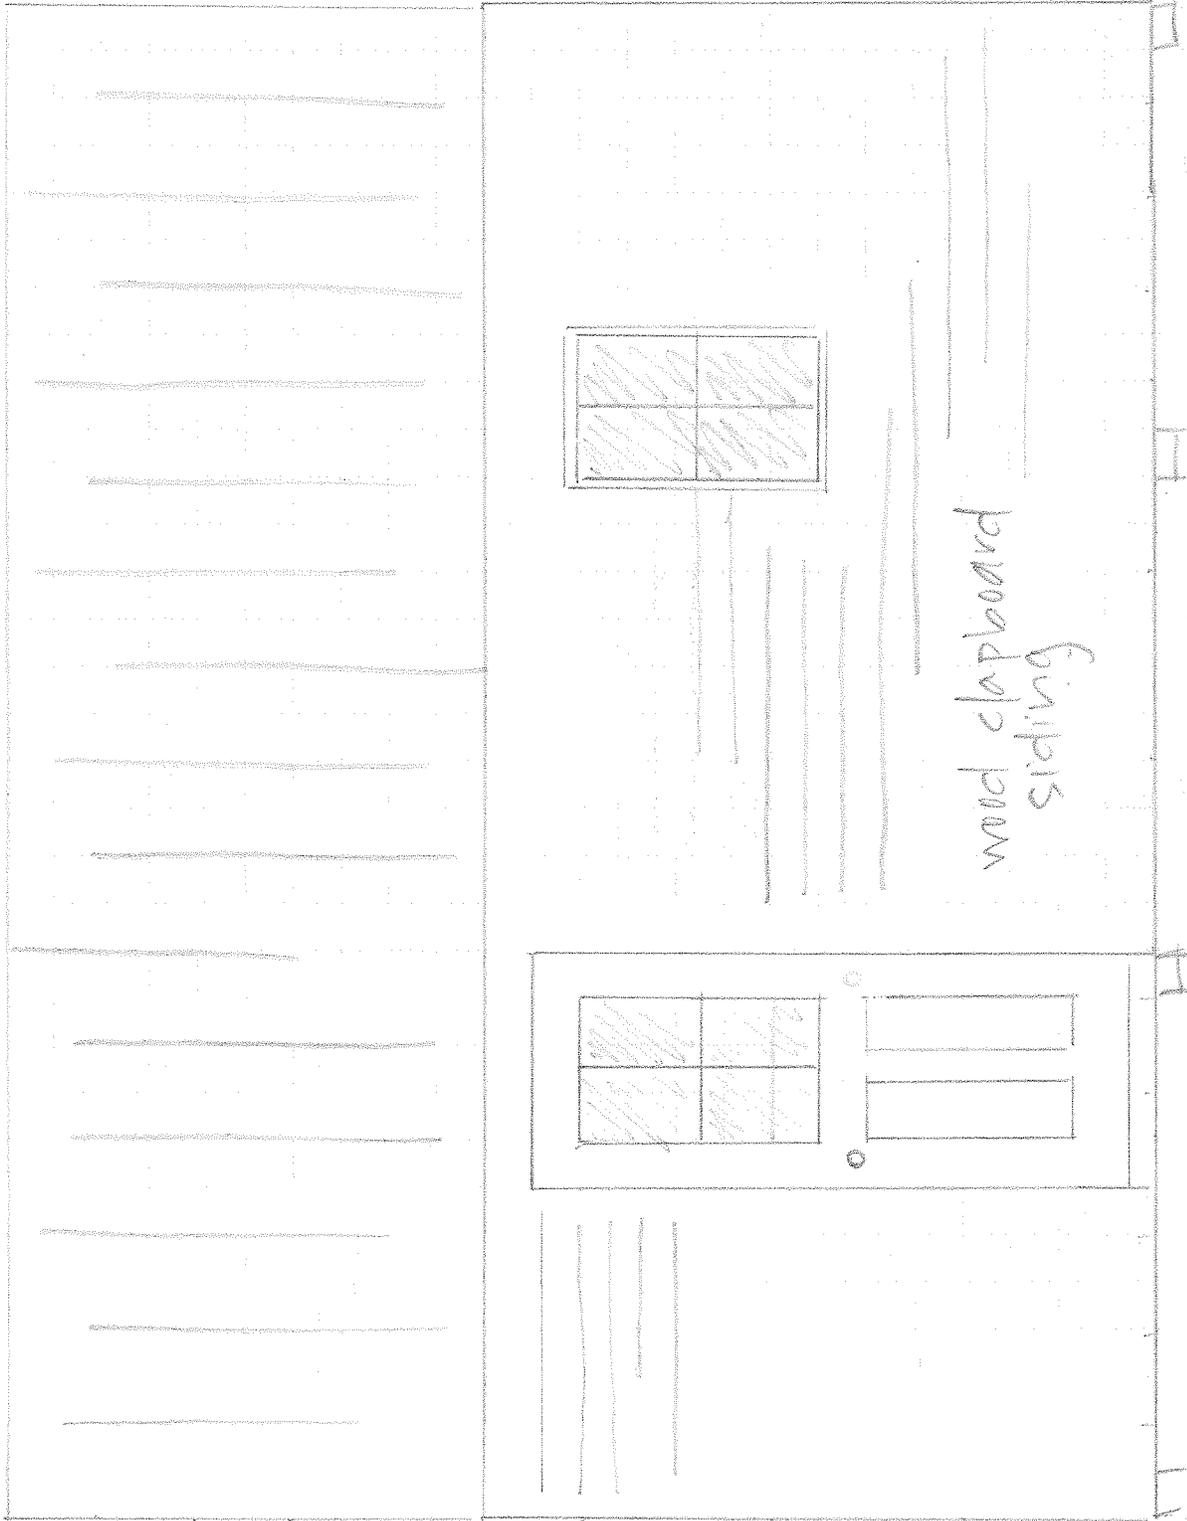
Proposed New Shed
East wall - facing street

grey metal roof

12/12 pitch

west wall facing fenced will have no windows

wood clapboard siding

piers

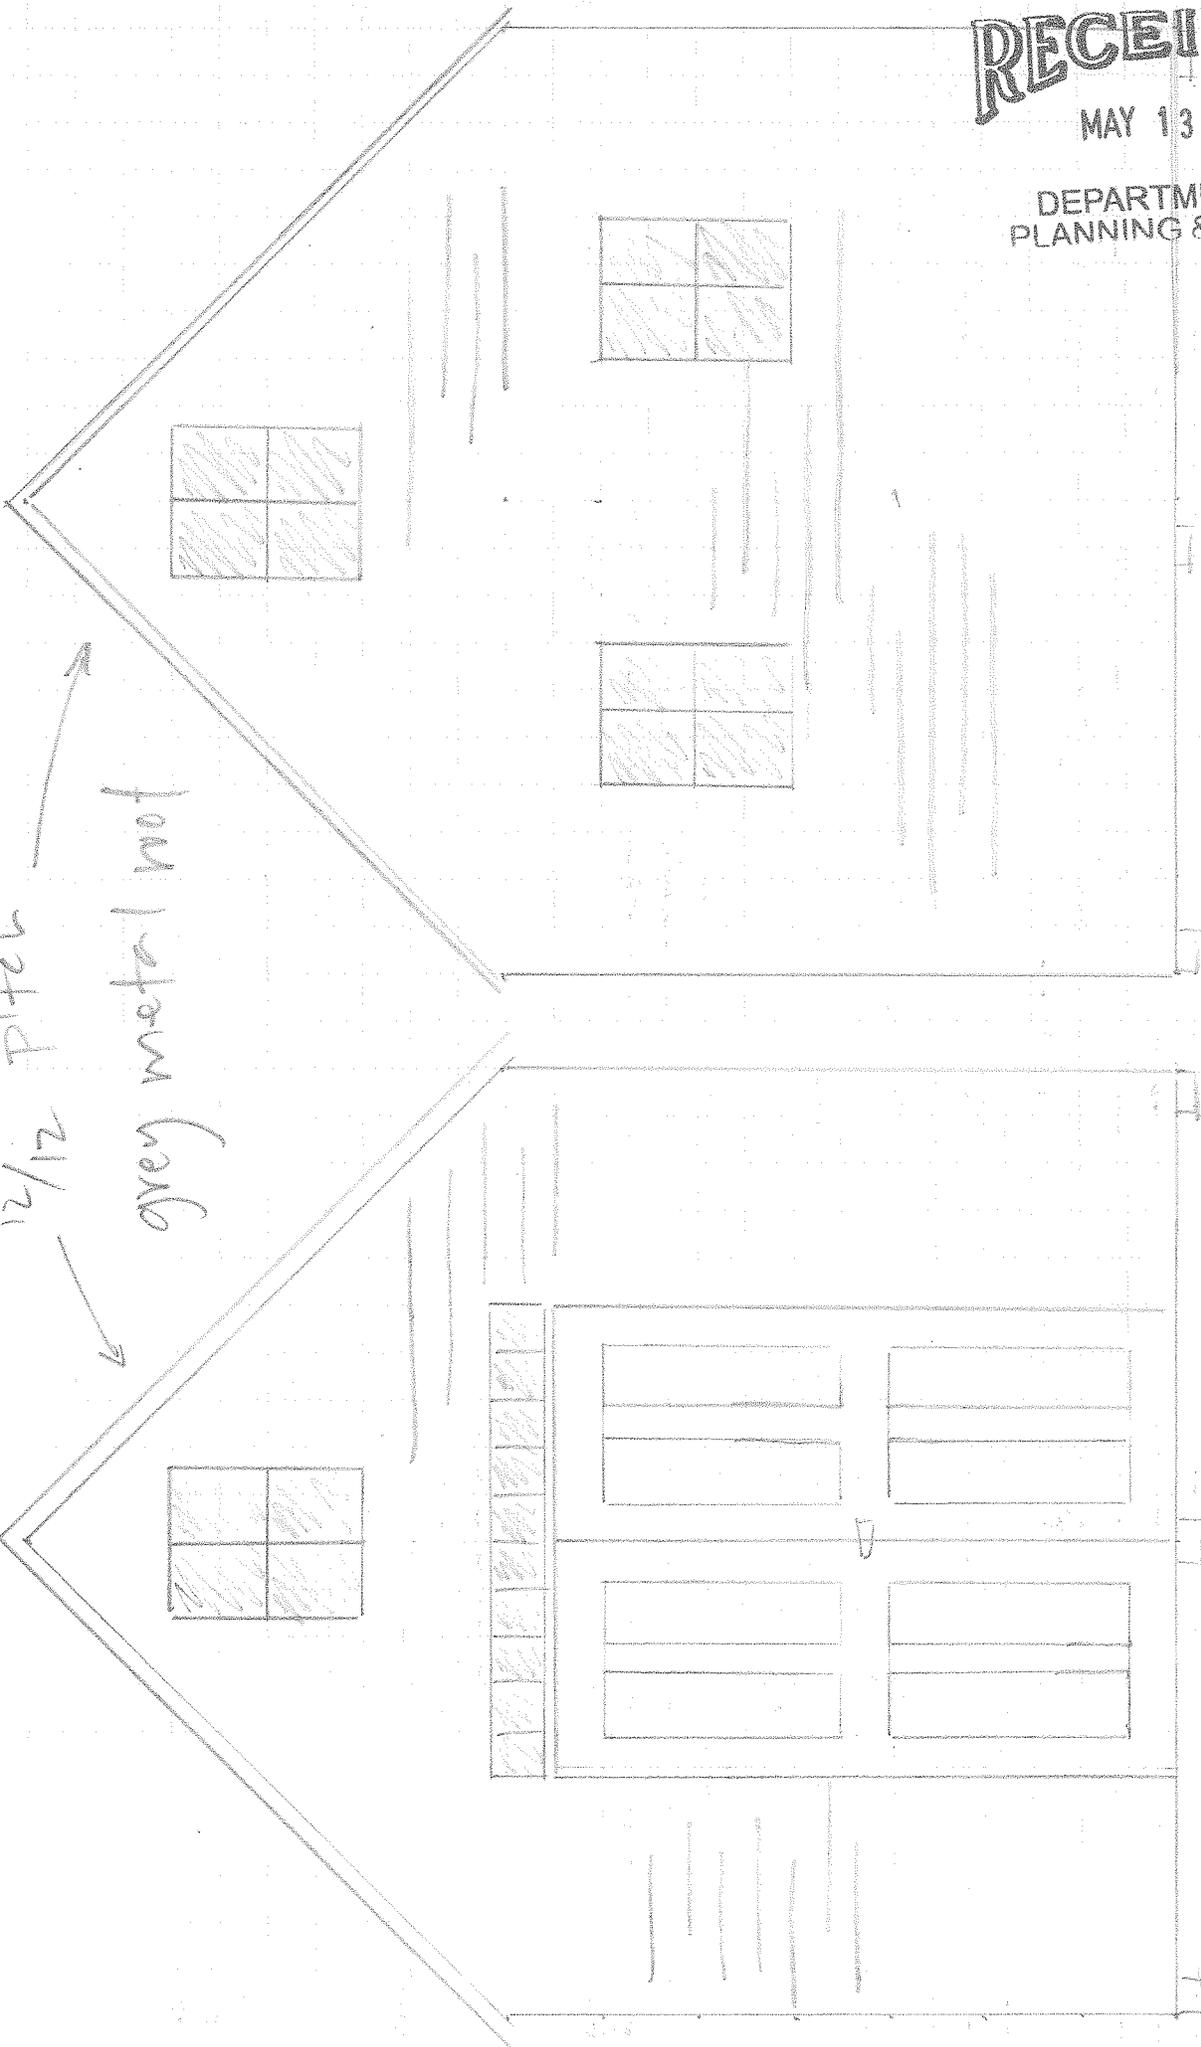
12/12 Pitch
grey metal roof

South wall

North wall
