JAY WHITE, ARCHITECT, PLC

Burlington Zoning Department RE: ZP15-0747SP, 495 Colchester Ave.

**Description of Proposed Project,
Revised and Resubmitted on June 6, 2015**

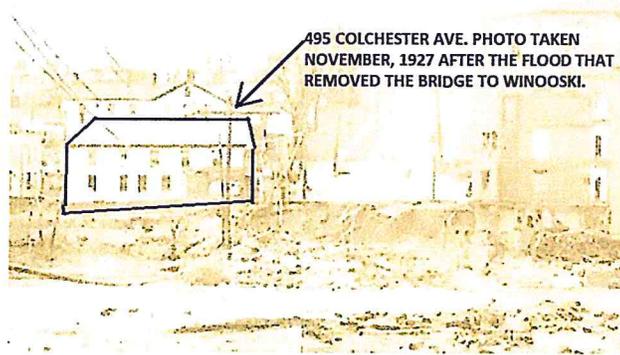
Historic Photo (1927) showing building before it was buried

After the flood of 1927, this historic building was buried when the current bridge to Winooski was built at a higher elevation. As a result both of the lower two floors (that used to have on-grade access and daylight at both levels) are now well below grade. Basement window-wells were added in the first floor (which seems like a basement) in an attempt to get some daylight this floor. These window-wells have had to be covered with little shed roofs in an attempt to mitigate water coming off the roof and blowing rain and snow from flooding the first floor. Apartments at that level get almost no daylight.

The former stone-walled cellar below the first floor originally had windows above grade on the north side, and full on-grade access and tall windows to retail space on the east side. These have been removed and filled in with concrete block. This floor is now entirely well below grade and is useless except as a place for the building's boiler room. A sump pump runs nearly constantly to keep water out of the cellar.

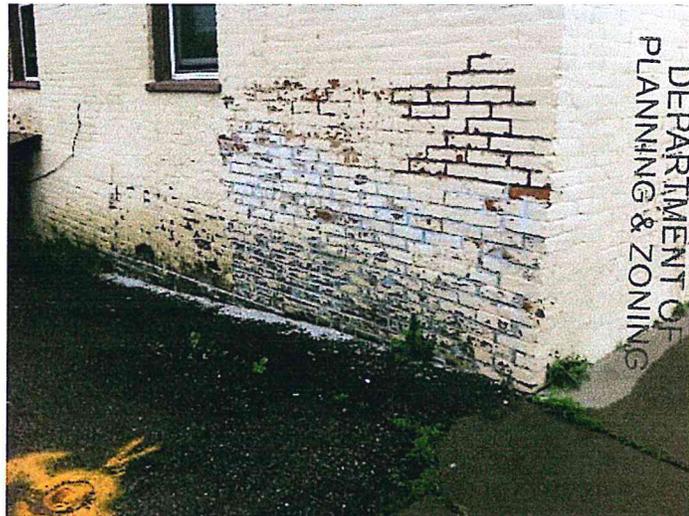
The upper two floors are constructed of brick veneer just one wythe thick, supported on a heavy-timber frame similar to the other mill buildings in the area. When the building was buried, a concrete retaining wall was poured against the brick veneer walls on the north and west sides. This supports the current raised street elevation, but has caused significant damage to the buried brick and wood frame behind it, as seen below in the photo of rising-damp on the west end of the north facade.

Rising damp damage to bricks at west end of north façade.

The recommendation from us -- and as confirmed as the best solution by Caitlin Corkins from the Vermont Division of Historic Preservation who has conducted an on-site visit -- as the best way to prevent further damage to this historic building, is to simply lift the building straight up 8' 0" , including all of its heavy timber framing and posts, leaving all of the stone foundation walls and concrete retaining wall behind where they will remain visible in the Café space intended to occupy the eastern part of the cellar. This will get the historic brick out of the ground where it is deteriorating.

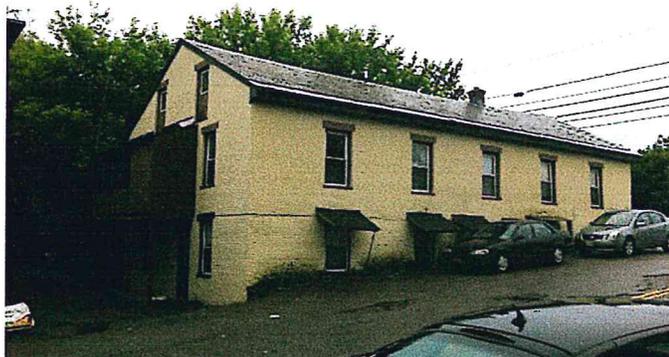
View of window wells and shed roofs over them we want to remove.

NO SITE WORK is proposed in the R.O.W. except connection to existing utilities lined under Mill Street, and the removal of the four window-wells and the shed roofs over them when the building is lifted. These will not be necessary, nor will they be replaced.

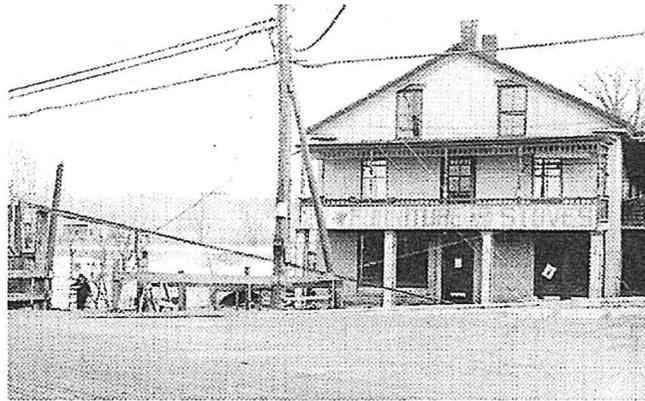
Historic photo (1927) showing original porch we are not allowed to rebuild without Vtrans permission. We will restore the façade behind the porch as you see it here.

1. Although we originally proposed rebuilding the historic west porch, we will not be able to do that unless we were to be given use of seven feet of ROW space against our west façade and the curb was moved out to align with that on the bridge. Vtrans will not allow use of non-transportation functions within the Route 7 ROW. After discussion with Laura Wheelock at the Burlington Public Works Department and Scott Gurley, an historic preservation specialist at Vtrans, it may be possible, but seems unlikely within a year and won't happen without Burlington's support. If the option becomes available, we may file to do this work under a separate permit, but it is no longer part of this proposed project. The restoration of the building, however, including restoration of windows and doors that are now buried, is part of this project.
