MEMORANDUM

Date: April 1, 2014
RE: 14-0556CA/CU; 287-289 South Winooski Avenue

Request: Demolish historic garage, construct new garage of same size in existing footprint.

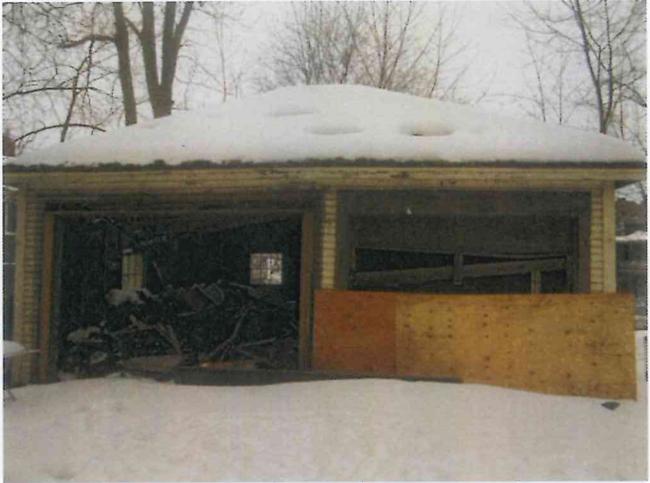
Photo #1 - Front (East) Elevation

2. The garage has a hip roof. The roof has several broken rafters and holes in it (photos #1-2 and #6-7), which is damage that resulted from a tree falling on the roof approximately two years ago.

I recommend that the structure be demolished as soon as possible, and that until that time, both the structure and the surrounding area be barricaded to prevent entry into the structure, and to protect passersby.

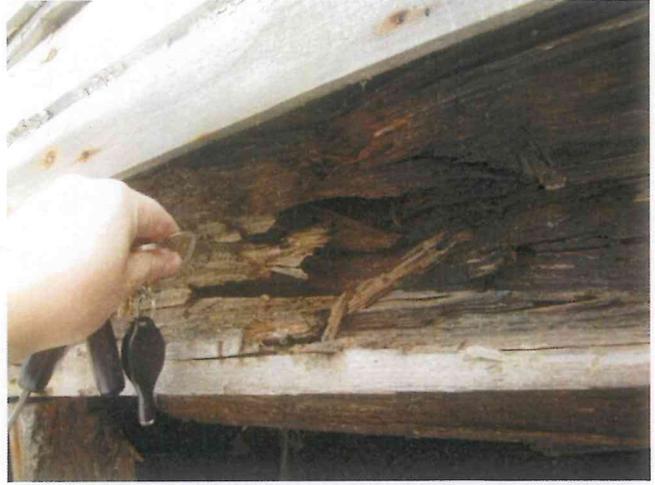
3. The rear wall of the garage has severe deteriorated rot in the sill beam below the garage floor (photos #8-10). The rot is so severe that pieces of wood break off with even light pressure.

Photo #9 - West wall, rotted sill beam

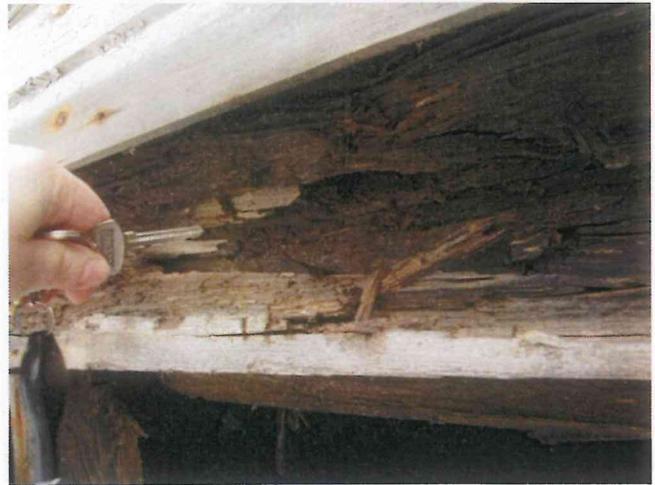
Photo #10 - West wall, rotted sill beam, breaks away with light pressure from key

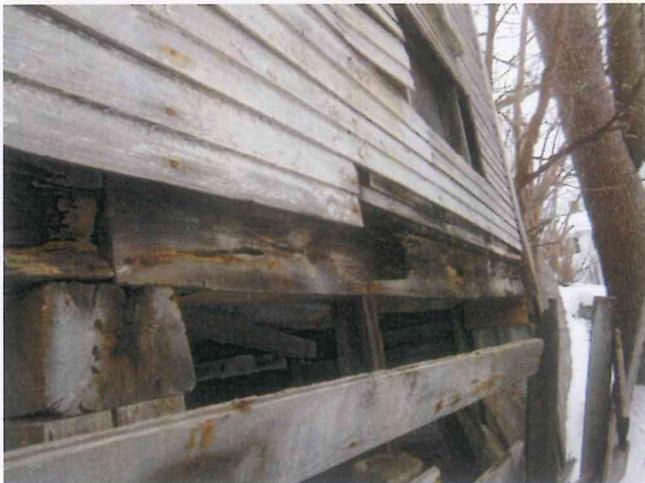
Photo #8 - West wall, rotted sill beam

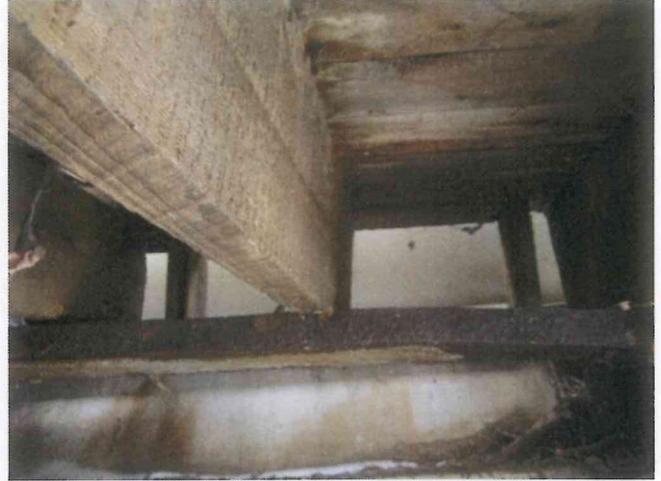
4. The south foundation wall is composed of horizontal metal sheeting braced by vertical metal struts (photos #12-15). The base of the vertical metal struts is not visible, however based upon leaning (photo #15), it appears that the struts were sheared off at the base by lateral soil pressure. The struts and the horizontal metal channel at the top of the wall are severely corroded and the sheeting is displaced (photos #13-15).

Photo #14 -South wall corroded top horizontal channel

It is also my opinion, based upon the available evidence, that the foundation is failing and that it should be replaced in its entirety. The north and south foundation walls are failing, and a collapse could occur. Additionally the interior pier supports are not stable and the west wall is deteriorated and inadequate.

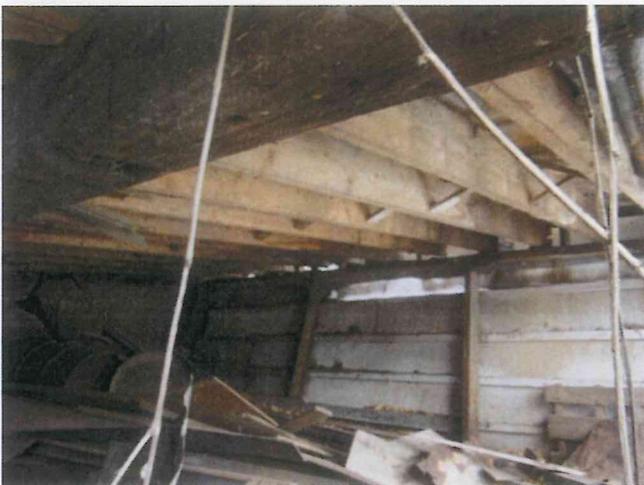
Photo #12 - South wall with failed vertical metal struts, metal sheeting and top horizontal channel

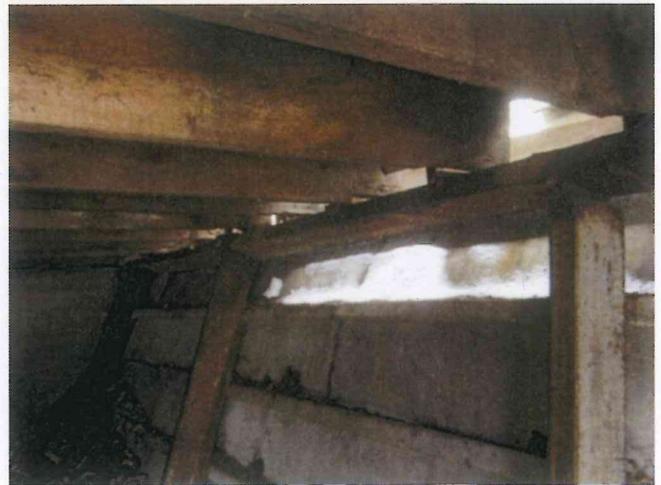
Photo #15 -South wall displaced metal sheeting and vertical struts leaning, probably sheared off at the base

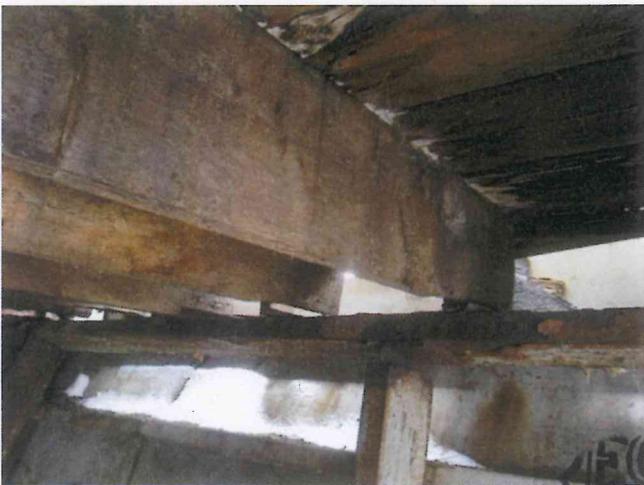
Photo #13 -South wall corroded top horizontal channel and displaced metal sheeting

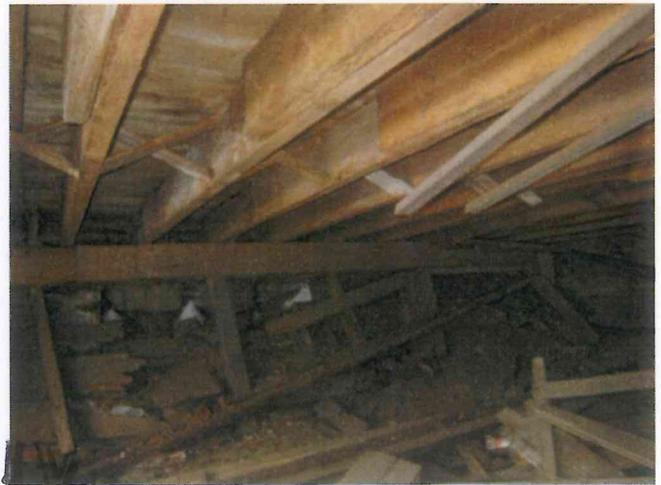
5. The north foundation wall appears to be composed of two courses of boulders, reinforced at the west end with wood sheeting. The boulders are undermined and the sheeting has failed (photo #16). The floor joists have been supported with a supplementary line of beam and posts, however the failing foundation wall is kicking out the base of the posts, and could cause them to collapse.

Photo #16 - North wall failed wood sheeting

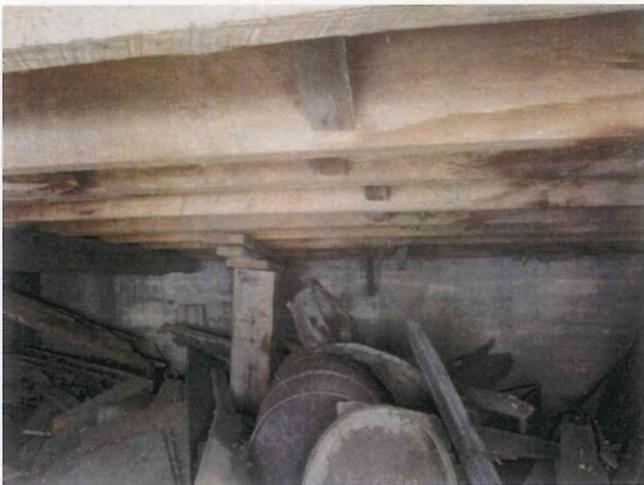
6. The floor of the garage is a wood structure supported by 2x8's at 16" on center spanning approximately 11'. The floor joists are supported on a 6 1/2"x8" wood beam with 2 spans of approximately 9'. The center beam, appears to have been reused from another structure because of the deep mortises chiseled in the bottom (photo #17). The center beam has failed in shear and flexure at the west end (photo #19). The east end of the center beam appears to have rotted off and due to the rot, it appears that there is no support at the east foundation wall (left side of photo #11 and #18). I was not able to verify this with a close examination because the conditions were unsafe. The center beam is supported by one leaning timber on a concrete base (photo #20). A supplementary timber post, with precariously stacked 2xshims, has been added under the south bay floor joists (photo #18).

Photo #18 - East wall, and timber post with shims

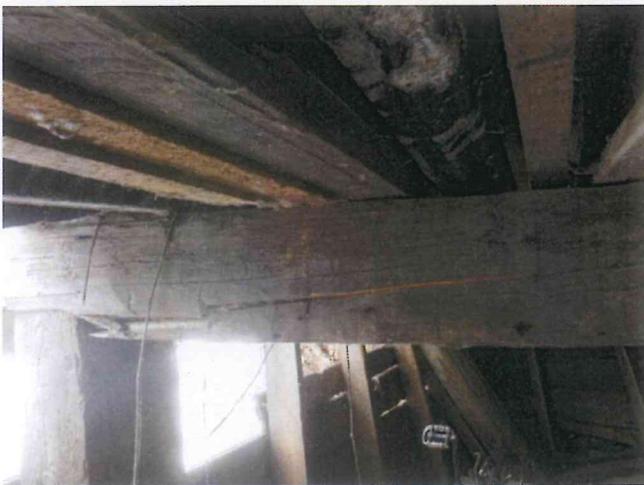
It is my opinion, based upon the available evidence, that the wood garage structure is extensively damaged and cannot be salvaged. The damage consists of both long-term deterioration of the sill plate and center beam, and shorter term deterioration due to the hole in the roof and the gaps and holes in the siding and walls. In addition to deterioration, the wood center beam has failed in flexure and shear. Furthermore, even if the center beam was replaced, neither the floor joists or the center beam are adequate in terms of size, to safely support vehicle weight.

Photo #19 - failed center beam supporting floor joists

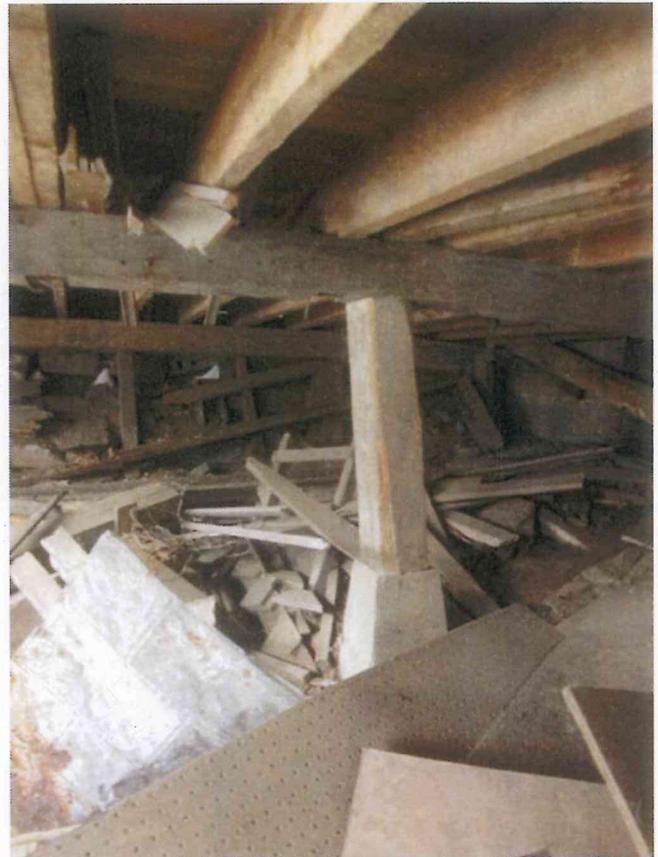
Photo #20 - leaning timber post under center beam
