City of Burlington Stormwater Management Program
MS4 Annual Report for Calendar Year 2015

In accordance with State of Vermont permit 7022-9014 issued to the City of Burlington on October 1, 2013, we are submitting the following annual report documenting stormwater activities completed in calendar year 2015.

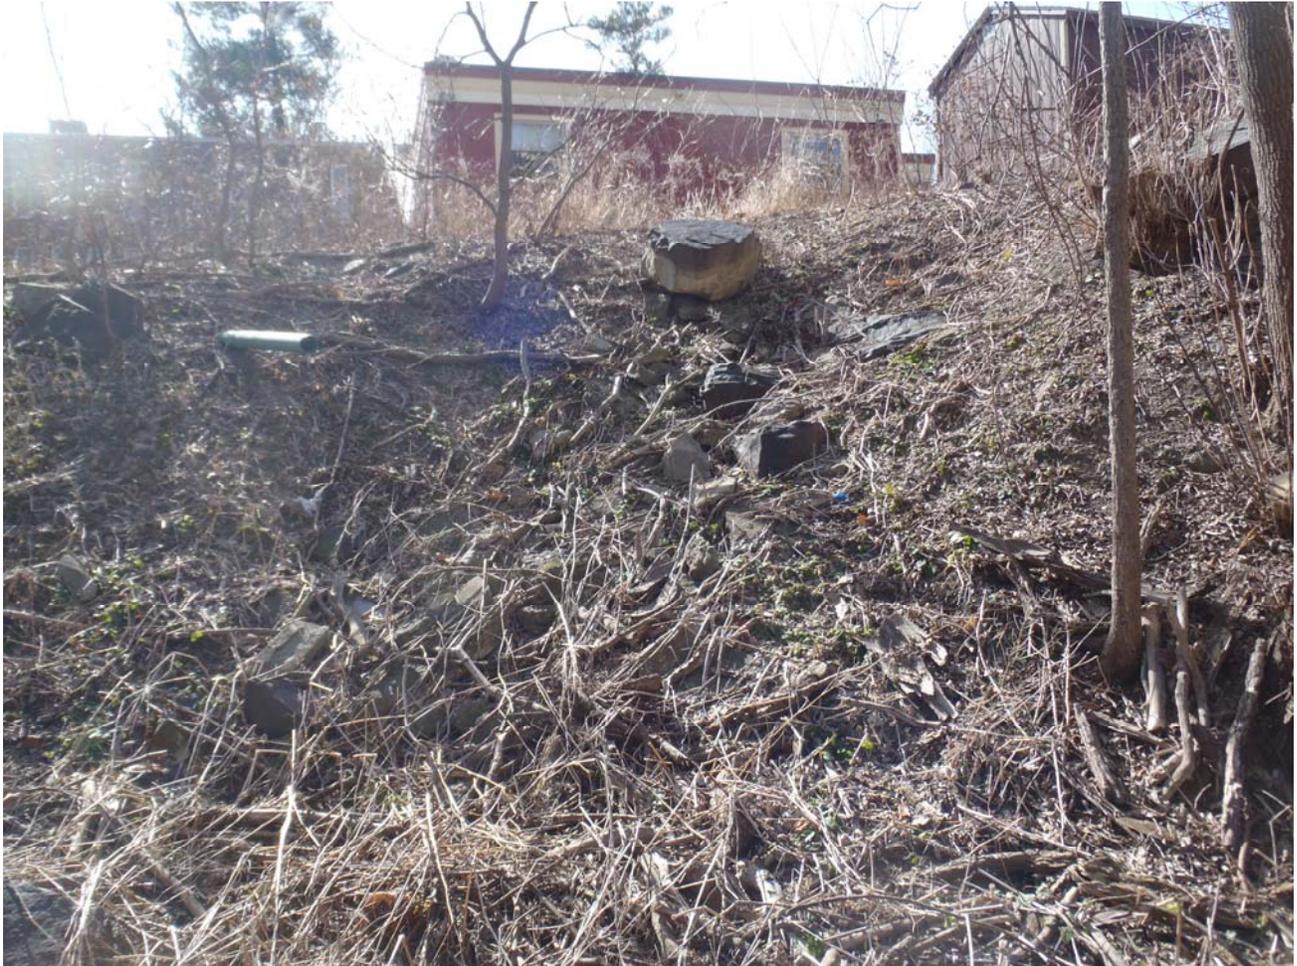
Photo 1: Presumed Location of Natural Drainage Swale and Unknown Subsurface Drainage Outlet

Permit covers the discharge of roof drainage via “stone lined ditch in natural drainage swale” to Englesby Brook; parking lot runoff does not appear to be regulated under the permit. During the site visit we found that the stone lined ditch is not well defined. The majority of flow leaving the site and discharging to Englesby Brook appears to occur via subsurface drain pipes not included in the permit; four outfalls were identified during the site visit that are not included in the City’s stormwater GIS layer, including one of which appears to divert water directly from Pine Street. In order to bring this facility into compliance with its existing permit, the stone lined ditch would need to be improved. In addition, the source of the water draining to each of the subsurface drains should be confirmed. As part of the Englesby Brook Flow

Restoration Plan (FRP), a potential retrofit was identified for managing runoff from parking lots draining to the existing green space behind 300 Flynn Ave.

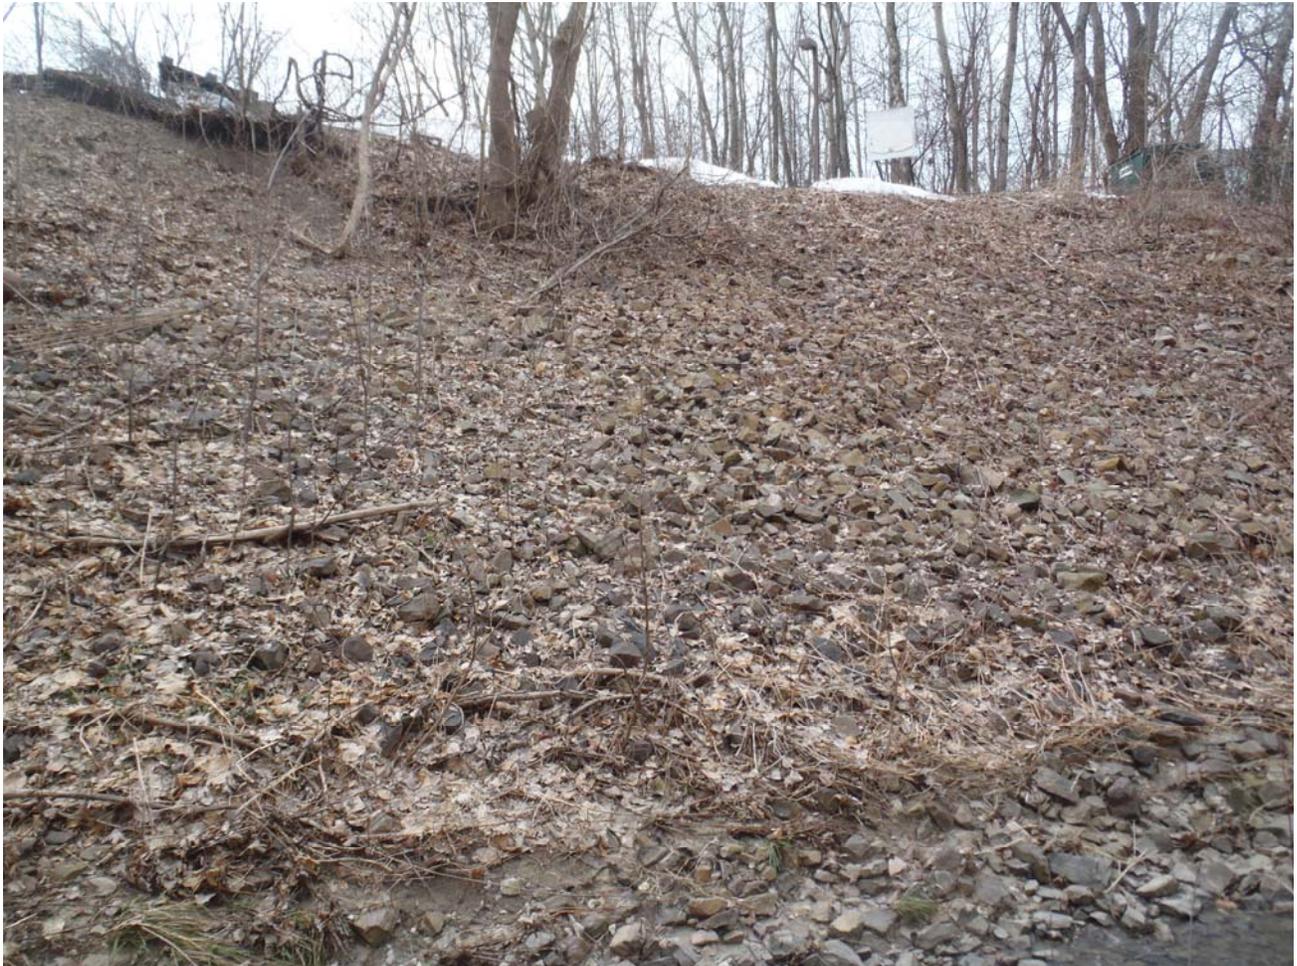
Photo 2: Rip-rapped Slope Behind 288 Flynn Ave

Permit covers the discharge of stormwater runoff from roofs and paved parking lots following treatment “via grass-lined swales, through rip-rapped areas at the top of bank of Englesby Ravine, and via overland flow across vegetated terrain...” During the site visit we found that there are grass-lined to the north of the apartment complex which appear to convey stormwater runoff to rip-rapped areas that lead down to the ravine. We also noted during our site visit that the parking lot catch basin indicated in the City’s stormwater GIS layer does not exist. This site was generally found to be in compliance with its permit. As part of the Englesby Brook FRP, a significant potential retrofit was identified for in the green space immediately to the west of 288 Flynn Ave. and to the east of the proposed Champlain Parkway alignment.

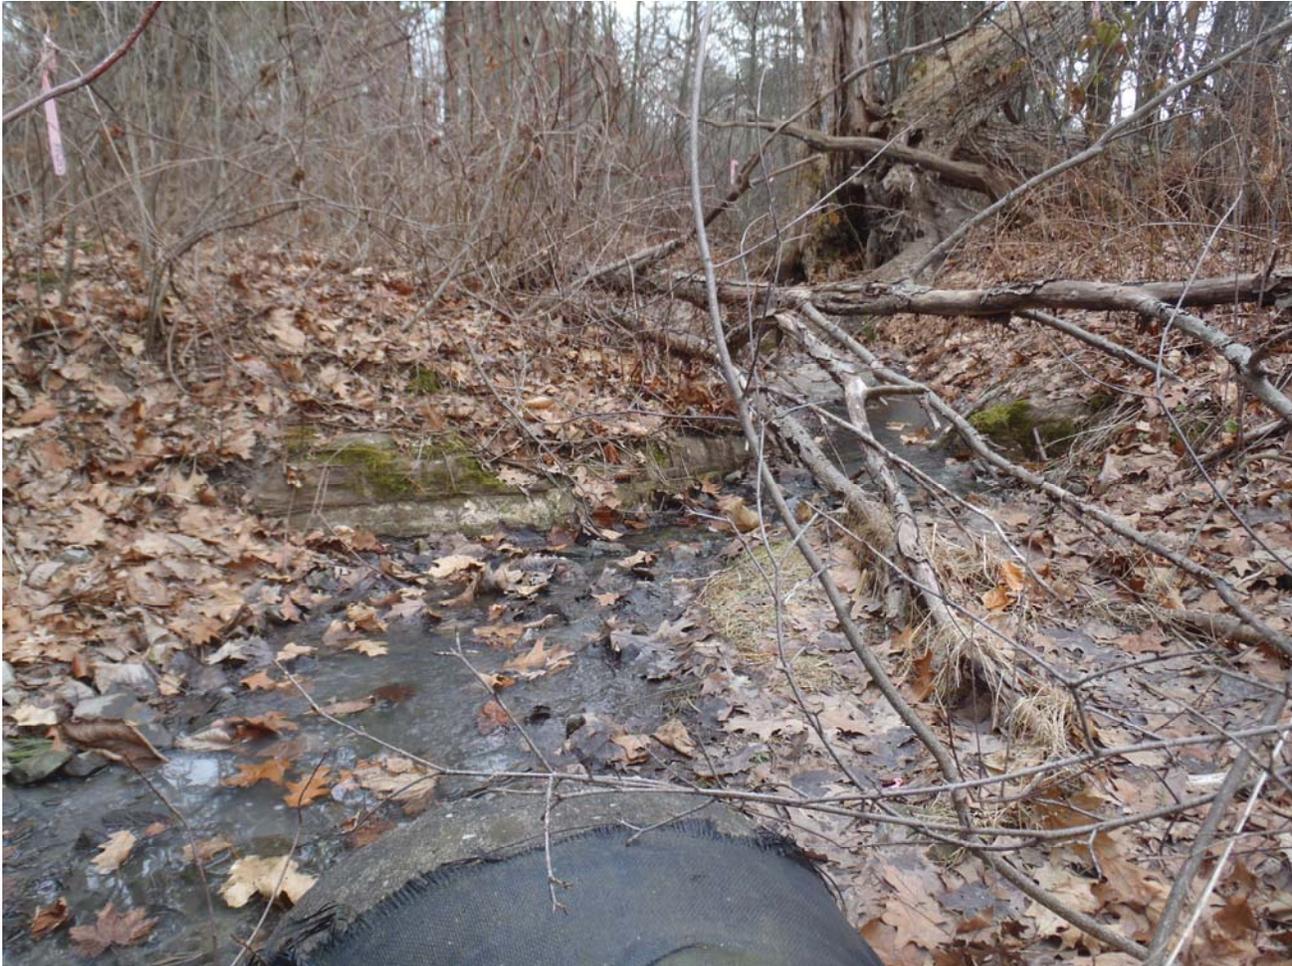
Photo 3: Looking Downstream from the 15" Concrete Pipe Outfall

Permit covers the discharge of stormwater runoff from paved road and parking lots after treatment by “passage through trap catch basins” to a stone bed and “approximately 1000 feet overland flow through wooded area and grassed drainage swale to the stream.” During the site visit we observed that sediment levels in the catch basin were below the invert of the outlet pipe, but that the outlet lacked a trap or hood. In addition, we observed a PVC pipe passing through the basin (not draining into). The stone bed noted in the permit could not be located. A 15” concrete pipe and 6” PVC pipe were both located approximately 100 feet southeast of Prospect St, which discharged into a small wetland area (see Photo 3). We followed the outflow from the wetland area for a considerable distance but could not see where it connected to the stream; a portion of the flow appeared to cross Prospect Pkwy. In order to bring this facility into compliance with its existing permit, a trap or hood would need to be fitted onto the catch basin outlet and a stone bed or other

energy dissipation measures added at the outlet. In addition, it would also be prudent to determine the source of the water passing through the catch basin in the PVC pipe in order to guard against a potential illicit discharge were it to carry something other than stormwater. As part of the Englesby Brook FRP, a potential retrofit was identified for managing runoff in the green space at the southern end of the parcel.

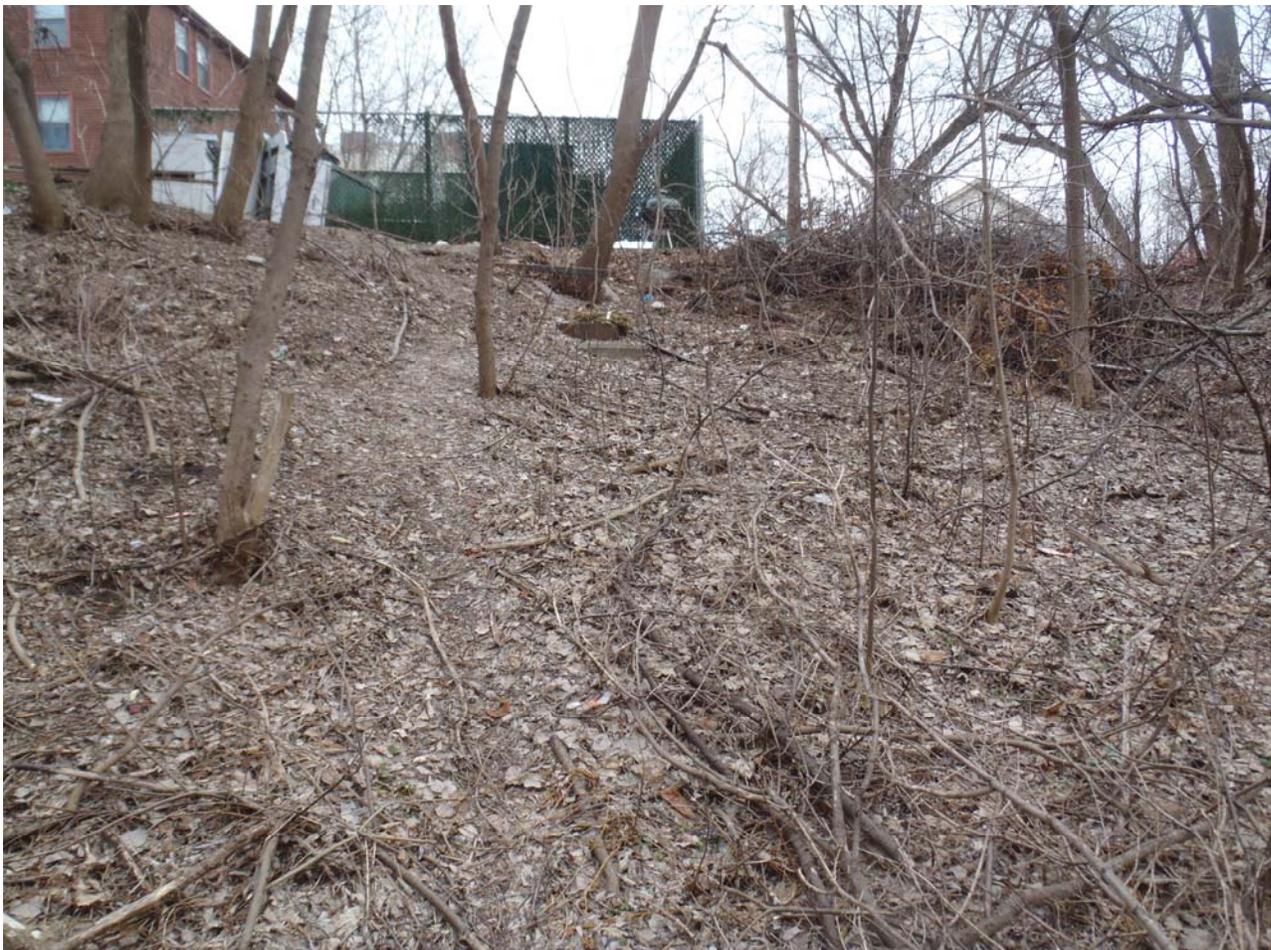
Photo 4: Looking East toward Dumpster Cage and Probable Septic Tank Location

Permit covers the discharge of stormwater runoff from paved parking areas after “passage through trap catch basins and a 1500 gallon septic tank in series” before being piped directly to the city stormwater system. During our site visit we observed that sediment in all three parking lot catch basins has accumulated above the invert of the outlet pipe. No access manholes (or similar) for the septic tank were observed; the septic tank may be located under the dumpster cage in the south west corner of the parking lot (see Photo 4). The catch basin indicated in the City’s stormwater GIS layer in the green space/courtyard area near the building could not be located. In order to bring this facility into compliance with its existing permit, the catch basins would need to be serviced and a trap or hood would fitted onto each of the outlets. In addition, the septic tank should be formally located and likely serviced. As part of the Englesby Brook FRP, a potential retrofit was identified along/underneath the western edge of the parking lot.

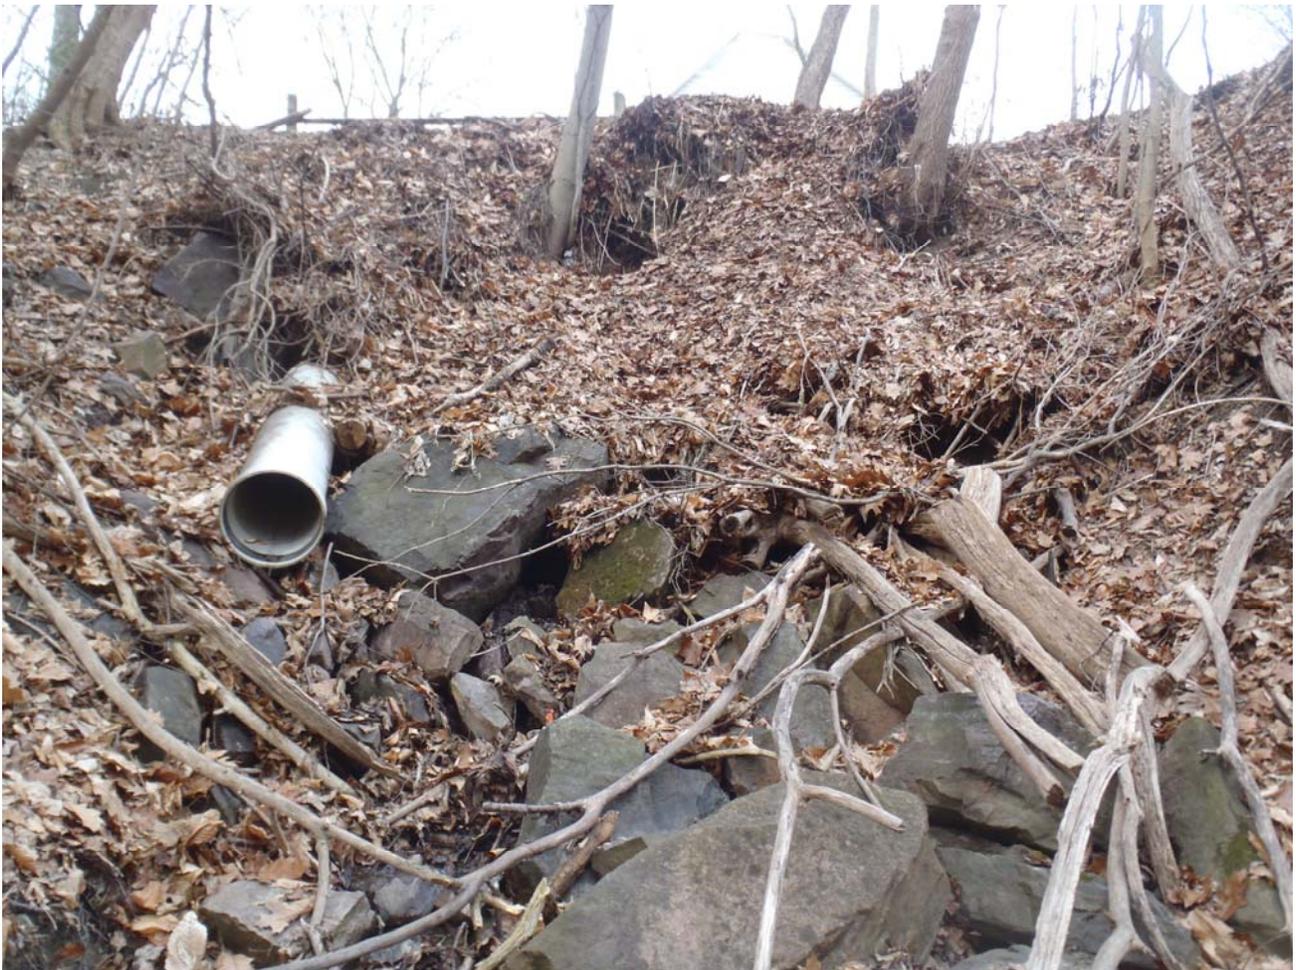
Photo 5: Large Stone Rip-Rap at Outfall

Permit covers the discharge of stormwater runoff from the paved roads and driveways, roofs and natural terrain, via overland flow across “grassed and/or vegetated terrain to a catch basin and rip-rapped outfall, prior to discharge to an unnamed tributary...” During our site visit we observed that sediment levels in the three catch basins indicated in the City’s stormwater GIS layer were below the invert of the outlet pipes. The vegetated terrain and rip-rapped outfall were observed as described in the permit. This site was generally found to be in compliance with its permit. No specific retrofit for this site is currently contemplated as part of the Englesby Brook FRP, however this is a part of a neighborhood generally being evaluated for targeted disconnection.

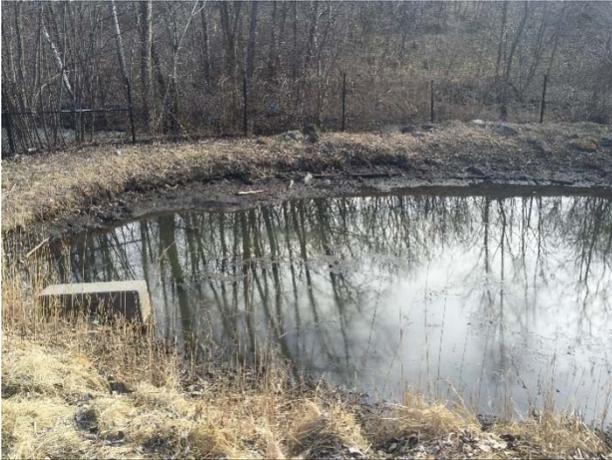
- The banks of the pond are eroding (A-2, Figure 1).
- WCA noted that there were several cracks / holes in the outlet pipe, and the pipe was tilted. Additionally, trash and vegetation debris were noted in and around the pipe (A-2, Figure 2 and 3).
- Sediment was built up in the bottom of the pond (A-2, Figure 4).
- Half of the gate to the pond was disconnected from the fence hinge and was held up with twist ties.

Figure 1. Eroding pond banks.

The existing problems with the pond are significant and exceed normal pond maintenance. Additionally, a retrofit has been proposed for this pond as part of the Potash Brook Flow Restoration Plan (FRP) as it does not meet post 2002 stormwater standards. The proposed retrofit in the FRP includes expanding the pond or potentially creating a gravel wetland to increase storage capacity, improve water quality, and provide channel protection control. Approximately 16,117 cubic feet of storage would need to be added to the pond to meet the upgrade as proposed in the FRP. As such, WCA recommends that this pond be considered a high priority for retrofit as part of the FRP and scheduled for upgrade in the near future. However, in the meantime, WCA recommends that the following be completed:

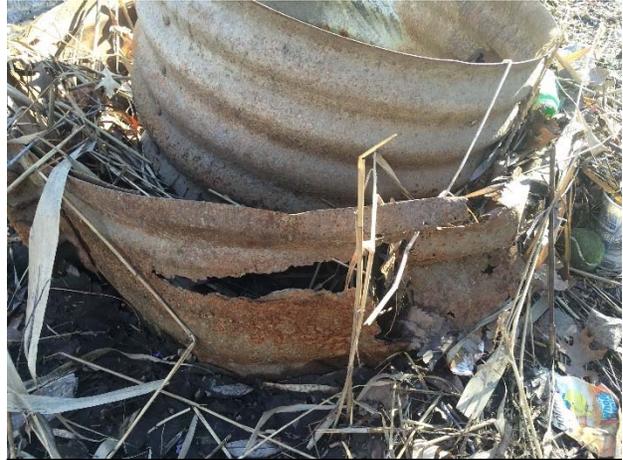
Figure 2. Holes, debris buildup, and trash at pond outlet structure.

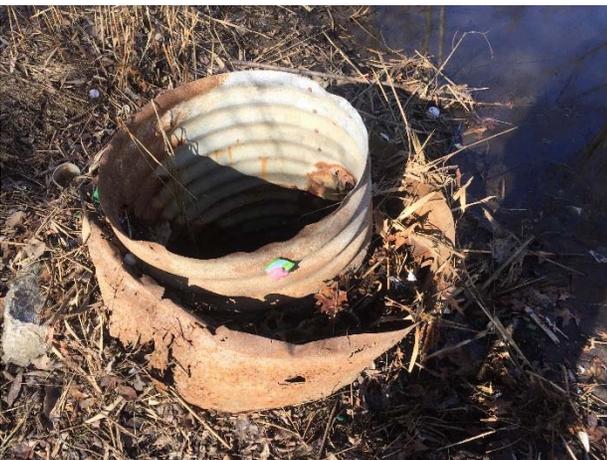
Figure 3. Alternative view of tilted pipe with holes, debris buildup, and trash.

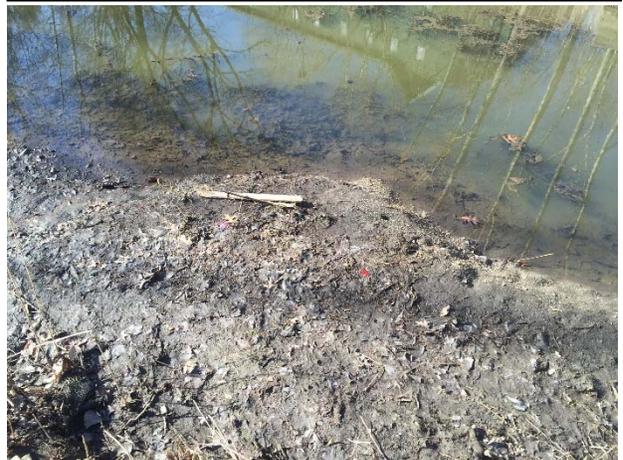
Figure 4. Sediment buildup along the sides and bottom of pond.

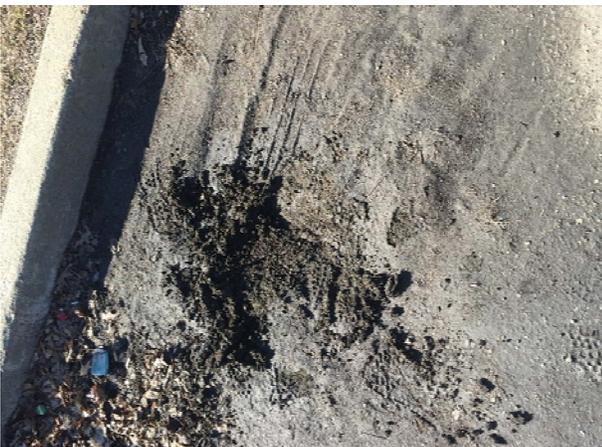
1. Catchbasins need to be vactored. WCA noted accumulated sediment and detritus in catchbasins.
2. Sediment buildup was noted on top of one catchbasin (catchbasin farthest east in the drainage area; A-2, Figure 5).
3. Unvegetated soil was noted in front of one of the residences to the east of the intersection of Baird Street and South Meadow Drive. It appears that some type of construction was recently completed. This surface should be revegetated as soon as possible to minimize sediment runoff into catchbasins, pond, and Potash Brook (A-2, Figure 6).

Figure 5. Sediment buildup on top of one catchbasin in parking area.

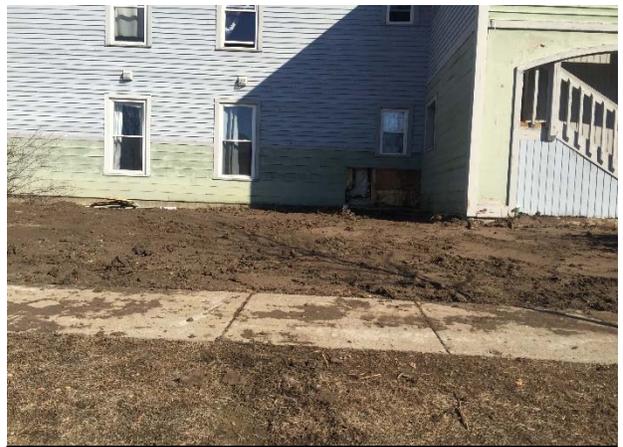
Figure 6. Construction area in need of re-vegetation.

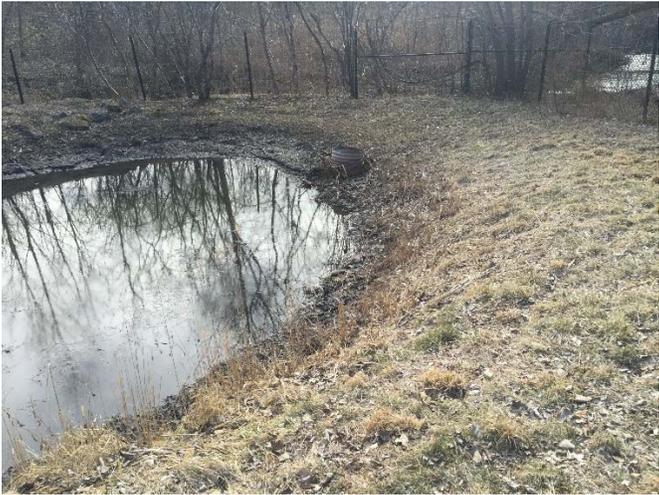
Assessment Information		Site Information
Site Name: South Meadows Pond		Site/Practice Description: Fenced detention pond

Current Permit #: 1-0661		
BMP Type: Detention Pond		
BMP Ownership: Private		
Post 2002 Upgrades (Y/N): N		
Date/Time Assessed: 09-09-2015, 10:00am; 03-11-2016, 2:30pm		
Address/Cross Streets: S Meadow Dr and Baird St		
Reviewed Site Plans Prior to Field Visit: Yes		
Active Pollution Visible: Trash, litter		
Operation/Maintenance Issues: Sediment buildup in pond, pond sides are eroded, outlet structure damaged (cracked / holes, tilted) and debris and trash are built up around standpipe. Catchbasins need to be vactored (significant buildup of sediment and debris noted in catchbasins). Significant sediment buildup on top of one catchbasin.		
Existing BMP Sizing Information		
Access Issues: Area is fenced, but half of the gate is was no longer attached to the fence (held on by twist ties) on March 11, 2016 visit.

BMP Outlet Structure Overview: Standpipe with culvert outlet to Potash Brook.		
Orifice 1: Culvert	Orifice 2: Standpipe	Orifice 3: Could not determine how water was entering the pipe.
Multiplier: 1	Multiplier: 1	Multiplier:
Diameter (in): 18	Diameter (in): 24	Diameter (in):
Orientation (V/H): Vertical	Orientation (V/H): Horizontal	Orientation (V/H):
Material: CMP	Material: CMP	Material:
Invert from Rim: 31"	Invert from Rim: 0	Invert from Rim:
Emergency Spillway (Y/N): No		
Notes: Suggest foregoing pond maintenance and concentrate on upgrading the pond as repairs and maintenance would be a significant undertaking.		
Retrofit Feasibility		
Is Retrofit Possible/Needed: Yes		
Justification: Pond does not meet post 2002 standards; does not provide water quality benefit.		
Proposed Practice Type: Potential to expand pond, add forebay, upgrade to post 2002 standards.		
Feasibility Issues/Comments: We noted a water line that could limit expansion potential. Proximity to Potash Brook is also of concern.
