Burlington Flowing

WATER, WASTEWATER AND STORMWATER
SYSTEMS IN THE QUEEN CITY

Burlington Water Resources: One Water

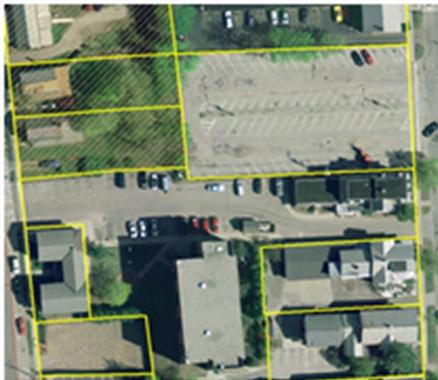
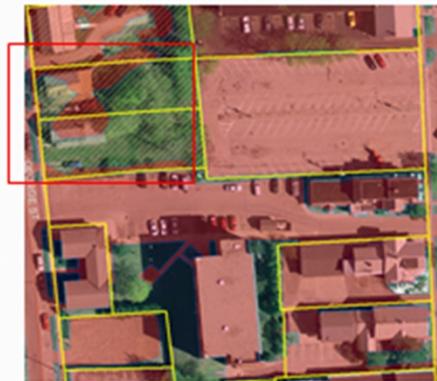
Impervious based billing

- Most equitable method, but time intensive depending on accuracy needed
- Impervious recognition algorithms not perfect, so QA/QC and manual delineations are important for directly billed customers

- Water and Sewer costs are based on the amount of water used monthly (measured by water meter)
 - Water: \$4.05/100 cf
 - Wastewater: \$5.55/100 cf
- Stormwater is based on impervious surface measurements
 - Monthly flat fee for single family (\$6.60), duplex (\$6.56), triplex (\$7.56)
 - Directly measured and billed for other properties
 - \$2.47/1000 sq. ft. of impervious

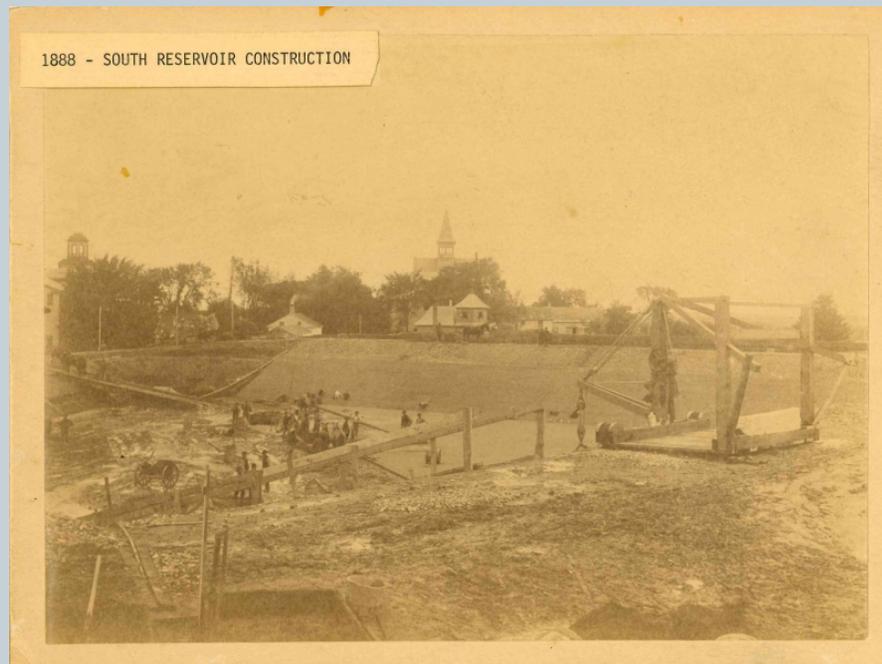
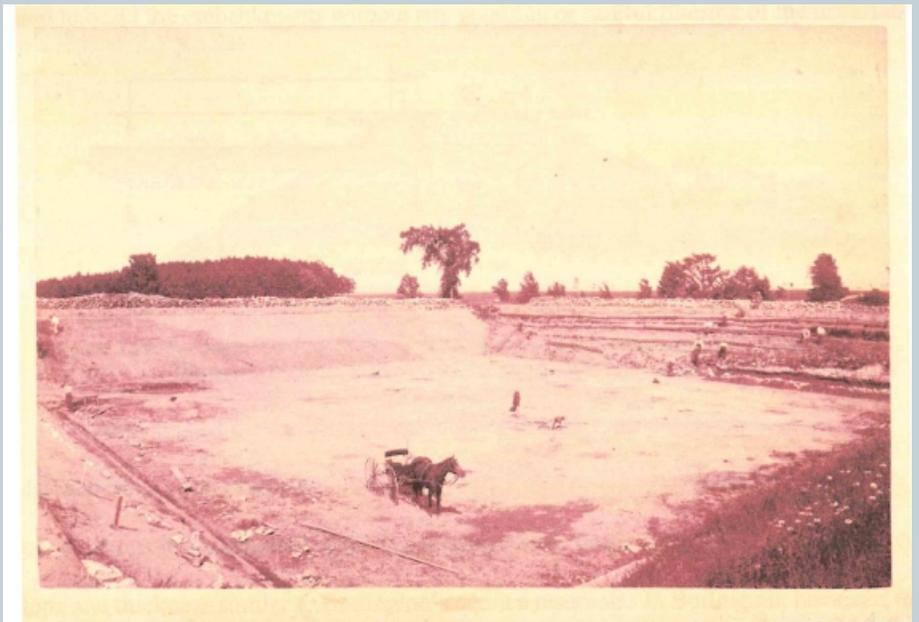
- 1872-1880: City determined needed additional water for low service system (second reservoir), but delayed many years because of worries about quality of City water supply
- 1888-1891: Construction of South Reservoir (~4 MG) and renovation of North Reservoir, bringing total to ~7 MG

Figure 7.18: Main Street reservoir, drained of water and under renovation, circa 1890
(Courtesy Burlington Water Department)

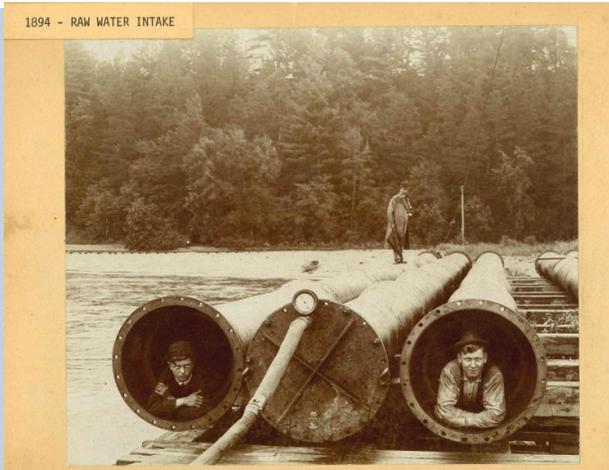
1894 Intake Project

- 24" diameter
- 2 miles off-shore
- Really heavy diving suits!

- 1894: installed new raw water intake 2 miles off shore on Appletree Shoal

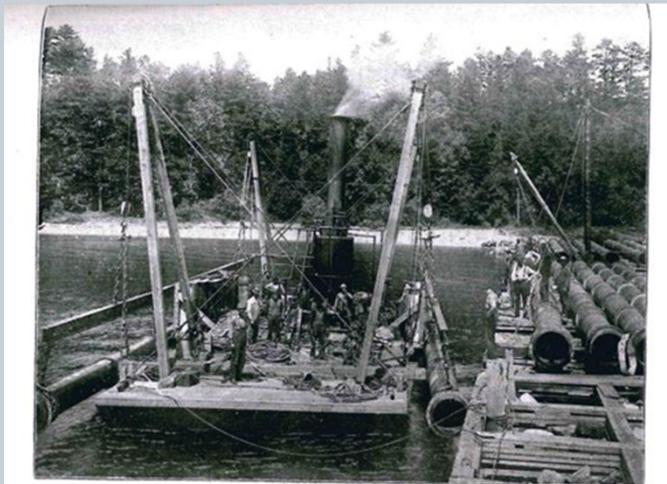
Ready to start with one hundred and fifty feet of Intake Conduit. F. R. Mears, Photographer.

Figure 10.4: The scow and derricks used to install underwater pipes, from *Annual Report* (1894)

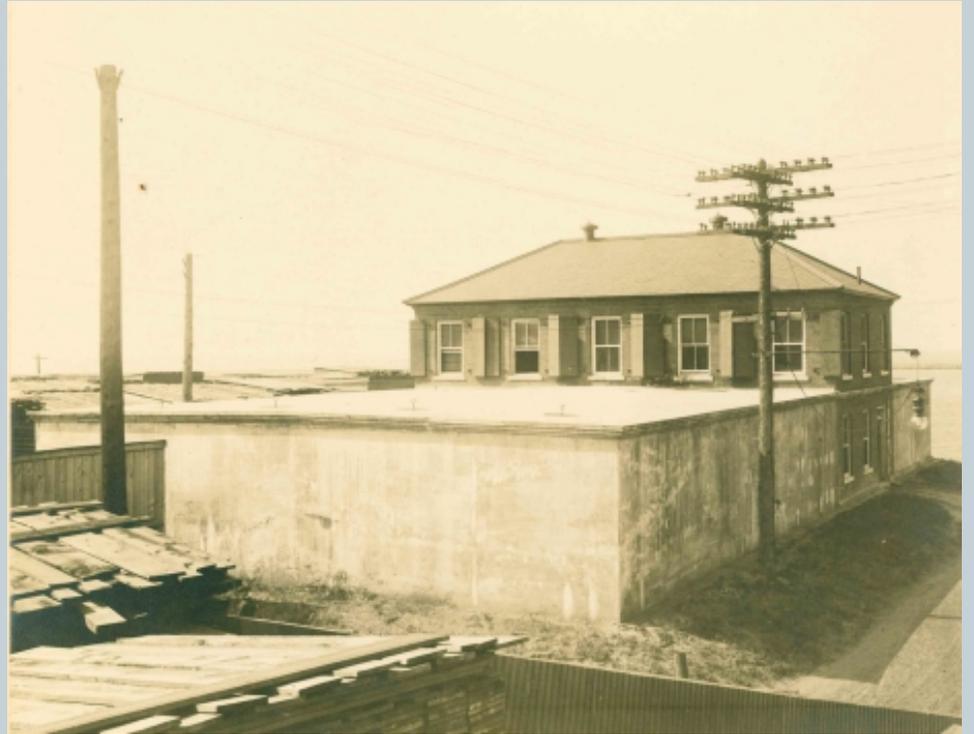
Water treatment is born! (in the form of a filter)

- 1904: Understood that sewage was a likely contributor...debates about whether to “purify” sewage or filter the drinking water. As there was no practical purification for sewage... decided to go with water filtration
- 1908: Construction of filter plant using sand filtration, with alum as coagulant before (still no disinfection)
 - Also recommended covering the reservoirs to prevent contamination of the filtered water (this would not happen until 1984)

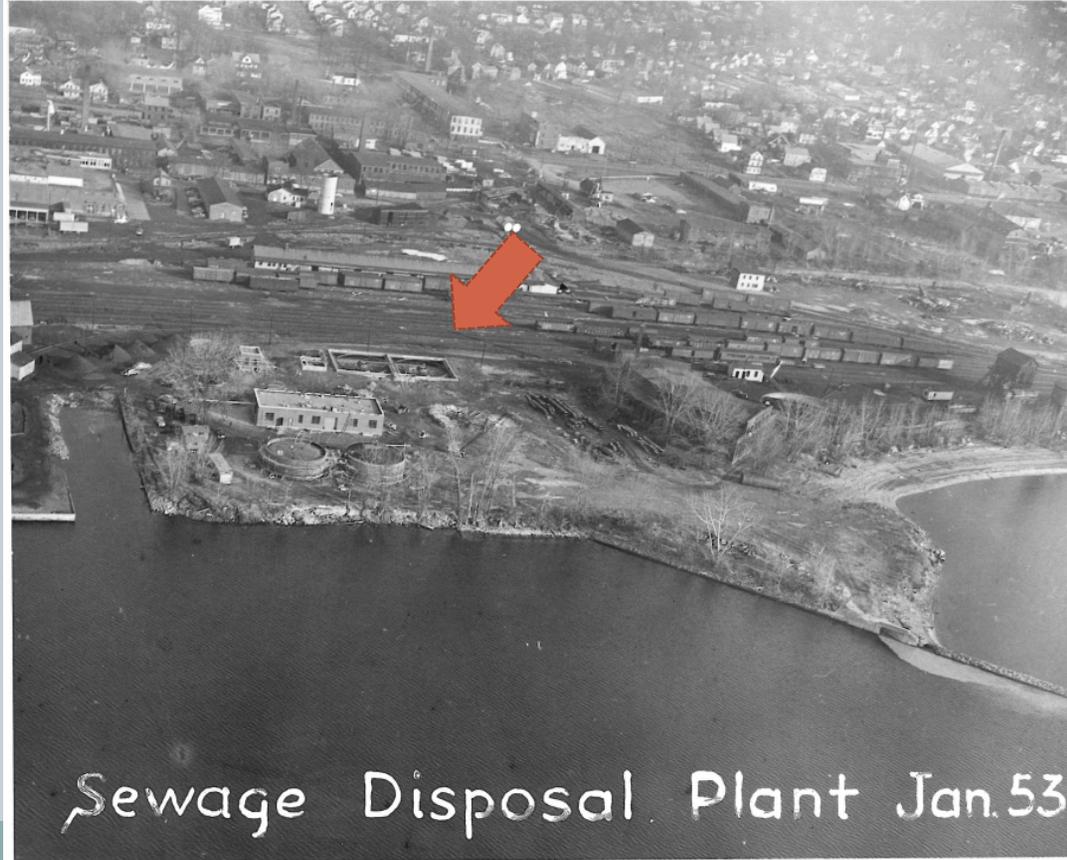
Sewage Disposal Plant Jan. 53

- 1953: Main WWTP constructed (clarification and chlorination); Sewage Disposal Dept created, later renamed Water Pollution Control Dept.

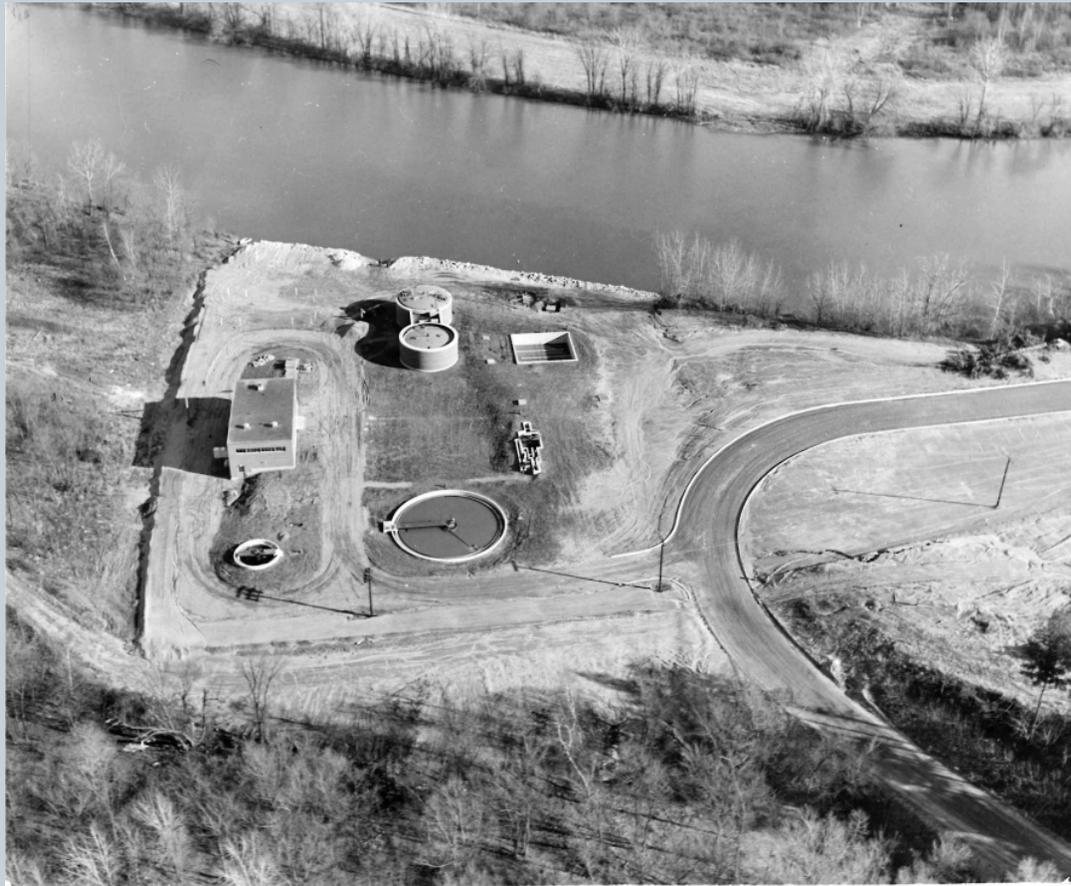
- 1959: North WWTP constructed at end of North Avenue

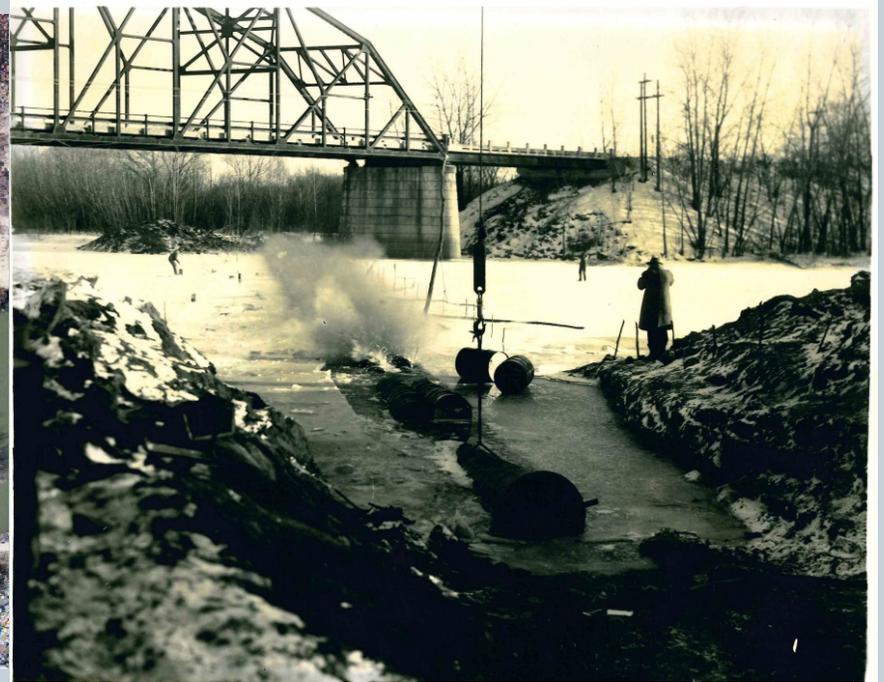
- Sewer River Crossing (North Plant Collection System)

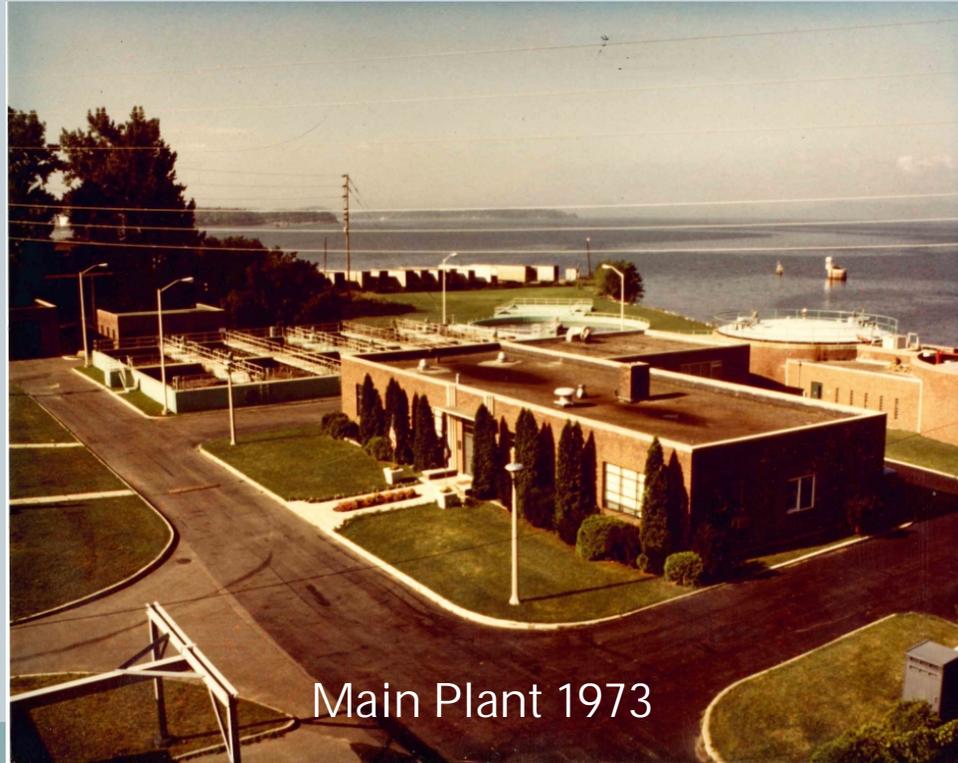
Main Plant 1973

- 1965: East/Riverside WWTP constructed (Finally!)
- 1968: ordered by State to upgrade to secondary treatment
- 1973: All plants were upgraded again (improved pollutant removal from 35% to 95% with addition of biological treatment); outfall at Main Plant extended to deeper water

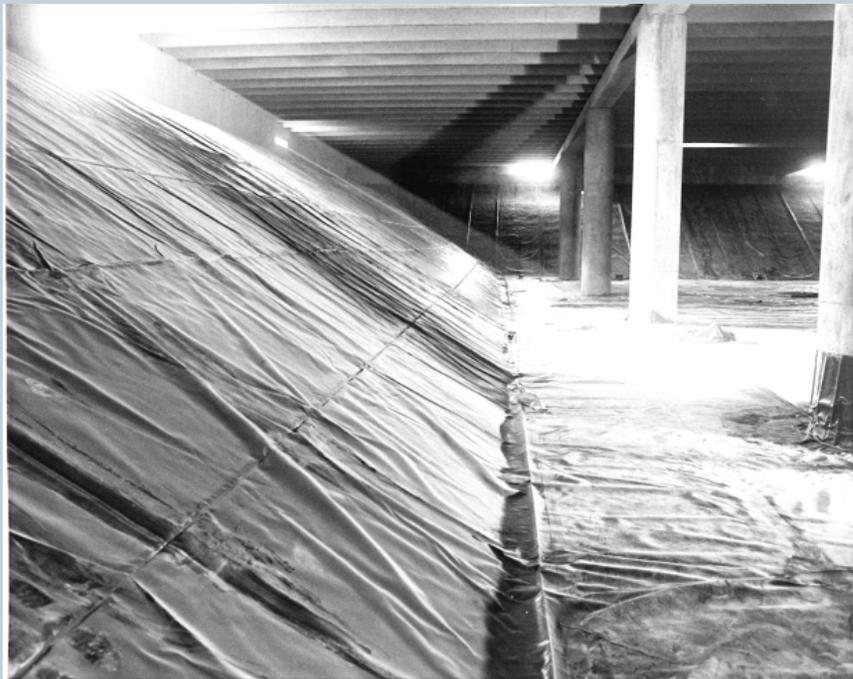
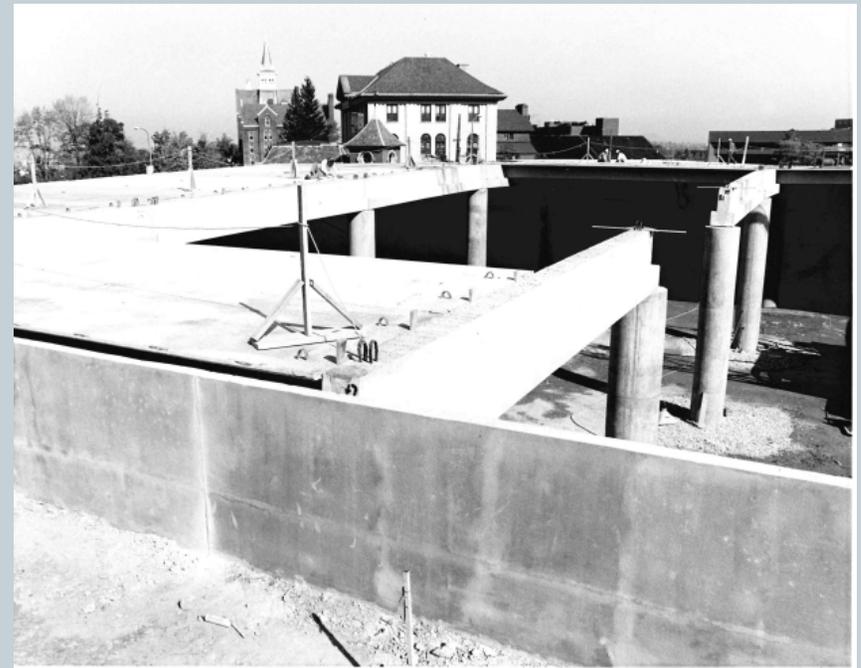
Improved reservoirs

- 1982-84: Lined and covered reservoirs reducing contamination and need for chlorination

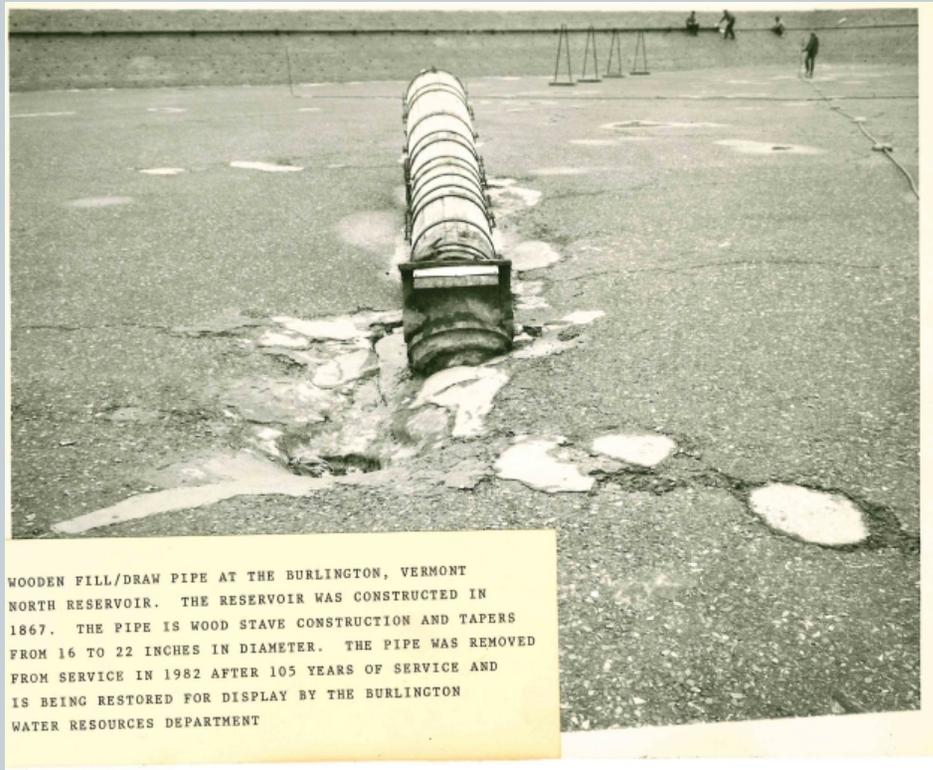
WOODEN FILL/DRAW PIPE AT THE BURLINGTON, VERMONT NORTH RESERVOIR. THE RESERVOIR WAS CONSTRUCTED IN 1867. THE PIPE IS WOOD STAVE CONSTRUCTION AND TAPERS FROM 16 TO 22 INCHES IN DIAMETER. THE PIPE WAS REMOVED FROM SERVICE IN 1982 AFTER 105 YEARS OF SERVICE AND IS BEING RESTORED FOR DISPLAY BY THE BURLINGTON WATER RESOURCES DEPARTMENT

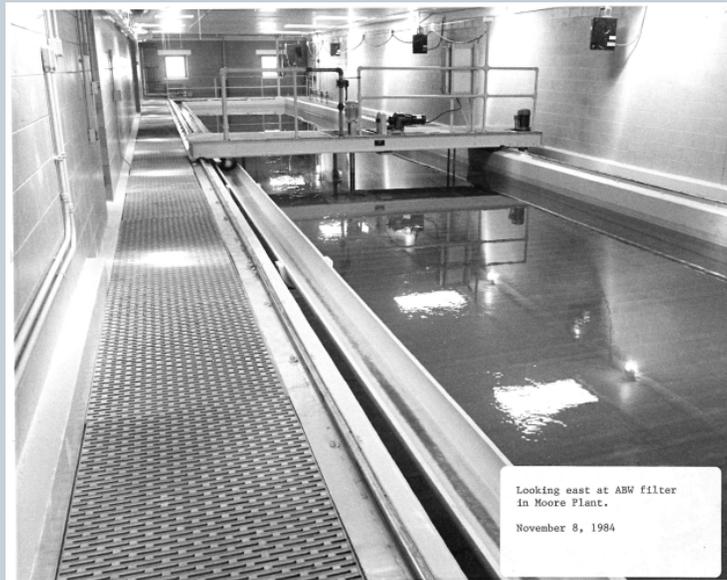
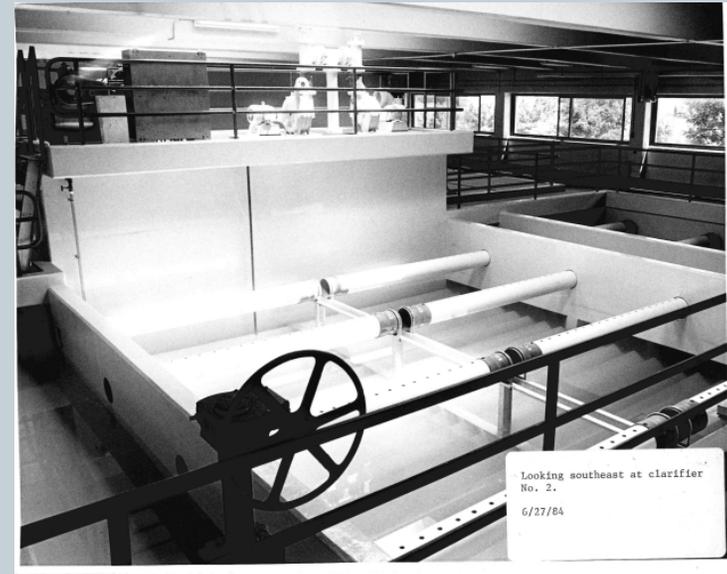
- Overhaul of treatment plant

- Because water usage did not grow at predicted rates (daily use averages between 3.6 -4.4 MGD vs. predicted 10 MGD) water operators have optimized the plant to provide two stage filtration – water passes through filters in series vs. in parallel!

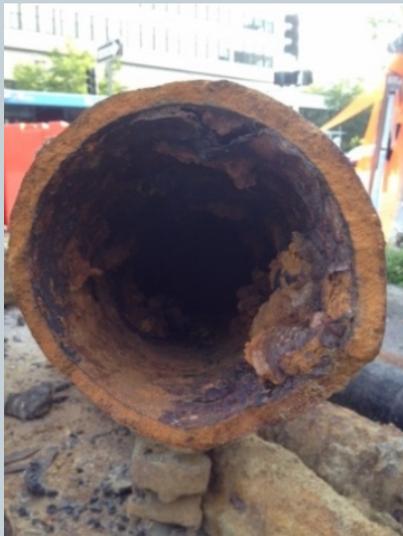
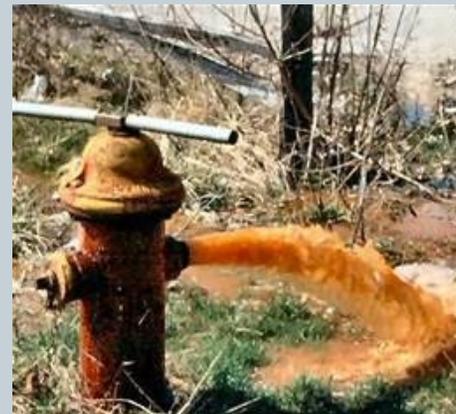
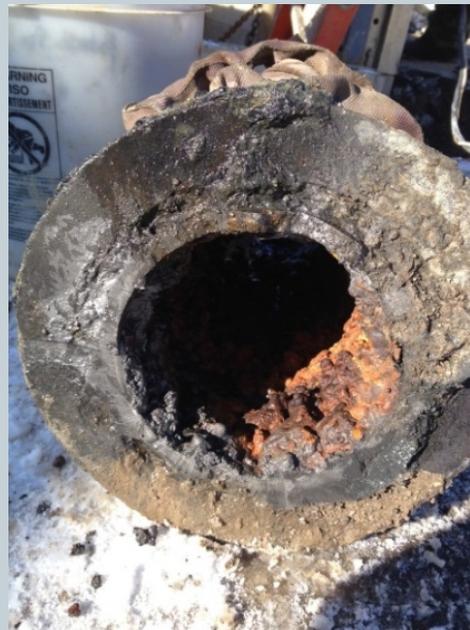
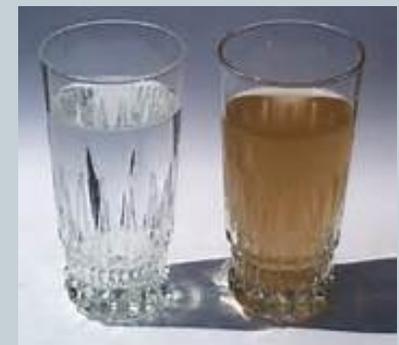
Normally forming tuberculation (internal corrosion i.e. rust) which forms in all metal water pipes everywhere leads to:

Reduction in pipe capacity which can cause water pressure issues and ultimately impact fire fighting ability

Discolored water at the tap and in appliances when rust particles break off when there is a pressure change

Our hydrant flushing program and our addition of anti-corrosion agents to our water slow this process down but many of our pipes are heavily tuberculated

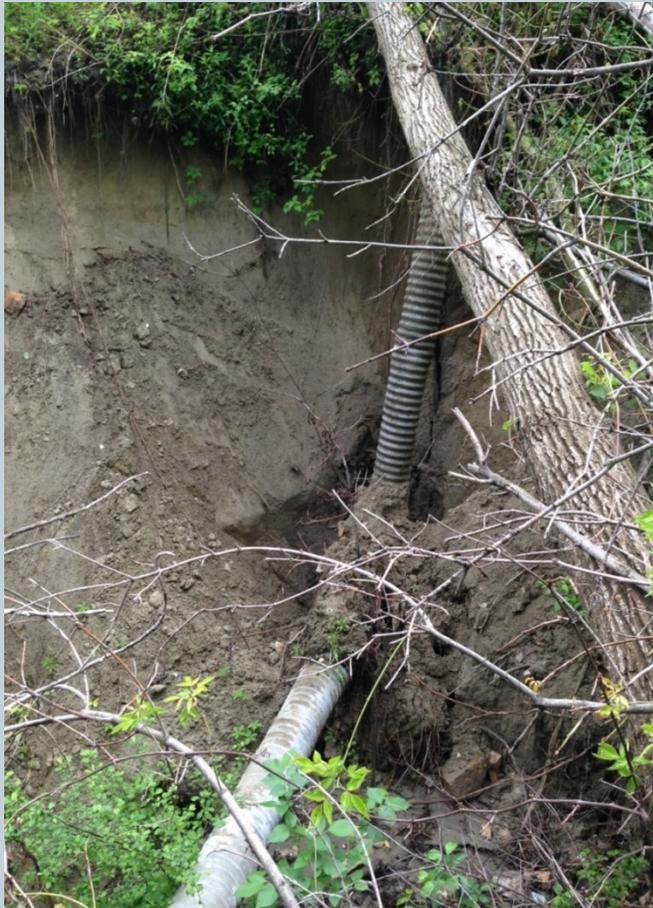
Storm Outfall Needs

- 150+ outfall pipes
- 10-20% outfall areas are failed, with others in poor condition

→ water quality impacts (sediment)

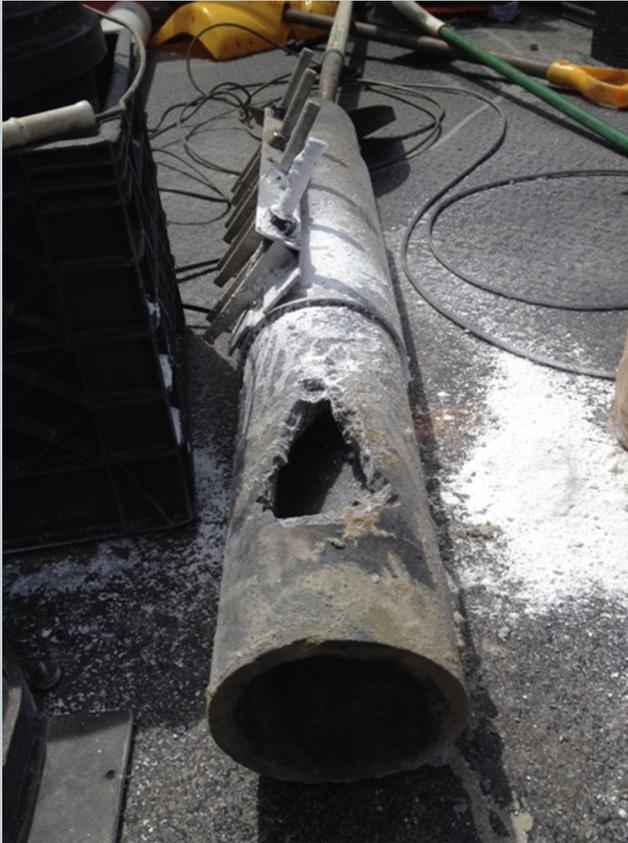
~53,000 linear feet of Corrugated Metal Pipe (CMP)

~50% have some sort of structural deficiency;
~10-20% need near term repair

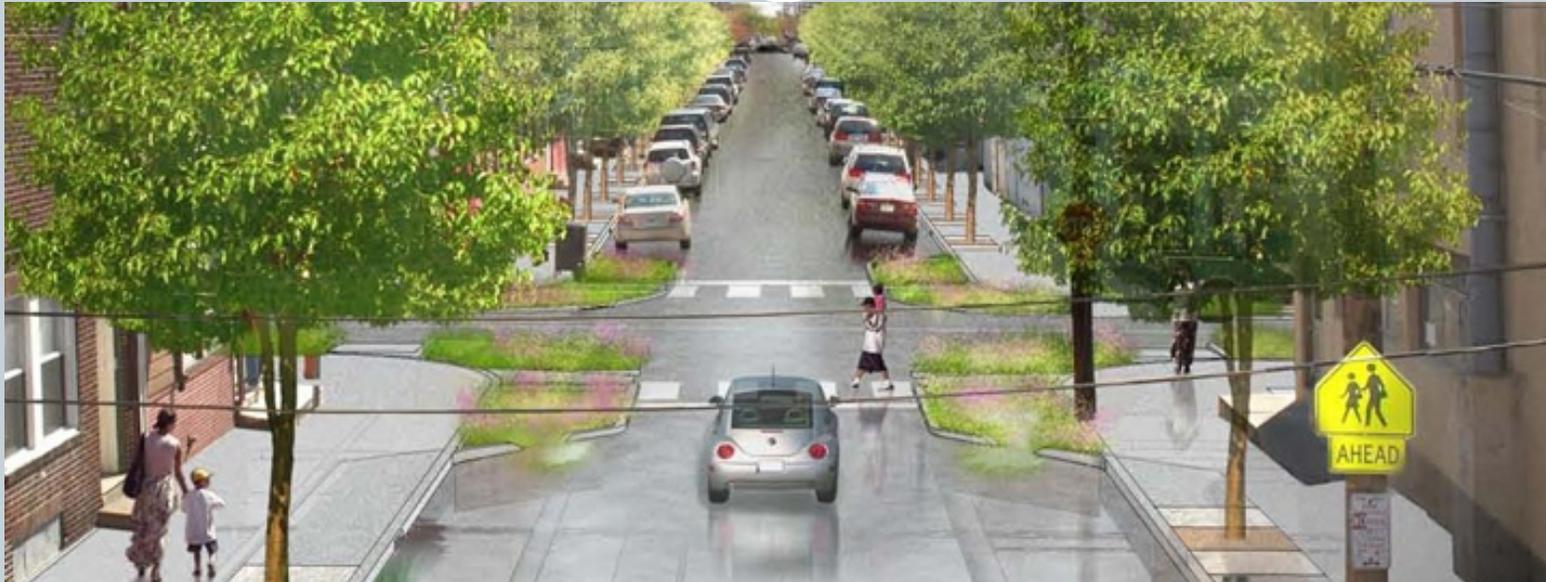
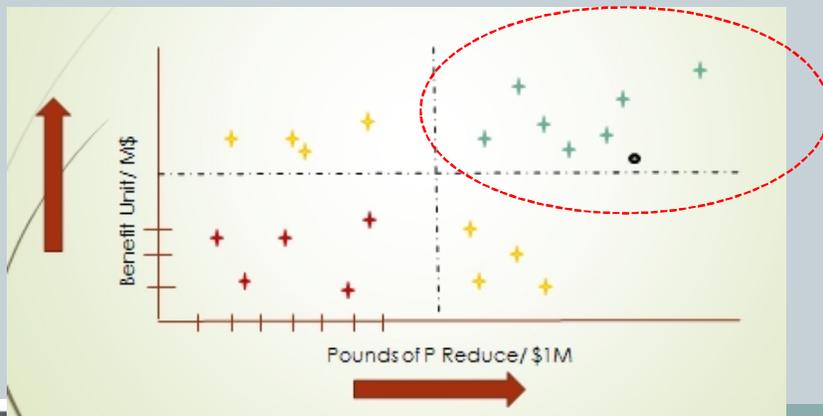
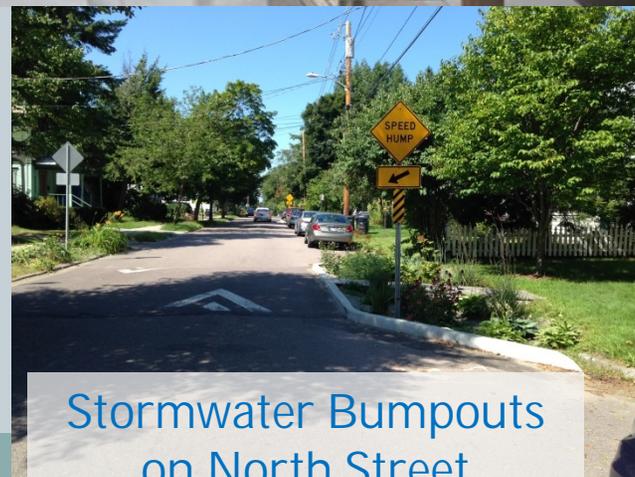
Stormwater Bumpouts on North Street

Solutions may not be as simple as “end of pipe” if we want to maximize co-benefits
