# Ethan Allen Park Site Assessment

Integrating Historical, Cultural  
And Natural Resources

Prepared for the Burlington Department of Parks and Recreation  
by LANDS Program Interns, July 2008

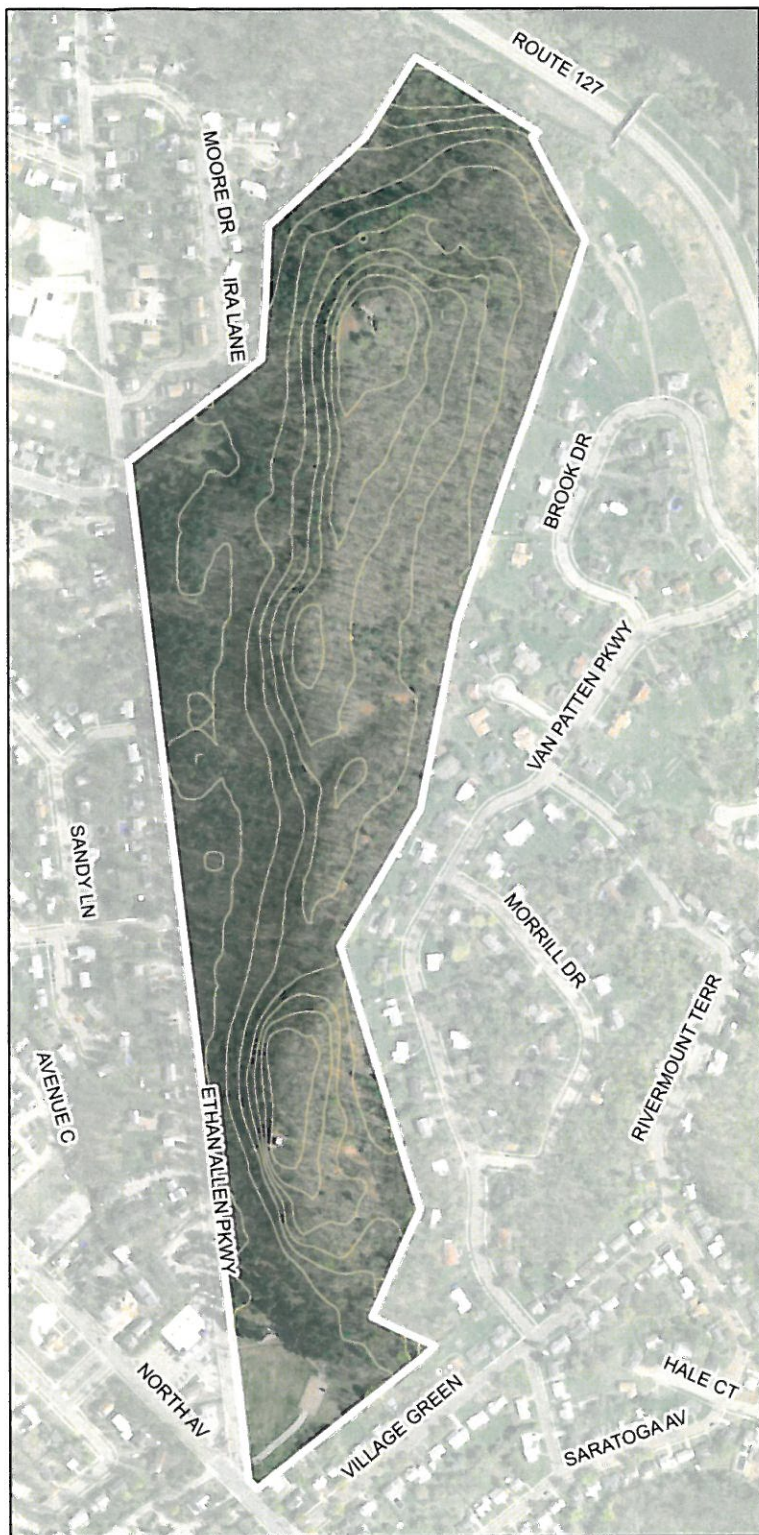
# Map 1: Ethan Allen Park

Ethan Allen Park is a sixty-seven acre parcel situated between Ethan Allen Parkway and the Winooski River in the City of Burlington (see Map 1). It is currently owned and managed by the City of Burlington's Parks and Recreation Department. The Vermont Natural Heritage Program recently described these forested lands as 'exceptional' and 'uncommon'. It also contains great examples of rocky outcrops due to its placement along the world famous Champlain Thrust Fault. In addition to important natural communities, the park contains a rich cultural history.

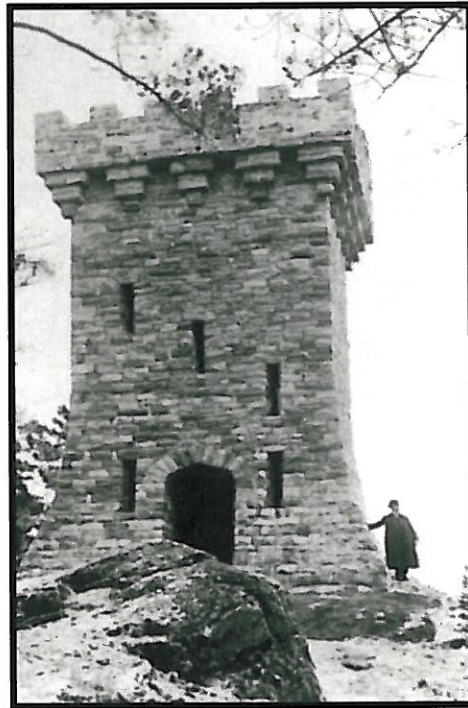
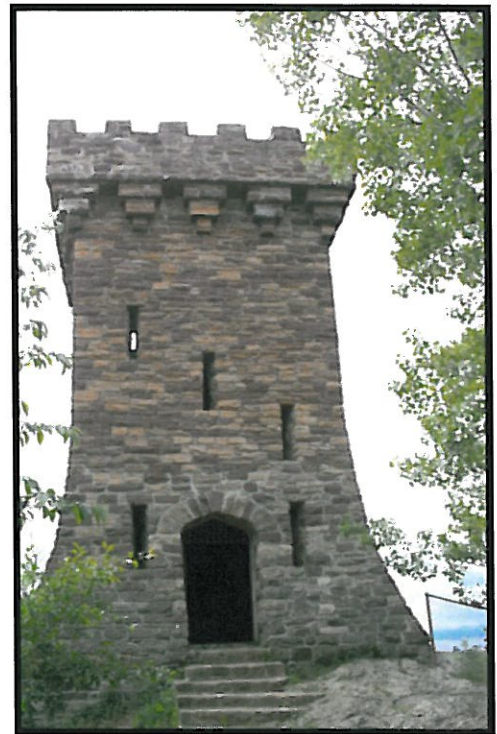
## Tower

**Right:** Ethan Allen Tower, 1905 after construction and in June 2008. The tower is an important historical feature, and one of the main tourist attractions of the park. As apparent from the pictures, the tower has retained its original shape and charm even after 100 years.

Since the tower's construction, it has been a major focal point of the park. This can be attributed to the spectacular 360° view available from the top. In 1942, the tower was renovated because of stabilization issues. The tower was closed in 1974, due to unsafe conditions. It was eventually reopened with the help of a local advocacy group known as "Save the Tower, Inc." In 1983, they rebuilt the battlement, platform and replaced the stairs inside the tower. Today, volunteers are responsible for unlocking and locking the tower on a daily basis.

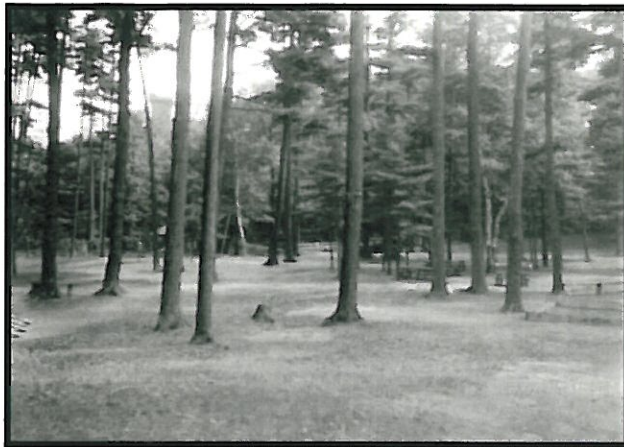
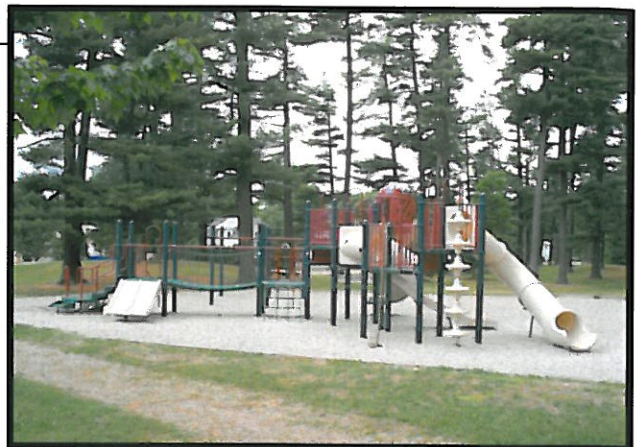
## View of Ethan Allen Park

**Above:** View of Ethan Allen Park looking north, 1937 and June 2008. The playground was constructed in the 1990's as a collaboration between the Parks and Recreation, a playground manufacturer, and the students of C.P. Smith School.

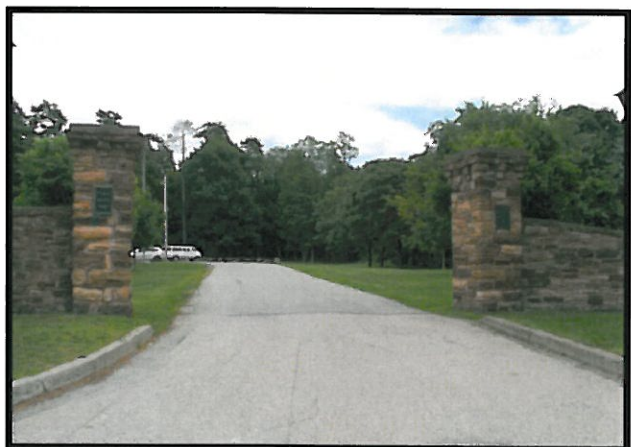
## Park Entrance

**Above:** Entrance to Ethan Allen Park (1907-1915) and June 2008. The parking lot is a noticeable physical change to the entrance. Car traffic within the park was banned in the early 1980's, which has been beneficial to the health of this forested area.

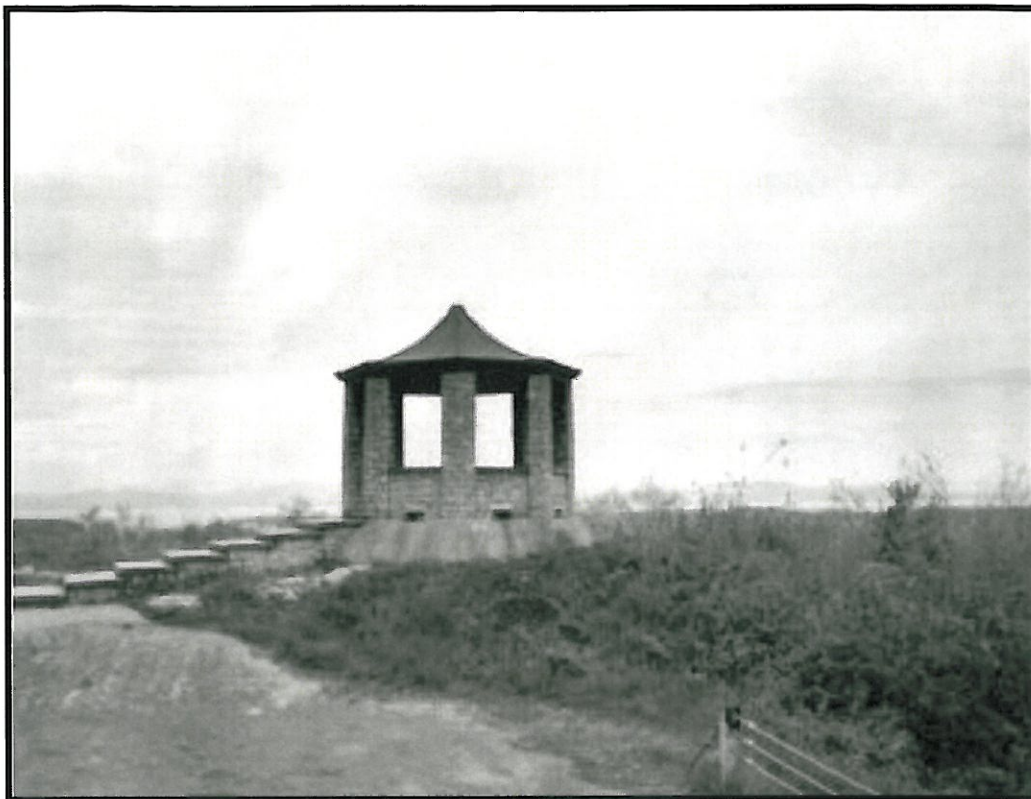
## Gazebo

**Left:** Gazebo in the early 1900's and June 2008. This structure was originally wooden but was reconstructed to be more permanent in the early 1900's. Today the vegetation inhibits the gorgeous view that was available from the gazebo.

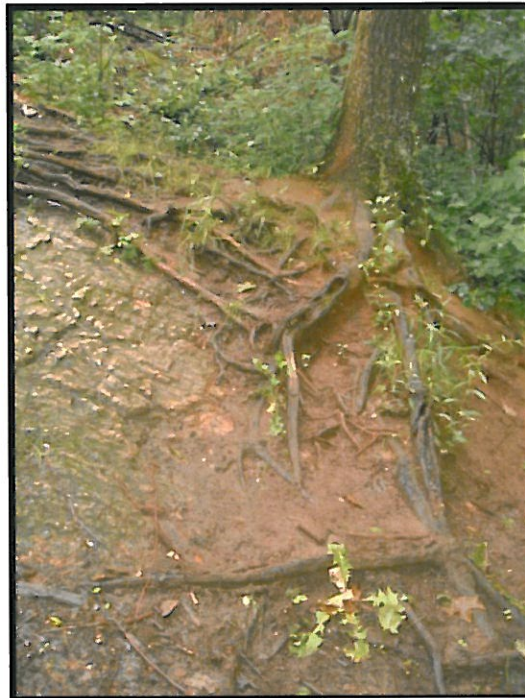
**Above:** An example of a dangerous trail condition: root system growing on a rocky outcrop on a trail

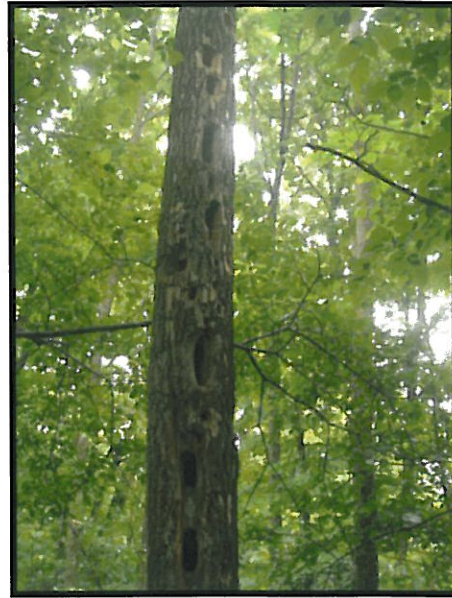
**Left:** A snag with cavities that provide habitats for certain species

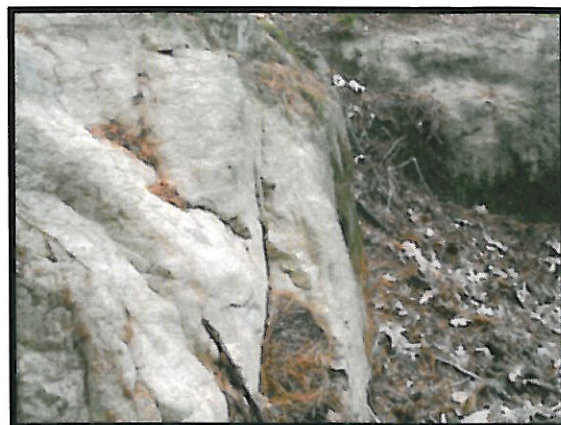
Above: A calcareous dolostone outcrop along one of the trails

To determine whether these rocks are composed of calcium, a simple acid test was performed. When treated with HCl the rocks yield a bubbling reaction; indicating the presence of calcium. All the outcrops at Ethan Allen Park contain calcium. This is beneficial to the soils as the calcium-rich bedrock buffers the pH. As the outcrops break into smaller particles, they provide nutrients which as a result, create nutrient-rich soils that support a wide array of plants.

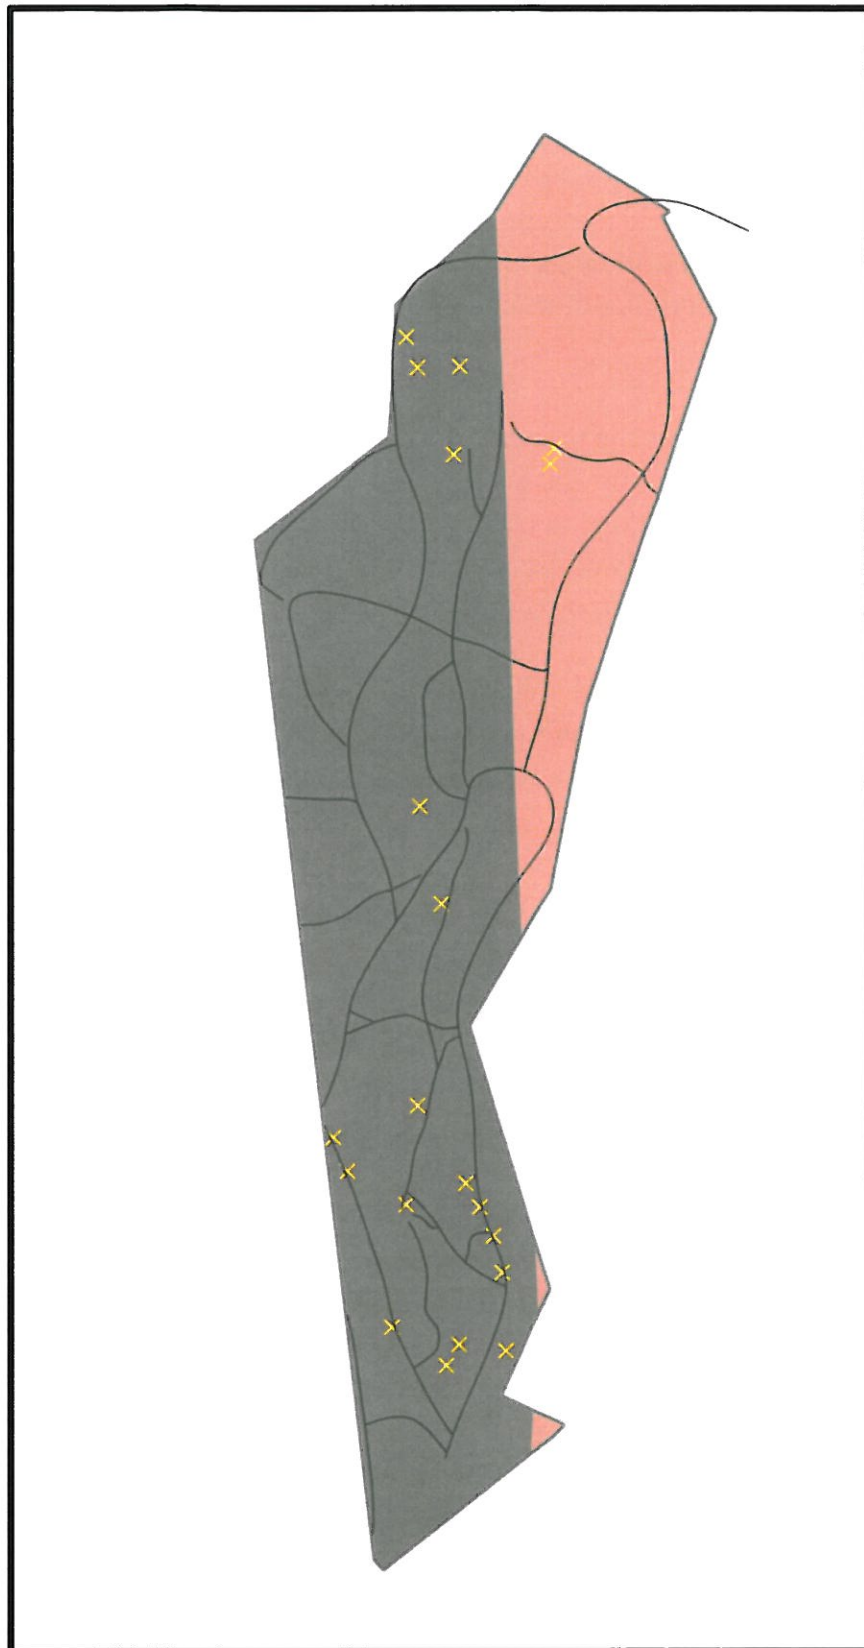
## Map 4: Bedrock

- Trails
- × Calcareous Outcrops
- Bedrock Type**
  - Dunham Dolostone
  - Iberville Shale
  - Ethan Allen Park Boundary

Ethan Allen Park is located in the Champlain Lowlands, where the bedrock is composed of beach sandstone and shallow marine limestone (Johnson 1998). This bedrock layer is thought to be 560 to 455 million years old. Around 12,500 years ago, the area was covered by Lake Vermont, a post glacial lake much larger in surface area than present-day Lake Champlain. The presence of this giant lake as well as the two bedrock layers (Dunham Dolostone and Iberville Shale) have laid the foundation for the soils above (Map 4). The bedrock plays a significant role in determining the soil type because soil is the product of weathering of rocks at the earth's surface. These two types of bedrock occur as a result of placement of the park along the world famous Champlain thrust fault. At Lone Rock Point in Burlington there is a perfect example of this type of fault, in which the older Dolostone was thrust over the younger Iberville shale.

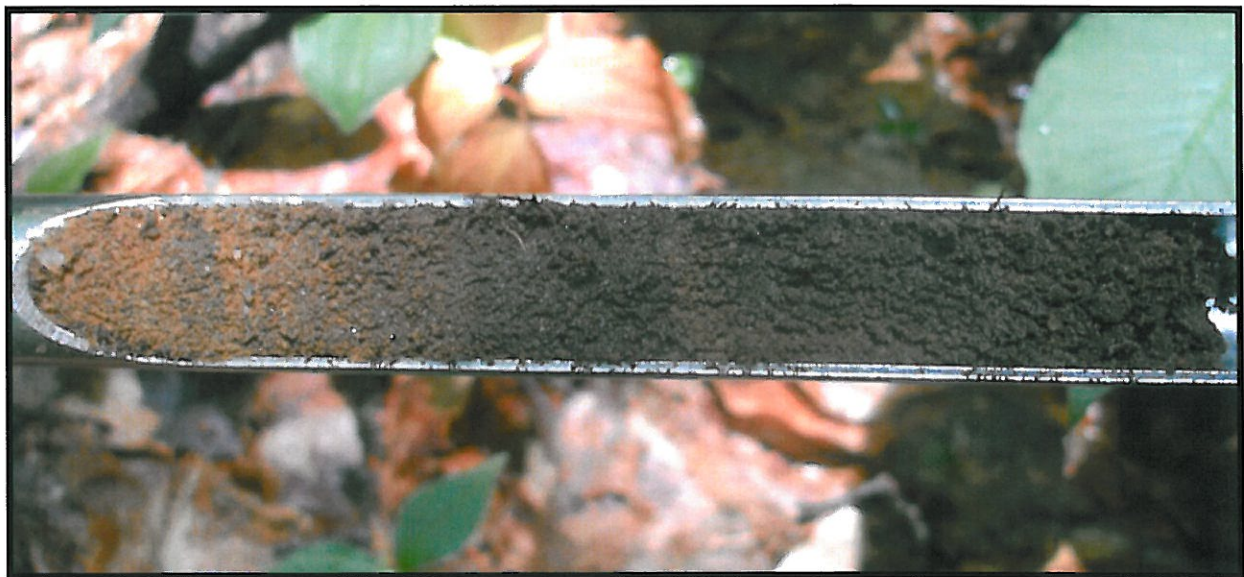
**Above:** Soil sample drawn from Soil Pit 6 (see map) classified as Adams and Windsor loamy sand. Note the mixed dark and light brown colors and the gritty texture of sand

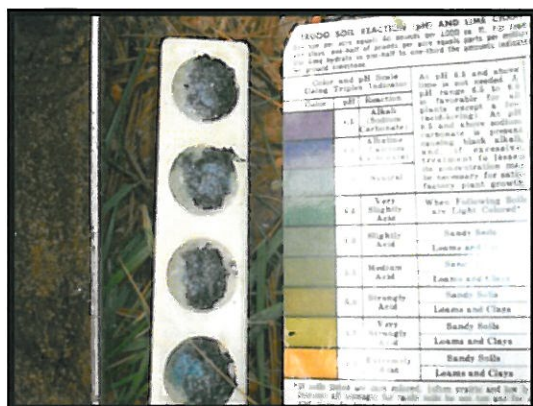
Soil sample drawn from Soil Pit 10 (see map) classified as Farmington Extremely rocky loam

The Farmington series is located throughout a portion of the park and consists of soils that were formed from glacial till and contain a considerable amount of limestone. These soils are shallow, rocky, extremely rocky or somewhat excessively drained and loamy throughout their profile (Allen 1974). Farmington soils have medium natural fertility and a moderately available moisture capacity. The Farmington extremely rocky loam that is found on 20 to 60 percent slopes consists of soils that are shallow to bedrock and that are too rocky and steep to be used for farming. Thus, land over this soil is mostly covered with vegetation. In areas of no vegetation, the hazard of water erosion is severe.

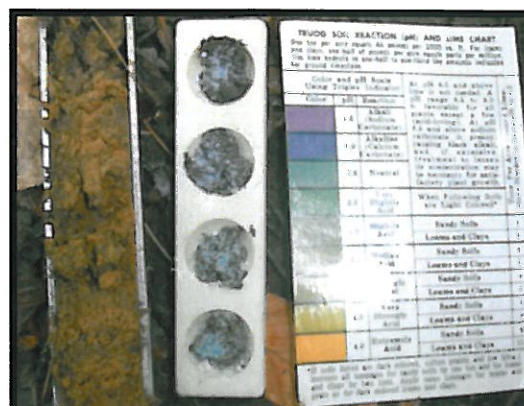
Soil sample drawn from Soil Pit 7 (see map) is classified as Hinesburg fine sandy loam. Note light brown clay.

The Hinesburg series found in the north eastern part of the park consists of soils that are deep and well drained and formed in sandy deltas and beaches. In order to maintain good soil structure and to increase the water-holding capacity of the surface layer, it may be advisable to add organic matter to the Hinesburg soil (Allen 1974).

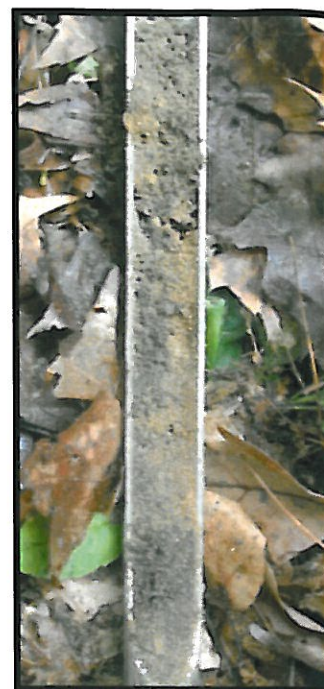
Above: Soil sample drawn from Soil Pit 8 (see map) classified as Adams and Windsor loamy sand (0-5% slope). Note the sandy soil and gravel at bottom.

Adams and Windsor loamy sands that are found on 0 to 5 percent slopes consist of soils that are loamy sand and acidic (Table 1). Surface runoff in this type of soil is low but ground should be covered with vegetation in order to prevent soil from blowing (Allen 1974). This type of soil is most extensively used for woodland (Allen 1974).

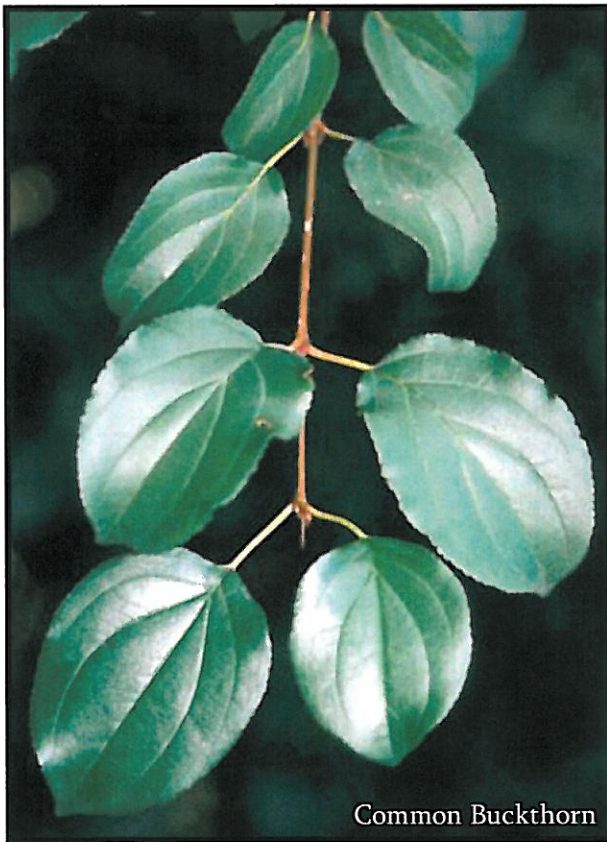
Common Buckthorn

Buckthorn is the most common invasive exotic in the park and should be considered a top priority. This shrub commonly grows in groups but can occur singly, and there aren't many places in the park where buckthorn can't be found. The plant is native to Eurasia and was introduced in the 1880's. It is so successful due to its high tolerance of various soil and light conditions. Buckthorn is a strong competitor with early leaf out and late senescence – an average of 58 days longer than native species (Huebner, 2006) which means that it's growing season is longer, allowing it to collect more energy than its competition.

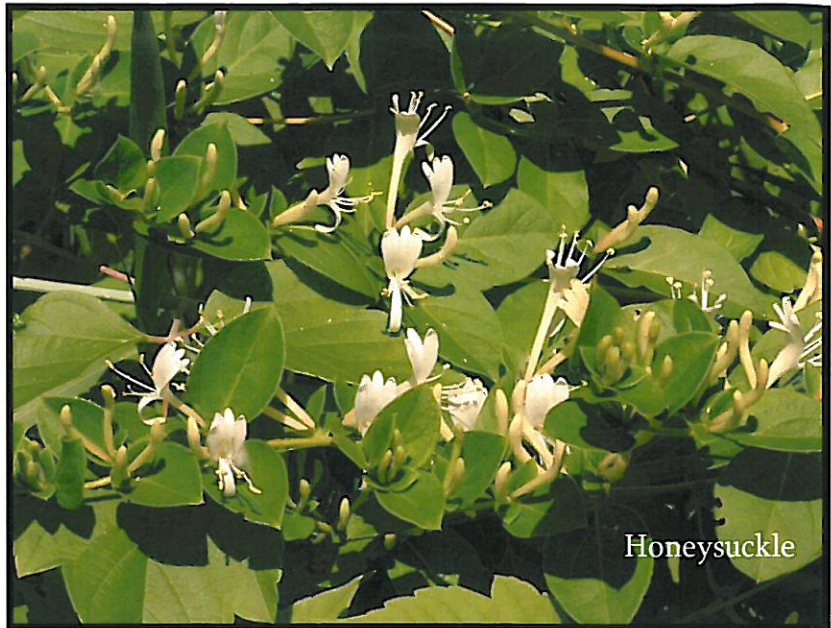
The plant has aggressive root systems that often out-compete those of native plants. Honeysuckle can be found in woods, fields and edges. It is mildly shade tolerate but prefers full sun. In the park it is mostly found on edges or in canopy gaps where more light is allowed into the under story (Huebner, 2006). Japanese honeysuckle climbs and winds over native vegetation, shading them out (Nyboer, 2008).

Honeysuckle can be removed by hand by pulling the entire plant, including roots, and taking out of the forest to dry or placing it in the crotch of a tree where the roots cannot reach the ground to re-shoot. Chemical options include applying a 2% spray to foliage after native foliage has fallen but before the first hard frost (Colby, 1989).

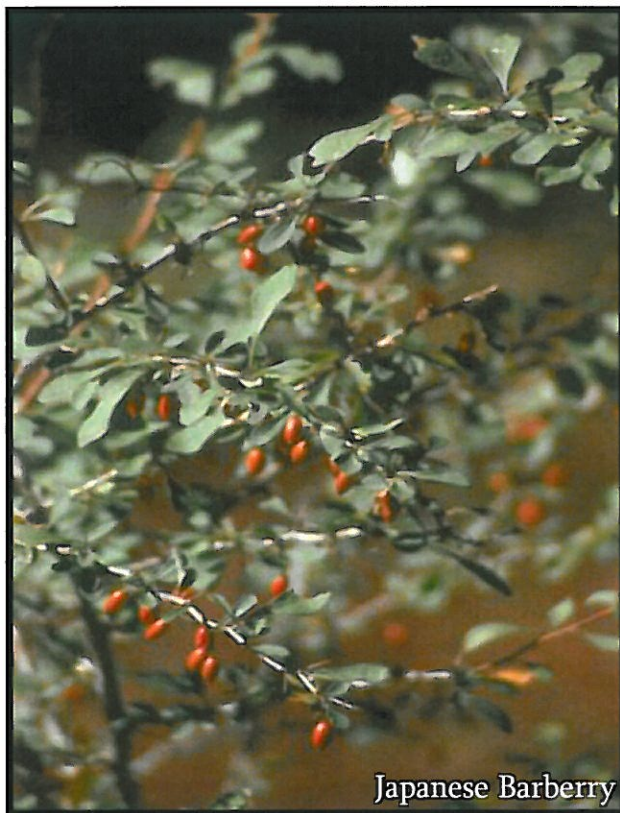
Japanese Barberry

This prickly plant is found in spotted locations throughout the park. It grows about waist high, but sometimes taller, and has bright red berries. The stems are singular but grow in close bunches. Ninety percent of the

berries fall within 3 feet of each shrub but some have been mapped as far as 262 feet away (Silander, 1999). Barberry prefers a wide variety of conditions, from full sun to full shade, from dry ridges to wetlands to deep forests. Similar to buckthorn, barberry has leaf out before and after native plants. The plant was introduced in the mid 1800's from Japan.

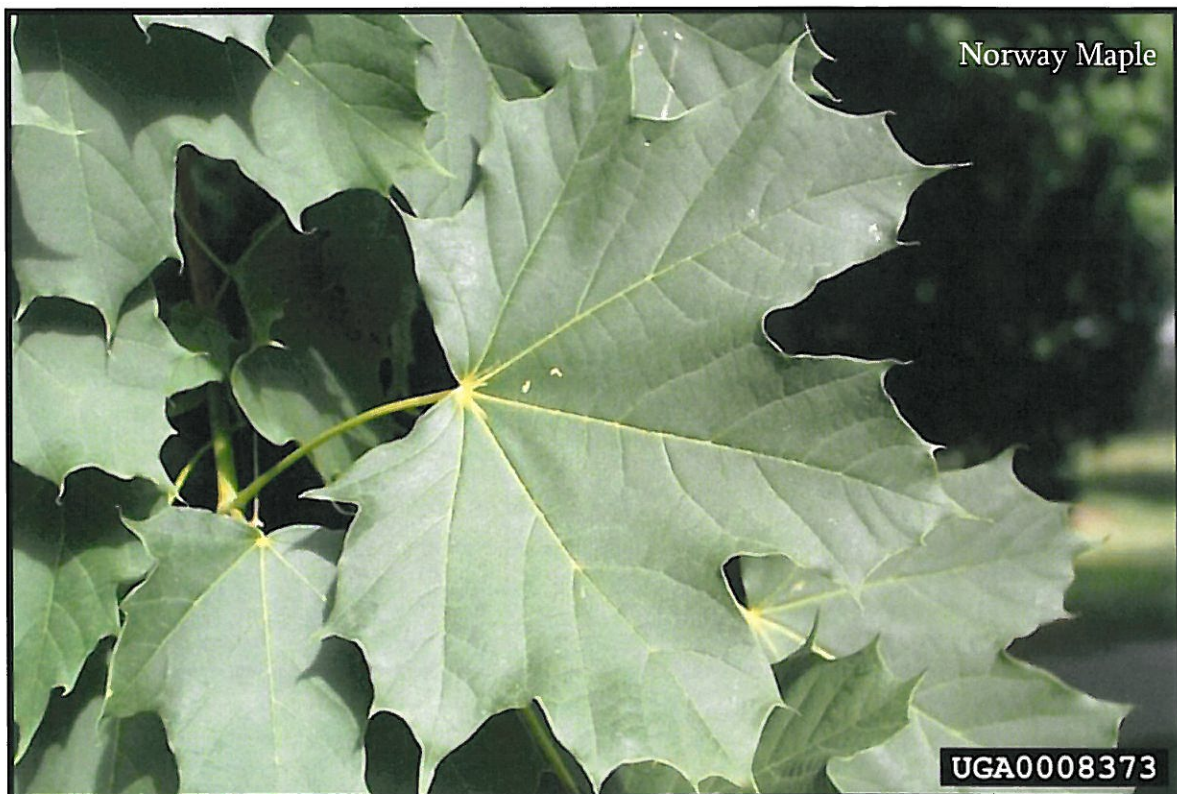
## Norway Maple (*Acer platanoides*)

This deciduous tree grows up to 100 feet high and is in the maple family. It can easily be mistaken for sugar maple; however the petioles of Norway maple leaves contain a milky juice and the bark is grooved similar to ash bark. Introduced from Europe in the 1700's, it has been over planted as an urban tree due to its resilience against pollution. It is also an effective replacement to the vacancies left by American elm after the Dutch elm disease outbreak. It has since escaped into roadsides, thickets and edges. In Ethan Allen Park, it is found primarily along the road near the eastern boundary. The tree is susceptible to various

leaf diseases, especially tar spot and leaf scorch. It has a shallow root system and late falling leaves. Some studies have shown that its root system is allelopathic towards the roots of competitors – meaning it releases chemicals into the soil to discourage competitive plant growth. Norway maple squeezes out native vegetation because of its thick and aggressive root systems and large, dense, shade-causing canopy.

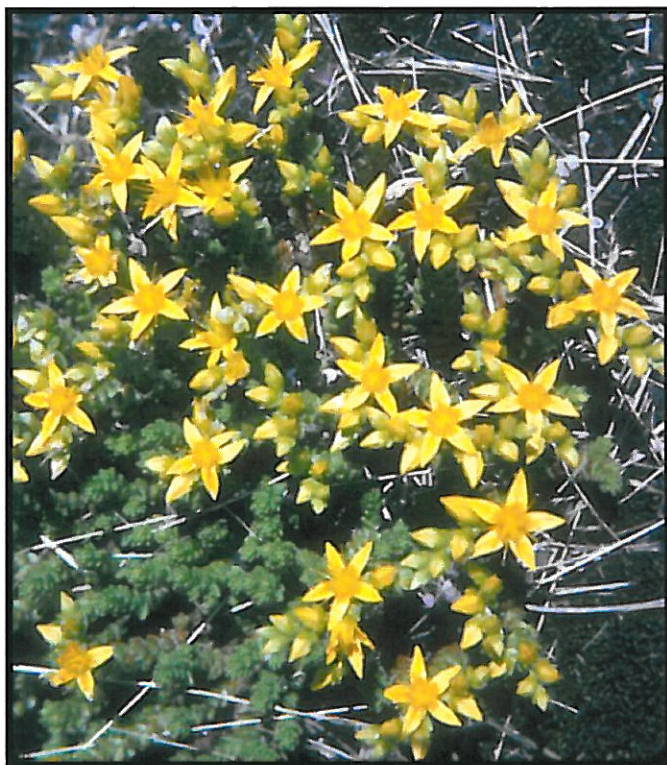
### Stonecrop (*Crassula helmsii*)

This is a plant that has spread over the boulder tops throughout the park. The plant favors shady spots and very shallow soils. Because of the shallow soils on top of rocks it is easy to mechanically remove by scraping off the soils – but that also removes the fragile soils, preventing the regeneration of other native species. An aquatic version of this plant is much more aggressive and can be removed by raking.

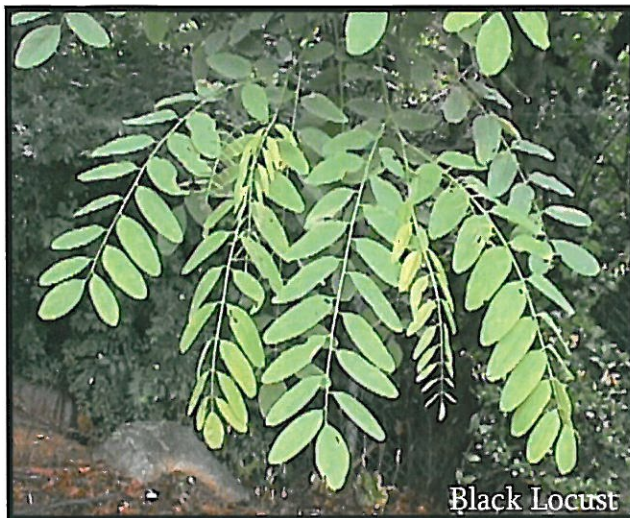
Black Locust

This popular ornamental species originated in the southeastern US and has since escaped to road sides, wetlands and edges. Black locust is a tree species with alternate branching and pinnately compound leaves. A pair of sharp horns (1/2-3/4 inch) grow at each node. The bark of this tree is deeply furrowed and is dark reddish-brown in color. It has shallow, aggressive root system. Once introduced into an area, black locust expands readily from roots and their shade eliminates competition of native vegetation.

Also, large, fragrant flowers compete with native plants for pollinating bees. In managing for this species, mowing and burning are only effective in reducing the spread of young shoots. Herbicides applied to stems and stumps spread into the root system to provide more effective control. It is found in the park near the pinnacle, ringing the clearing.

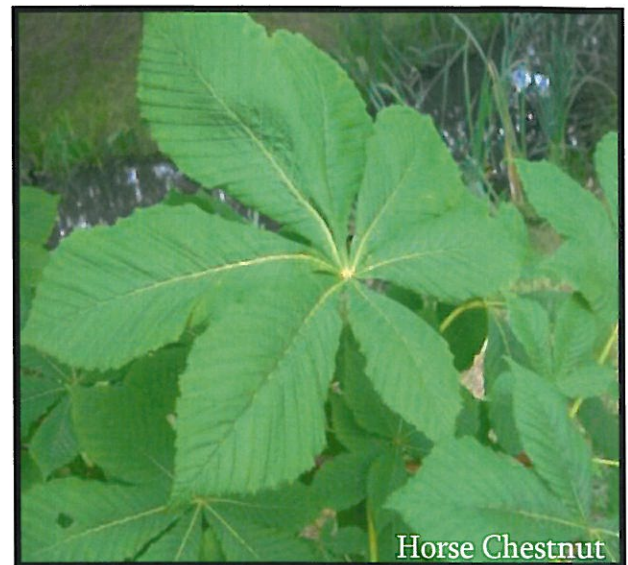
Horse Chestnut

Horse chestnut is a large deciduous tree that originated in Europe. It has an opposite leaf structure which contains five leaflets (as seen in the picture). The flowers are white, large and very aesthetically pleasing. The tree also produces fruit that is in a chestnut brown capsule. This tree prefers full sun and can grow in a variety of soil types (USDA, 2008). It was originally planted because of its beautiful flowers but has spread and is now classified as an invasive exotic species in Georgia, Maine, Oregon, Pennsylvania and Wisconsin by the National Park Service (NPS, 2007). Although Vermont is not among those listed, this species could become a serious problem in Ethan Allen Park as it was seen in both seedling and sapling age classes.

The horse chestnut has the potential to out-compete the native species growing around it. This occurs through the large amount of litter it creates and simple competition for basic growing necessities. If the species is considered invasive in the area and removal is needed, there are a few options. The large trees can be girdled –cut shallowly around the base to the tree to cut off sap circulation but not fell the tree- in order to stop their growth and to eventually kill them. The “clip-and-drip” method can also be used by cutting the tree and applying an herbicide directly to the trunk. This method works best in the fall.

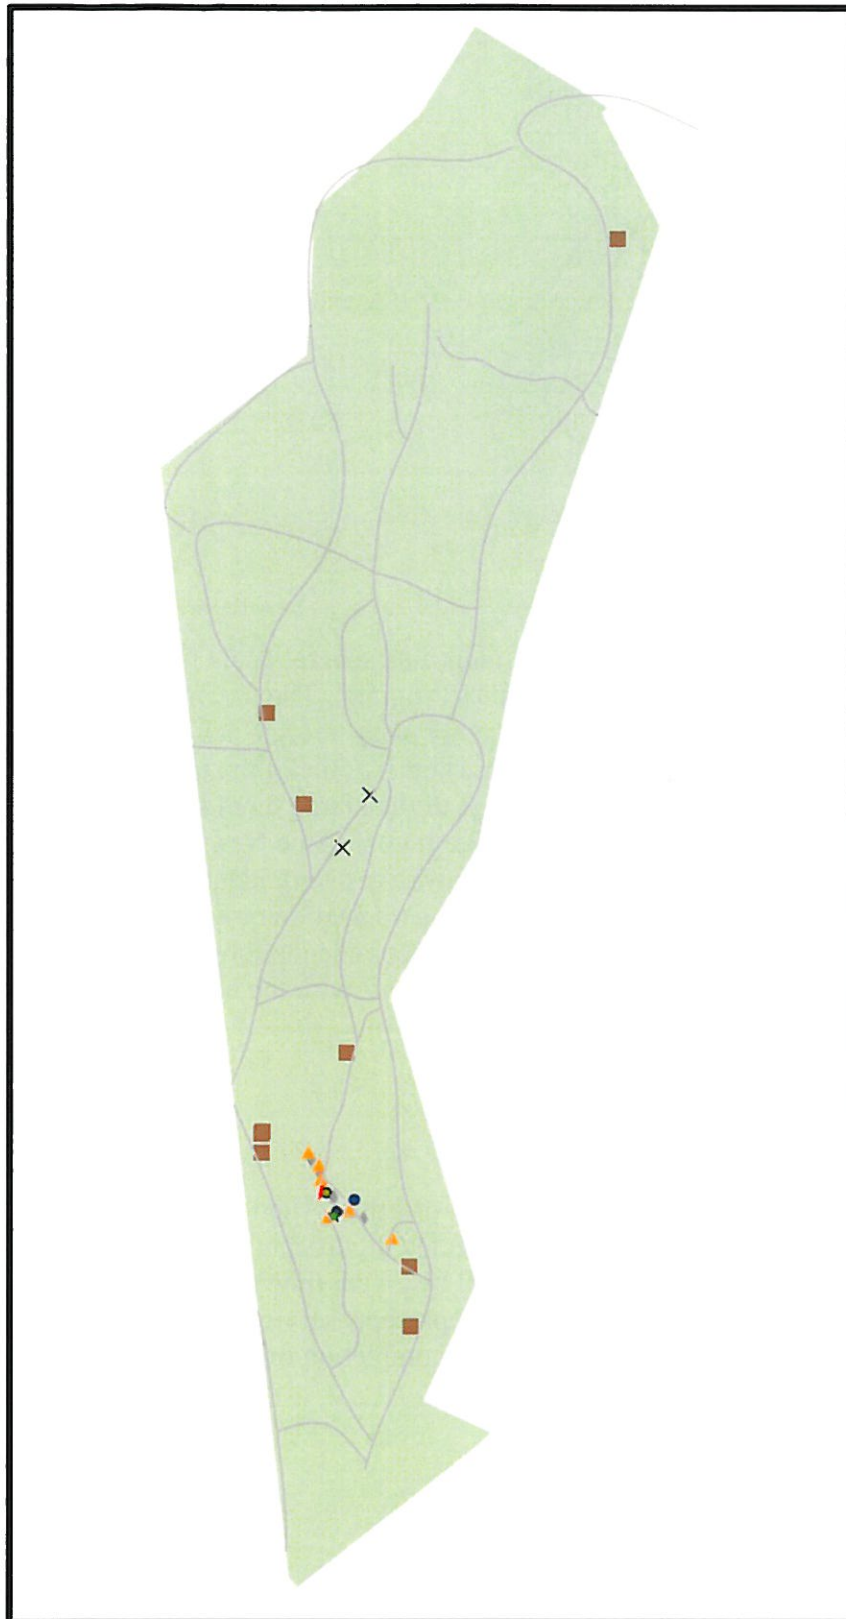
- Sweet Joe Pye Weed
- ★ Low Bindweed
- ▲ Seneca Snakeroot
- × Poke Milkweed
- ✂ Cliff Brake Fern
- ◆ Four leafed Milk Weed
- Wall rue
- Yellow Oak
- Trail
- Park Boundaries

These plants, though rare, make significant contributions to the ecosystem as a whole. These species do not exist in isolation, but rather are interrelated with other organisms, such as pollinators. Through these unique interactions and the processes they perform, the consequences of the loss of these plants could affect a broad range of species. Ultimately, these rare, threatened and endangered plants improve human life. It is recommended that special care is taken to protect the identities and locations of these plants. Map 8 shows the sensitive plant sites within Ethan Allen Park.
