495 COLCHESTER AVE. PHOTO TAKEN NOVEMBER, 1927 AFTER THE FLOOD THAT REMOVED THE BRIDGE TO WINOOSKI.

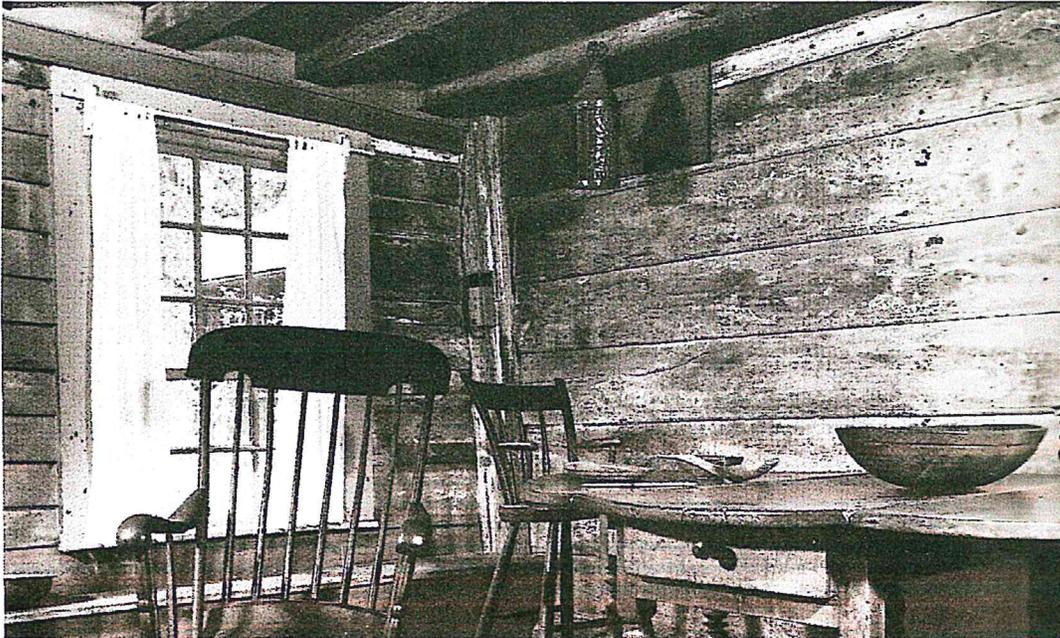
Photo 37. The new floor structure of the inserted floor and the first floor apartments when seen from the cellar floor will be similar to that seen here.

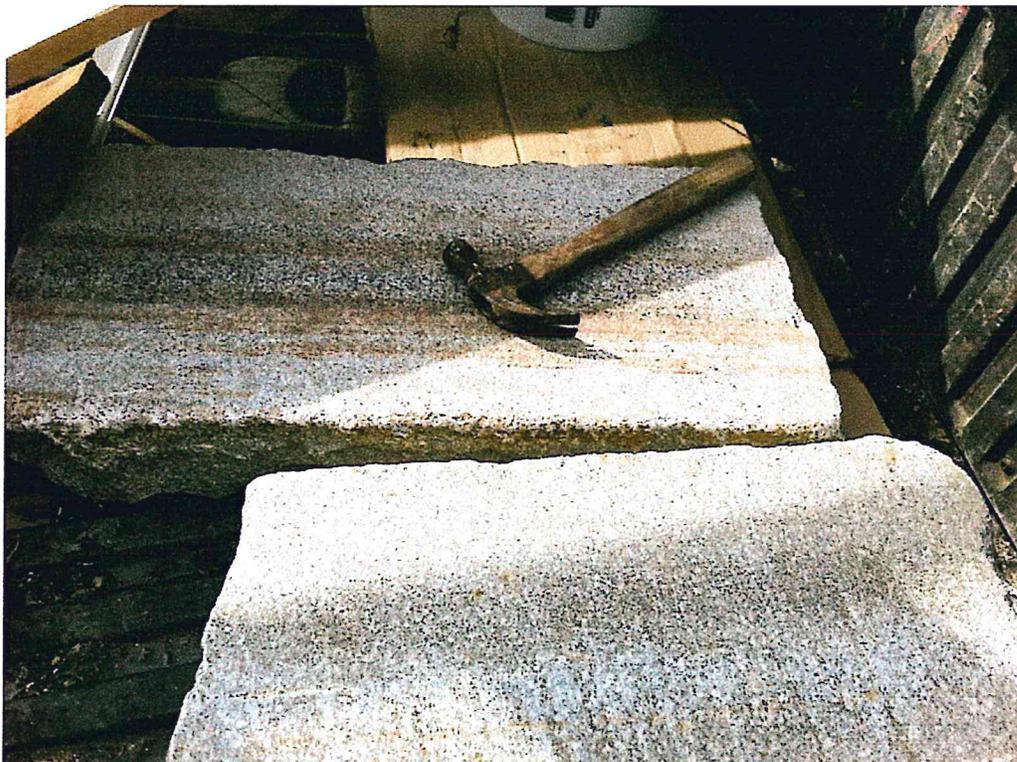
Photo 38. This photo shows two the granite stones that will be used to reconstruct the foundation wall between the top of the existing stone foundation that will remain and the bottom of the brick at the lifted building. Sizes are similar with similar cut to the existing stones, but these are grayer – compatible, but different so they do not fool someone to thinking they are the original stones. These stones will only be visible on the exterior and will be backed up to a new insulated concrete foundation wall on the interior, faced with plaster.
