2.0 MEMORIAL AUDITORIUM

2.1 Existing Conditions

This study was prepared by Bargmann Hendrie + Archetype, inc. for the **City of Burlington, Department of Parks and Recreation**. It is intended to investigate the agency's capital needs, evaluate alternatives, and recommend solutions for the Burlington Community Recreation Center's two proposed locations, Memorial Auditorium and Leddy Park.

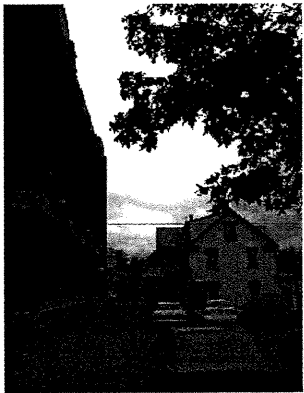
Fig. 3: West Elevation- Alley

On Main Street, an adjacent house converted to commercial use is also considered to contribute to the historic district. It is separated from Memorial Auditorium by an alley that is used as a driveway to and from the parking lot. Pedestrians also use this alley, which includes a makeshift wheelchair ramp for the existing teen center "Club 242", resulting in a safety hazard.

- Remove and reconstruct non conforming wheelchair ramp at west elevation
- Repair, patch and refinish concrete and other surfaces
- Reconstruct masonry stair buttresses at north and south entry stair. Main entry stair at east elevation was already resolved.

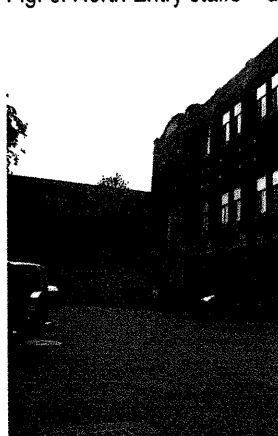
Fig.7:North-stairretaining wall

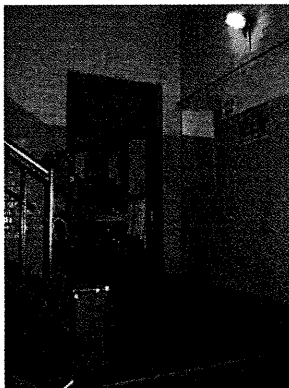
Other restrooms are located on the dressing room level, multipurpose room 3rd floor, and on the intermediate landing levels off the stairs. These restrooms are in desperate need of a fixture upgrade and finishing in accordance with current codes.

Fig. 58: Toilet Room Entry

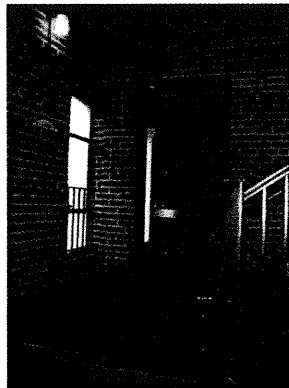
Fig. 59: Toilet Room Entry
off stair landing: not
accessible

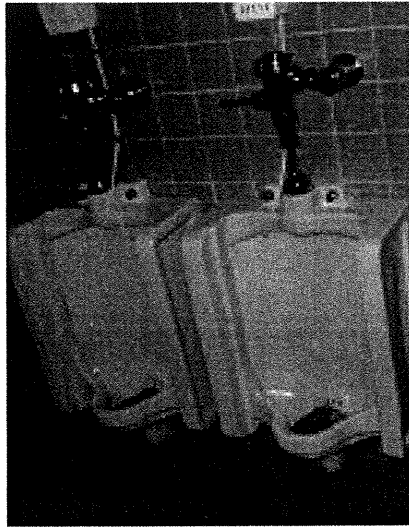
The plumbing fixtures in the annex toilet rooms are modern and seem to comply with ADA standards. However, most of the plumbing fixtures throughout the remainder of the building, including the changing area, do not appear to comply.

Urinals in
Men's Changing Room

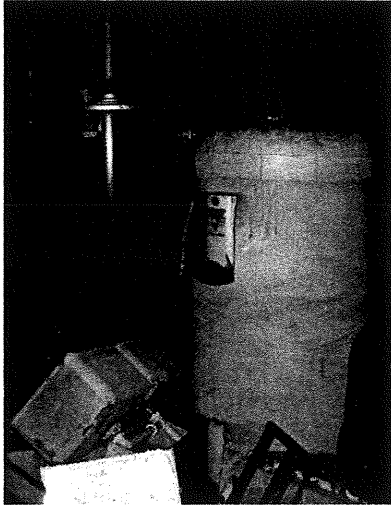
Gas Fired Hot Water Heater and
Storage Tank in Boiler Room

We recommend replacing the electric hot water tanks with steam-heated tanks. Further study must be conducted to see if a steam line is close enough to make this possible. We also recommend replacing any hot water tanks which are stone or glass-lined to tanks which are polyethylene-lined or stainless steel to prevent corrosion and failure.

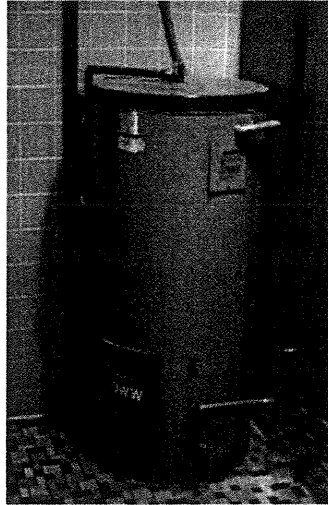
Electric Hot Water Heater in
Annex Toilet Room

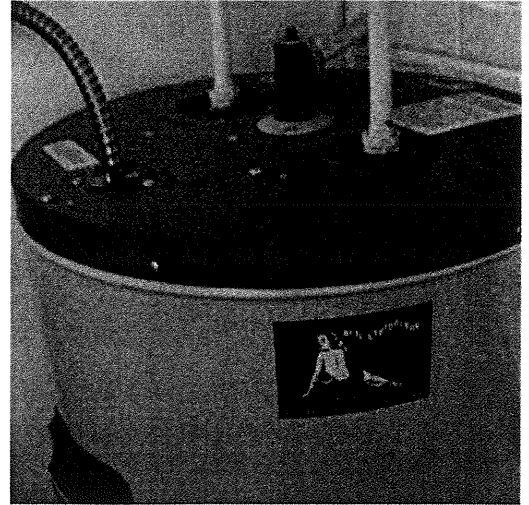
Electric Hot Water Heater
in Hall Toilet Room

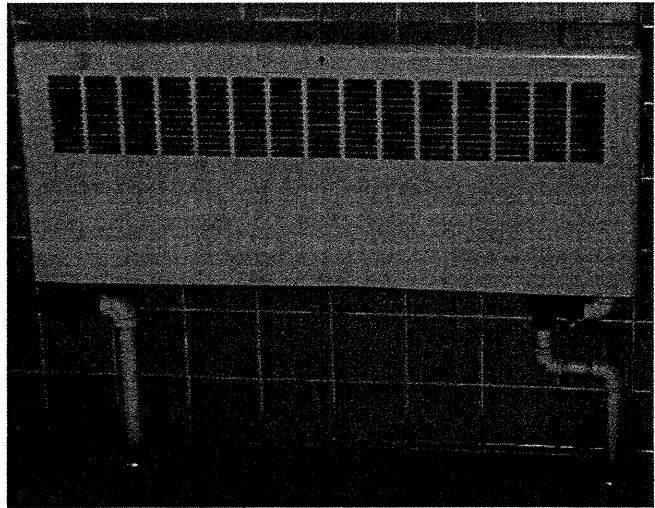
Many heating units did not appear to have vacuum breakers in the steam piping connections. This would cause "water hammer" noises when the steam is flowing through the heater. Steam piping should be inspected and any incorrect piping techniques should be replaced.

Steam Convector in Changing Room Area

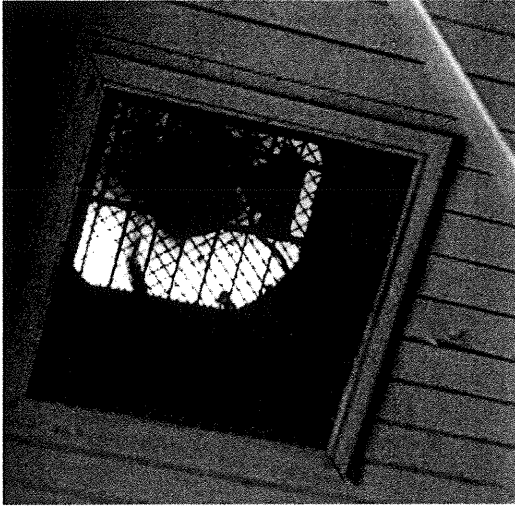
Exhaust fan opening in auditorium ceiling

Backdraft damper is open, fan is running.

Backdraft damper sometimes stick open as corrosion accumulates.

Recommend replacing the backdraft dampers with motorized dampers which will open automatically when the fans are in use and close when they are not. While closed, they have less leakage than backdraft dampers. Relief vents should also be equipped with these units.

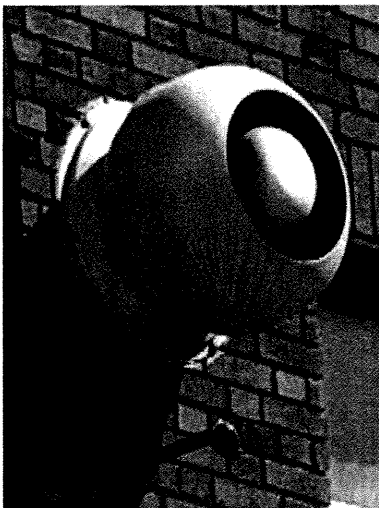
The changing area near the stage is also ventilated with exhaust fans. Three wall-mounted fans associated with three switches exhaust air out of each changing room, the toilet rooms, and the shower rooms. This system appears to be working satisfactorily.

Wall Fan for Changing Area

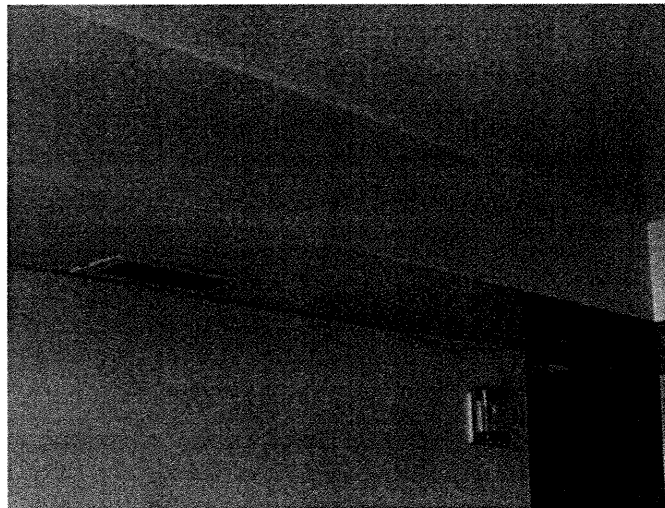
Ceiling Exhaust Grille in Changing Room Area

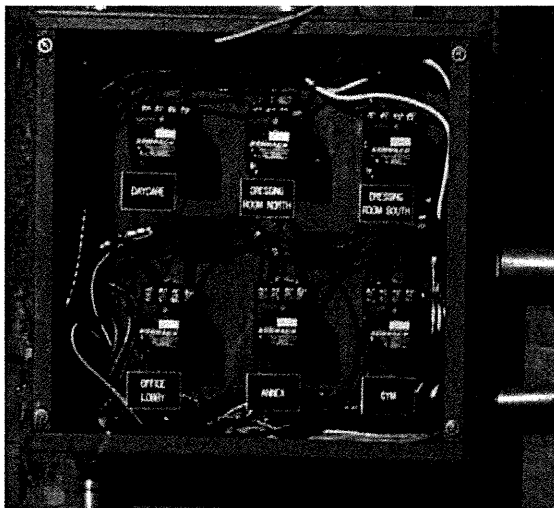
There is no central control system in this building, all heating control is done by the programmable thermostats. Some areas are controlled by manually turning the steam valves by hand.

Relay Control Panel in Boiler Room

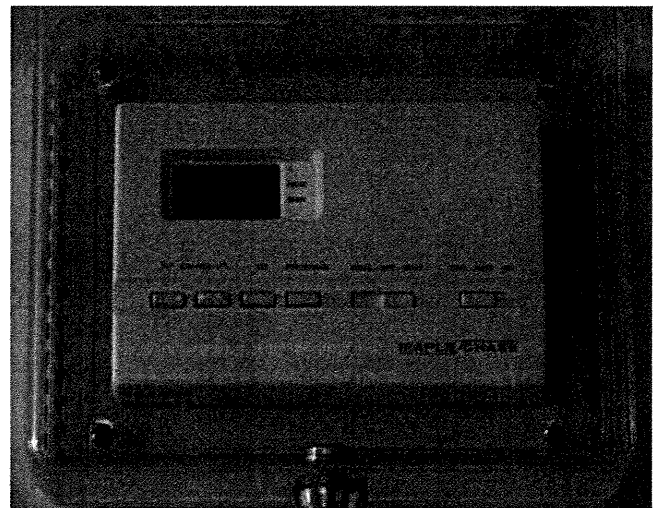
Programmable Thermostat

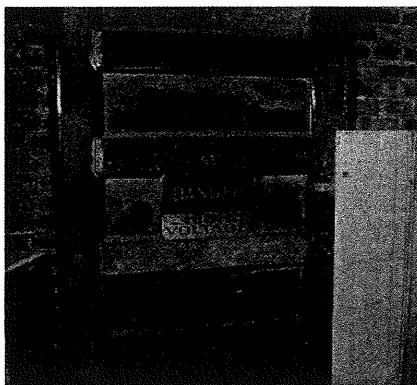
Service transformer vault is located in basement. Access is only by Electric Utility Co. It was stated that the transformer supplies other buildings besides the Auditorium.

Basement Transformer Vault

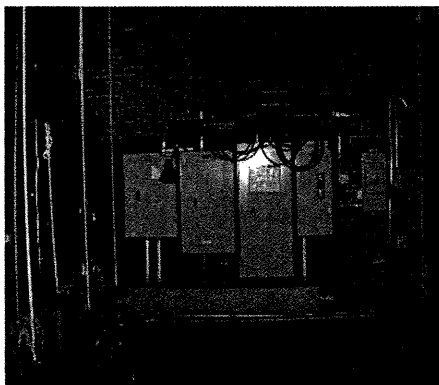
Stage Service, 400A & 200A

With 400A and 200A panels the stage electric service is properly sized for all but the largest touring shows.

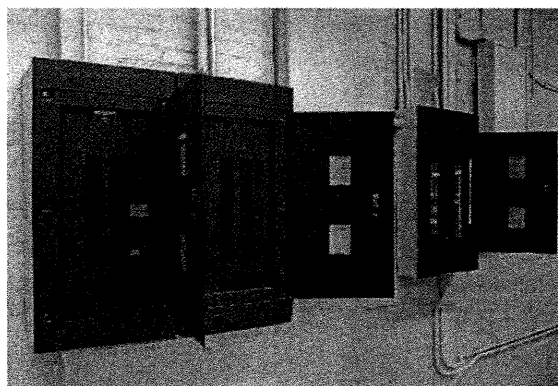
Annex Level Load Panels

Annex level power distribution from modern circuit breaker panels.

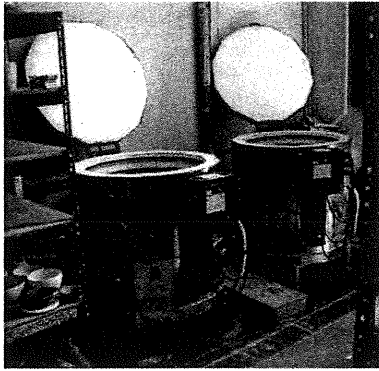
Two Electric Kilns

The pottery shop kilns use large amounts of power, 40-50KW peak (140A at 208V, 3Ø) This is a large load which significantly affects both Peak Demand and Electrical Energy usage for the building's electric bill. An electronic energy analyzer meter was installed to prorate electrical usage to the pottery shop. While it can measure the KW hours of energy consumption, it cannot calculate the additional peak demand added by the Pottery Shop to the Auditorium's electric bill.

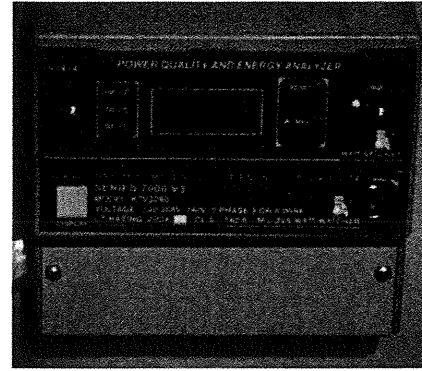
Pottery Studio KWH Meter

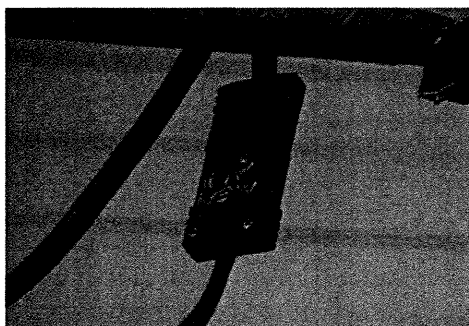
Stage Pin plugs are used for auditorium lighting equipment connections.

Stage Pin Plug Connector Set

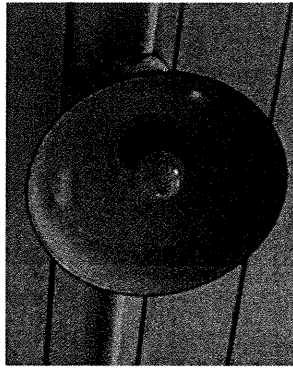
Incandescent Lamp

Most of the remaining original fixtures are incandescent types with 120V medium screw base sockets. Many of these have been supplied with retrofit type PL fluorescent lamps. Replacement of this type lamp is expensive because the solid state ballast is usually integral and must be thrown away with the lamp. If the ballast assembly does have a socket for lamp replacement, then it is usually low wattage and low lumen output to make the lamp assembly small enough to fit in the fixture.

Other utilitarian fixtures should be replaced with plug-in PL or modern T-8 or T-5 fluorescent lamps for economy and energy efficiency.

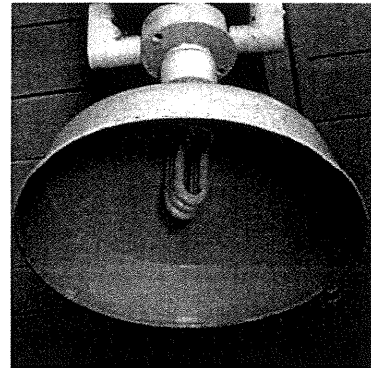
Retrofit Fluorescent

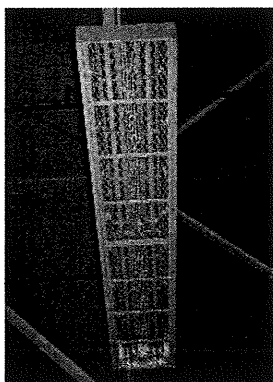
Fifteen 4 x 32W T-8 fluorescent units installed for "instant on" applications and switched in banks to dim lights for stage performances.

8' "Instant on"
Fluorescents

Recommend retrofitting house fluorescent units with dimmable ballasts for true houselight dimming for stage performances.

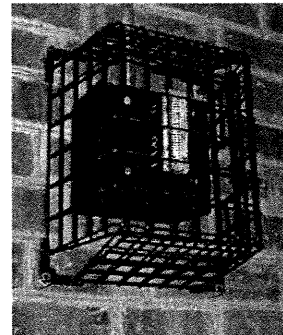
Horn/Strobe Alarm

Insufficient number of strobes to meet modern ADA standards.

Recommend adding strobes in all public spaces, corridors, rest rooms and other locations to meet intensities as required by ADA.

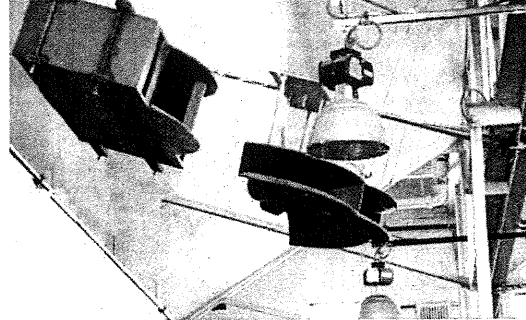
The components are 1970's/1980's vintage equipment. It was stated that sound quality was not good and this may be due to the age of the electronics or possibly a blown driver(s) in the speaker array. The speaker cabinets and horns are valuable components worth keeping and if there are blown drivers they can be replaced. The electronic components should be replaced with current equipment. The enclosed rack assembly can be reused to house the new equipment.

Stage PA Speaker Array

Some small improvement in sound quality may be obtained by rearranging the speaker cabinets so that the drivers are physically aligned and time domain phased.
