Assessment of City Parking Garage Structures College Street Garage

Hoyle, Tanner
& Associates, Inc.

Prepared for:
City of Burlington, Vermont

July 2014

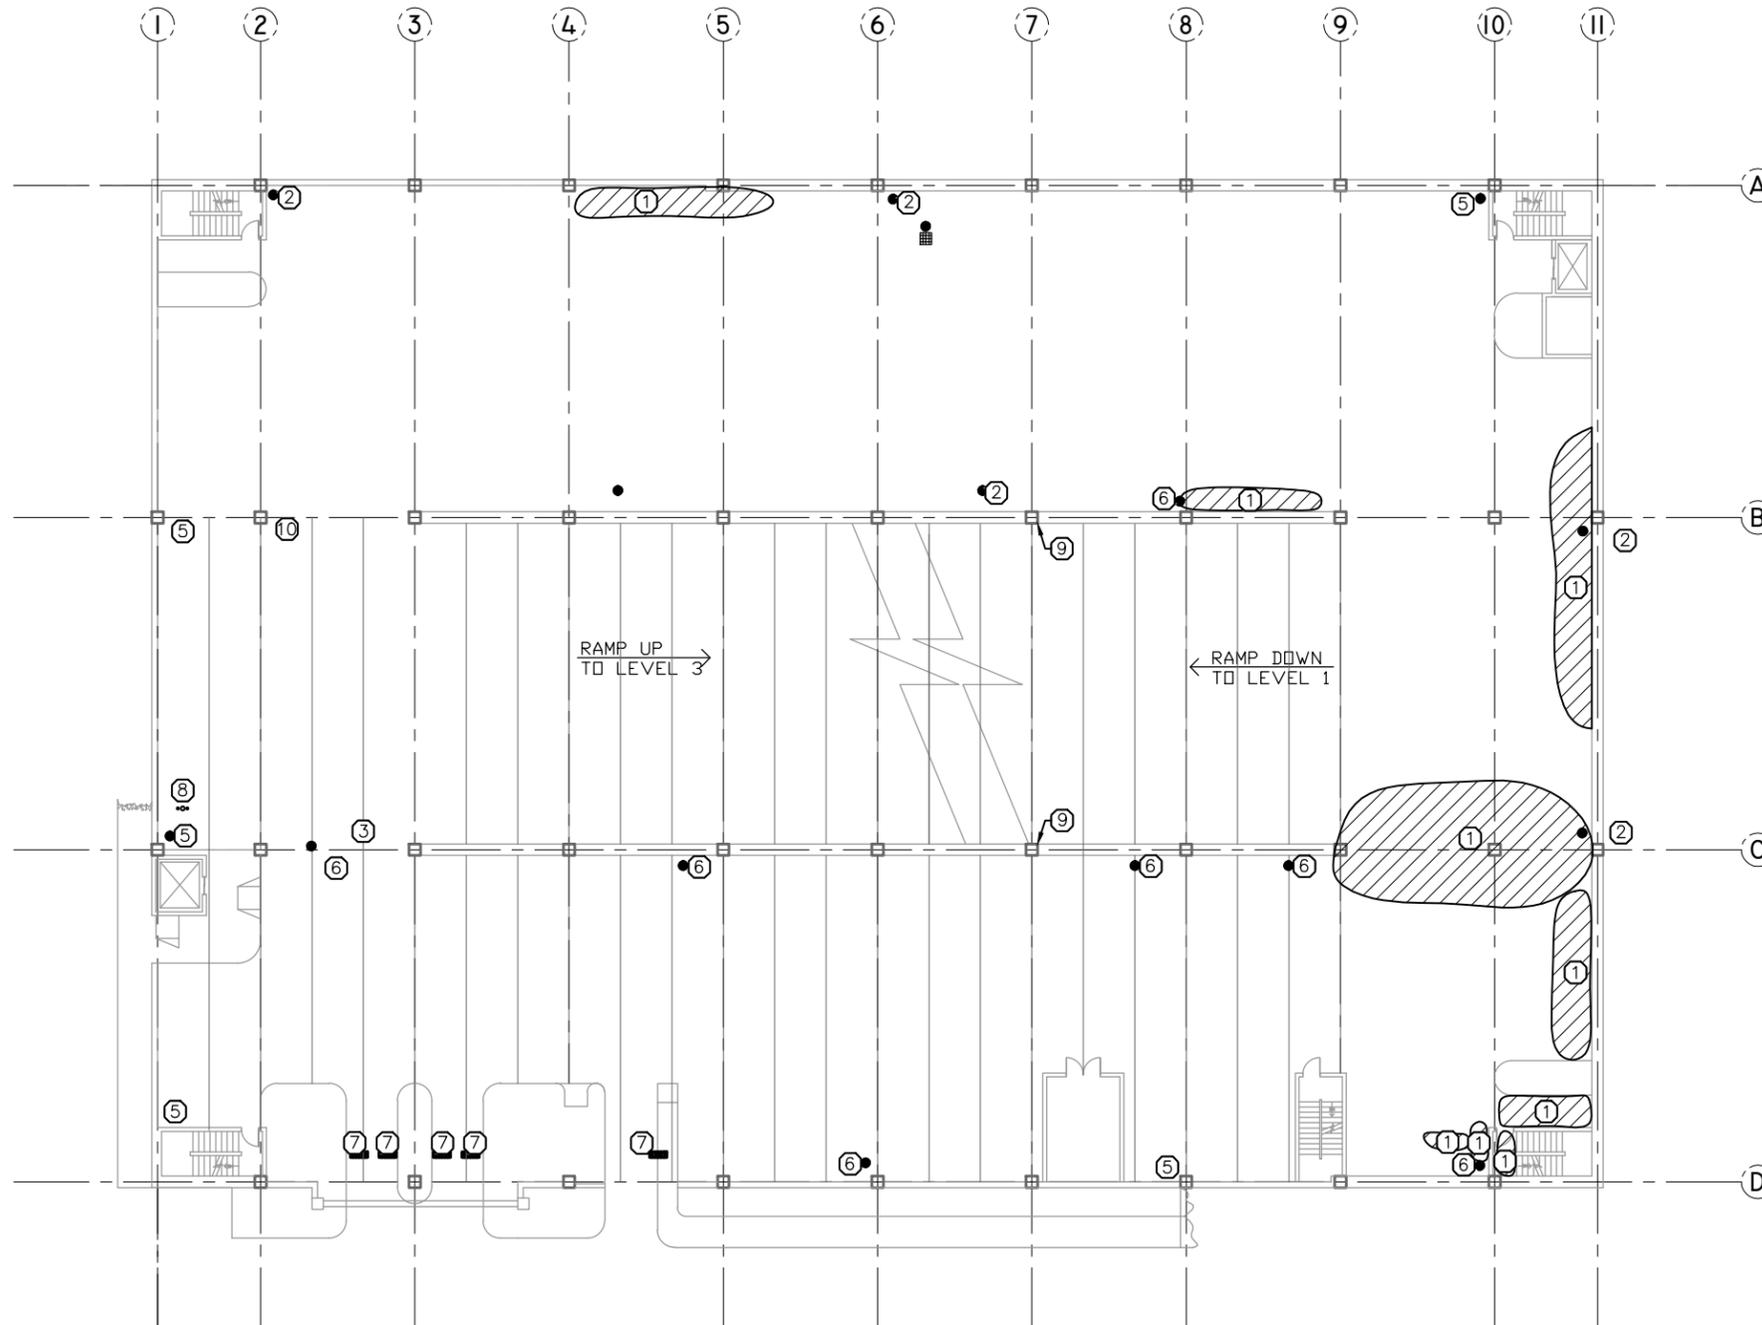
SHEET NO. <h1 style="margin: 0;">I-1</h1>	
SHEET 1 OF 4

- ① STANDING WATER (OBSERVED DURING INSPECTION ON 5/23/14)
- ② PLUGGED STORM DRAIN
- ③ CONCRETE SPALL IN BEAM
- ④ STORM DRAIN NOT LOCATED DUE TO DEBRIS COVER
- ⑤ POTENTIAL STORM DRAIN LOCATIONS (FURTHER DESIGN REQUIRED FOR OPTIMUM LOCATION)
- ⑥ DAMAGED STORM DRAIN TO BE REPLACED
- ⑦ DAMAGED/DETERIORATED TRENCH DRAIN
- ⑧ HOLES CORED IN PRECAST BEAM (REPAIR 'PC-5')
- ⑨ GAPS AT COLUMN WALLS
- ⑩ DOUBLE-TEE BEAM WITH BEARING ISSUE (REPAIR 'PC-9')
