Re: 351 North Avenue, Burlington, Vermont

After our conversation about the roof project at Burlington College, and an inspection on the premises Sept 25th, here are my findings.

Due to the high cost of a new slate roof, I would recommend a standing-seam copper roof, which is a historically appropriate material to replace the existing roof, according to the National Park Service, which lists copper roofs as old as 1774.

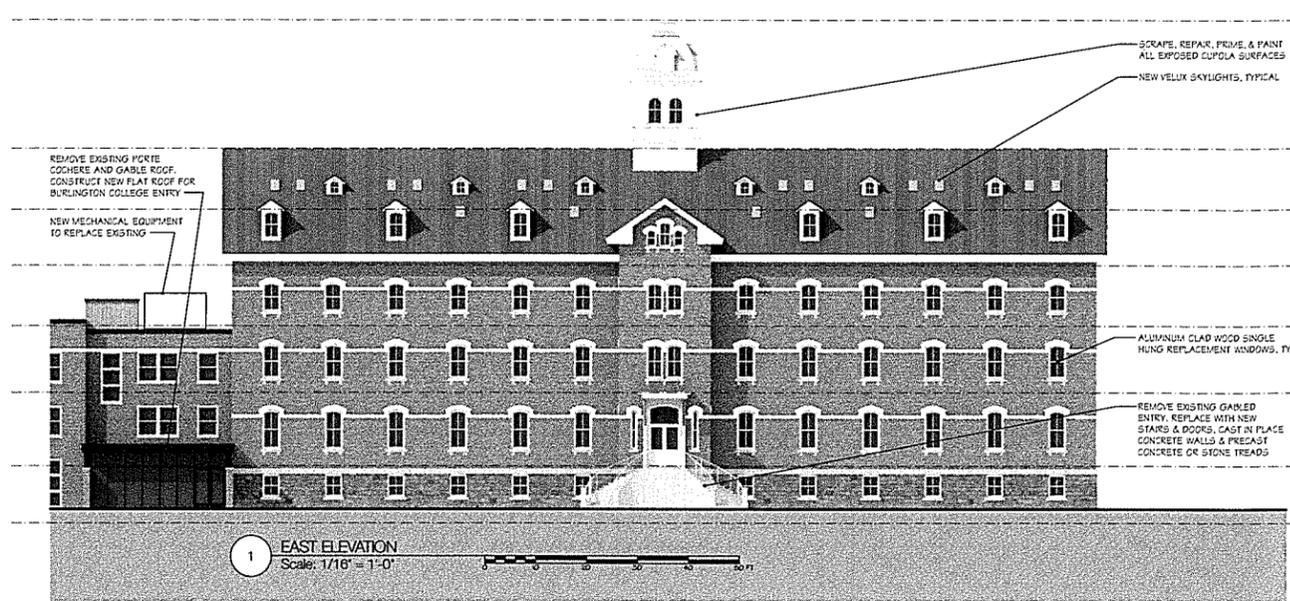
EST. TOP OF CUPOLA
86'-7 1/2"

MAIN ROOF PEAK
73'-5"

FF ATTIC LOFT
61'-5 3/4"

FF ATTIC FLOOR
50'-6"

FF FOURTH FLOOR
38'-7 1/4"

FF THIRD FLOOR
25'-6 1/4"

FF SECOND FLOOR
11'-2 1/2"

FF FIRST FLOOR
0"

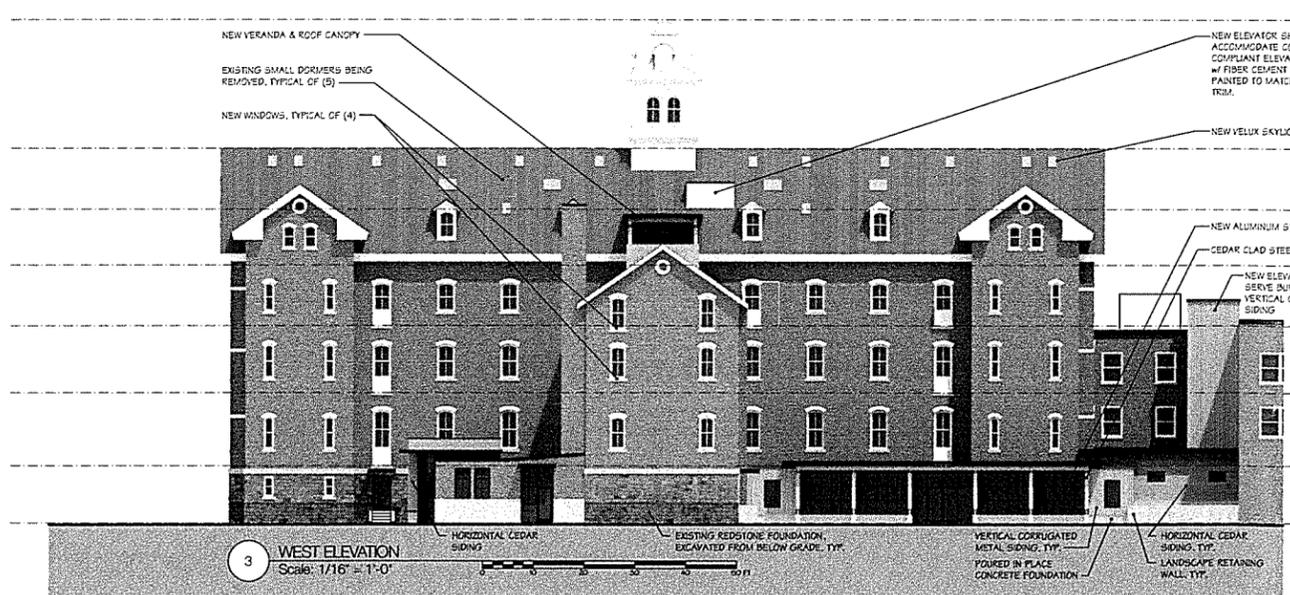
3 WEST ELEVATION
Scale: 1/16" = 1'-0"

EST. TOP OF CUPOLA
86'-7 1/2"

MAIN ROOF PEAK
73'-5"

FF FIRST FLOOR
0"
