**FACILITIES ASSESSMENT REPORT
For
Burlington Memorial Auditorium
Burlington, Vermont**

April, 2009

Stantec, Inc.
54 Route 106, PO Box 29
North Springfield, VT 05156-0029
&
Banwell Architects
6 South Park Street
Lebanon, NH 03766

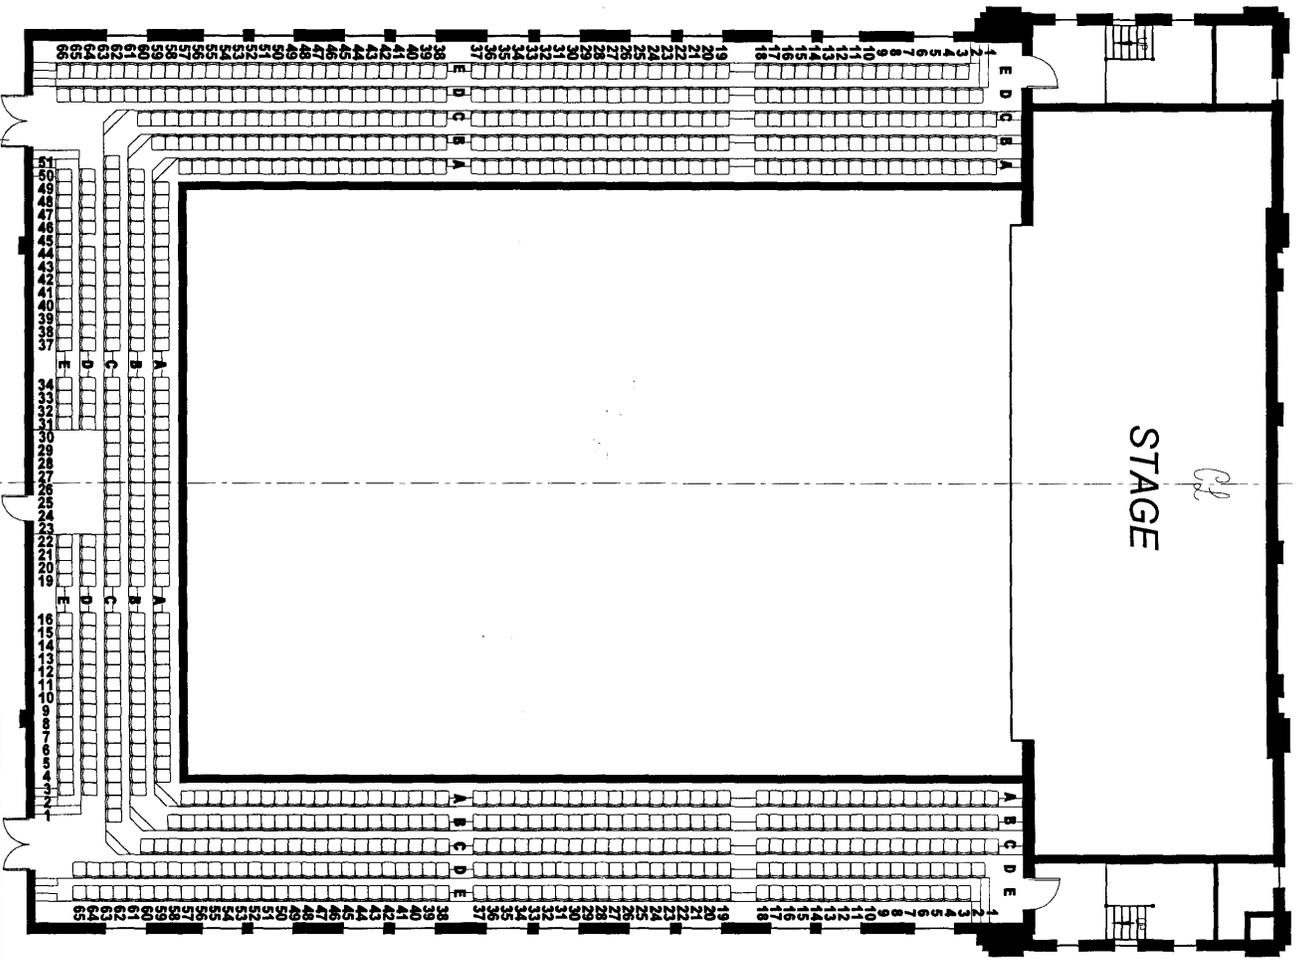
MEMORIAL AUDITORIUM
Balcony Floor Plan
4:2'0 4' 8"

Fixed Balcony Seating - 812 Seats
