**ZP-22-489; 251-253 South Union Street**  
**Re: Architectural Design Standards 3. Building Openings**

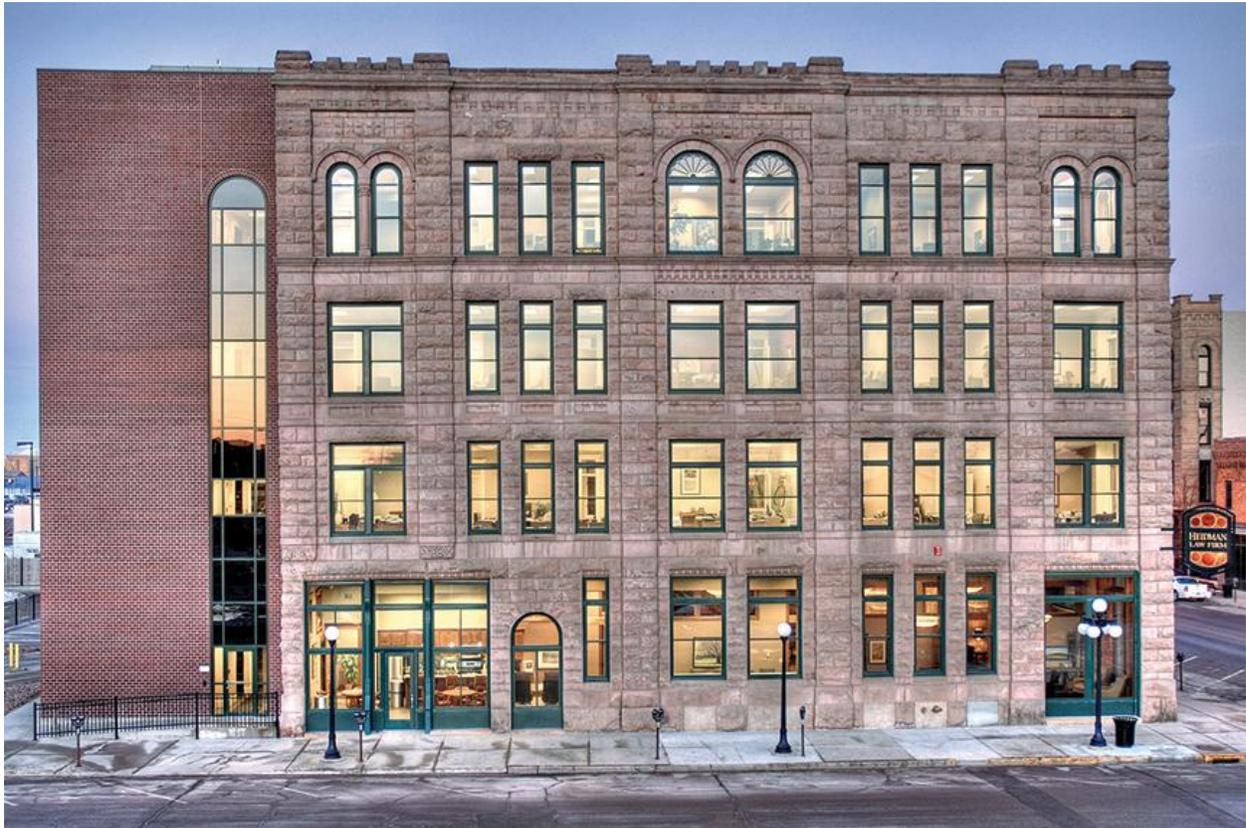
*“Figure 27a. The compatible addition is set back and does not compete with the historic building. Photo: Chadd Gossmann, Aurora Photography, LLC”* [Preservation Brief 14: New Exterior Additions to Historic Buildings: Preservation Concerns \(nps.gov\)](#). Please note that the new exterior addition has fenestrations that echo the aesthetic rhythm of the historic structure in a more creative way – the new windows are larger, allowing more light.

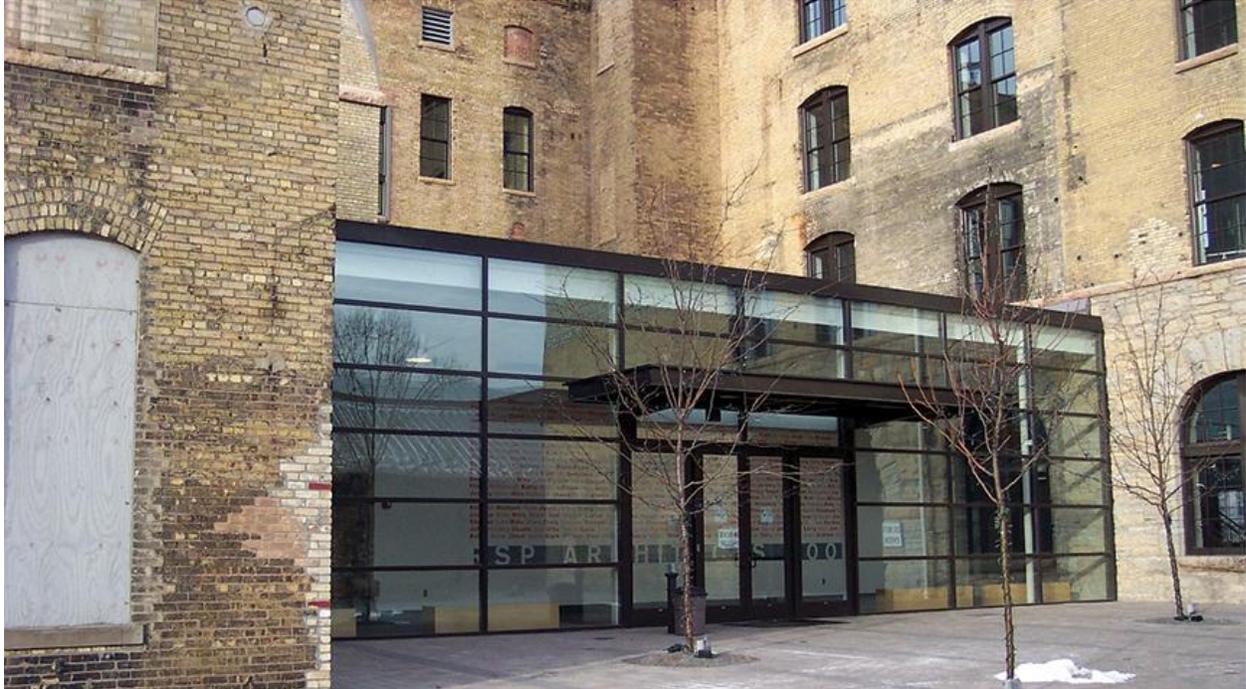
*“Figure 14. This glass addition was erected at the back of an 1895 former brewery during rehabilitation to provide another entrance. The addition is compatible with the plain character of this secondary elevation.”* [Preservation Brief 14: New Exterior Additions to Historic Buildings: Preservation Concerns \(nps.gov\)](#) Note that on a rear elevation, the standard for assessing compatibility is given much more room for interpretation – in this case, an all glass enclosure is still seen as “plain” in total even though the fenestrations do not match the existing historic fenestrations. The addition is assessed as a whole.

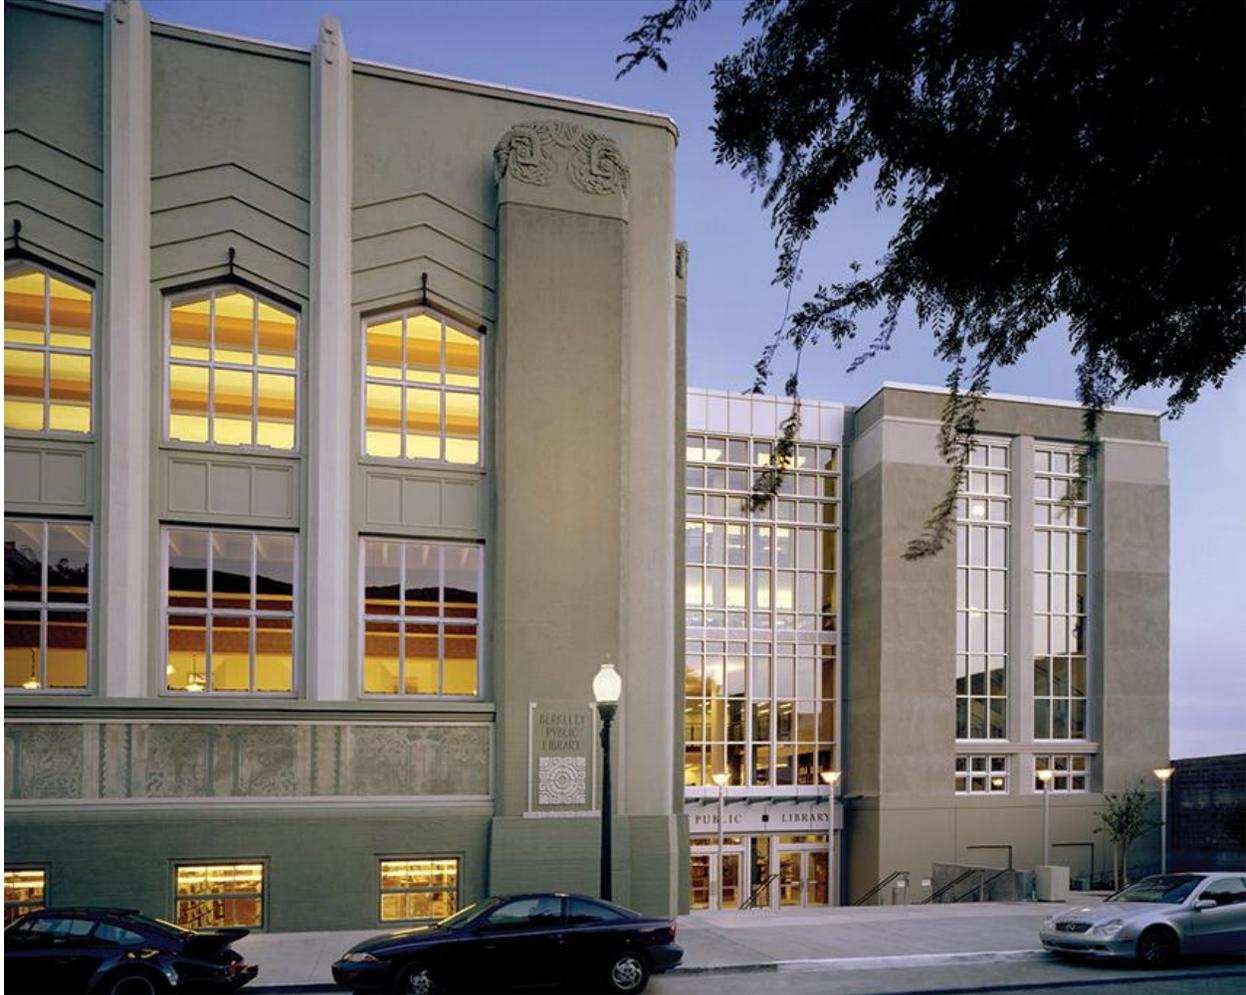
*Figure 1. The addition to the right with its connecting hyphen is compatible with the Collegiate Gothic-style library. The addition is set back from the front of the library and uses the same materials and a simplified design that references, but does not copy, the historic building. Photo: David Wakely Photography. [Preservation Brief 14: New Exterior Additions to Historic Buildings: Preservation Concerns \(nps.gov\)](#) Note that fenestrations borrow ratios from other design elements while favoring the ability to bring in maximum natural light.*
