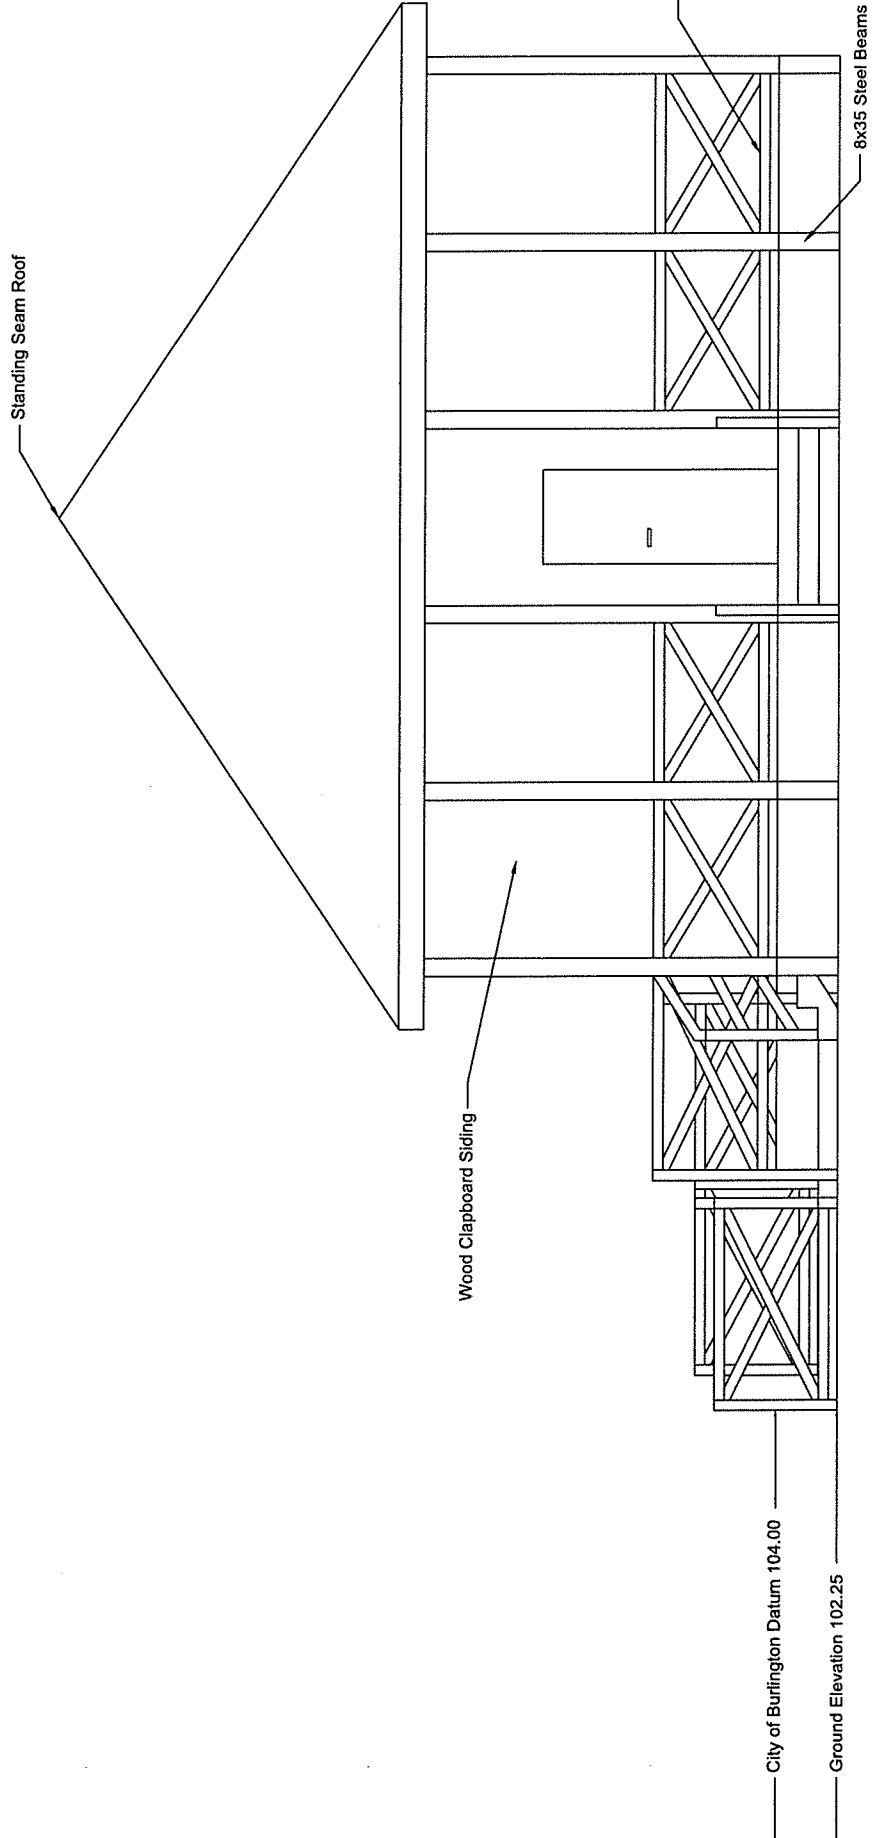
EAST

Standing Seam Roof

Wood Clapboard Siding

Composite Decking Material

8x35 Steel Beams

City of Burlington Datum 104.00

Ground Elevation 102.25
