CHAPTER 2: EXISTING AND FUTURE CORRIDOR CONDITIONS

Corridor Crash History

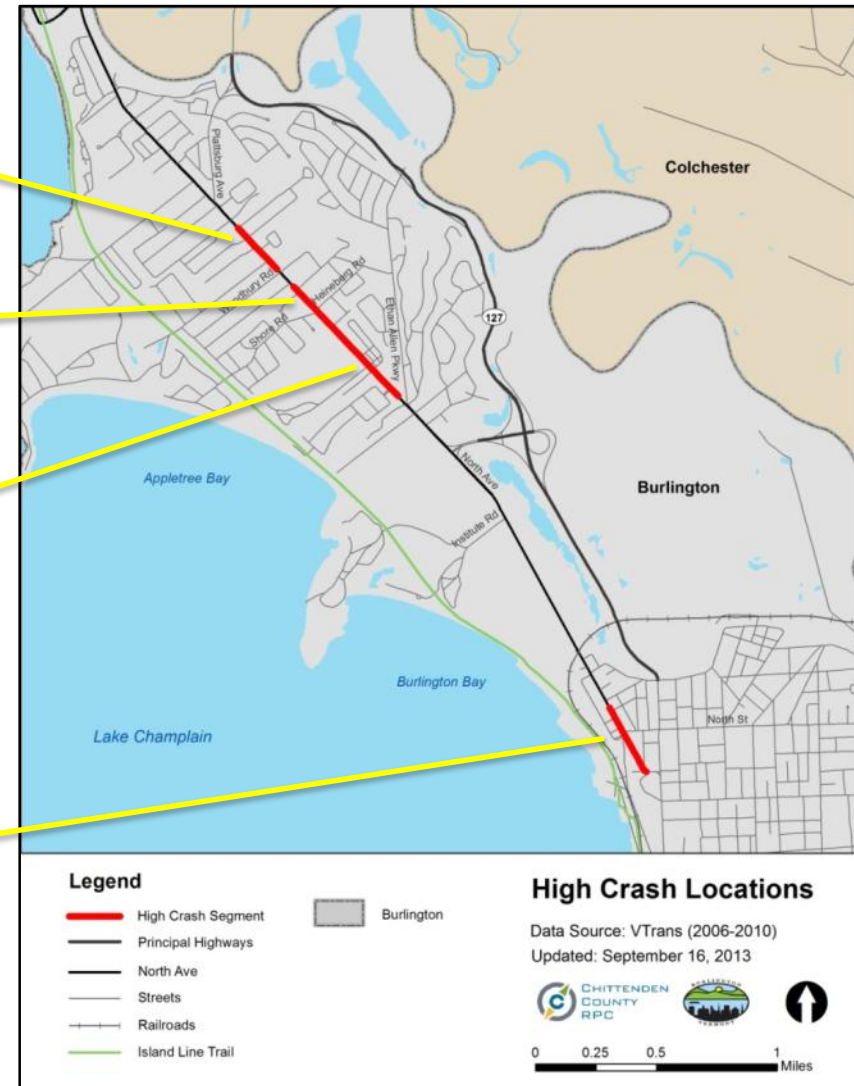
Figure 10: High Crash Locations (2003-2007)

Birch Ct to Woodbury Rd

Crashes: 39
 PDO: 33 (85%)
 Crash Rate: 6.48 per MVM
 Actual/Critical Ratio: 1.23
 Severity Index: \$21,677

Gosse Ct/Woodlawn Rd to Poirier Pl

Crashes: 46
 PDO: 42 (91%)
 Crash Rate: 6.18 per MVM
 Actual/Critical Ratio: 1.22
 Severity Index: \$13,100

Lakewood Pkwy to Ethan Allen Pkwy

Crashes: 76
 PDO: 60 (79%)
 Crash Rate: 10.16 per MVM
 Actual/Critical Ratio: 2.00
 Severity Index: \$41,204

Strong St/Ward St to Sherman St

Crashes: 58
 PDO: 4 (93%)
 Crash Rate: 9.51 per MVM
 Actual/Critical Ratio: 1.81
 Severity Index: \$12,107

During the 2006-2010 period, four segments on the study corridor were identified as HCLs (Figure 10 on the following page).

The Actual/Critical Ratio compares the crash rate for these locations to the average ratio for comparable facilities statewide. A ratio over 1.0 indicates higher than average frequency of crashes at all locations. The Severity Index, which is the average cost associated with crashes, indicates that the average severity of crashes is greatest between Lakewood Parkway and Ethan Allen Parkway; the Actual/Critical Ratio is highest here too. This segment is four-lanes, with frequent cross street and driveway connections. Crash records indicate high instances of at-angle crashes, typically associated with turning traffic.
