# FACILITY CONDITION ASSESSMENT AND LEVEL I ENERGY AUDIT

## FACILITY CONDITION ASSESSMENT AND LEVEL I ENERGY AUDIT of MEMORIAL AUDITORIUM 250 Main Street Burlington, Vermont 05401

**EMG Project #:** 110266.14R-009.294  
**Date of Report:** October 28, 2014  
**On site Date:** August 28 and 29, 2014

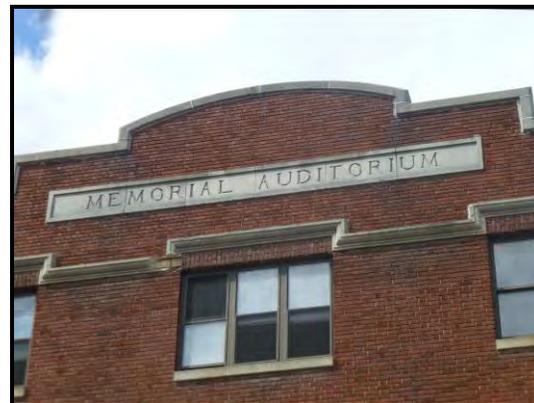
- The property and tenant identification signs are in fair condition. Routine maintenance will be required during the assessment period.
- The exterior site and building light fixtures are in poor condition. It appears that at one point in time, all the entrances to the building were equipped with building-mounted lamps. All but two entrances have had their lamps removed. The two lamps that remain are at service and side entrances and they are in poor condition. The reason for removal is unknown but the lamps are being stored in the basement of the building. Other than public street lighting the site has no other form of illumination. It is recommended that the original lamps be refurbished and re-installed at the entrances to the building. A lighting consultant is required to assess the re-installation and refurbishing of the historic lamps. The cost of this work is included in the Replacement Reserves Report.

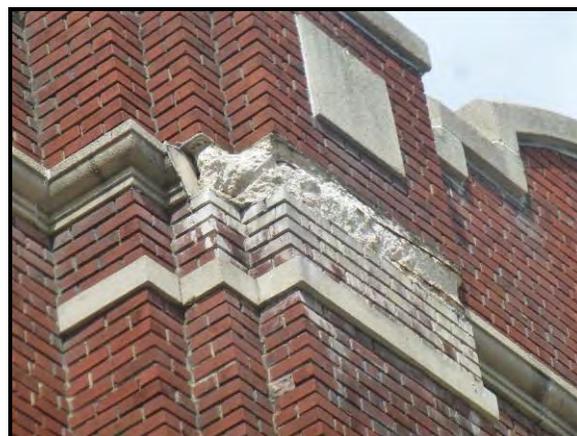
- The exterior finishes are in poor condition. Re-pointing and power washing the brick will be required during the assessment period. The cost of this work is included in the Replacement Reserves Report.
- Similar to the parapet walls, portions of the stone work around the building is crumbling resulting in possible life safety issues. Based on the stone work's current condition it will require repair during the assessment period. The cost of this work is included in the Replacement Reserves Report.
- The sealant is not flexible, cracked, and in poor condition and will require replacement during the assessment period. The cost of this work is included in the Replacement Reserves Report.

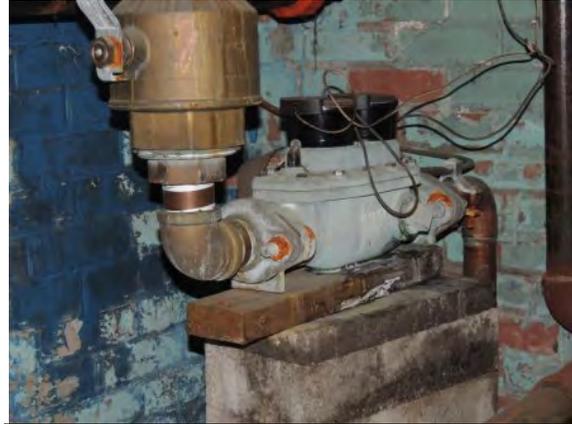
Photo #2: Domestic water meter located under the main southeast stairwell

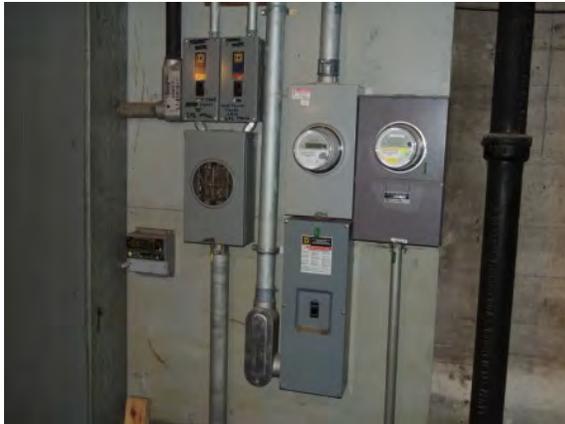
Photo #3: Electrical meters located in the basement mechanical room

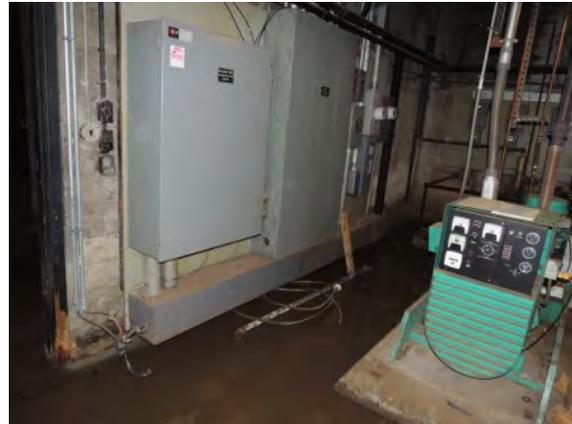
Photo #4: 800 amp 120/208 volt 3 phase incoming electrical service located in the basement mechanical room

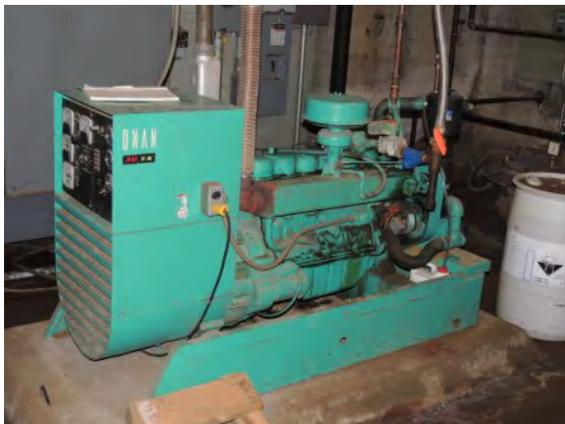
Photo #5: Onan 37.5 kva natural gas emergency back-up generator located in the basement mechanical room

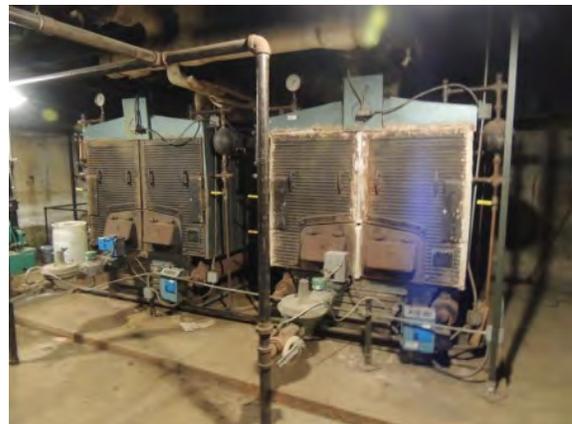
Photo #6: H. B. Smith co. 450 mills cast iron natural gas-fired steam boilers located in the basement mechanical room

| <b>Immediate Repairs Report</b><br><b>Memorial Auditorium</b><br><b>10/24/2014</b> | | | | | | | |
|--|---|--|---|---|---|---|---|
| 7.1 | 273324 | Replace steam boiler, gas 3563 MBH | 2 | Each | \$51,100.00 | \$102,200 | \$102,200 |

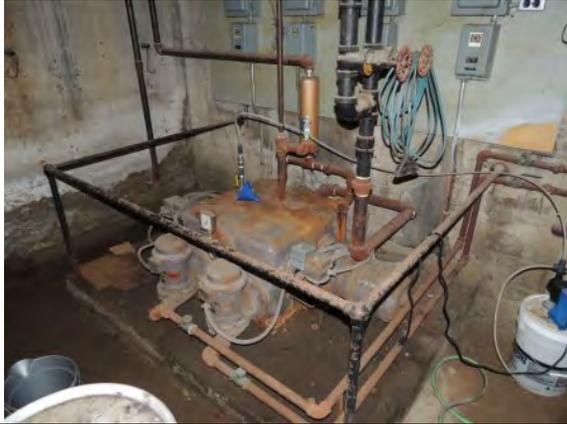
Photo #7: Steam heating condensate system located in the basement mechanical room

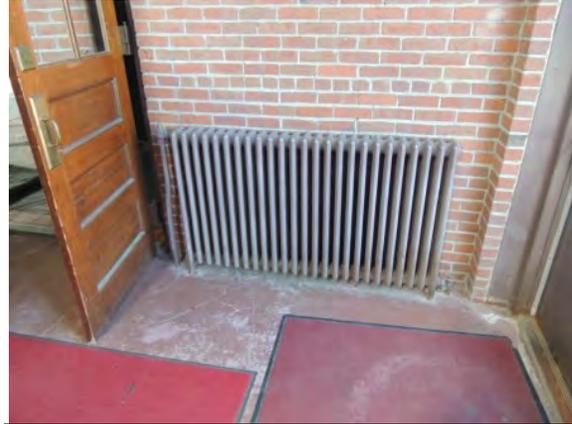
Photo #8: Typical floor mounted steam heating radiator

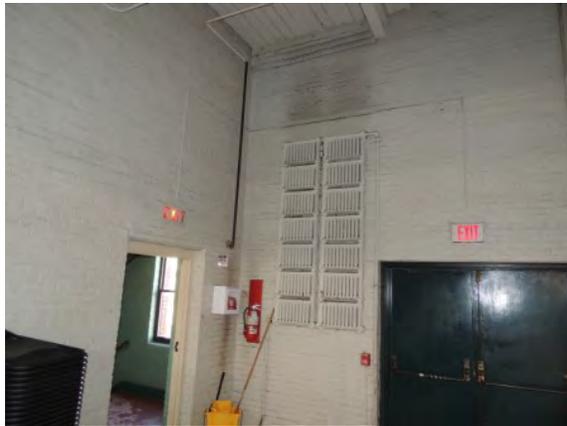
Photo #9: Typical wall mounted steam heating radiator

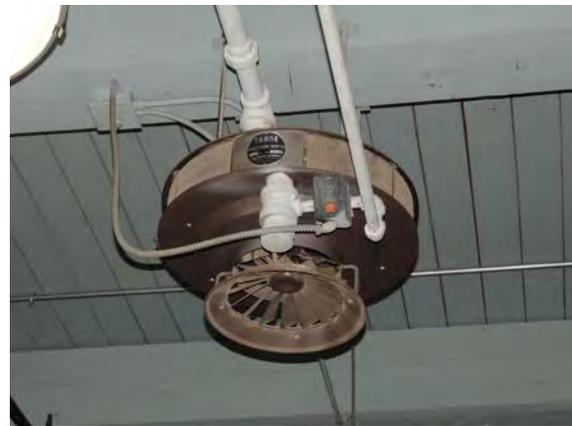
Photo #10: Typical ceiling mounted steam unit heater

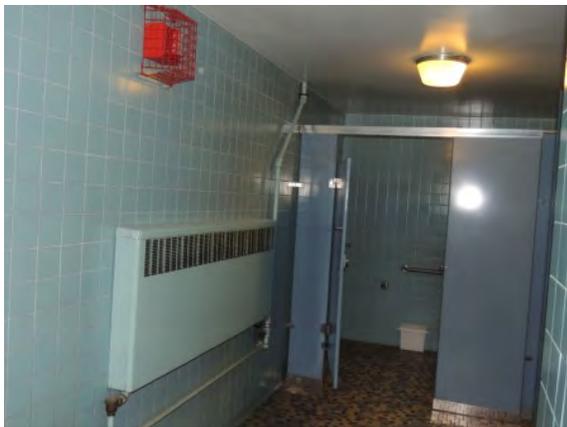
Photo #11: Typical surface mounted steam radiator

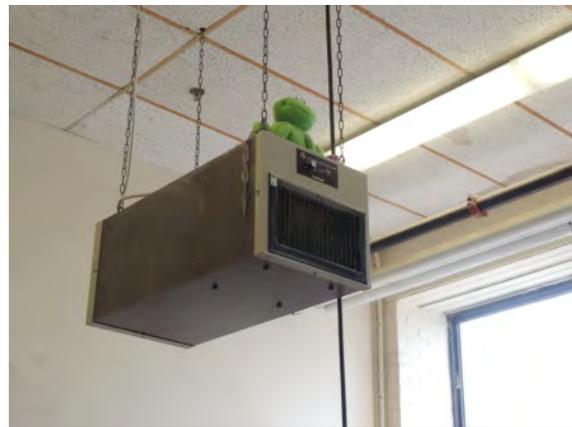
Photo #12: Suspended smoke eaters located in the ceramics workshop

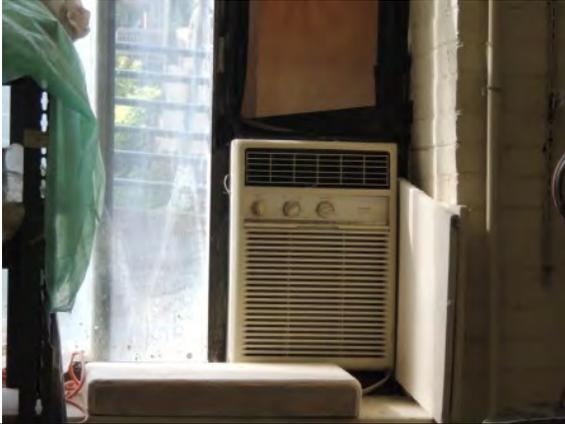
Photo #13: Typical user installed window air conditioning unit

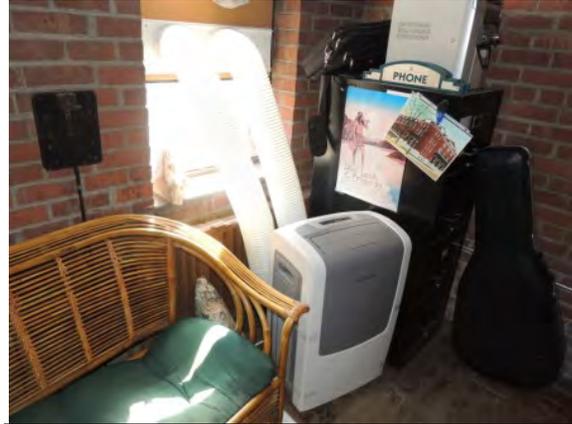
Photo #14: Typical user installed portable air conditioning unit

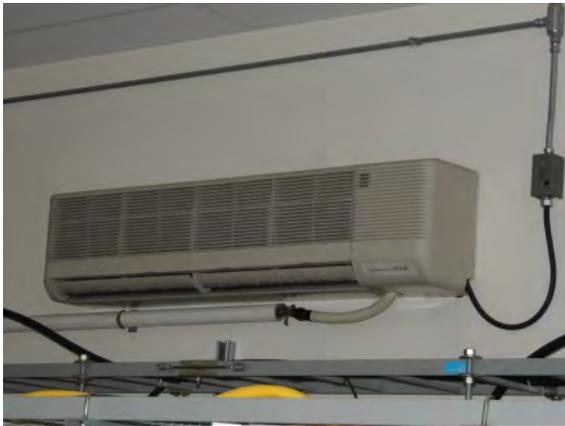
Photo #15: Mitsubishi split air conditioning unit located in the computer server room

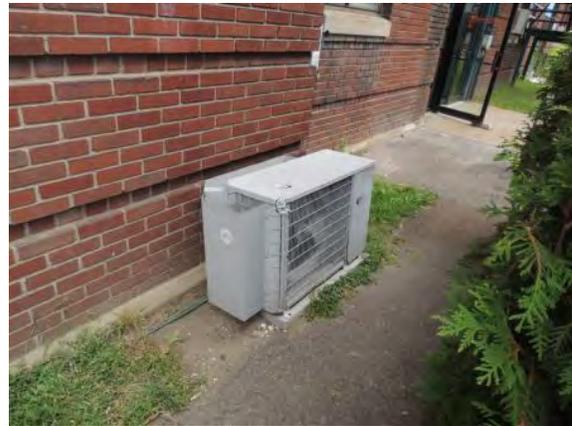
Photo #16: Grade mounted air conditioner condensing unit

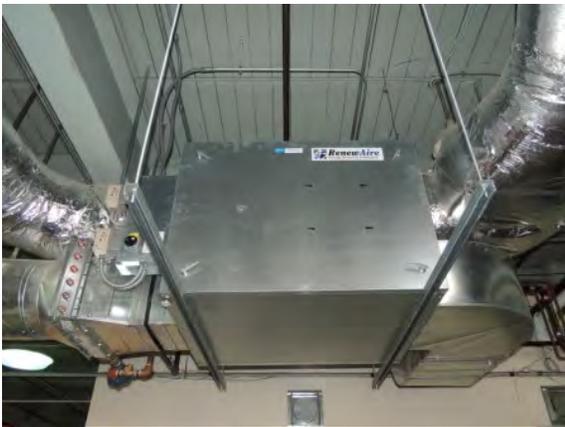
Photo #17: Renew aire energy recovery ventilator serving the printing workshop

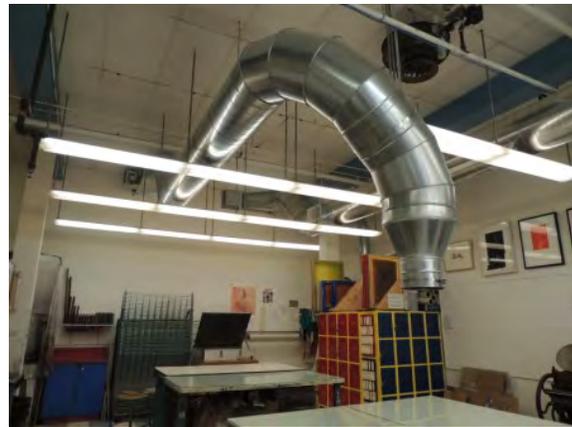
Photo #18: Exhaust ductwork serving the printing workshop

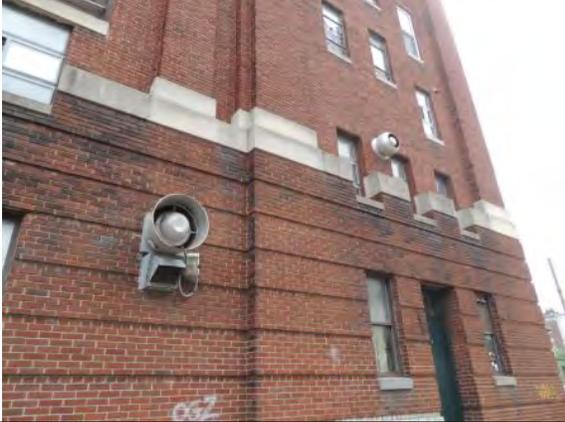
Photo #19: Typical wall mounted exhaust fan

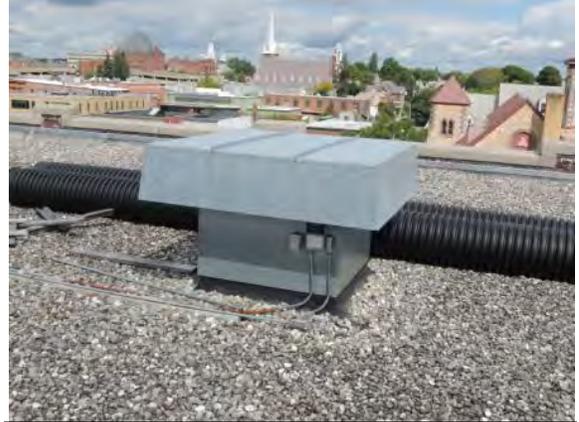
Photo #20: Typical roof mounted exhaust fan

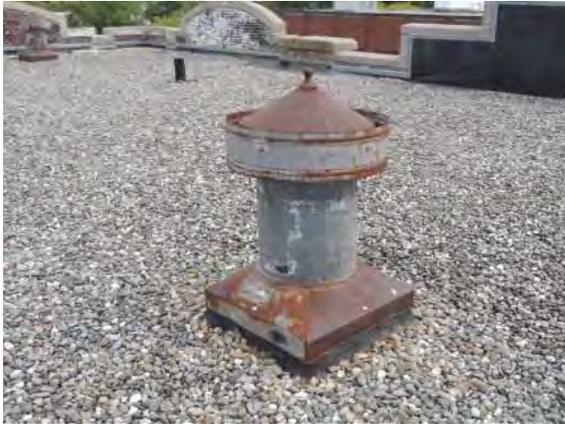
Photo #21: Typical roof mounted relief vent

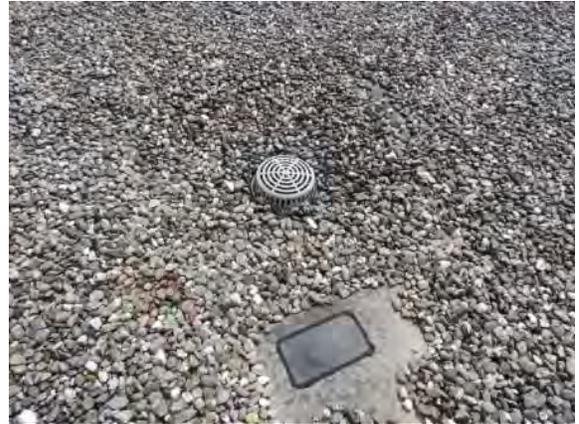
Photo #22: Typical roof drain

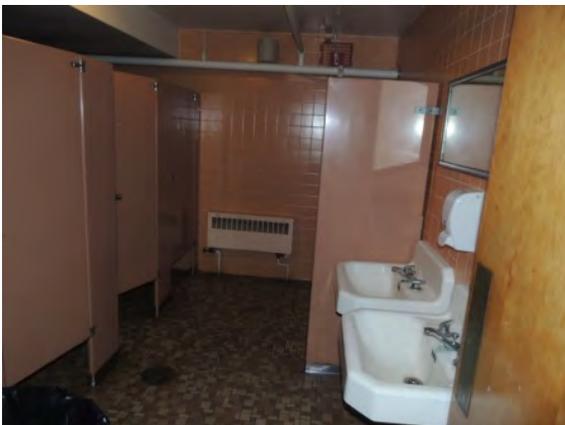
Photo #23: Typical restroom vanity area

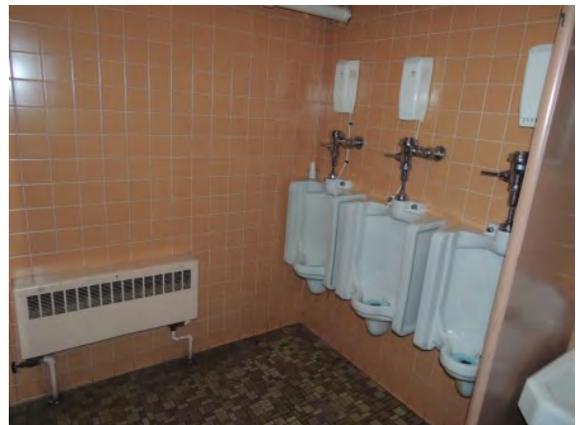
Photo #24: Typical restroom urinal area

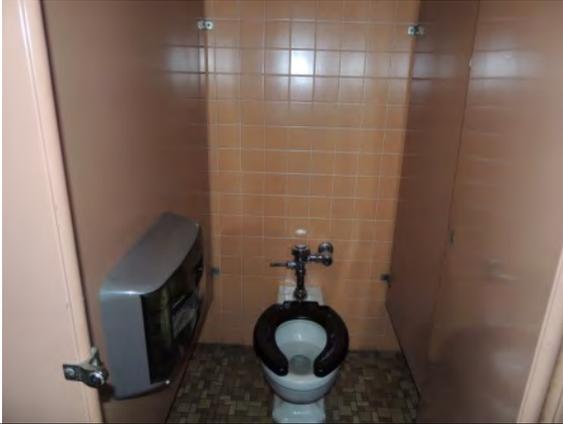
Photo #25: Typical restroom toilet area

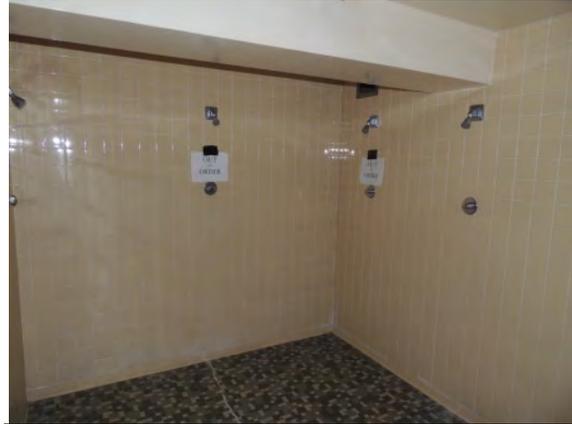
Photo #26: Typical restroom shower area

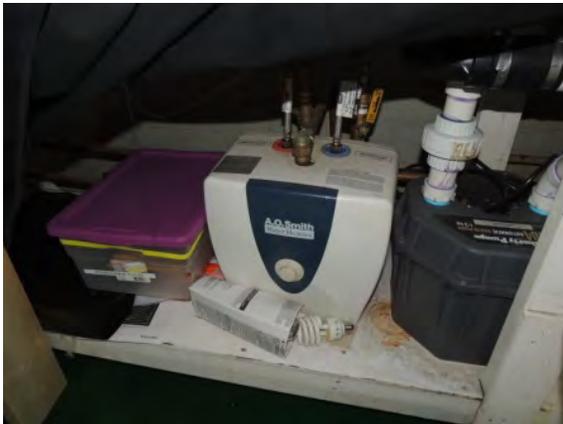
Photo #27: Typical a.o. Smith point of use under counter electric water heater

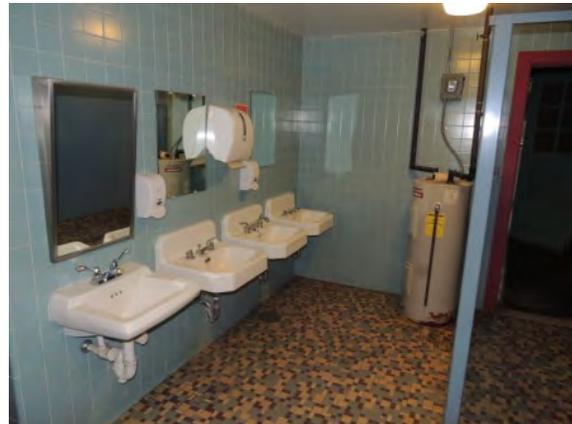
Photo #28: Typical a.o. Smith point of use 30 gallon electric water heater

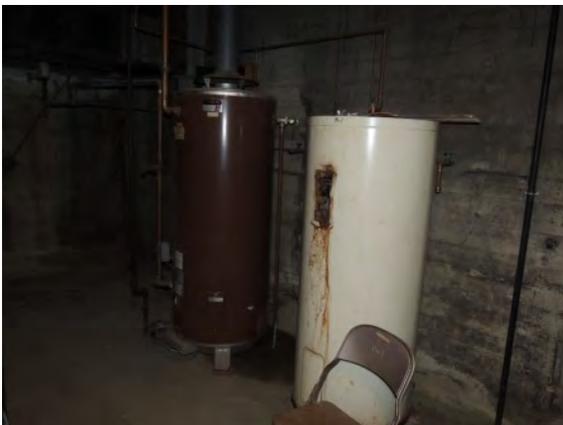
Photo #29: A.o. Smith 100 gallon gas water heater located in the basement mechanical room as well as an abandoned old unit

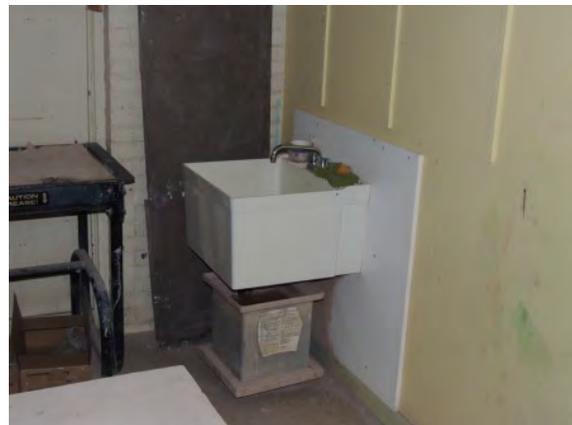
Photo #30: Utility sink located in the ceramic workshop

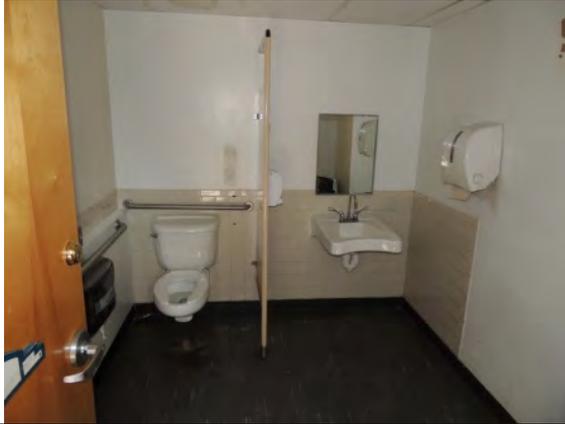
Photo #31: Updated ada restroom located in the main building lobby

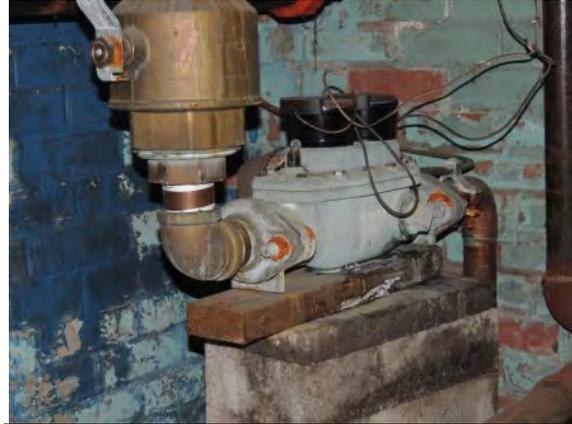
Photo #32: Incoming domestic water meter located under the southeast building stairwell

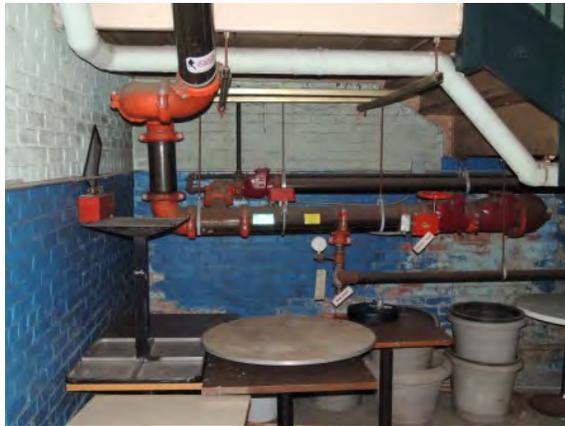
Photo #33: Incoming fire protection service located under the southeast building stairwell

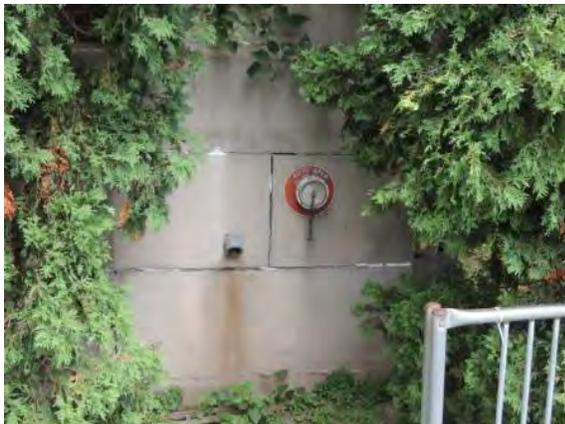
Photo #35: Fire department sprinkler connection located at the south east corner of the building

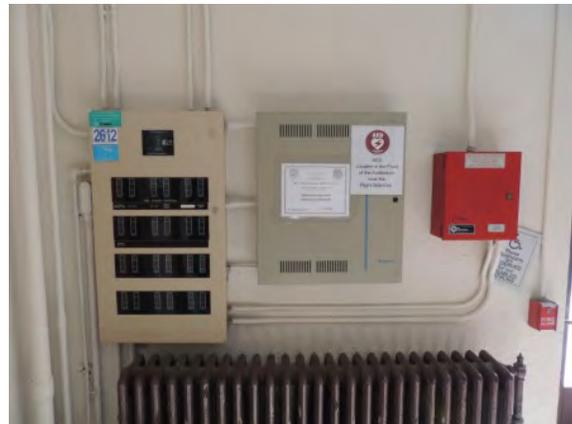
Photo #36: Fire alarm panels located at the main building lobby

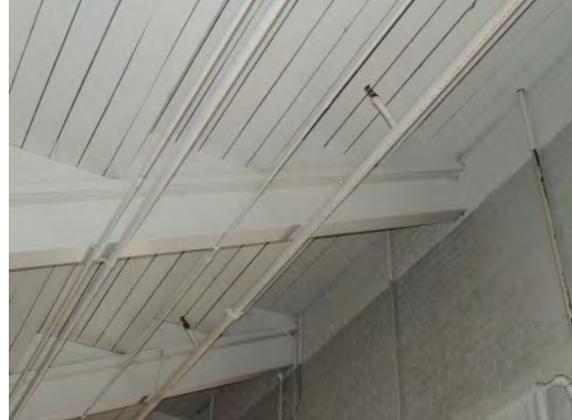
Photo #38: Typical fire sprinkler piping and heads

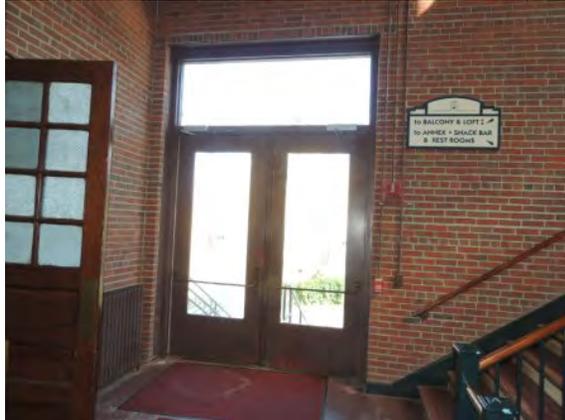
Photo #39: Typical fire alarm pull station and alarm with strobe

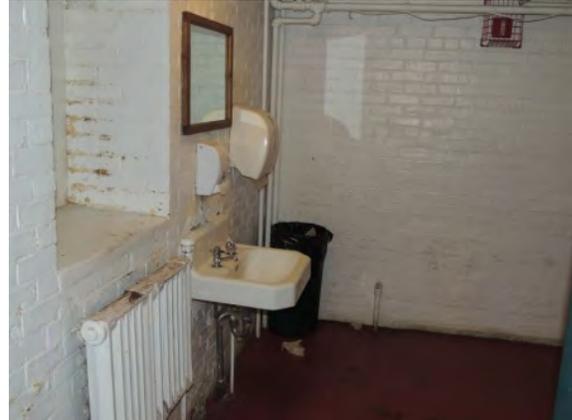
Photo #40: Typical restroom fire alarm with strobe

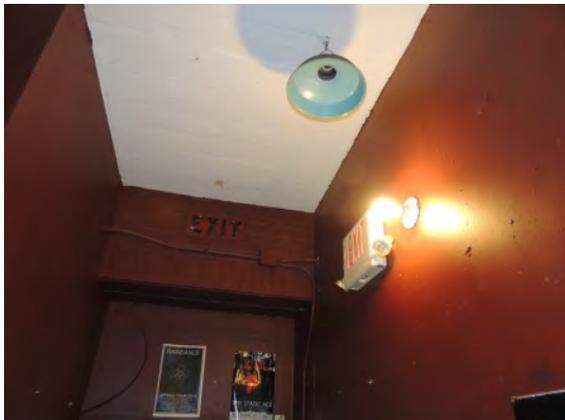
Photo #41: Typical incandescent lighting fixture

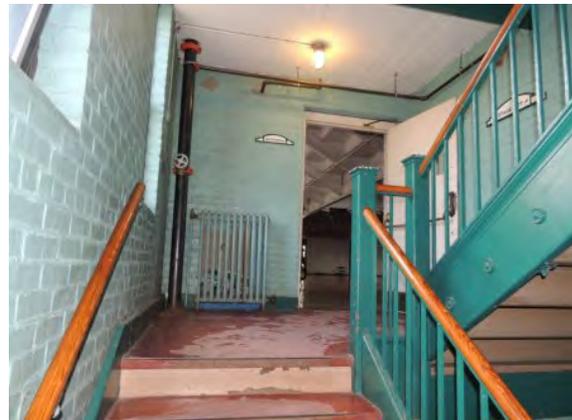
Photo #42: Typical incandescent lighting fixture

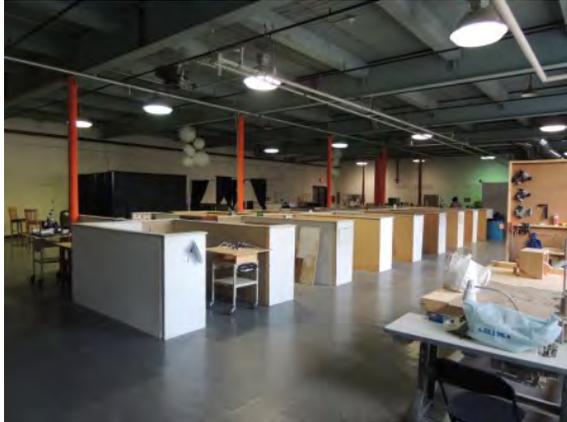
Photo #43: Updated metal halide lighting located in the lower level workshop

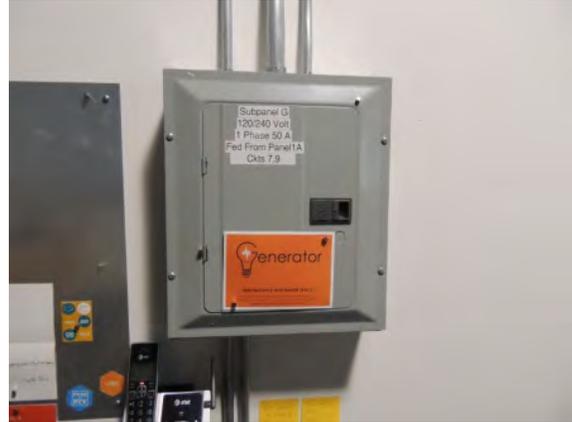
Photo #44: Updated electrical sub panel located in the lower level workshop

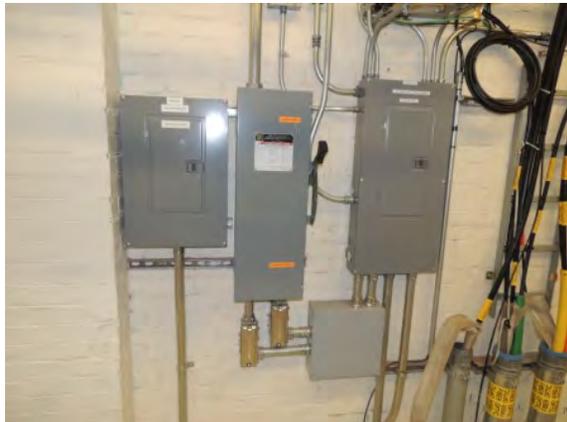
Photo #45: Updated electrical panels located in the computer server room

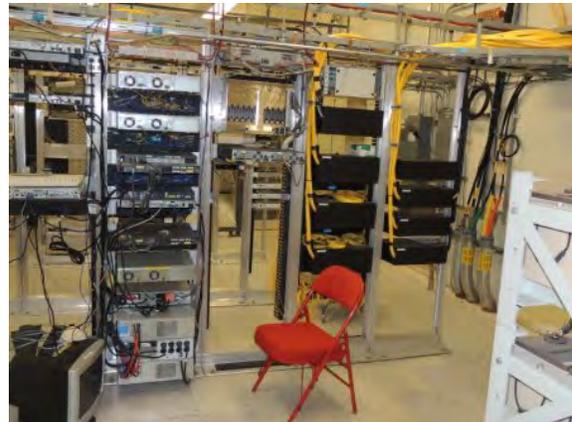
Photo #46: Computer server equipment

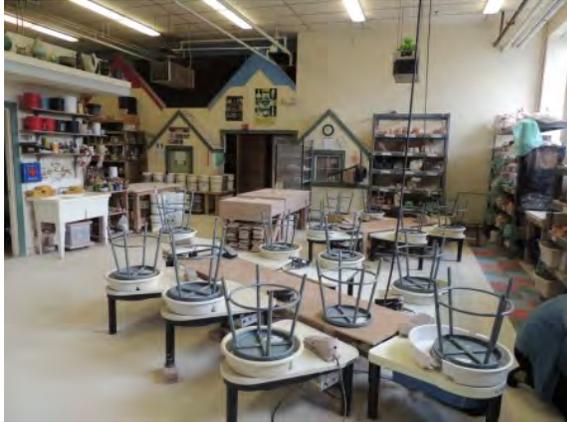
Photo #49: Florescent lighting typical throughout the lower level art work area

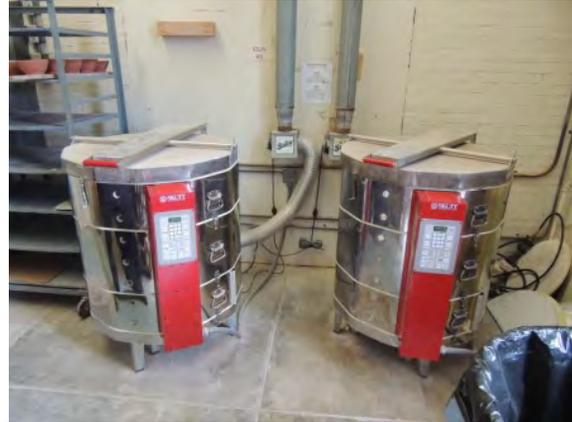
Photo #50: User installed electric ceramics drying kiln

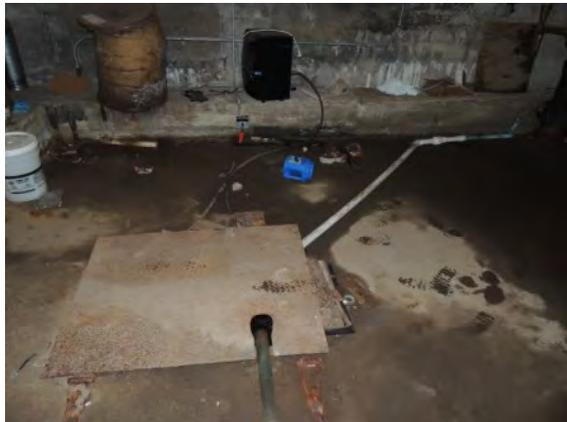
Photo #51: Sump pump and portable humidifier located in basement mechanical room

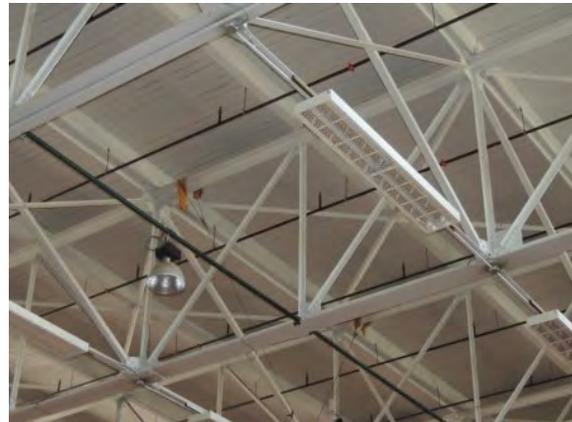
Photo #52: Combination of metal halide and florescent lighting installed in the gymnasium assembly area

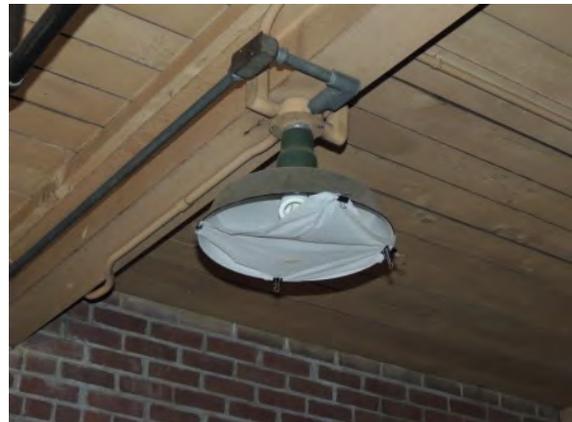
Photo #54: Incandescent lighting fixture located in an office area that a paper napkin has been utilized as a lighting diffuser

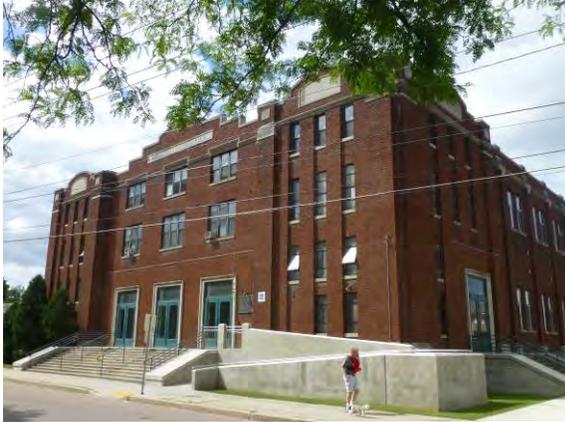
Photo #1: East elevation

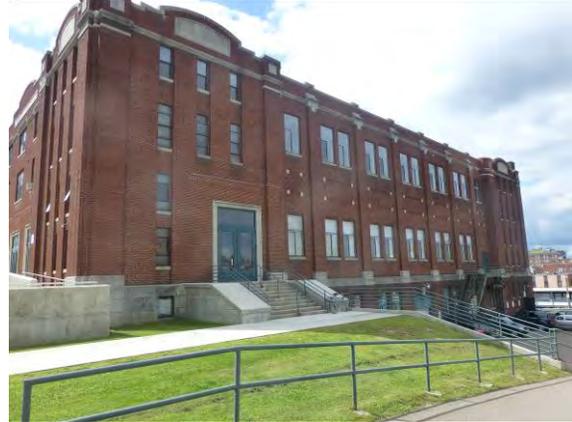
Photo #2: North elevation

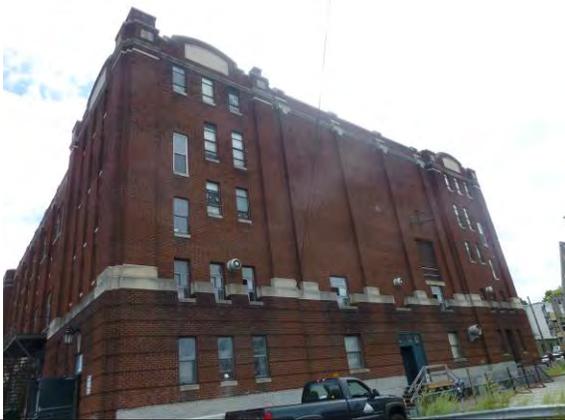
Photo #3: West elevation

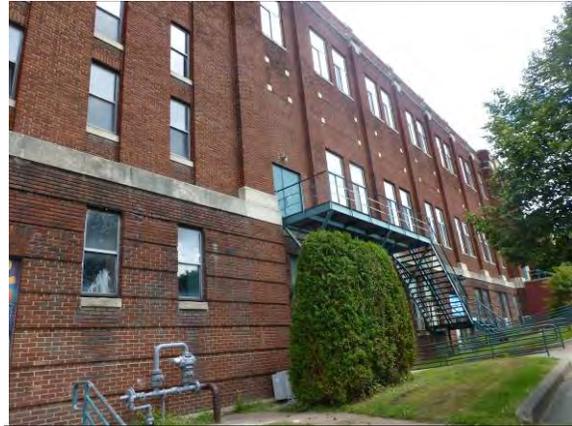
Photo #4: South elevation

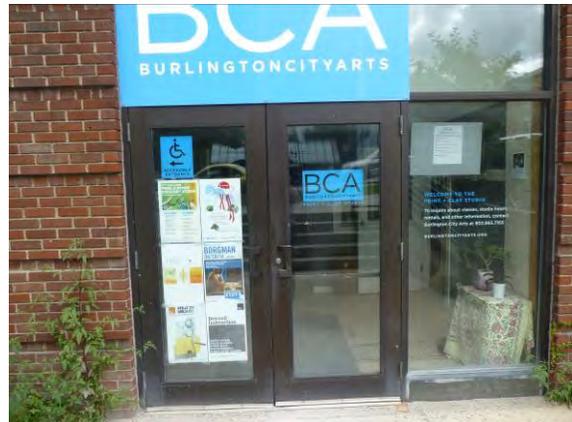
Photo #6: Exterior doors

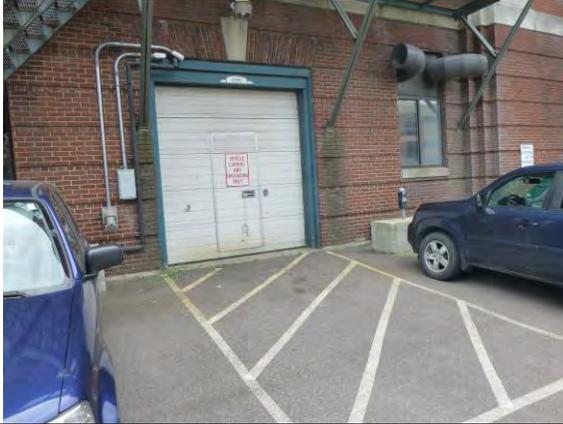
Photo #7: Exterior overhead doors

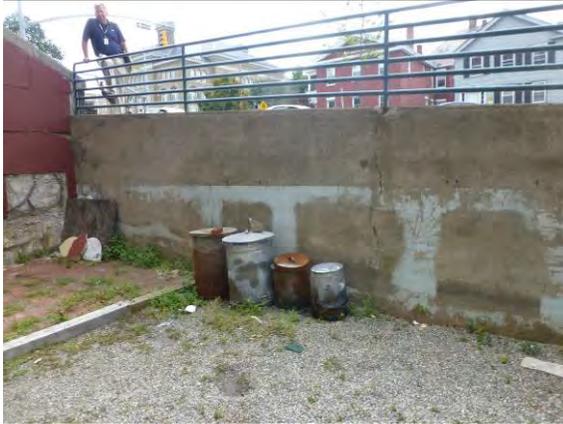
Photo #9: Retaining wall

| <b>Immediate Repairs Report</b><br><b>Memorial Auditorium</b><br><b>10/24/2014</b> | | | | | | | |
|--|---|--|---|---|---|---|---|
| 5.4 | 280658 | Retaining wall repair, concrete | 200 | SF Face | \$42.72 | \$8,544 | \$8,544 |

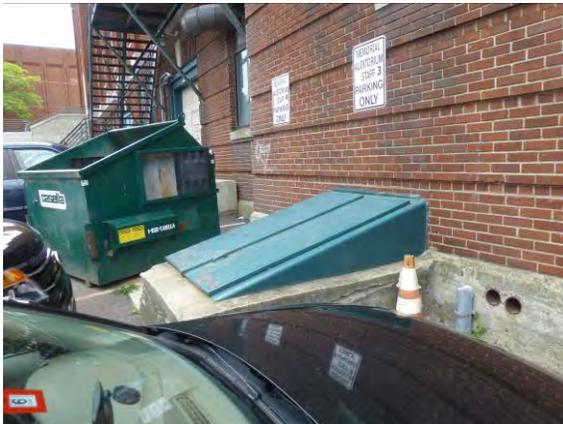
Photo #11: Basement access hatch

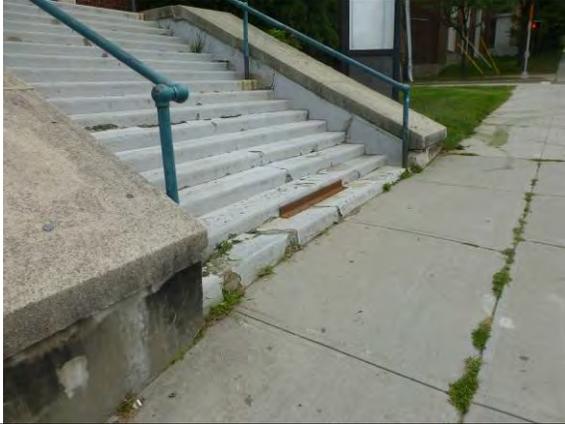
Photo #13: Exterior stairs

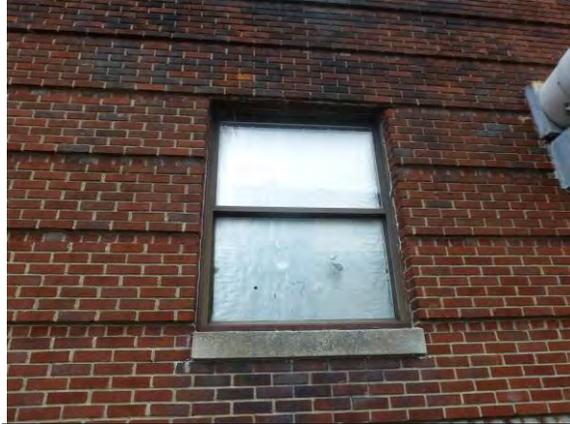
Photo #14: Window

| List of Recommended Energy Conservation Measures For Memorial Auditorium | | | | | | | | | | | | |
|--|--|---|---|---|---|---|---|---|---|---|---|---|
| 3 | Replace External Windows<br>Details: Replace Single Pane Windows With Energy Efficient Double-Pane, Throughout | \$36,300 | 9,042 | 0 | 0 | \$9,176 | \$92 | \$9,267 | 3.92 | 5.00 | \$145,342 | 30 |

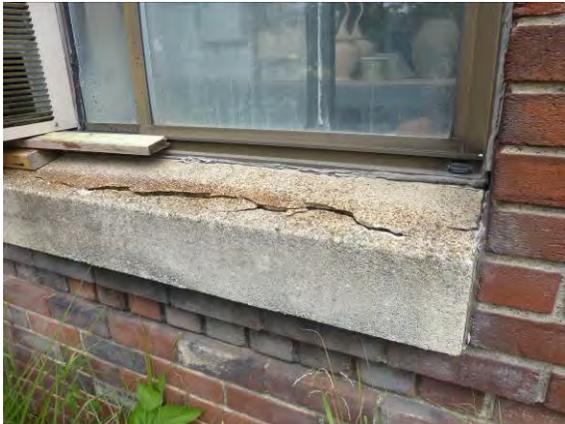
Photo #15: Window sill

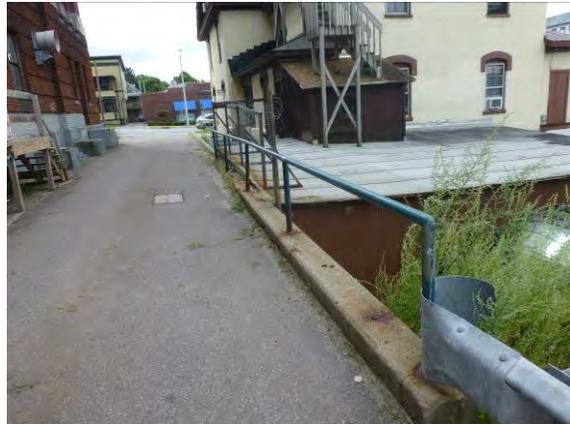
Photo #16: Drive aisle

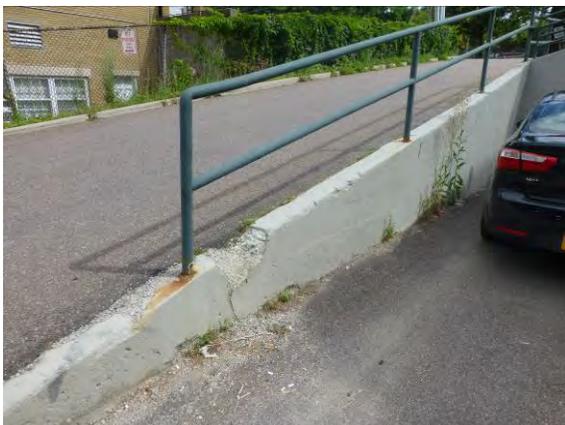
Photo #17: Parking area ramp

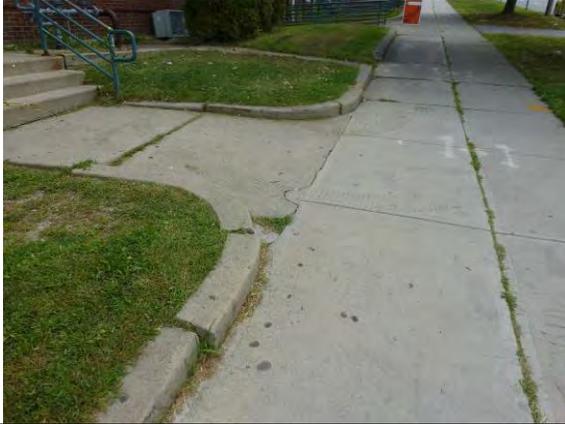
Photo #19: Sidewalk and curbing

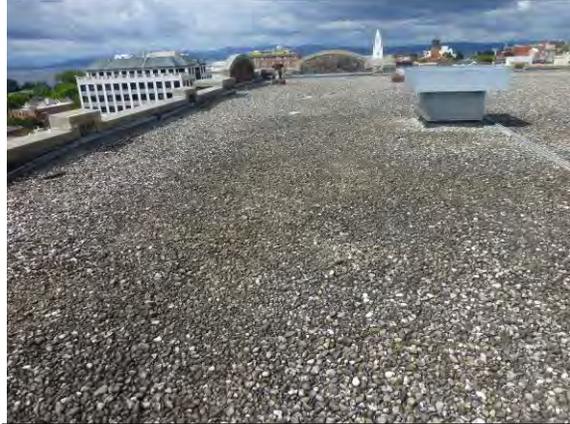
Photo #20: Roof overview

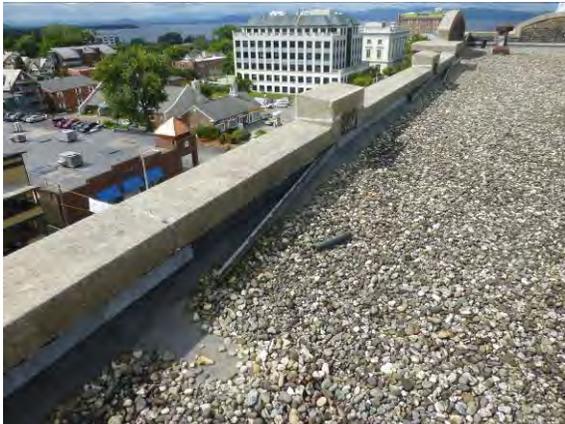
Photo #21: Parapet wall

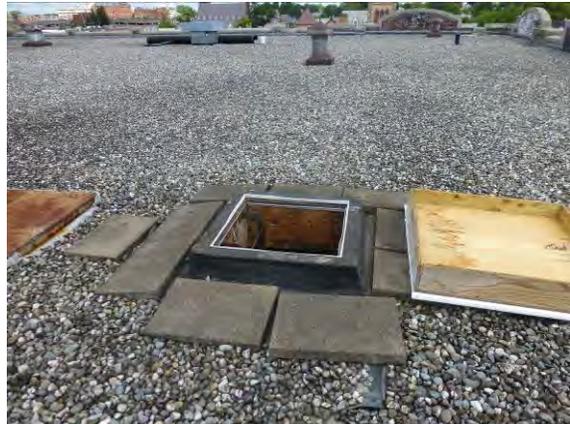
Photo #22: Roof access

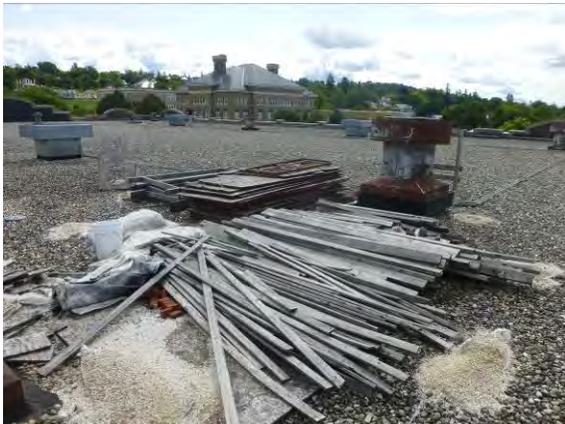
Photo #23: Debris on roof

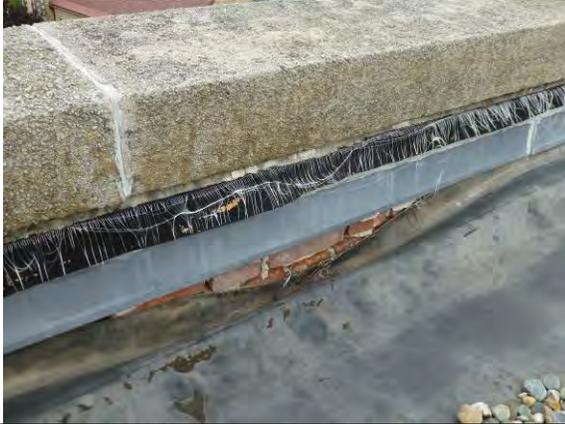
Photo #25: Parapet wall detail

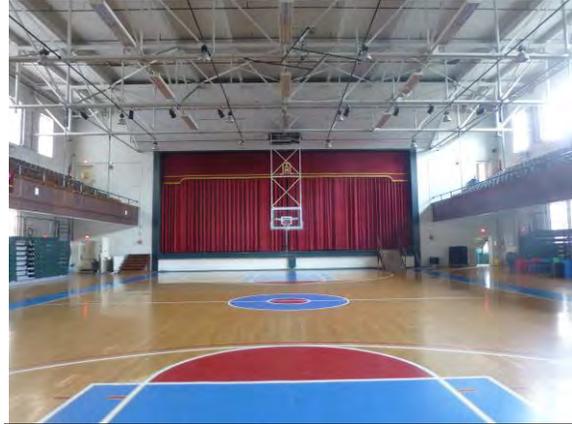
Photo #26: Main auditorium

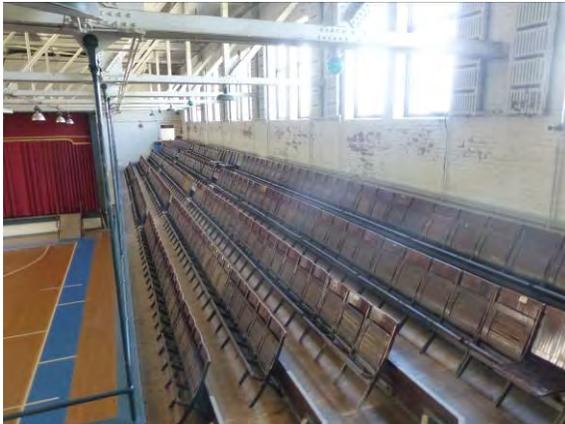
Photo #27: Auditorium seating

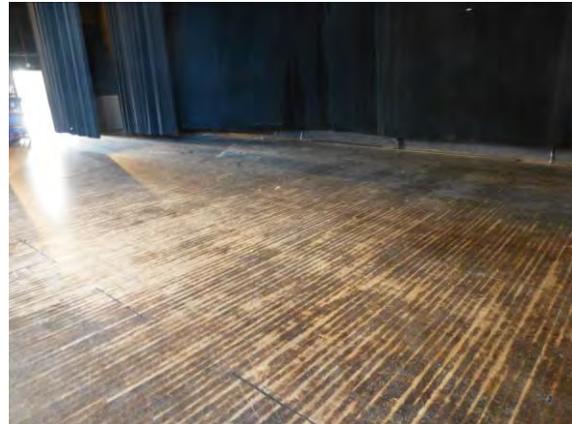
Photo #28: Stage

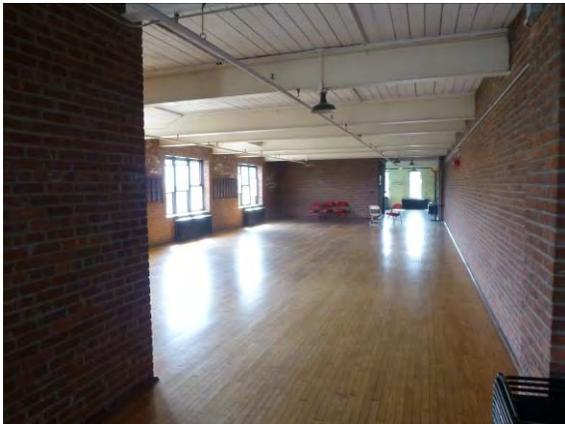
Photo #29: Loft area

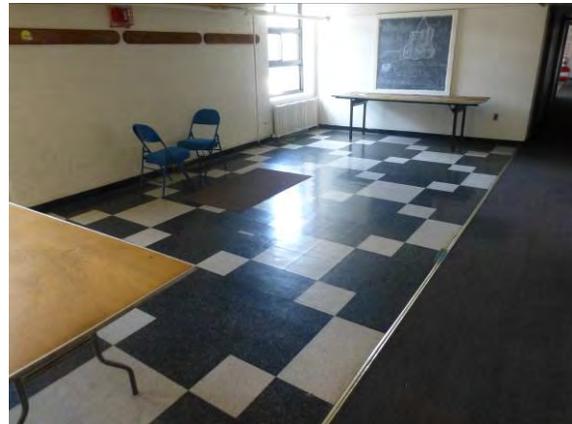
Photo #30: Dressing room

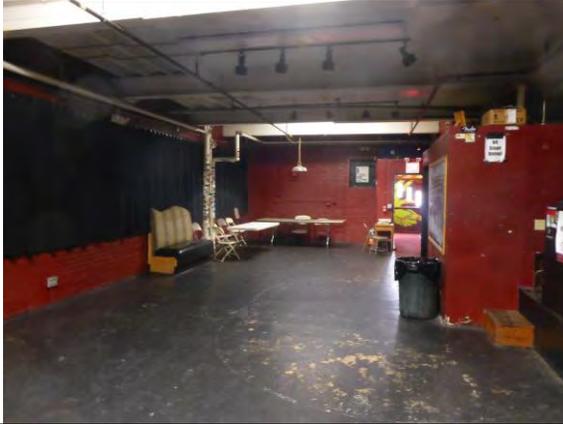
Photo #31: Performance space

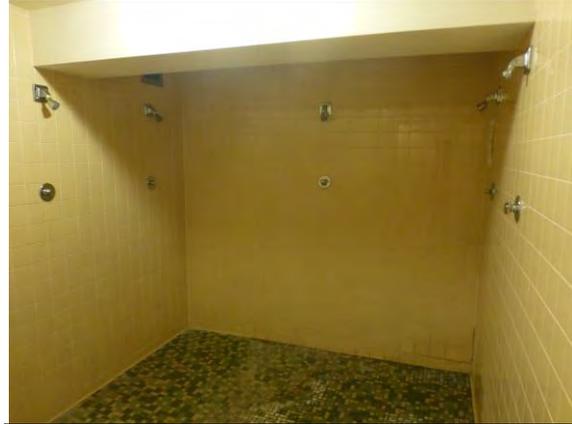
Photo #32: Dressing room shower

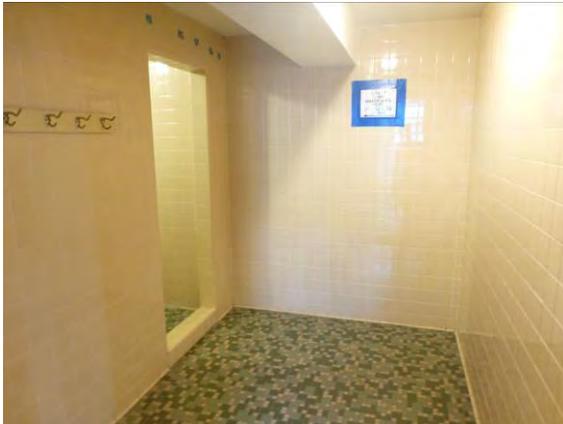
Photo #33: Dressing room restroom

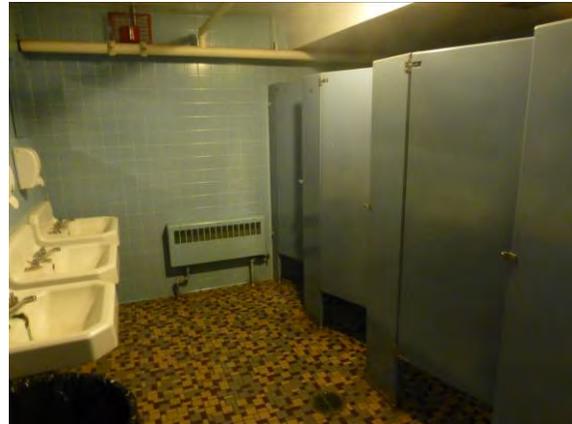
Photo #34: Dressing room restroom

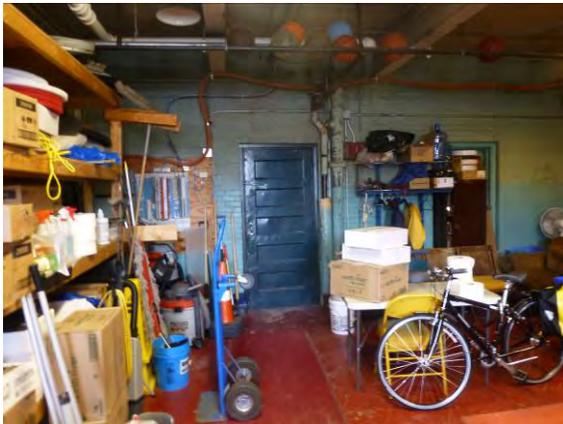
Photo #35: Maintenance area

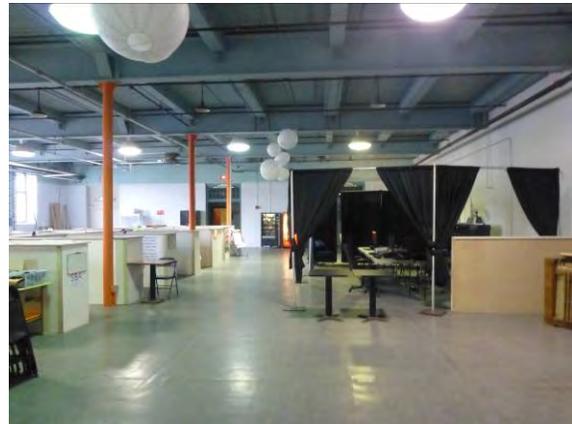
Photo #36: Work space

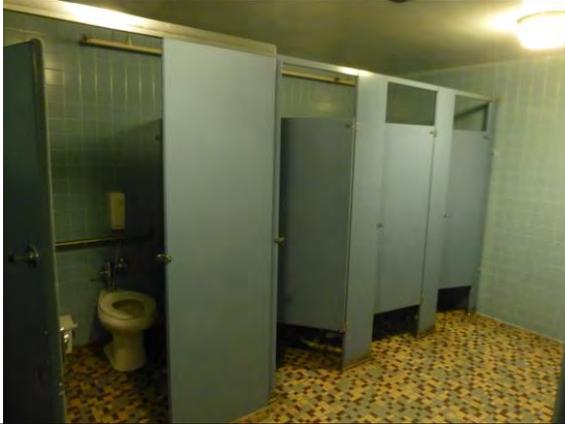
Photo #37: Restroom water closets

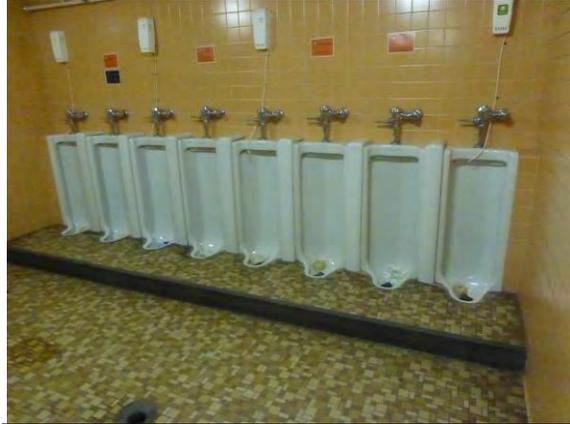
Photo #38: Restroom urinals

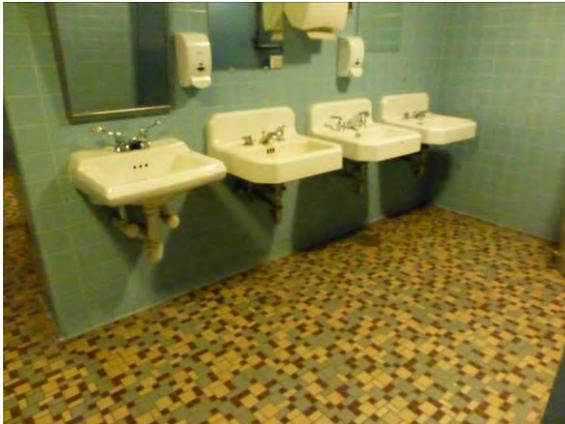
Photo #39: Restroom lavatories

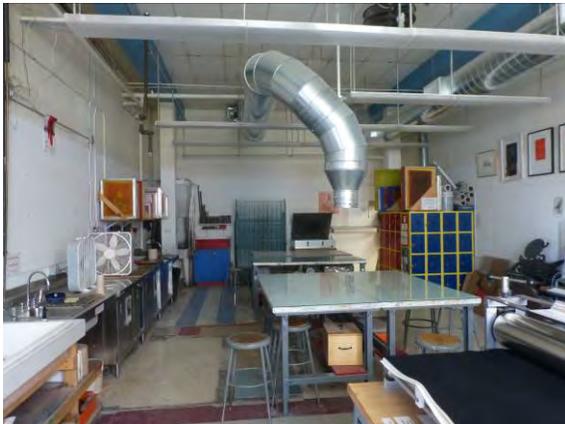
Photo #41: Artist space

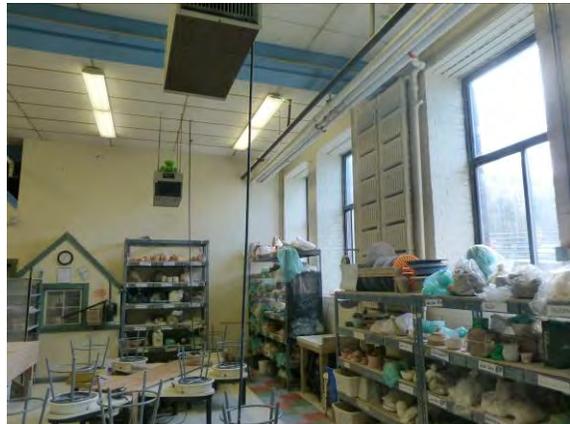
Photo #42: Artist space

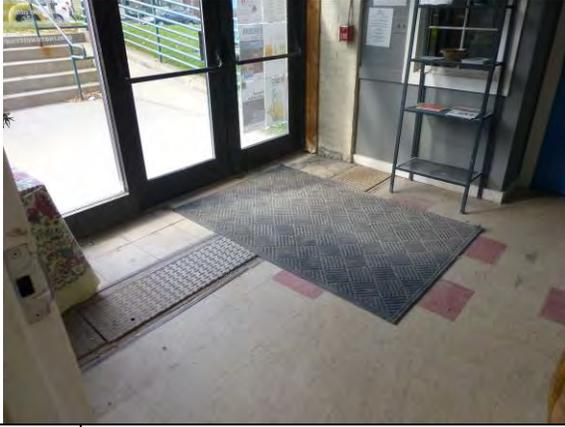
Photo #43: Artist space entrance

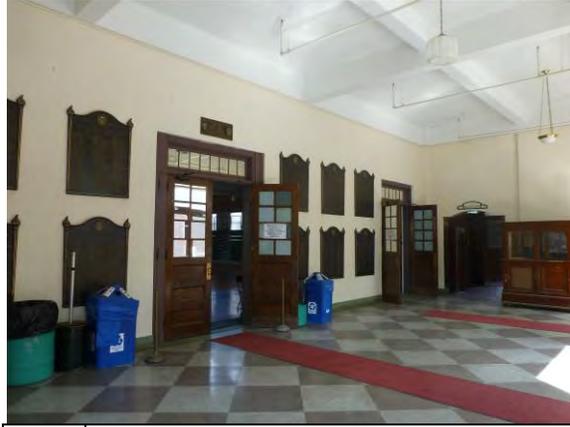
Photo #44: Main entrance

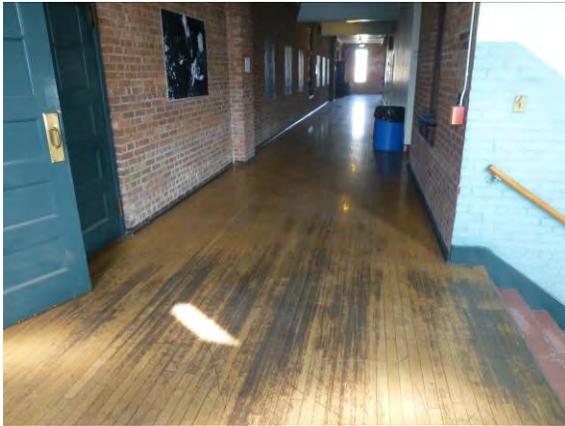
Photo #45: Corridor
