# FACILITY CONDITION ASSESSMENT AND LEVEL I ENERGY AUDIT

## FACILITY CONDITION ASSESSMENT AND LEVEL I ENERGY AUDIT of MEMORIAL AUDITORIUM 250 Main Street Burlington, Vermont 05401

**EMG Project #:** 110266.14R-009.294  
**Date of Report:** October 28, 2014  
**On site Date:** August 28 and 29, 2014

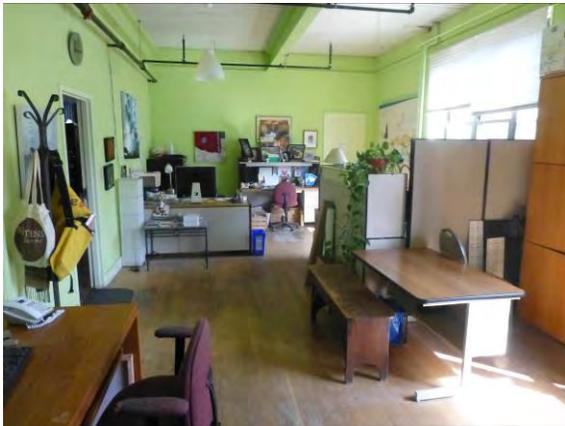
Photo #47: Office

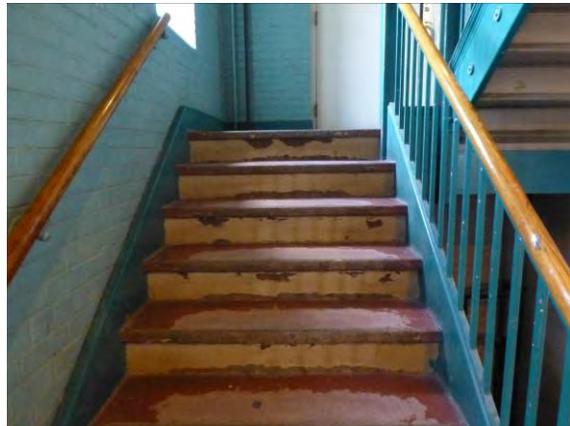
Photo #48: Interior stairs

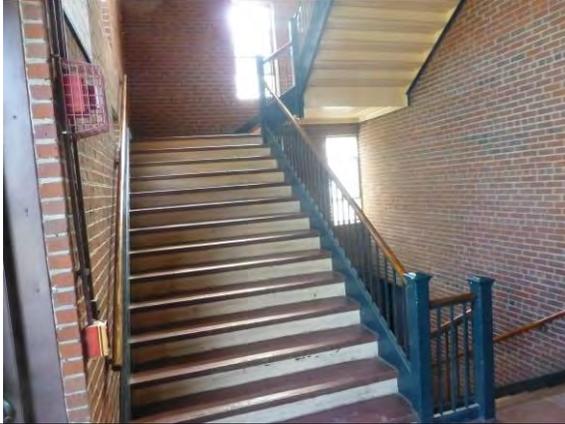
Photo #49: Interior stairs

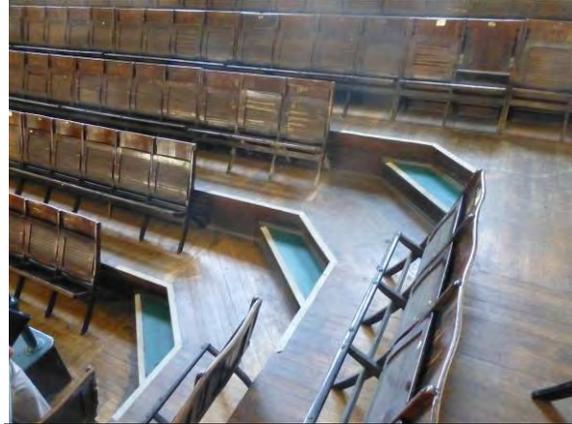
Photo #50: Auditorium stairs

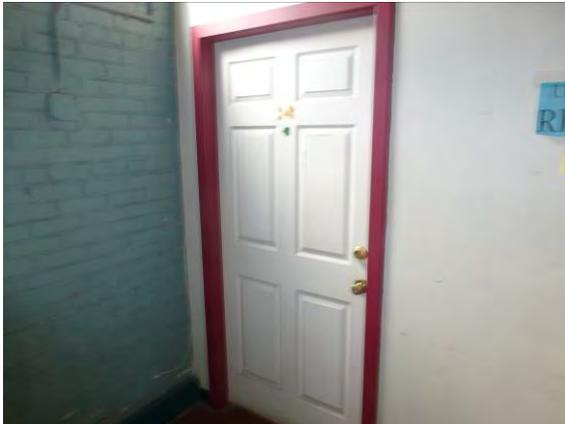
Photo #51: Interior doors

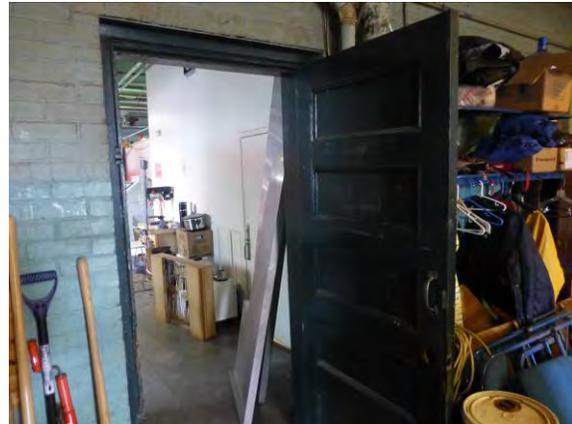
Photo #52: Interior doors

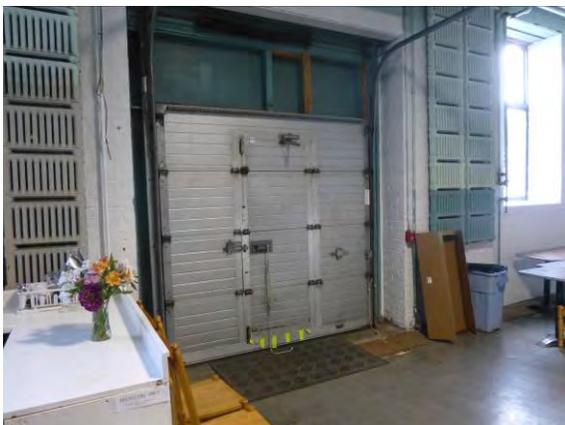
Photo #53: Overhead doors

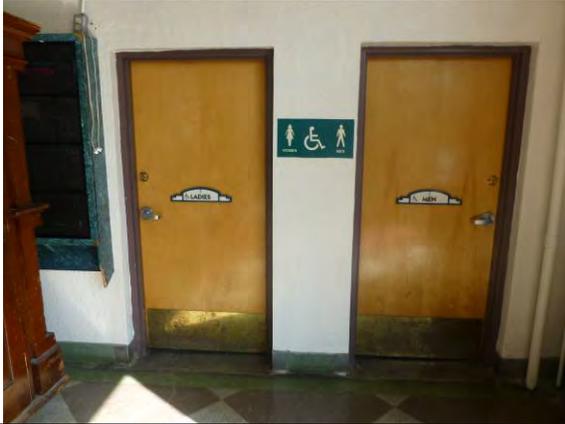
Photo #55: Interior doors

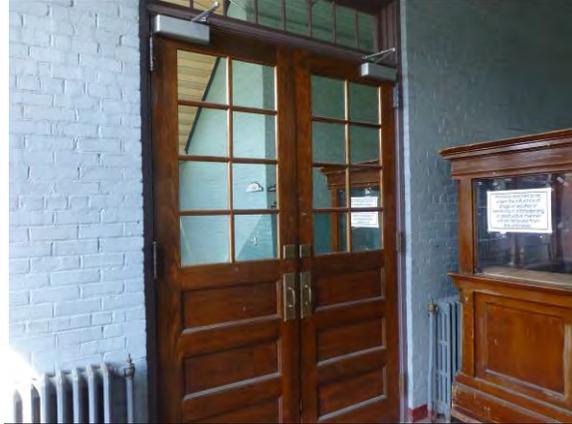
Photo #56: Interior doors

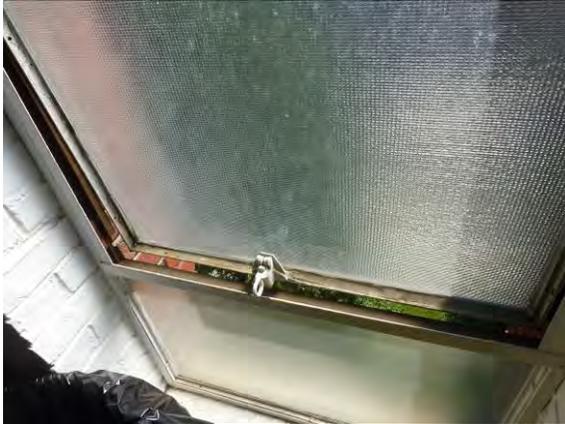
Photo #57: Window

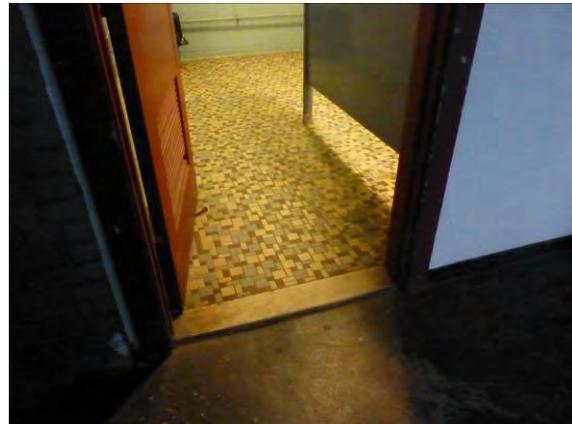
Photo #59: Vinyl flooring detail

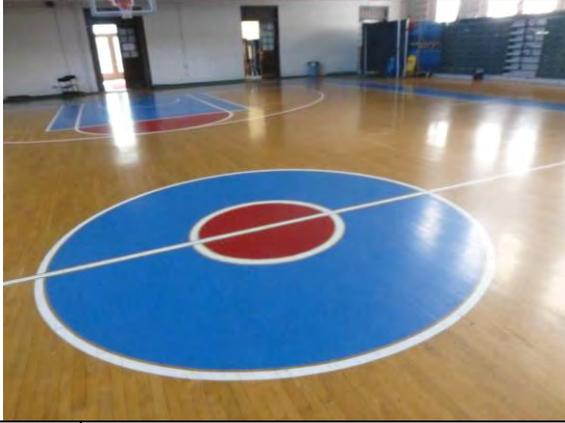
| Photo #61: | Auditorium flooring detail |

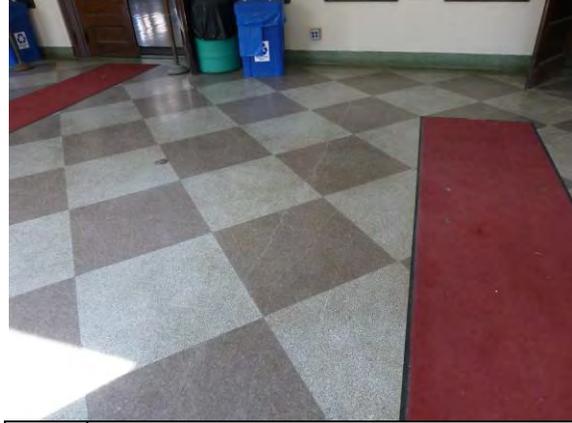
| Photo #62: | Terrazzo flooring detail |

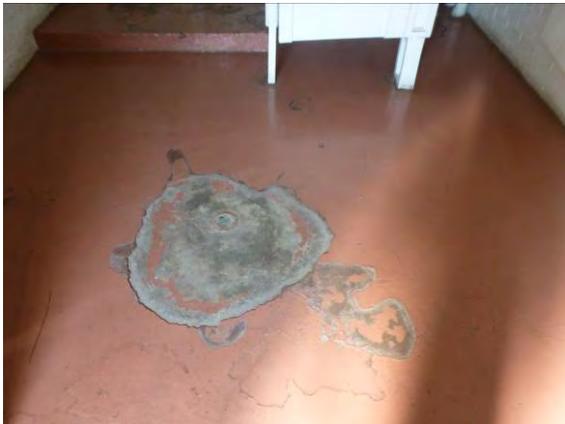
| Photo #63: | Concrete flooring detail |

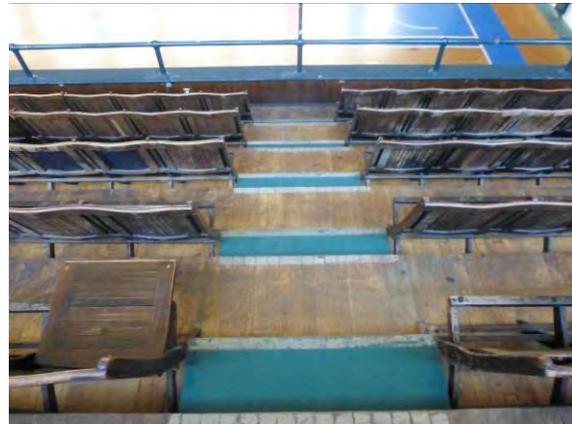
| Photo #64: | Wooden flooring detail |

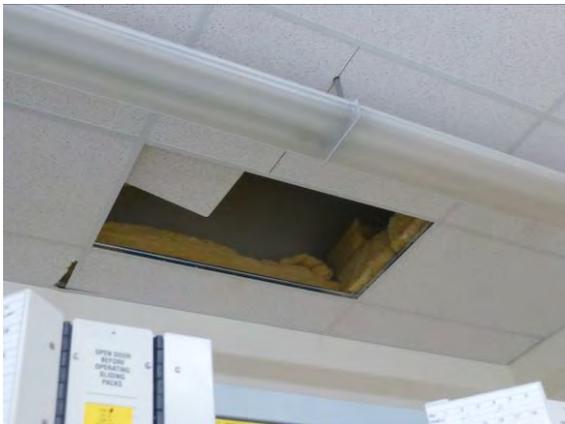
| Photo #65: | Ceiling and insulation |

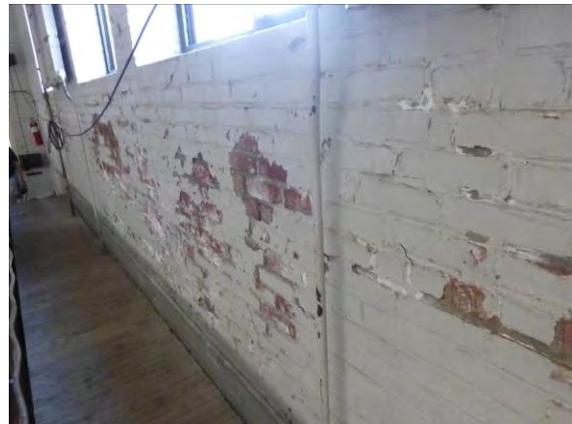
| Photo #66: | Wall detail |

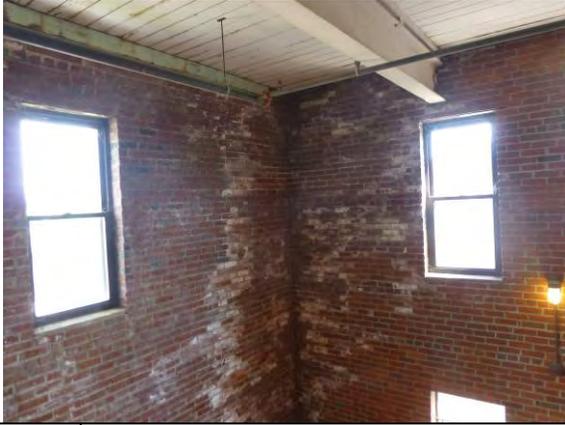
Photo #67: Interior walls

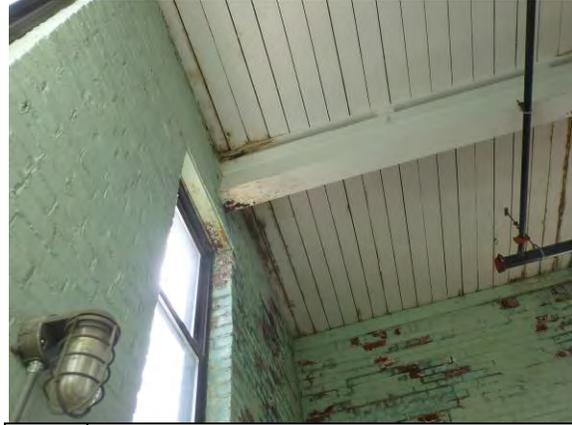
Photo #68: Interior walls and ceiling detail

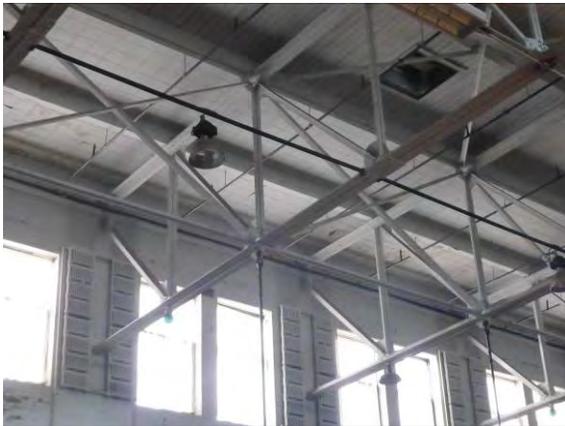
Photo #69: Roof structure

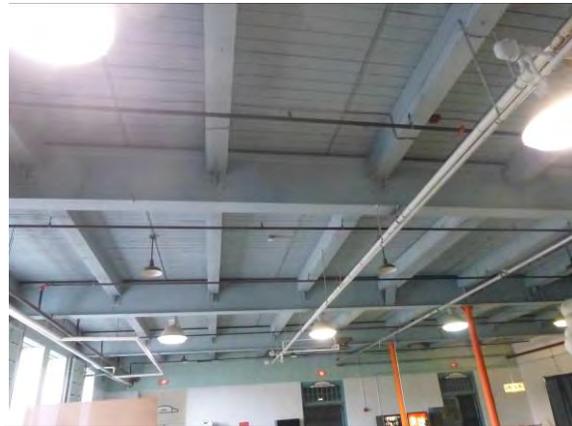
Photo #70: Flooring structure

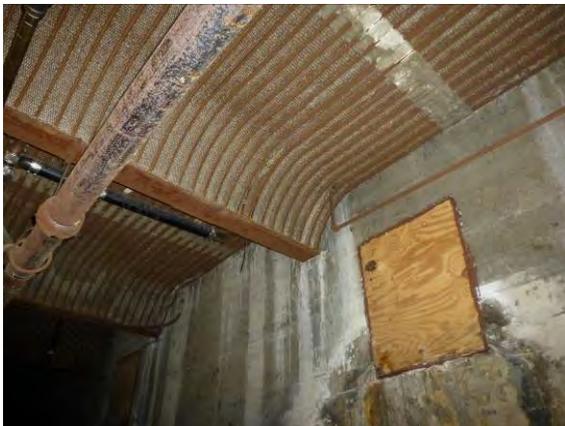
Photo #71: Ground floor structure

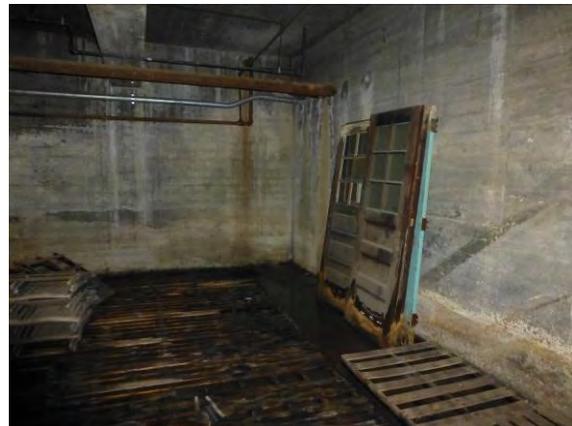
Photo #72: Foundation walls
