FACILITY CONDITION ASSESSMENT AND ENERGY AUDIT

LEDDY PARK AND ARENA

Leddy Park Road
Burlington, Vermont 05408

EMG Project #: 110226.14R-010.294
Date of Report: October 1, 2014
On-Site Date: August 25, 2014 and August 29, 2014

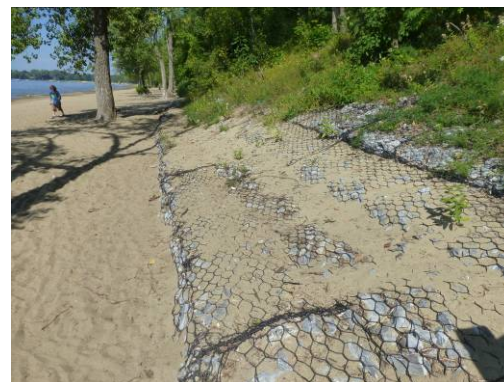
- There is no evidence of storm water runoff from adjacent properties. The storm water system appears to provide adequate runoff capacity. There is no evidence of major ponding or erosion.
- The erosion control mesh installed along the bluffs is in good condition and appears to be accomplishing the task it was meant to do. Routine maintenance will be required during the assessment period.

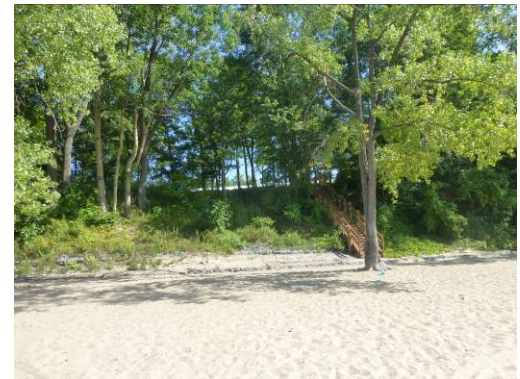
- The topography and adjacent uses do not appear to present conditions detrimental to the property.
- The landscape materials are in good condition and will require routine maintenance during the assessment period.
- The retaining wall is in good condition. Routine maintenance will be required during the assessment period.
- The grass lawn on the north side of the property has wheel tread damage. The area no longer drains properly and the lawn in this area has become muddy. The area must be re-graded and new sod needs to be laid. The area of concern is small enough that it should be rolled into routine maintenance.

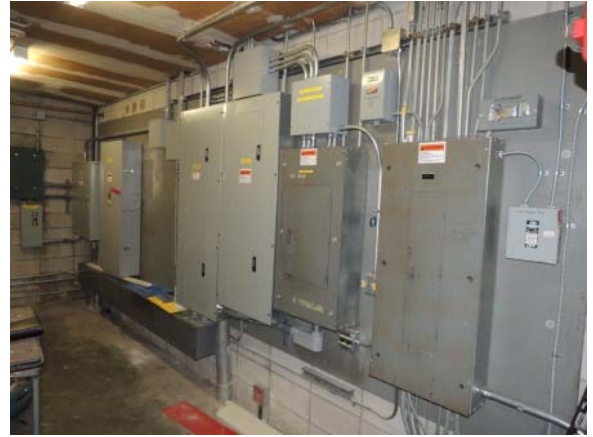
- The on-site electrical systems up to the meters are owned and maintained by the respective utility company.
- The electrical service and capacity appear to be adequate for the property's demands.
- The switchgear, circuit breaker panels, and electrical meters appear to be in good to poor condition and will require routine maintenance during the assessment period. The main switchgear, disconnects, and main panels were upgraded in February 2014. The majority of the remaining electrical system is original to the building and nearing the end of its useful life. Most of this equipment was manufactured by Federal Pacific (FPE) which is no longer in business with replacement parts hard to obtain. It is our recommendation that the Federal Pacific (FPE) be replaced.

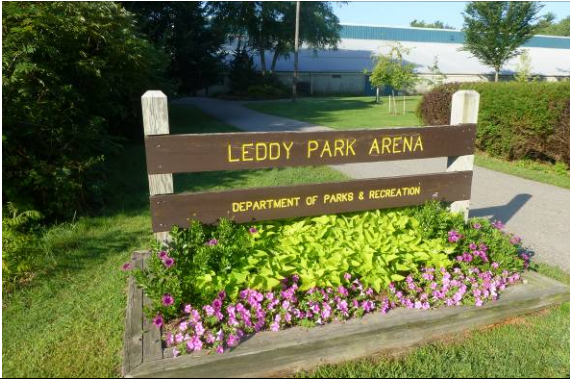
Photo #1:	Main signage
-----------	--------------

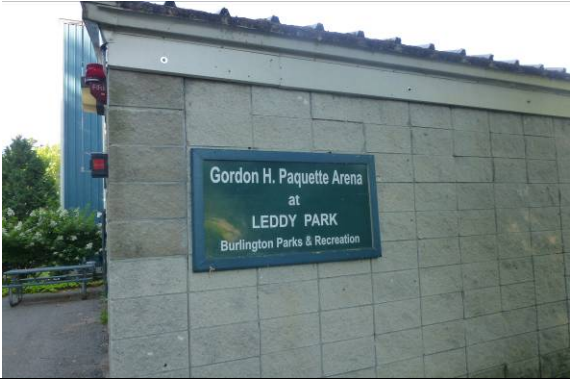
Photo #2:	Building mounted signage
-----------	--------------------------

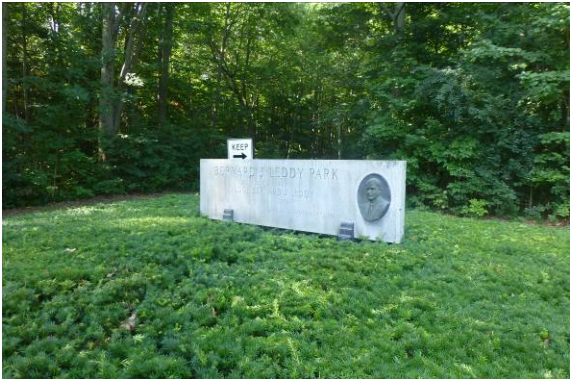
Photo #3:	Park signage
-----------	--------------

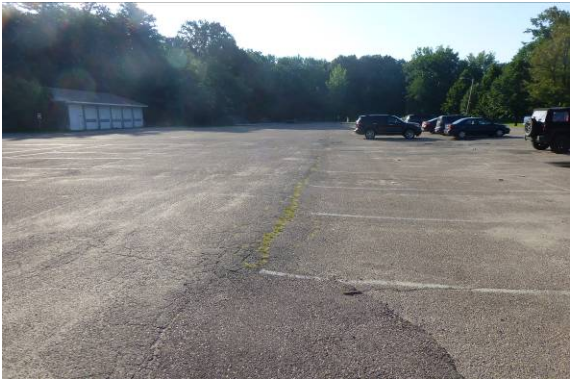
Photo #4:	Main parking area
-----------	-------------------

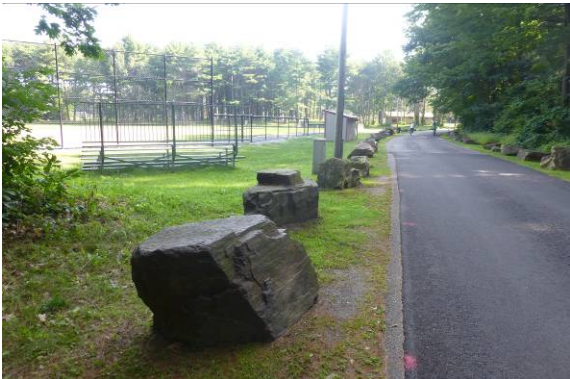
Photo #5:	Drive aisle
-----------	-------------

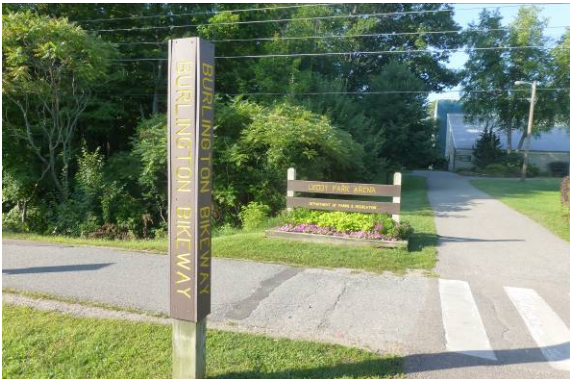
Photo #6:	Bike way and signage
-----------	----------------------

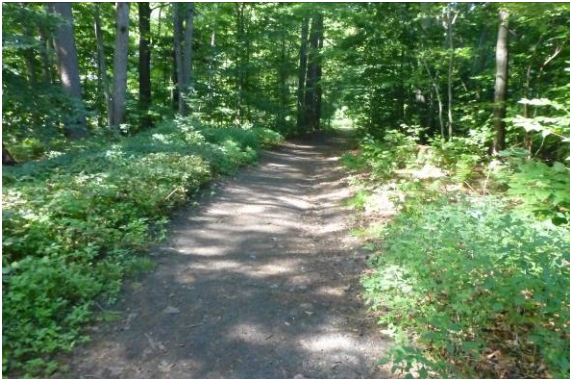
Photo #8:	Park trail
-----------	------------

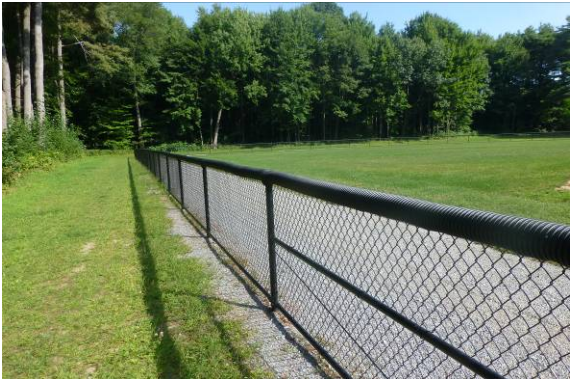
Photo #9:	Baseball park fencing
-----------	-----------------------

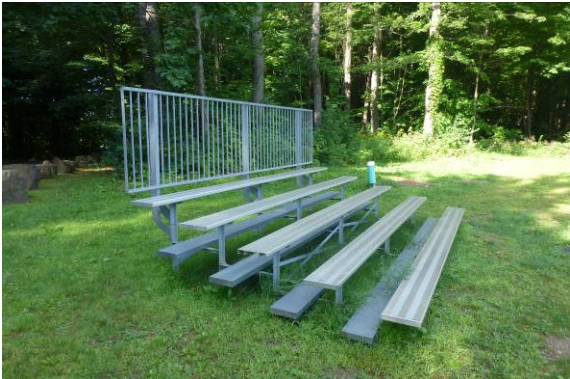
Photo #10:	Exterior bleachers
------------	--------------------

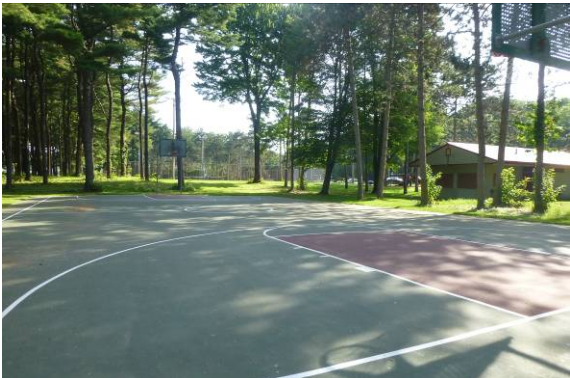
Photo #11:	Basket ball court
------------	-------------------

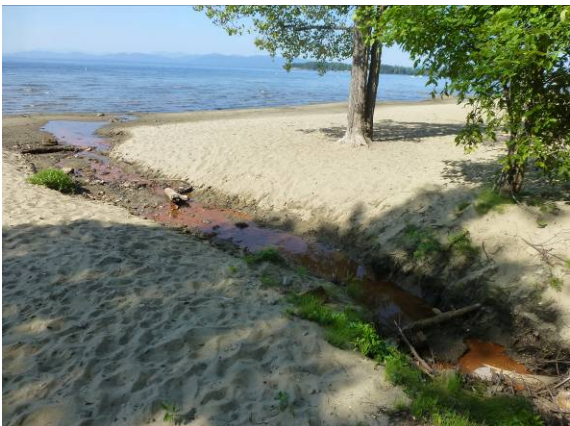
Photo #12:	Stream drainage to the lake
------------	-----------------------------

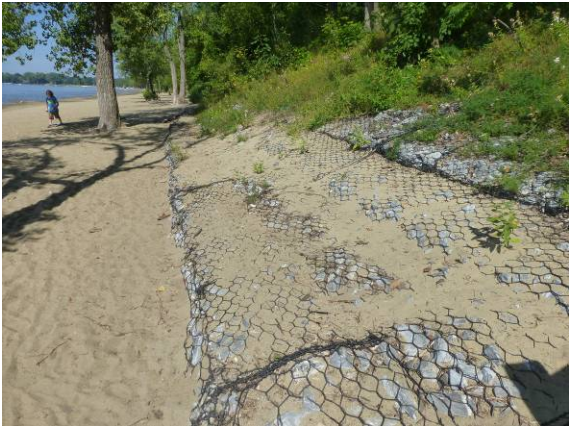
Photo #13:	Erosion control
------------	-----------------

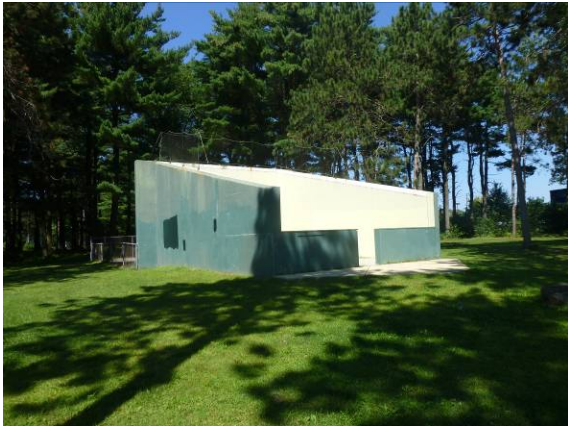
Photo #14:	Racket ball court
------------	-------------------

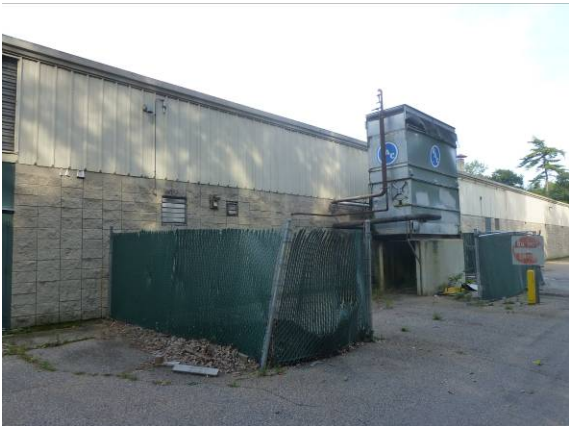
Photo #15:	Mechanical fencing
------------	--------------------

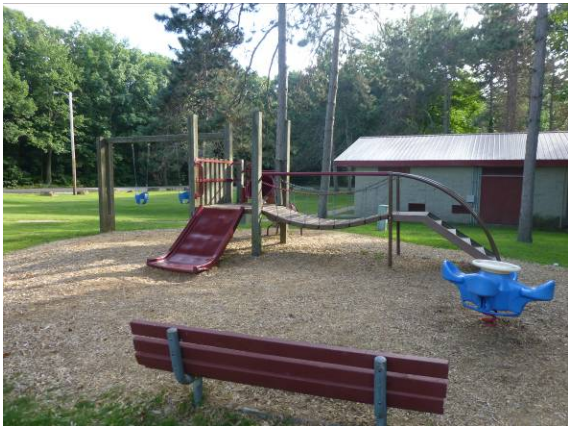
Photo #16:	Playground
------------	------------

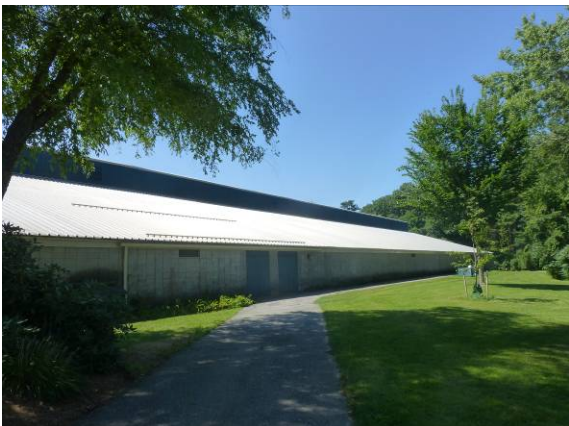
Photo #17:	North elevation of Leddy Arena
------------	--------------------------------

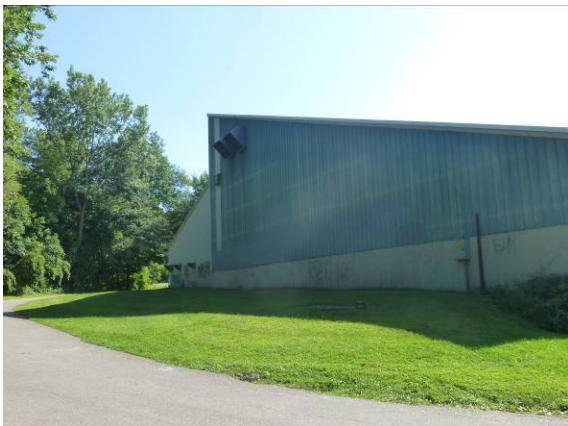
Photo #18:	West elevation of Leddy Arena
------------	-------------------------------

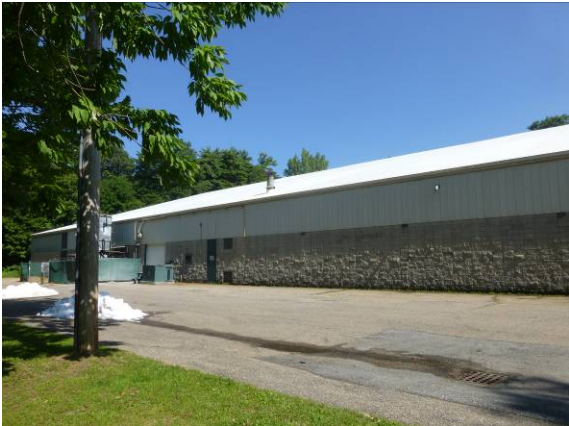
Photo #19:	South elevation of Leddy Arena
------------	--------------------------------

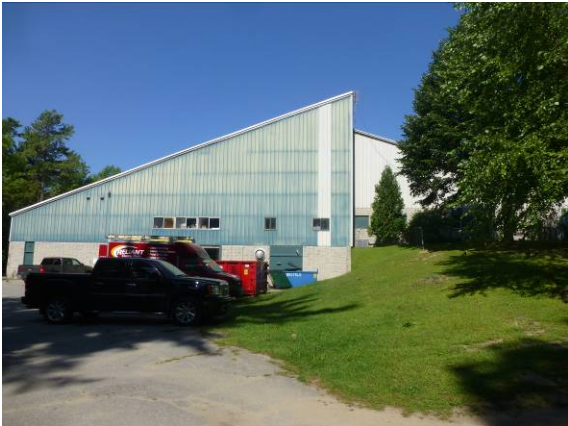
Photo #20:	East elevation of Leddy Arena
------------	-------------------------------

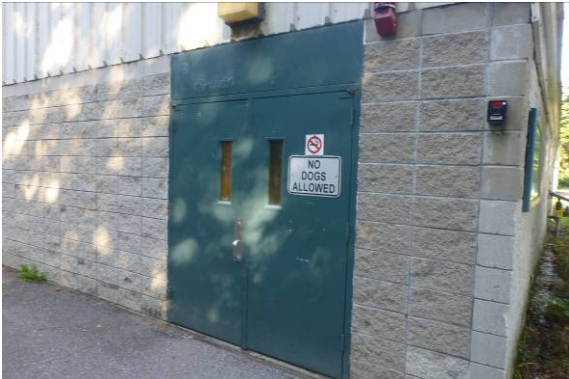
Photo #21:	Main entrance doors
------------	---------------------

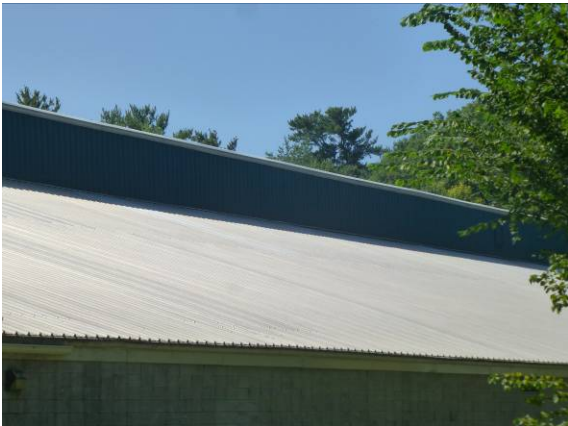
Photo #22:	Metal roofing
------------	---------------

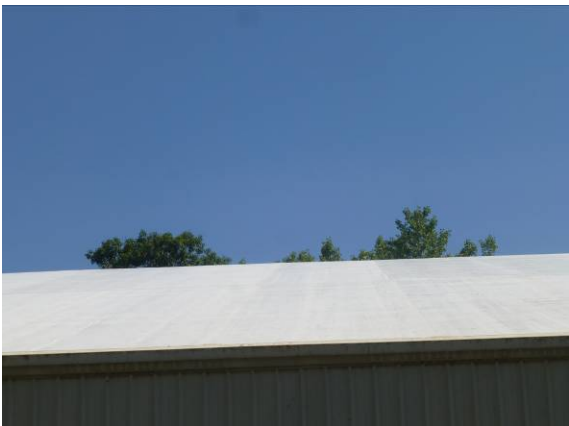
Photo #23:	TPO roofing
------------	-------------

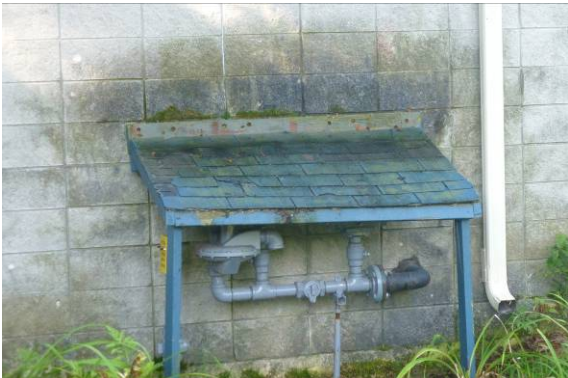
Photo #24:	Gas main
------------	----------

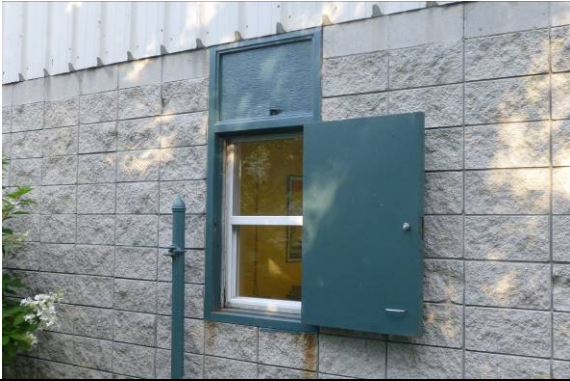
Photo #25:	Window
------------	--------

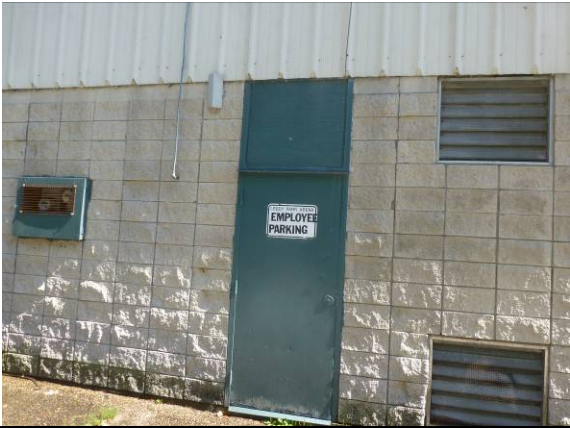
Photo #26:	Service door
------------	--------------

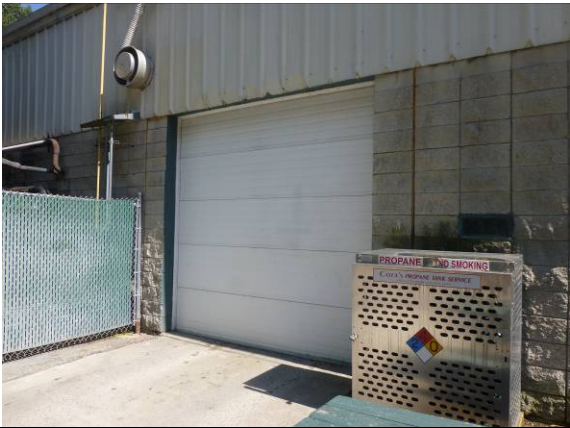
Photo #27:	Overhead door
------------	---------------

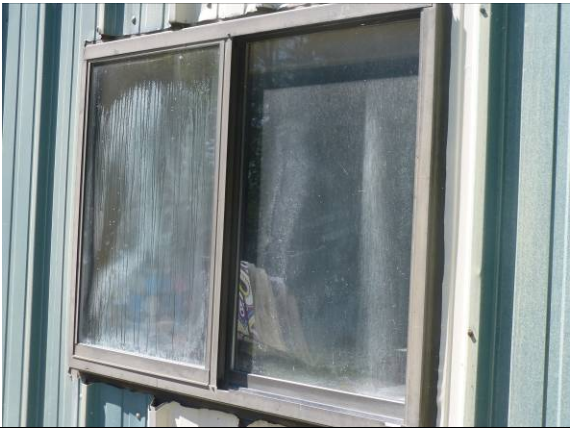
Photo #28:	Window
------------	--------

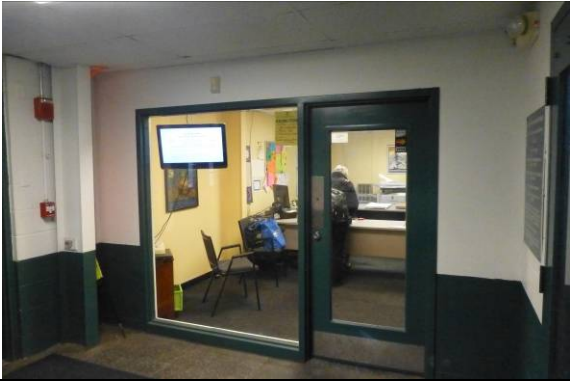
Photo #29:	Main entrance
------------	---------------

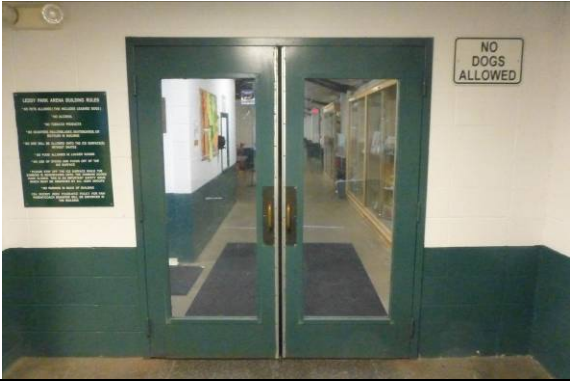
Photo #30:	Interior doors at main entrance
------------	---------------------------------

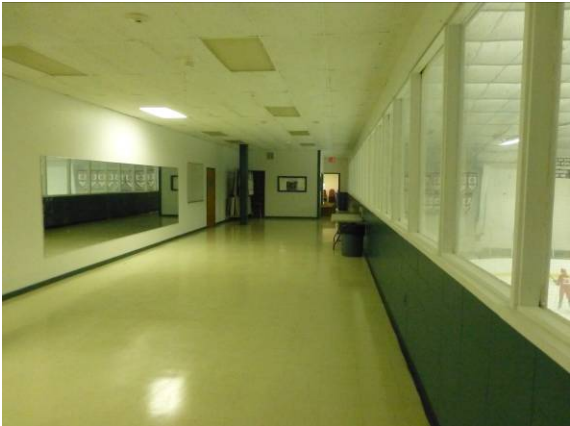
Photo #32:	Corridor
------------	----------

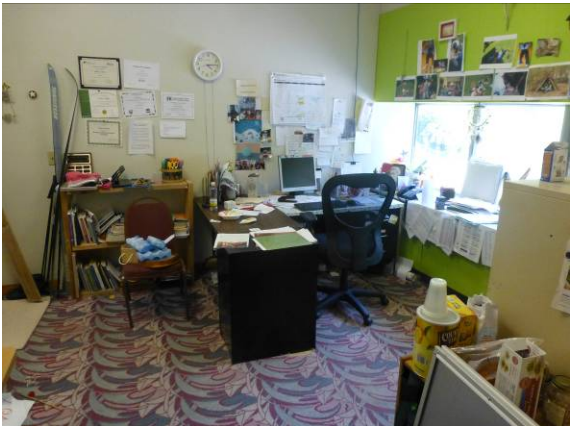
Photo #33:	Office
------------	--------

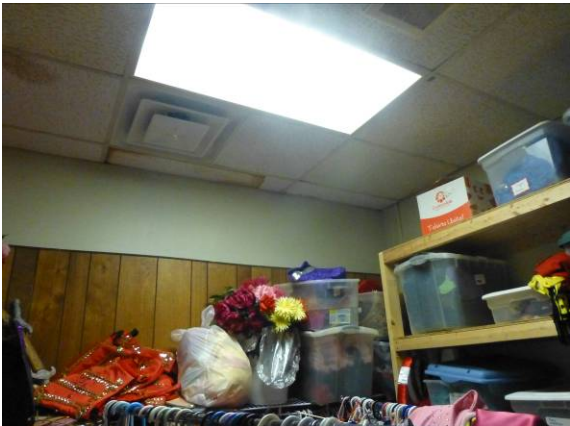
Photo #34:	Ceiling and light fixture detail
------------	----------------------------------

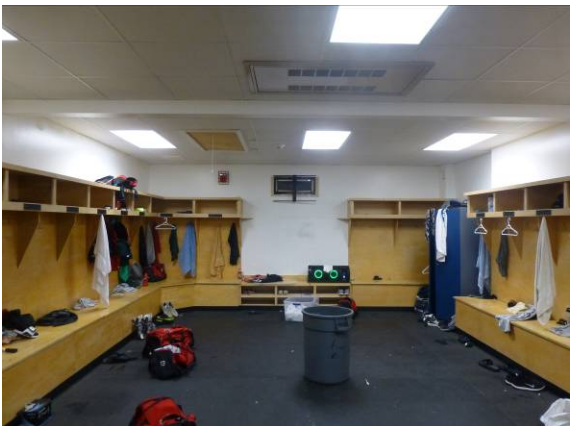
Photo #35:	Locker room
------------	-------------

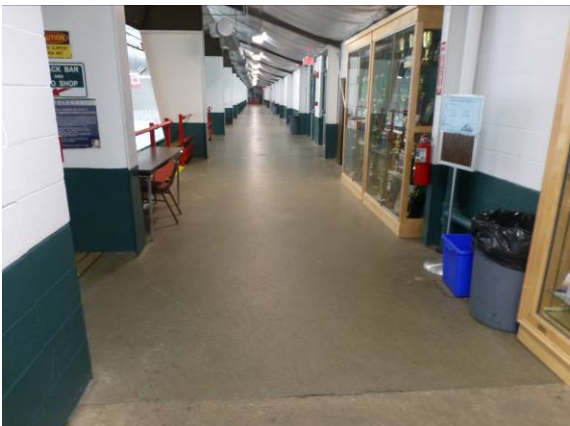
Photo #36:	Mezzanine level
------------	-----------------

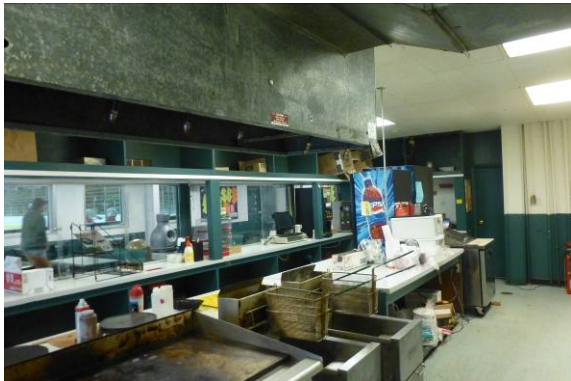
Photo #37:	Kitchen
---------------	---------

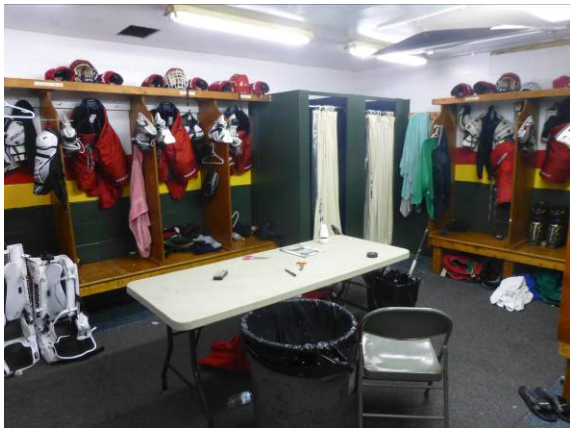
Photo #38:	Locker room
---------------	-------------

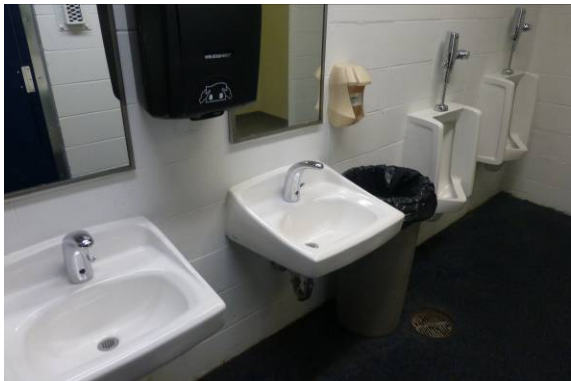
Photo #39:	Bathroom
---------------	----------

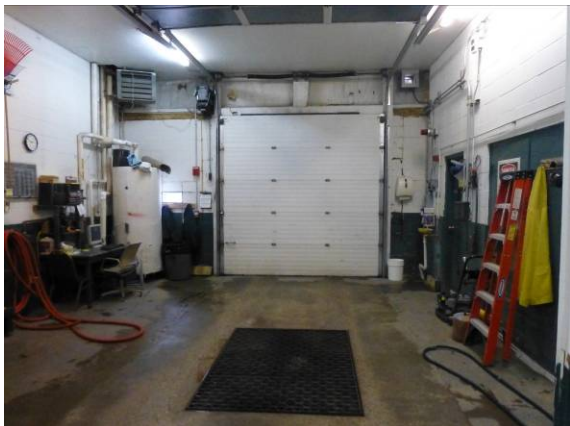
Photo #42:	Zamboni garage
---------------	----------------

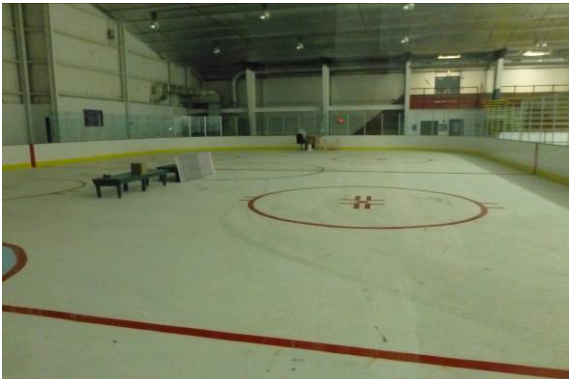
Photo #43:	Ice rink
------------	----------

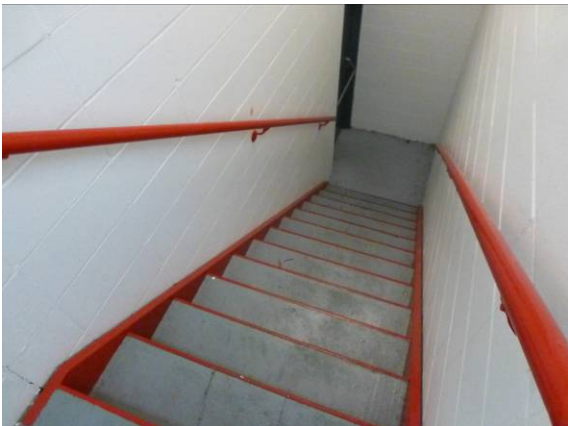
Photo #44:	Interior stairs
------------	-----------------

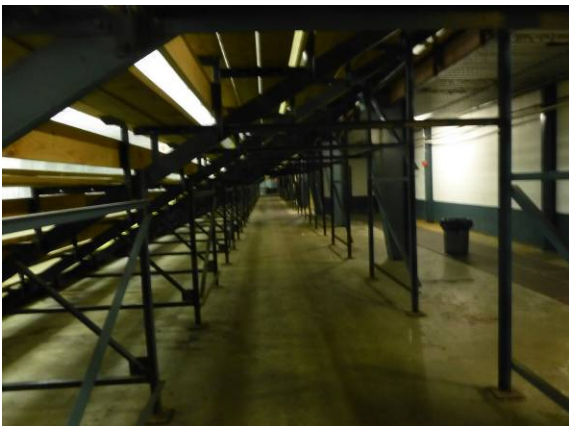
Photo #47:	Bleacher structure
------------	--------------------

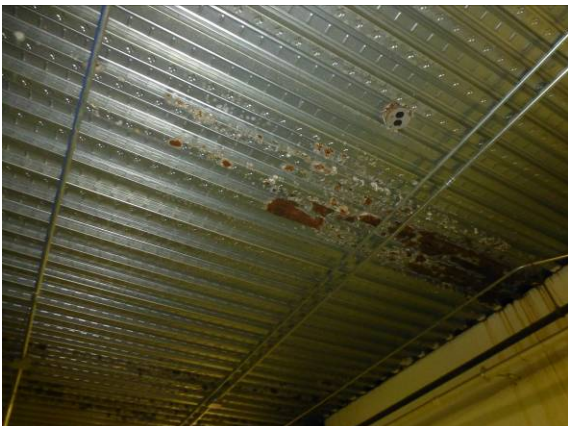
Photo #48:	Mezzanine flooring structure
------------	------------------------------

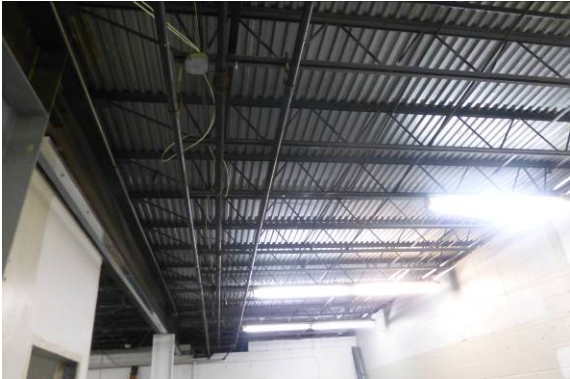
Photo #49:	Flooring structure
------------	--------------------

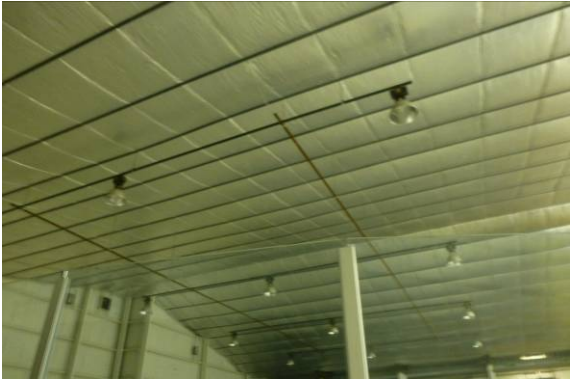
Photo #50:	Ceiling insulation
------------	--------------------

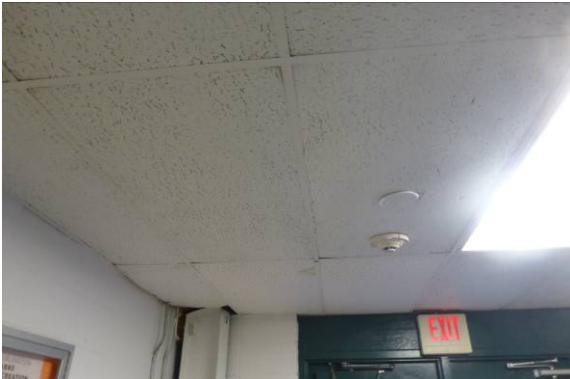
Photo #51:	Ceiling detail
------------	----------------

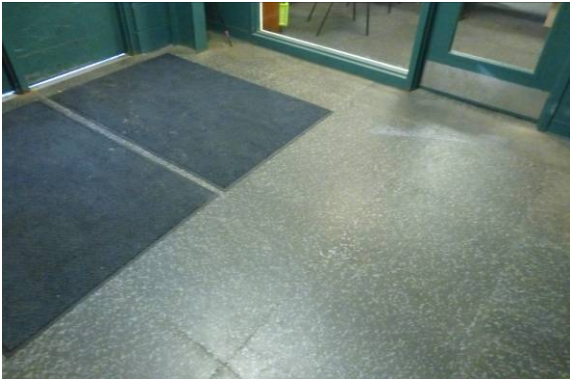
Photo #52:	Flooring detail
------------	-----------------

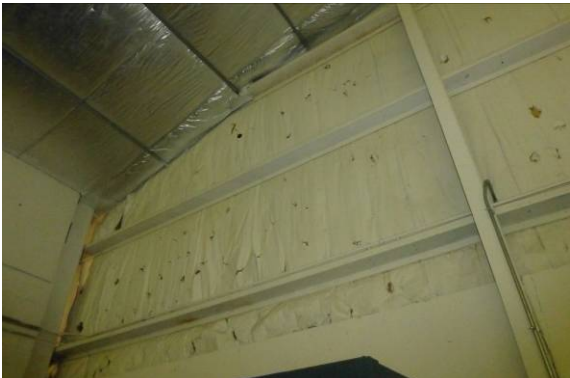
Photo #53:	Wall insulation
------------	-----------------

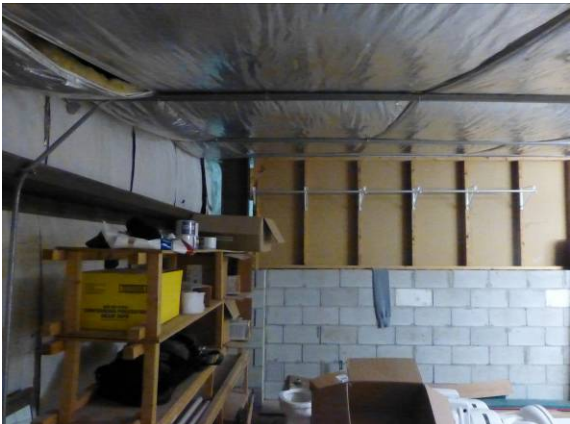
Photo #54:	Wall structure
------------	----------------

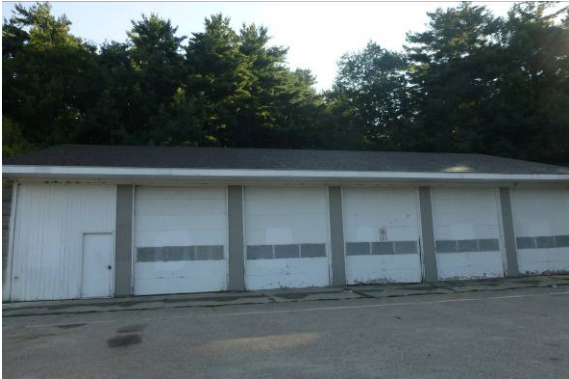
Photo #55:	Service garage front elevation
------------	--------------------------------

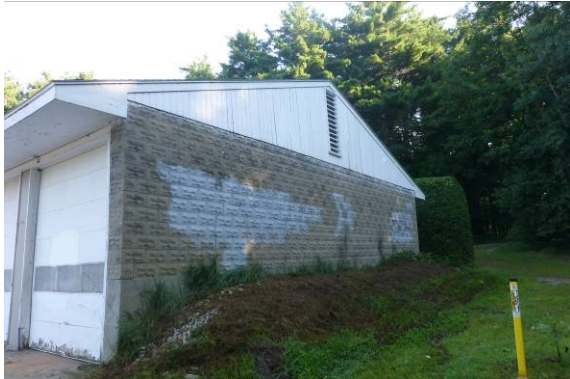
Photo #56:	Service garage side elevation
------------	-------------------------------

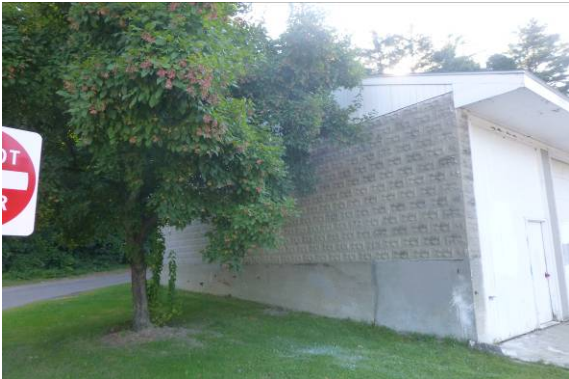
Photo #57:	Service garage side elevation
------------	-------------------------------

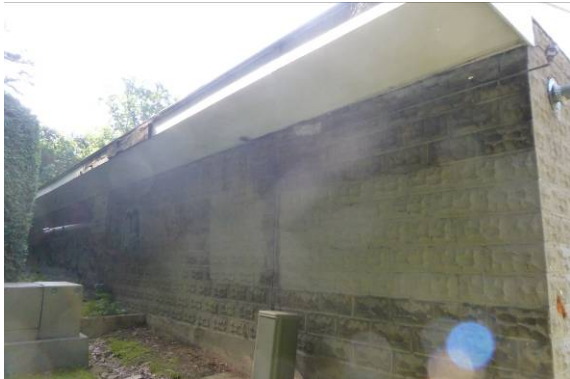
Photo #58:	Service garage rear elevation
------------	-------------------------------

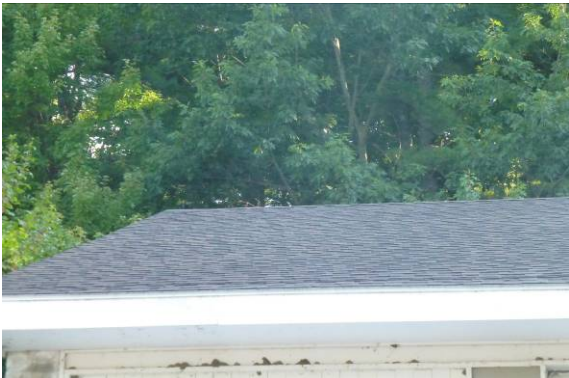
Photo #59:	Service garage roofing
------------	------------------------

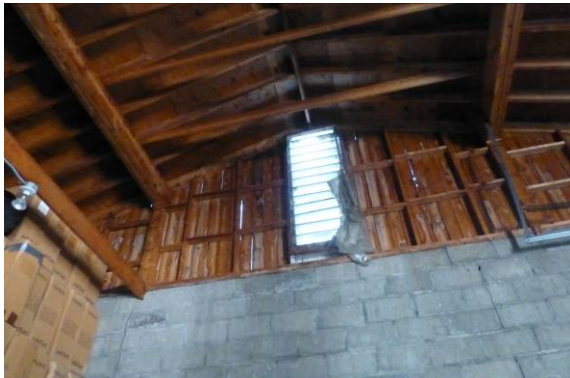
Photo #60:	Service garage structure
------------	--------------------------

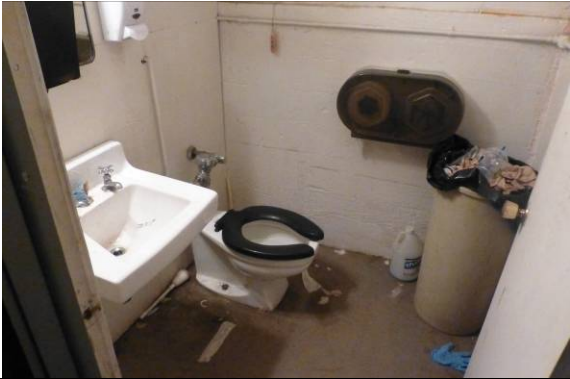
Photo #61:	Service garage bathroom
------------	-------------------------

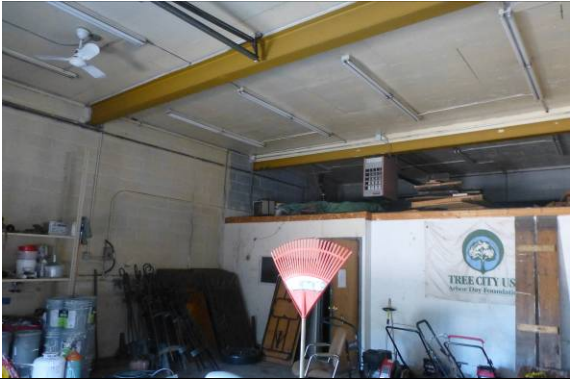
Photo #62:	Service garage interior space
------------	-------------------------------

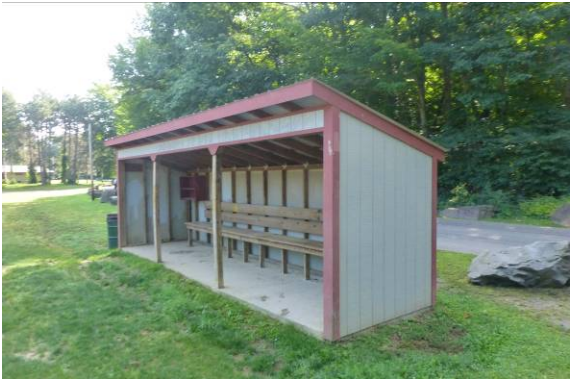
Photo #63:	Dugout
------------	--------

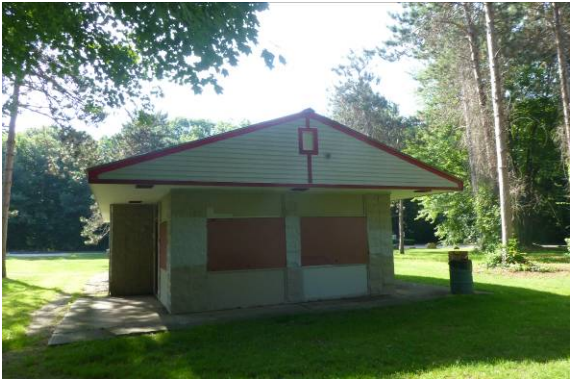
Photo #64:	Park building elevation
------------	-------------------------

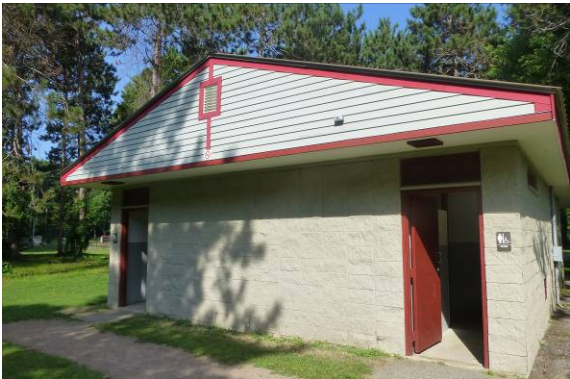
Photo #65:	Park building elevation
------------	-------------------------

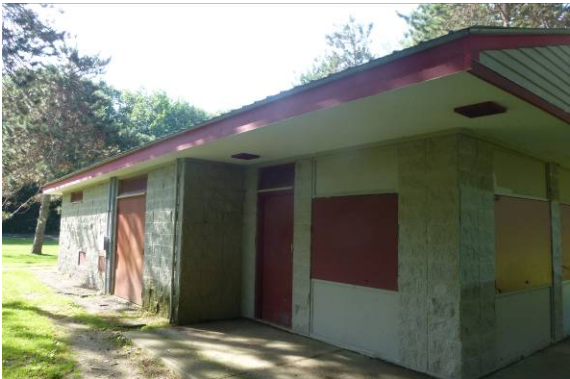
Photo #66:	Park building elevation
------------	-------------------------

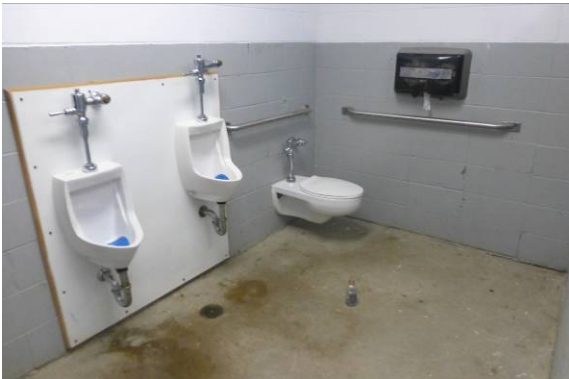
Photo #67:	Park building bathroom
------------	------------------------

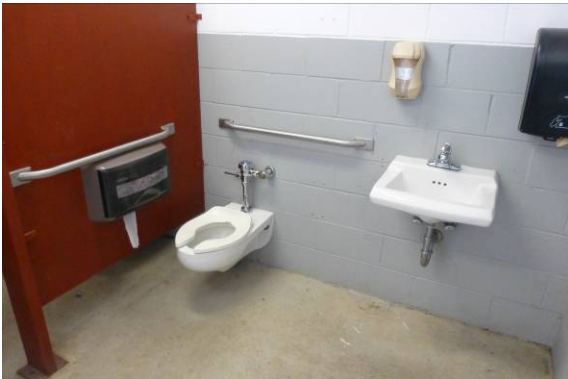
Photo #68:	Park building bathroom
------------	------------------------

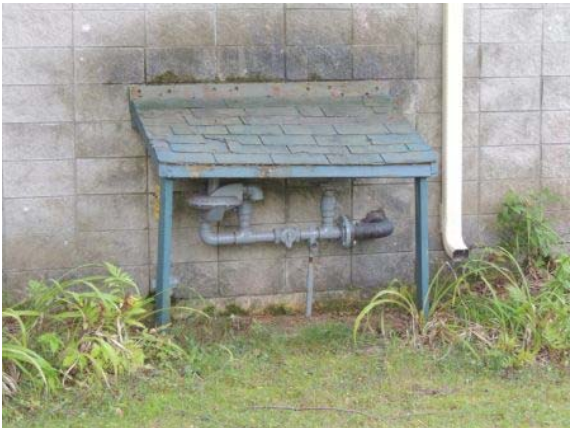
Photo #1:	Primary Natural Gas Meter at East Elevation of Building
-----------	---

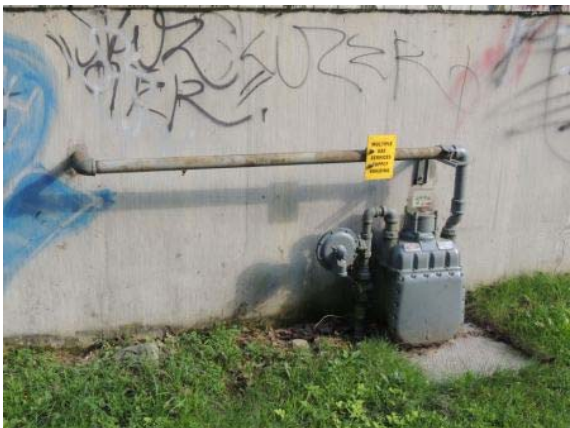
Photo #2:	Secondary Natural Gas Meter at North Elevation of Building
-----------	--

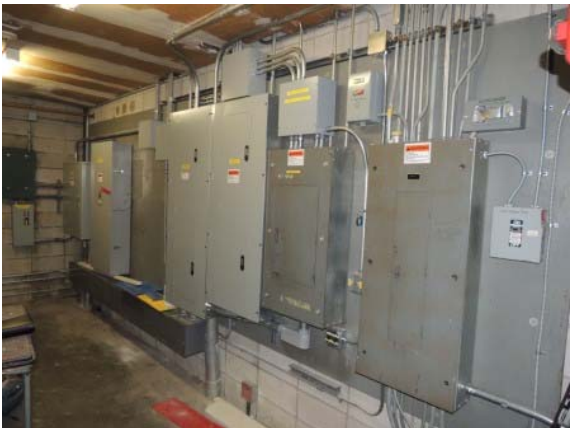
Photo #3:	Incoming Electrical Service located in the Main Electrical Room
-----------	---

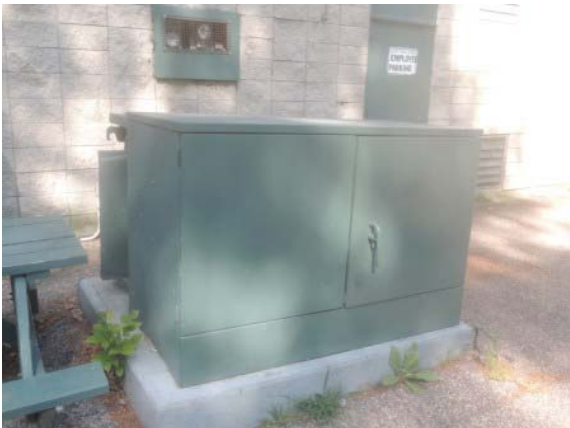
Photo #4:	Primary Electrical Transformer and Electrical Meters at West Elevation of Building
-----------	--

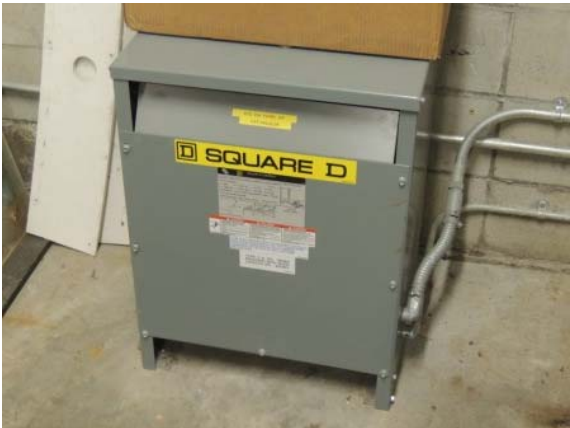
Photo #5:	Secondary Electrical Transformer located in the Main Electrical Room
-----------	--

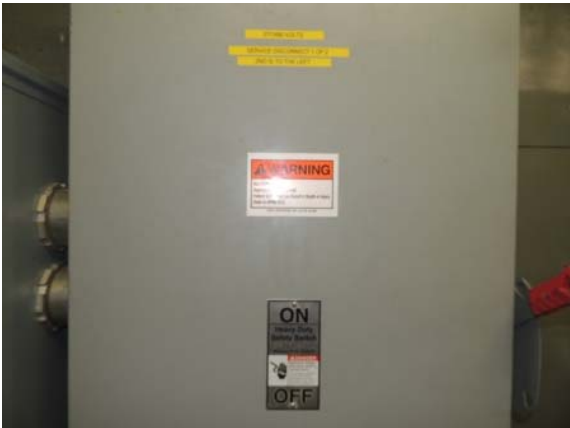
Photo #6:	New Square D Incoming Electrical Service Panels replaced in 2014
-----------	--

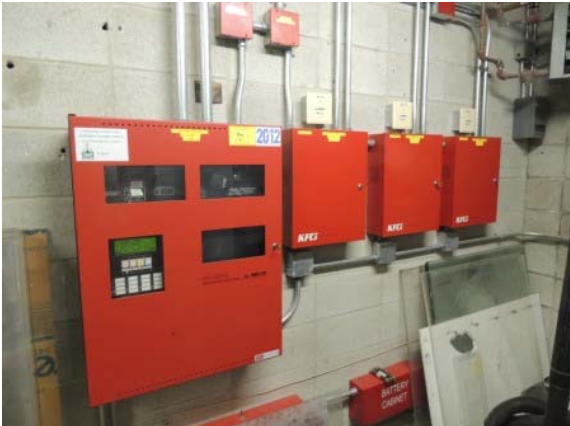
Photo #8:	Main Fire Protection Panel located in the Main Electrical Room
-----------	--

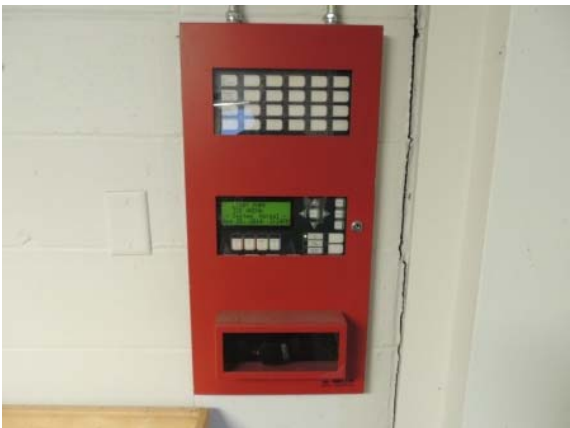
Photo #9:	Secondary Fire Protection Panel located at the Main Lobby
-----------	---

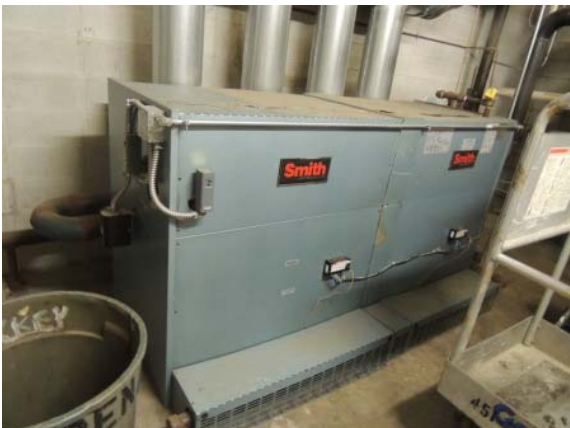
Photo #10:	Smith Gas-Fired Heating Hot Water Boilers located in the Main Mechanical Room
------------	---

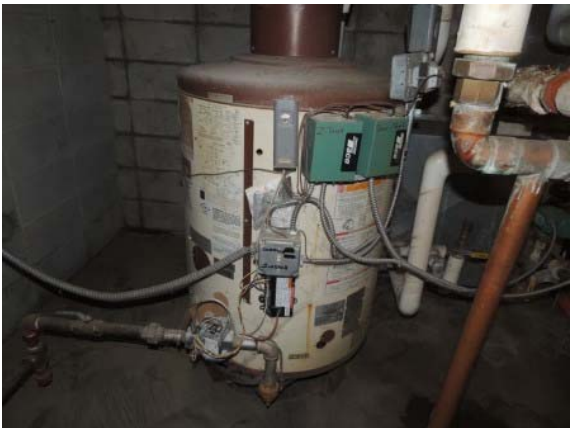
Photo #11:	A.O. Smith Domestic Hot Water Boiler located in the Main Mechanical Room
------------	--

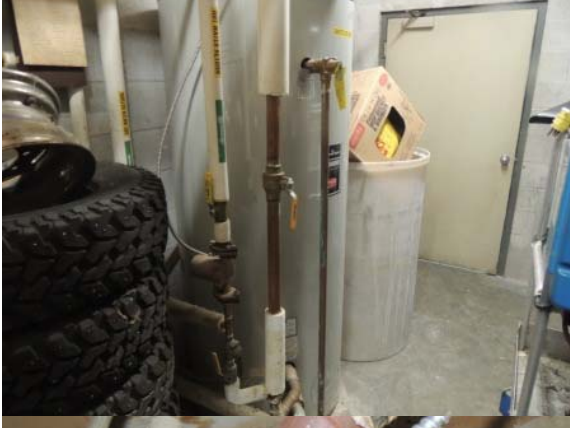
Photo #12:	Bradford White Domestic Hot Water Storage Tank located in the Main Mechanical Room
------------	--

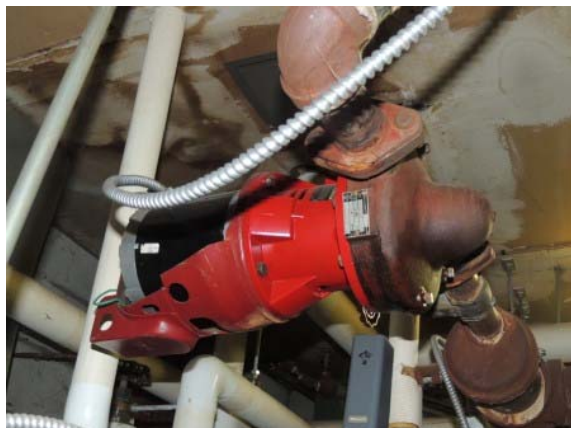
Photo #13: Bell & Gossett Circulation Pump located in the Main Mechanical Room

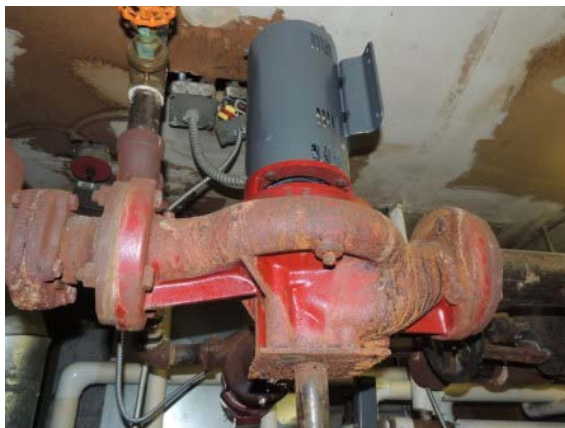
Photo #14: Bell & Gossett Circulation Pump located in the Main Mechanical Room

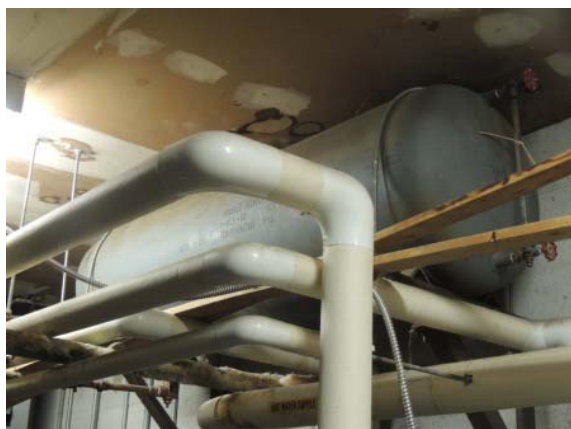
Photo #15: Expansion Tank located in the Main Mechanical Room

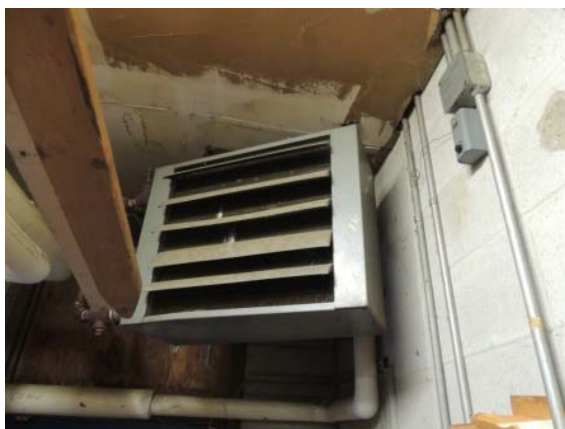
Photo #16: Hydronic Unit Heater located in the Main Mechanical Room

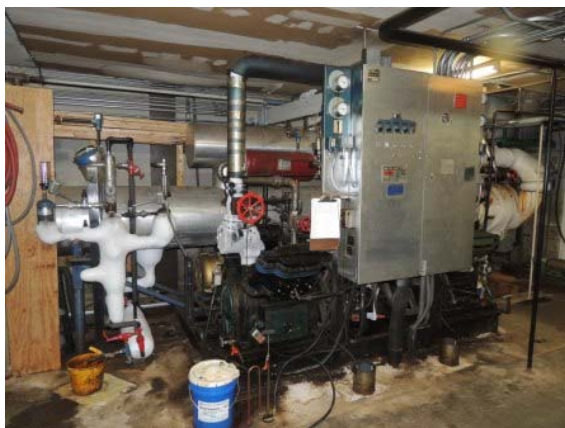
Photo #18: Docal Limited Ice Making Equipment located in the Ice Making Equipment Room

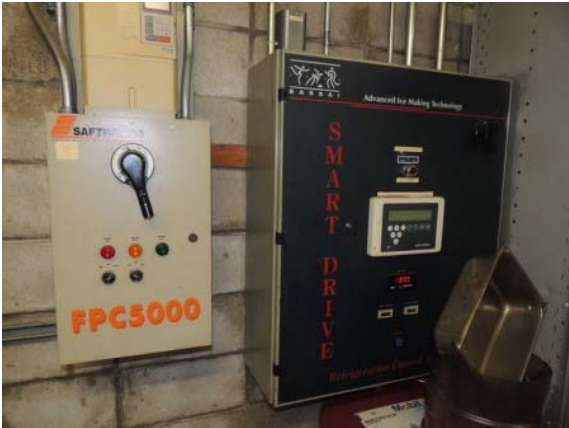
Photo #25: Bassai Ice Making Control System

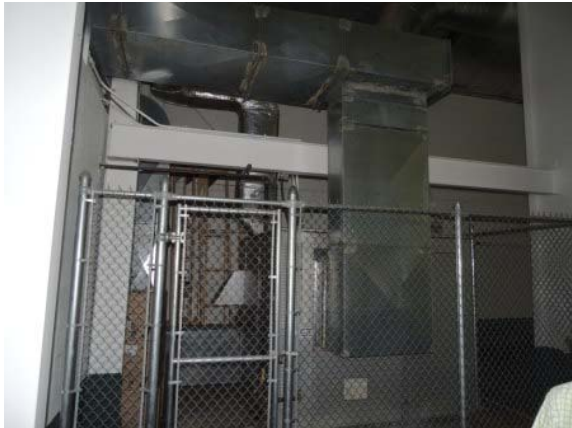
Photo #26: Munsters Building Dehumidification System located in the North-East Corner of the Building

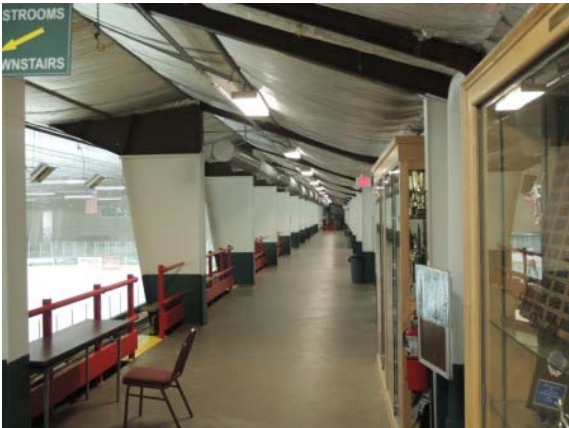
Photo #27: Building Dehumidification Ductwork located above the Main Grandstand

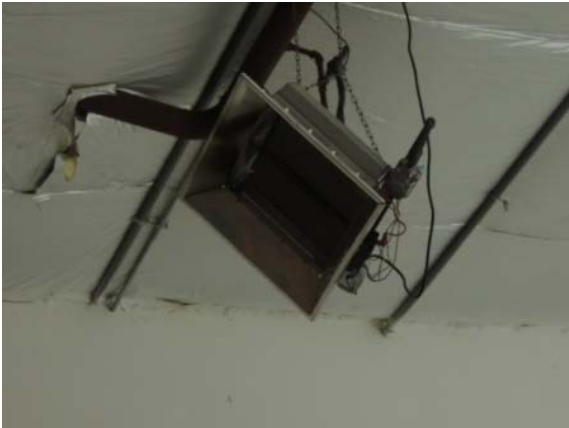
Photo #29: Typical Modine Gas-Fired Radiant Heaters located above the Main Grandstand

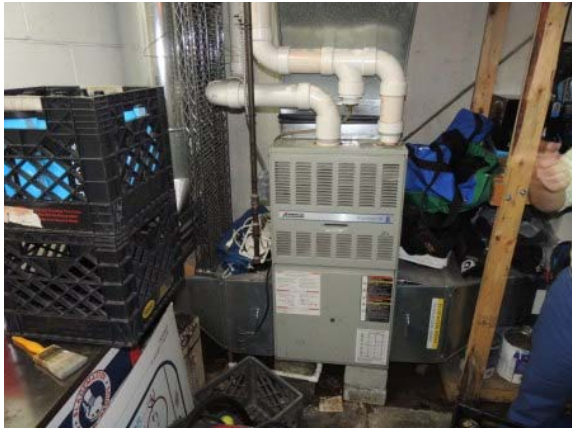
Photo #30: American Standard Gas-Fired Furnace (No Cooling) supplying the High School Locker Rooms located below the Main Grandstand

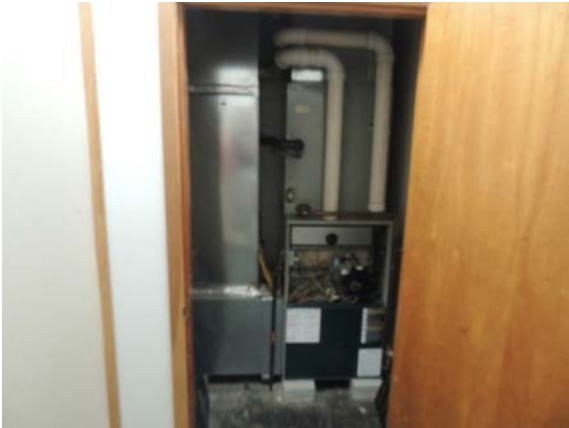
Photo #31:	American Standard Gas-Fired Furnace with Cooling Coil supplying the Main Office Area located on the Second Floor
------------	--

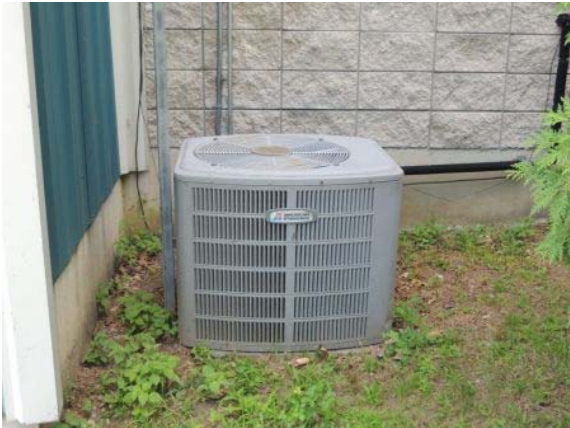
Photo #32:	American Standard Air-Cooled Condensing Unit supplying the Main Office Area located on the Second Floor
------------	---

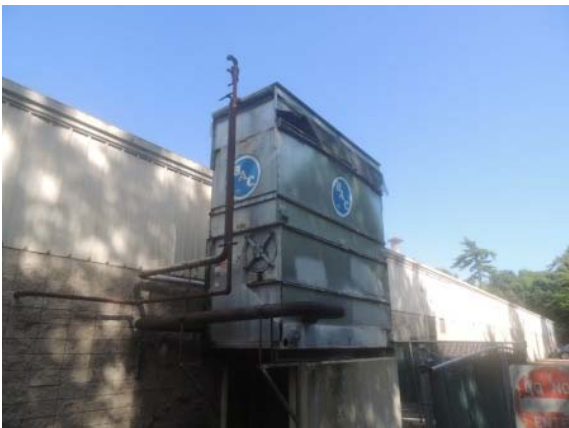
Photo #33:	Baltimore Air Coil Cooling Tower supplying the Ice Making Equipment located at the West Elevation
------------	---

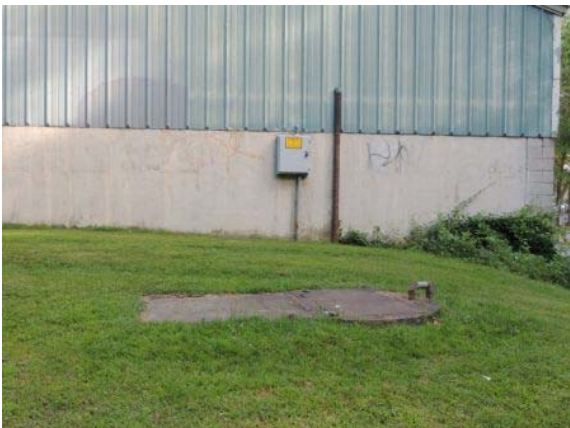
Photo #34:	Lift Station located at the North Elevation
------------	---
