FACILITY CONDITION ASSESSMENT AND ENERGY AUDIT

LEDDY PARK AND ARENA

Leddy Park Road
Burlington, Vermont 05408

EMG Project #: 110226.14R-010.294
Date of Report: October 1, 2014
On-Site Date: August 25, 2014 and August 29, 2014

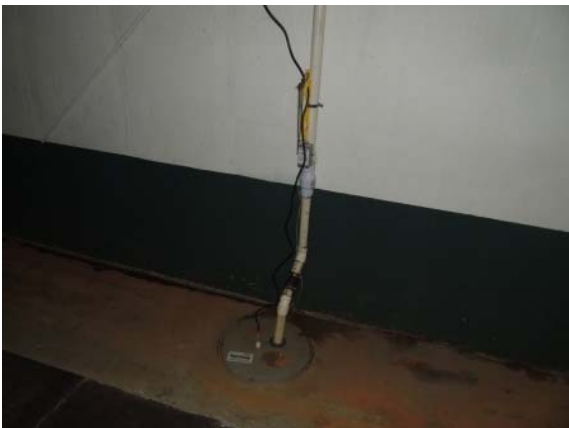
Photo #35:	Sump Pump Located under the Main Grandstand
------------	---

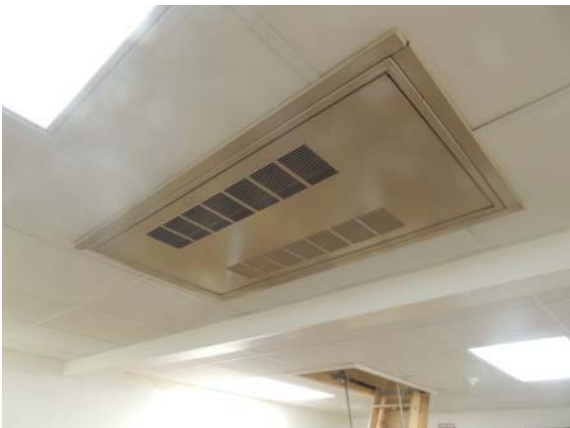
Photo #36:	Typical Ceiling Mounted Hydronic Hot Water Heater
------------	---

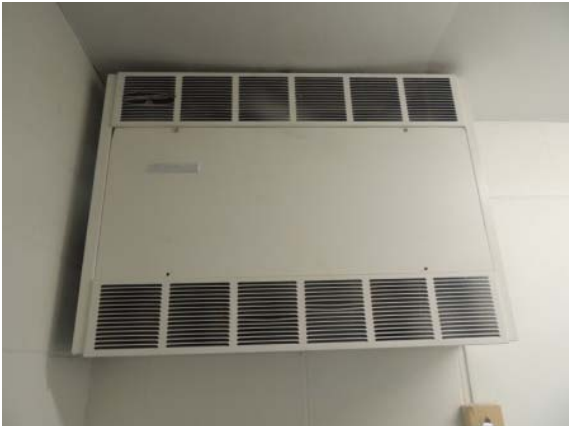
Photo #37:	Typical Wall Mounted Hydronic Hot Water Heater
------------	--

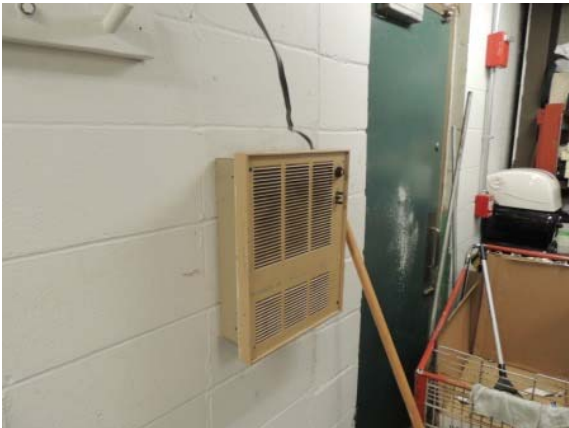
Photo #38:	Typical Wall Mounted Hydronic Hot Water Radiant Heater
------------	--

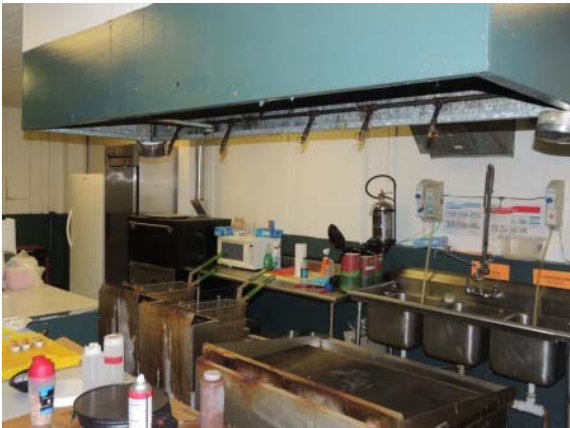
Photo #39:	Typical Wall Mounted Electric Unit Heater
------------	---

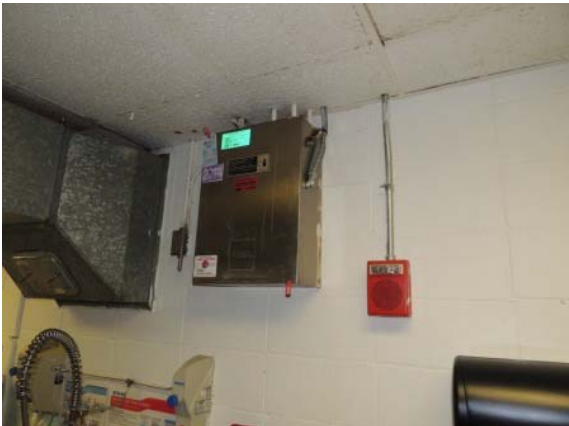
Photo #40:	Concession Kitchen Exhaust Hood with Ansul Fire Protection
------------	--

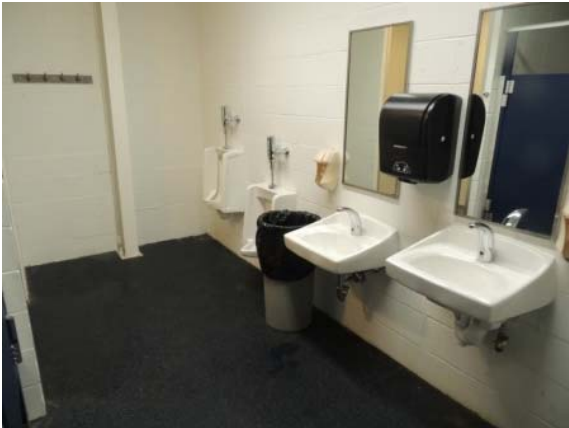
Photo #43:	Typical Shower Room Sink Area with Hands Free Faucets
------------	---

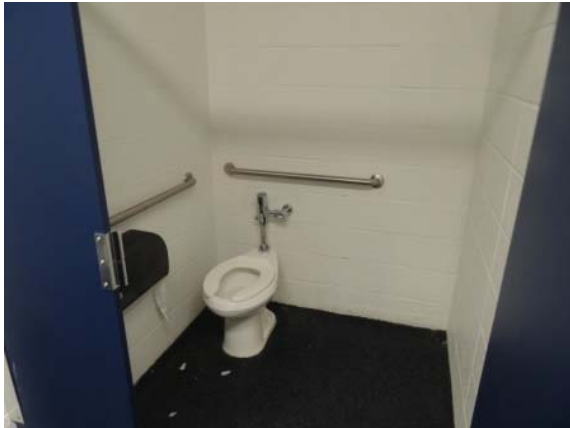
Photo #44:	Typical Shower Room Toilet Area with Hand Free Flush Valve
------------	--

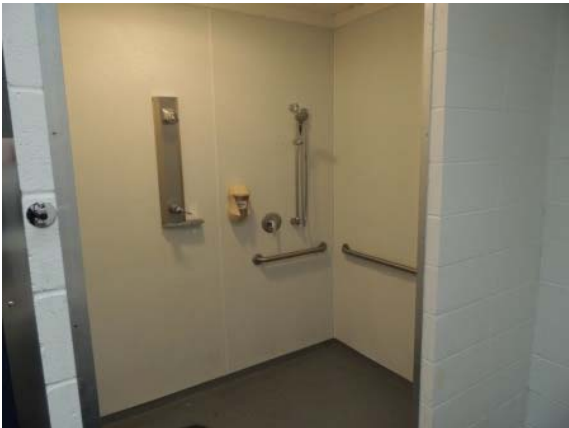
Photo #45:	Typical Shower Room Area
------------	--------------------------

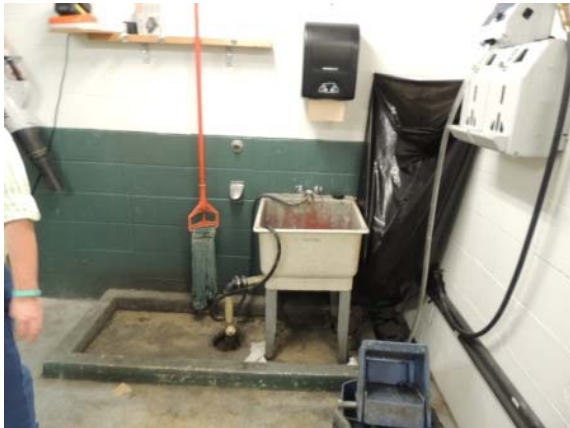
Photo #46:	Mop Sink located In Mechanical Room
------------	-------------------------------------

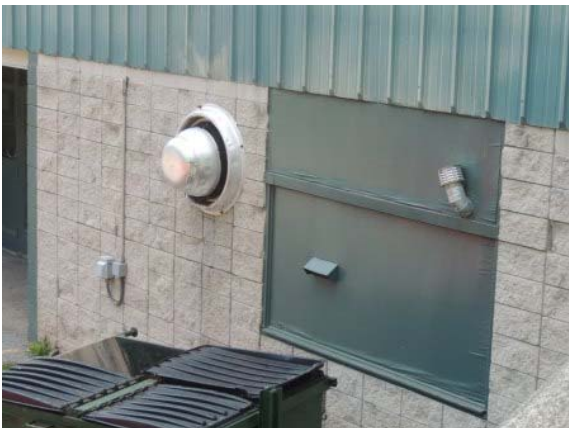
Photo #47:	Typical Side Wall Building Exhaust Fan
------------	--

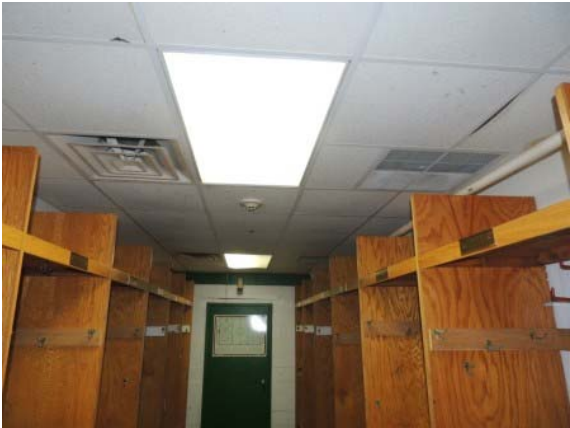
Photo #49:	Typical Locker Room Recessed Florescent Lighting
------------	--

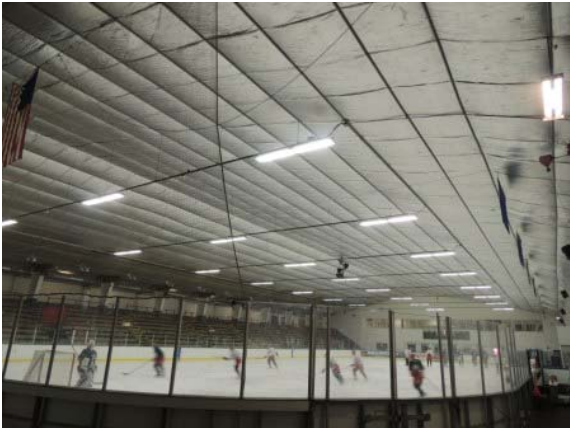
Photo #50:	Main Rink Overhead Florescent Lighting
------------	--

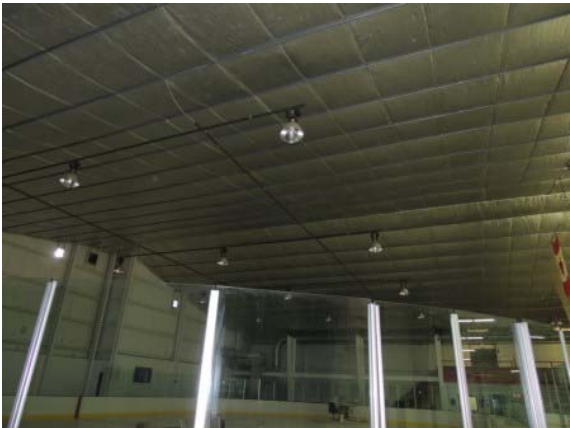
Photo #51:	Secondary Rink Metal Halide Overhead Lighting
------------	---

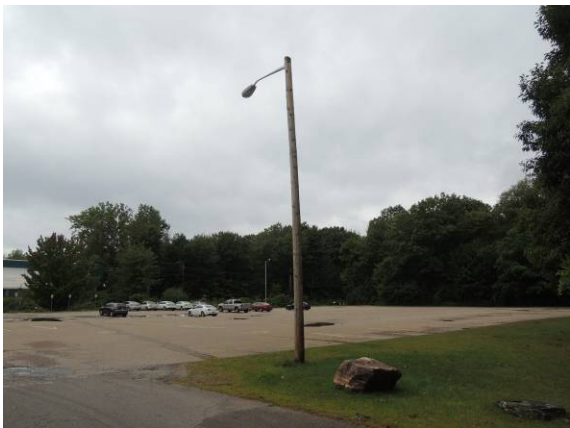
Photo #52:	Typical Utility Owned Site Lighting
------------	-------------------------------------

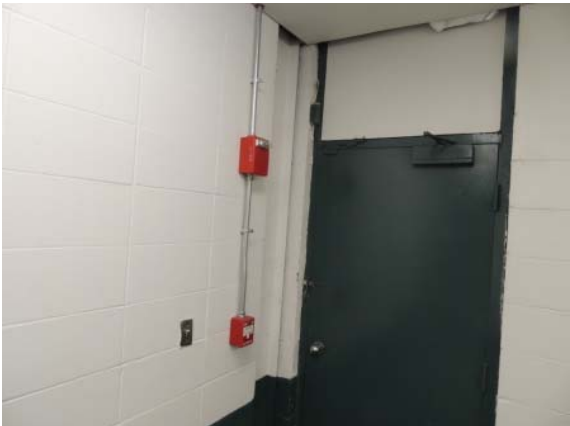
Photo #53:	Typical Fire Alarm Pull Station and Fire Alarm with Strobe
------------	--

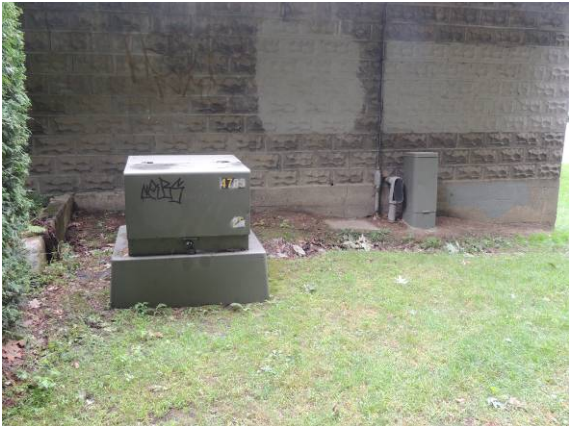
Photo #55:	Electrical Transformer Serving the Maintenance Building
------------	---

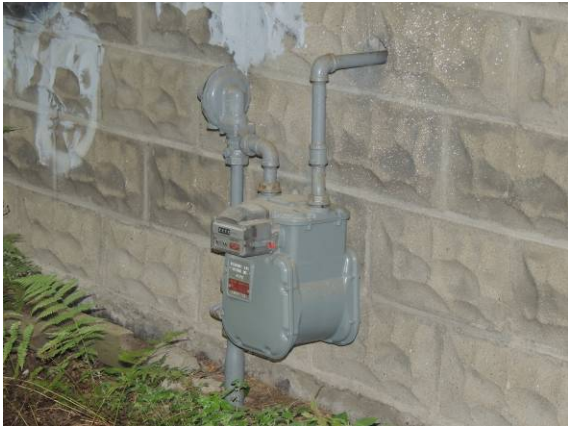
Photo #56:	Gas Meter Serving the Maintenance Building
------------	--

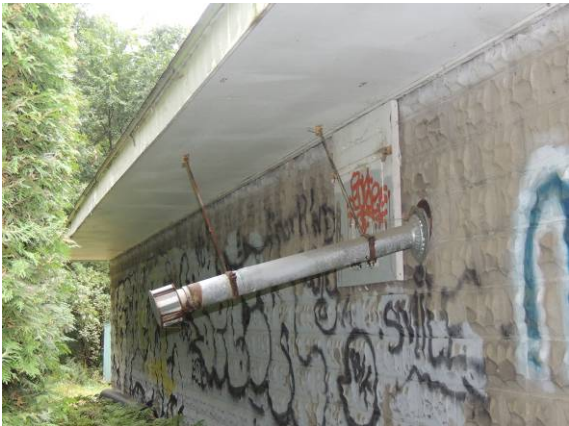
Photo #57:	Unit Heater Exhaust Flue Serving the Maintenance Building (typical)
------------	---

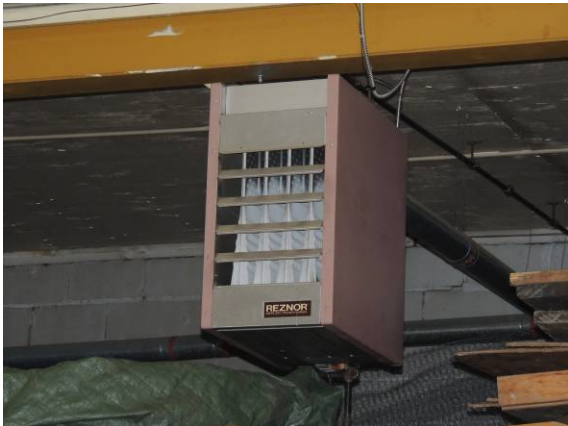
Photo #58:	Gas-Fired Unit Heater Serving the Maintenance Building (typical)
------------	--

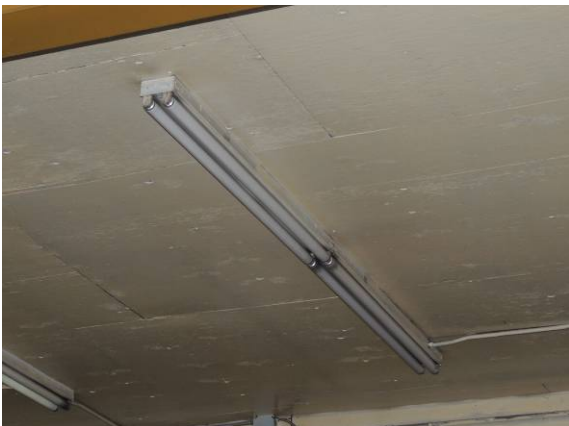
Photo #59:	Surface Mounted Florescent Lighting Serving the Maintenance Building (typical)
------------	--

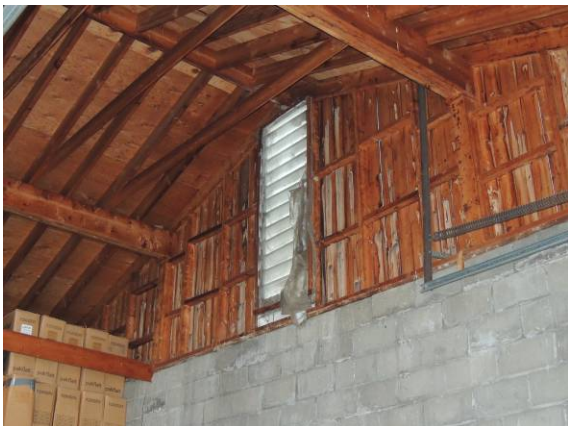
Photo #60:	Building Ventilation Louver Serving the Maintenance Building
------------	--
