FACILITY CONDITION ASSESSMENT AND LEVEL I ENERGY AUDIT

of FIRE STATION #5

23 Ferguson Avenue
Burlington, Vermont 05401

EMG Project #: 110226.14R-005.294
Date of Report: February 27, 2015
On site Date: September 24, 2014

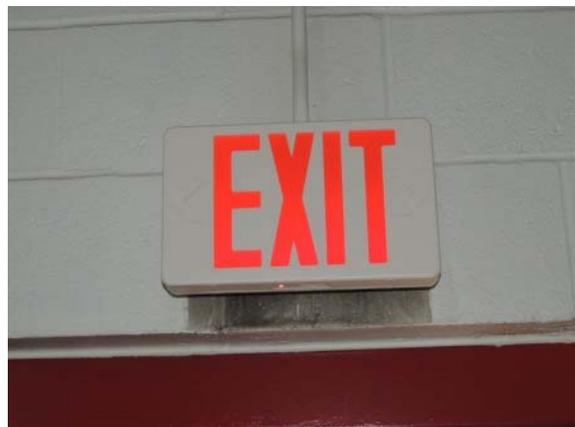
Photo #36:	Typical exit sign
------------	-------------------

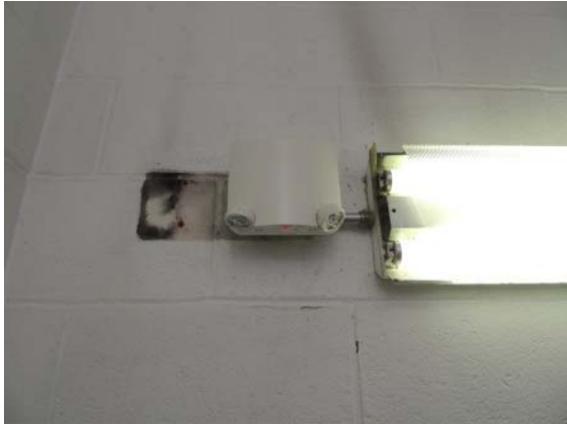
Photo #37: Typical emergency lighting

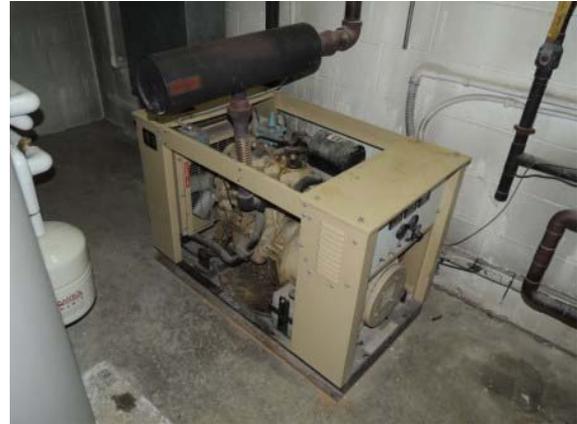
Photo #38: Emergency backup generator located in the first floor mechanical room

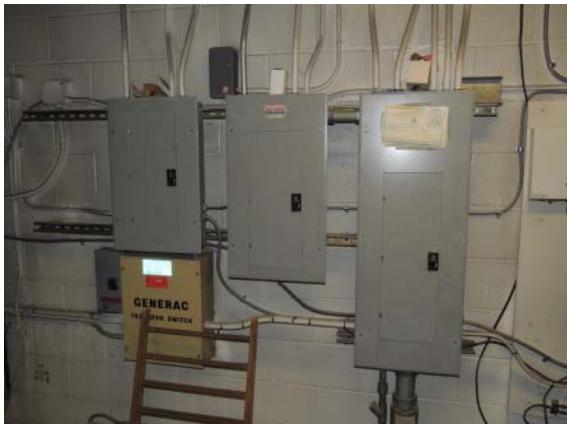
Photo #39: Incoming electrical service located in the first floor mechanical room

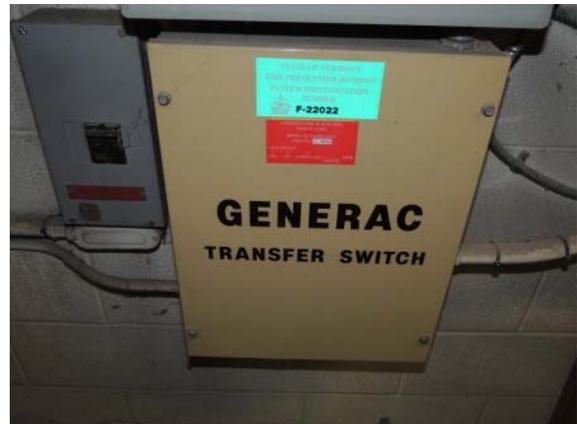
Photo #40: Generator transfer switch

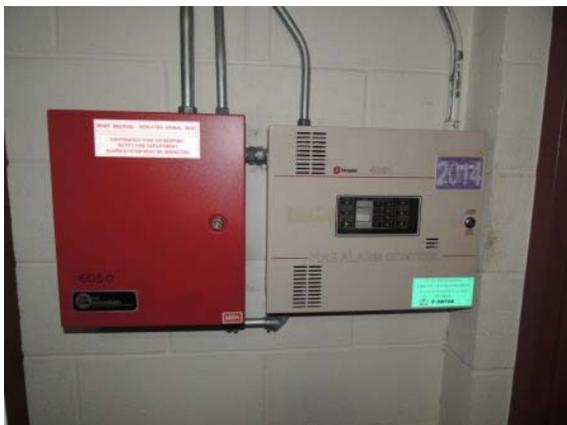
Photo #41: Fire alarm panel

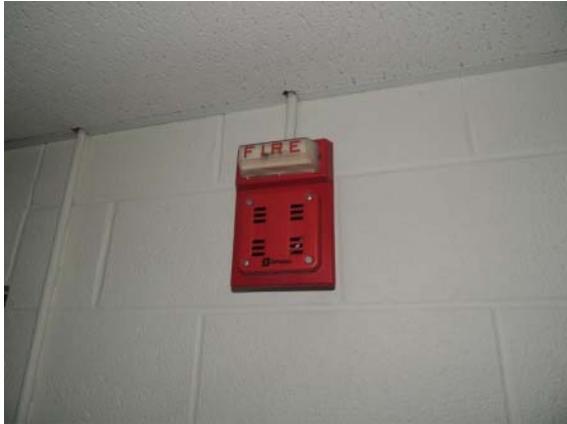
Photo #43:	Typical fire alarm with strobe
------------	--------------------------------

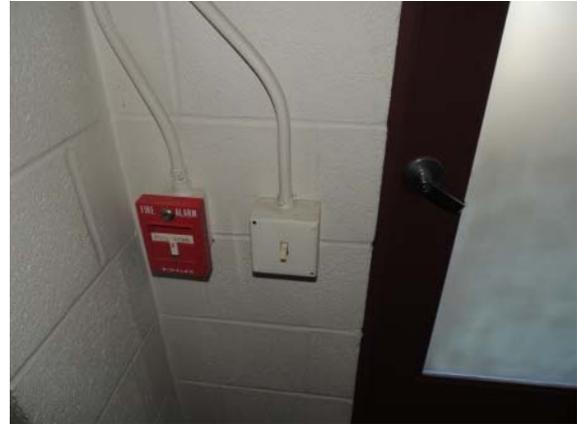
Photo #44:	Typical pull station
------------	----------------------

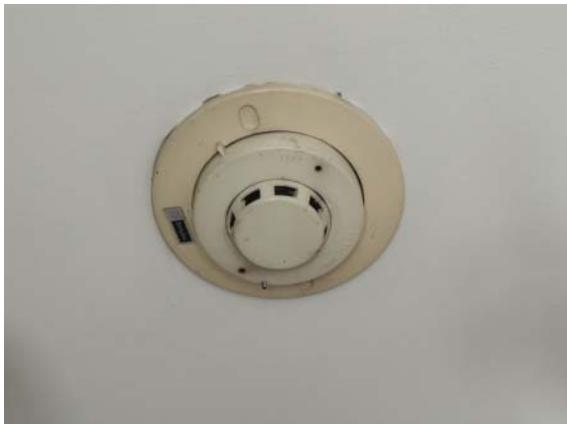
Photo #45:	Typical fire alarm sensor
------------	---------------------------

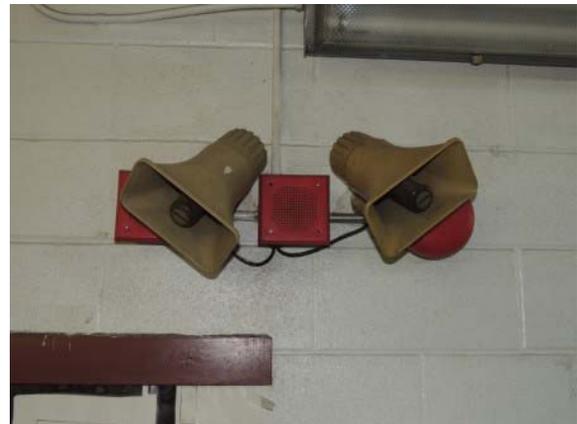
Photo #46:	Fire alarm located in the garage equipment bay
------------	--

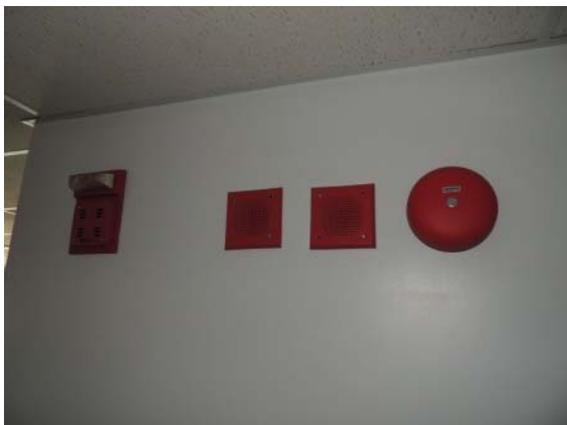
Photo #47:	Fire alarm located in the second floor living quarters
------------	--

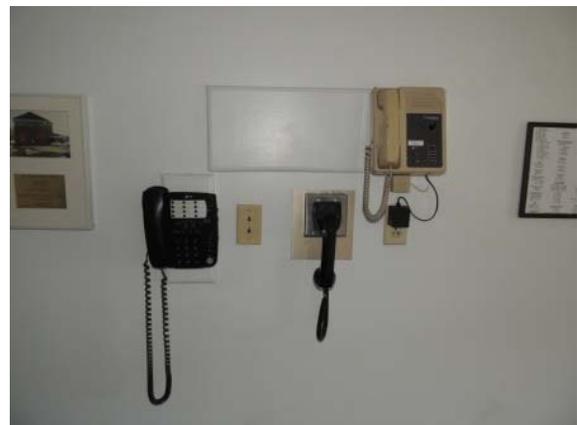
Photo #48:	Communications area located in the second floor living quarters
------------	---

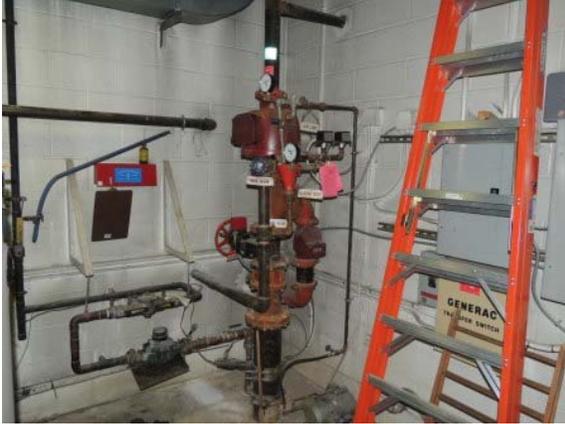
Photo #49: Incoming water and sprinkler service located in the first floor mechanical room

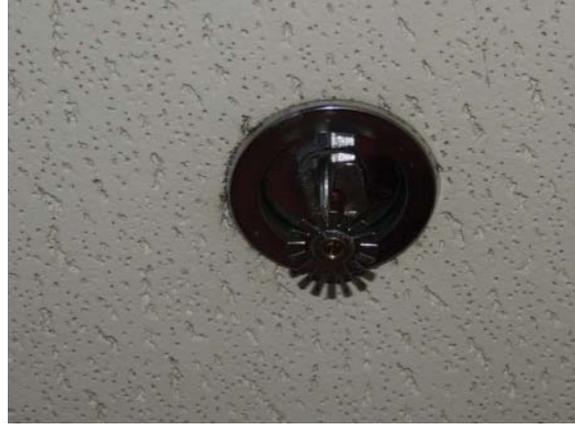
Photo #50: Typical sprinkler

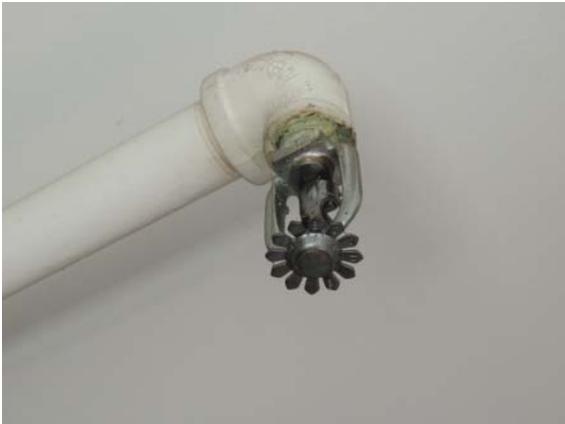
Photo #51: Typical sprinkler

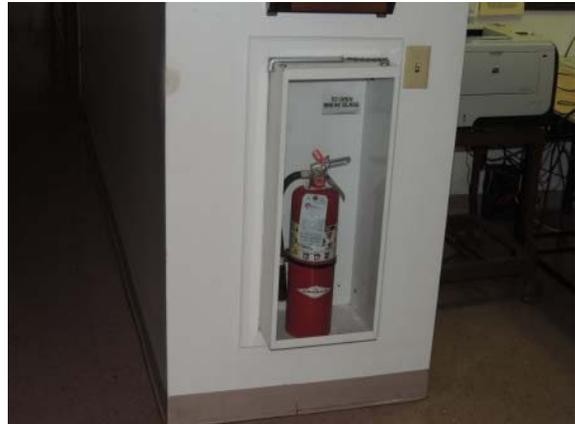
Photo #52: Typical fire extinguisher

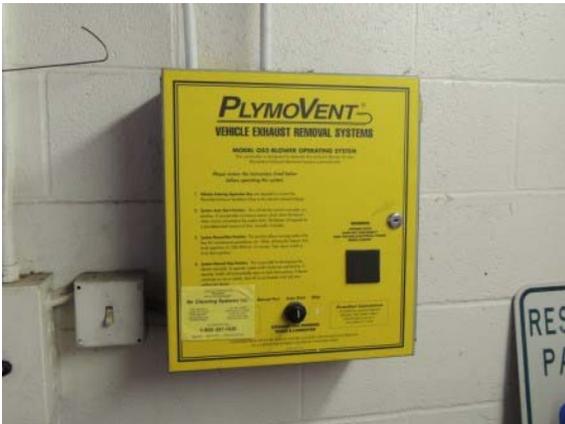
Photo #53: Vehicle exhaust system located in the garage equipment bay

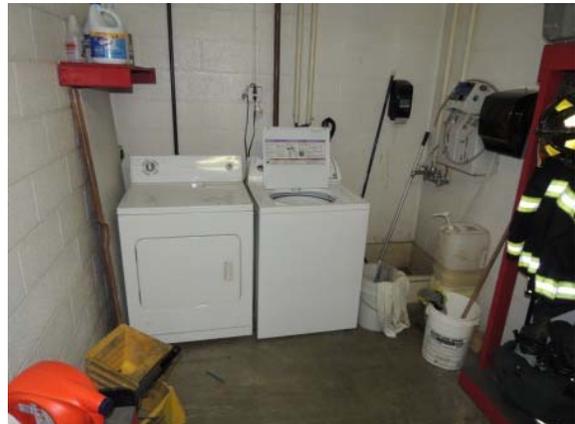
Photo #54: Laundry area located in the first floor equipment storage area
